XXIII SIMPÓSIO BRASILEIRO DE RECURSOS HÍDRICOS

REVIEW OF TAILINGS DAM FAILURES IN BRAZIL

Marcos C. Palu¹ & Pierre Y. Julien²

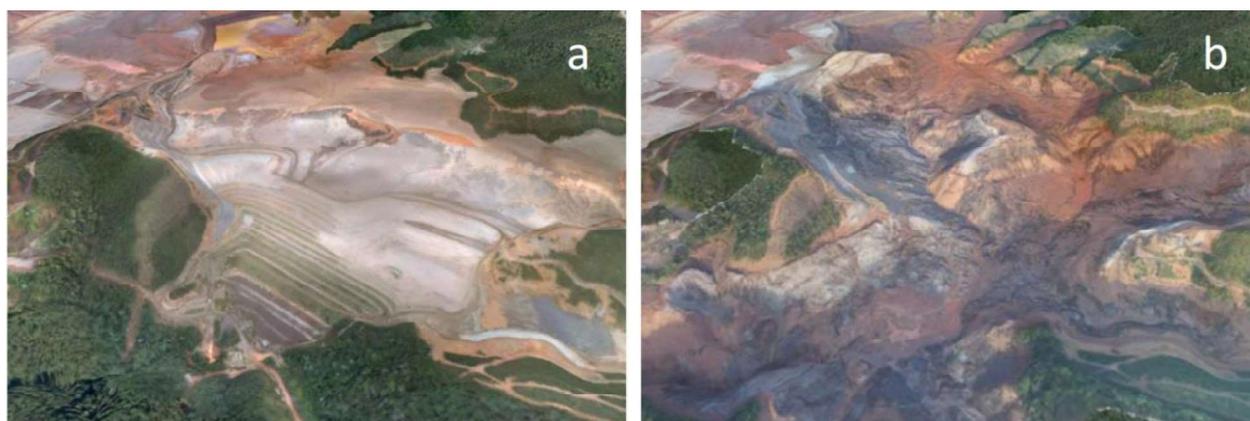
The Fundão Dam was a tailings dam with a height of 120 m designed to store tailings from the local iron mining activities, located in the town of Mariana, State of Minas Gerais. On 5 November of 2015 the Fundão Dam collapsed, the accident occurred at 3:45 PM (local time) being caused by liquefaction and flow sliding of the sand stored in the reservoir (Morgenstern et al., 2016). Figure 1 shows the aerial view of the dam before and after the collapse.

Figure 1 – Fundão Dam before (a) and after failure (b) (Morgenstern et al., 2016)

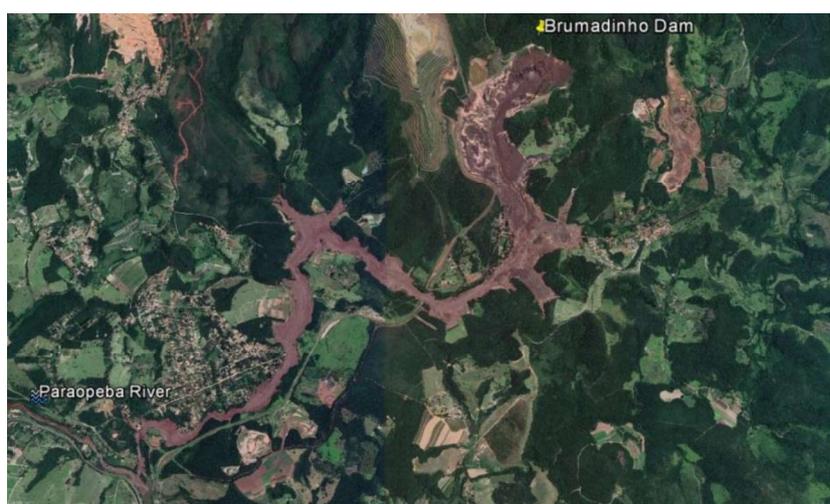
The dam “B1” of the Córrego do Feijão mining, also known as Brumadinho dam, was a tailings dam with a height of 86 m and a stored volume of approximately 12 Mm³, located in the Brumadinho Town, State of Minas Gerais. The dam collapsed on 25 January of 2019 at 12:30 approximately. From the images of the dam collapse recorded in safety cameras was possible to obtain a rough estimate of the flood wave velocity, which reached ≈ 20 m/s. The time of the accident (about lunchtime) and the location of the administrative facilities of Vale (few meters downstream of the dam), resulted in the deadliest accident with tailings dam in Brazil, where 233 people lost their lives, and there are still 52 people missing. Satellite images shows that the mud spread in an area of 2.7 km² (IBAMA, 2019) rapidly flowing to the Paraopeba River, a tributary of the São Francisco River. Figure 2 shows an aerial view from Google Earth of the Brumadinho Dam collapse in 01/02/2019.

Figure 2 – Aerial view of the Brumadinho dam collapse in 01/02/2019 (Google Earth)
