## Rehabilitation of an Incised Stream Using Plant Materials: the Dominance of Geomorphic Processes

*F. Douglas Shields, Jr.*<sup>1</sup>, *S. Reza Pezeshki*<sup>2</sup>, *Glen V. Wilson*<sup>1</sup>, *Weiming Wu*<sup>3</sup>, and *Seth M. Dabney*<sup>1</sup>

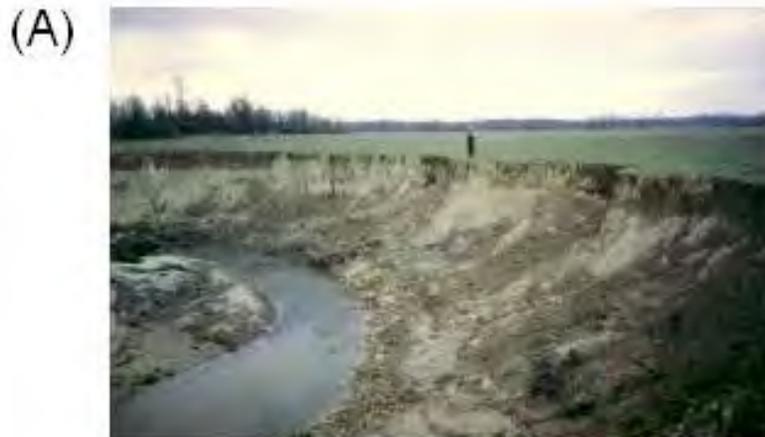
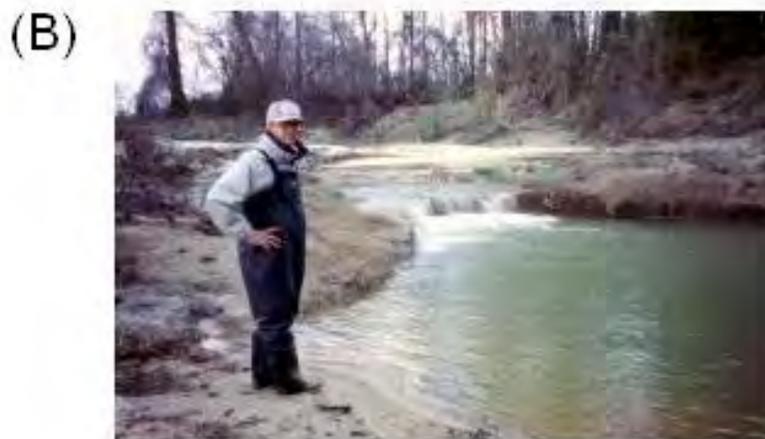
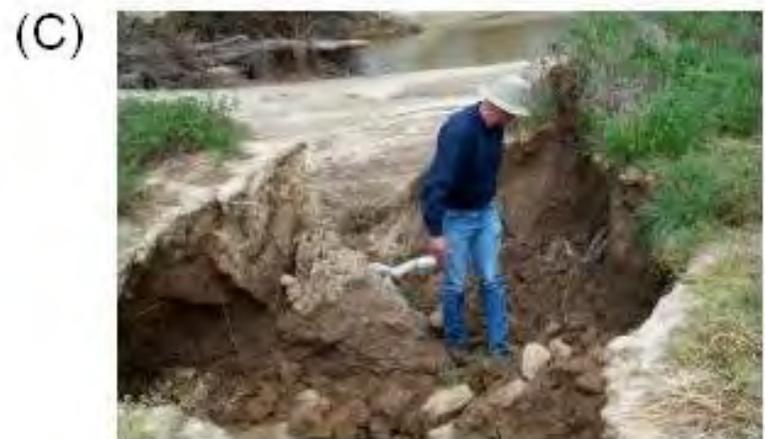
Inputs of sediment to the stream were sporadic because of the episodic nature of bank retreat, headcut advancement, and gully development (Fig. 3). Channel incision triggered the formation of approximately 30 riparian gullies along the study reach because concentrated flows of runoff or floodwaters that returned to the channel following an overbank event produced rapid erosion of the high banks (Dabney et al. 2004). Preliminary estimates suggest that gully erosion produced sediment at a rate equivalent to 42% of the sediment yield for the entire watershed containing the study site (Wilson et al. *unpublished data*). High banks were also sites for piping as a result of seepage erosion because subsurface flows as great as 0.9 m<sup>3</sup>/s with sediment concentrations as great as 660,000 mg/L emerged from individual pipes during rainy

**Fig. 3.** Physical instability along Little Topashaw Creek prior to rehabilitation. (A) Bank erosion, (B) headcut advancement, (C) riparian gully erosion.

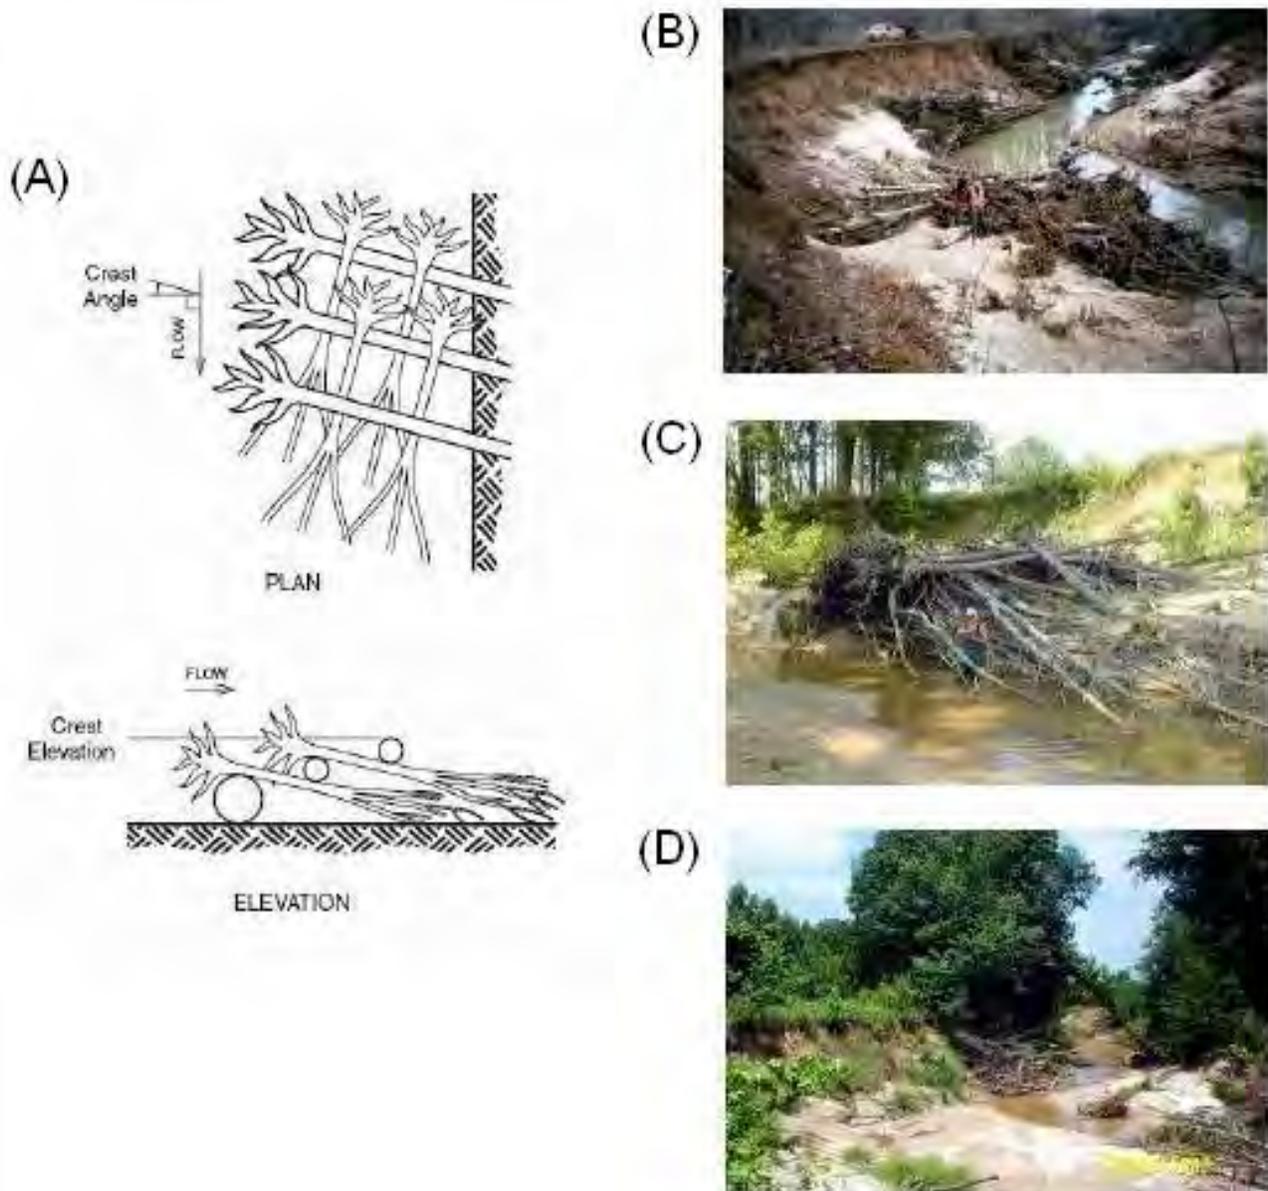
**Fig. 4.** A large wood (LW) structure deployed at Little Topashaw Creek. (A) Design plan and profile. (B) LW structure 5 months after construction; note sediment deposits within the structure. (C) The same structure in (B) 9 months after construction. (D) The same structure in (B) completely disappeared 3 yr after construction.

structures were destroyed and 35% were heavily damaged. Factors involved in failure included the simplification of LW matrices because of breakage and decay, scour of sediments deposited within the structures (Fig. 4B and C), and the failure of earth anchors (USDA 2006b). Structures that were located in sharp bends were most prone to fail. The damage rates were slightly higher for anchored LW structures (20 of 58 damaged) than for those without earth anchors (4 of 14 damaged). Of all anchors, 47% were located upon inspection 2 yr after construction, and 61% of these were not functional. Evidently, the anchors, which were load tested to 4.5 kN when installed, were undersized. The anchor sizing was based on LW structure design dimensions and the assumption that critical conditions would occur shortly after construction. Accordingly, a relatively high wood density of  $750 \text{ kg/m}^3$  was used to compute net buoyant forces. Retrospective computations using as-built dimensions and a wood density of  $450 \text{ kg/m}^3$  produced factors of safety well below unity.

For LW structure design, it was assumed that sediments deposited within the LW structure would add ballast to counteract the increased buoyant force associated with the drying of wood as the structure aged. A geomorphic assessment of the rehabilitation reach indicated that the period of channel deepening typical of incised channel evolution was ending; the natural tendency of the system favored the deposition of large sand berms within the enlarged, eroded channel. Initially, substantial volumes of sediment were captured by the LW structures (Fig. 4B). However, in many cases, sediments deposited during the first high flow season were scoured during the second, and approximately 0.3 m of thalweg degradation occurred throughout the reach.

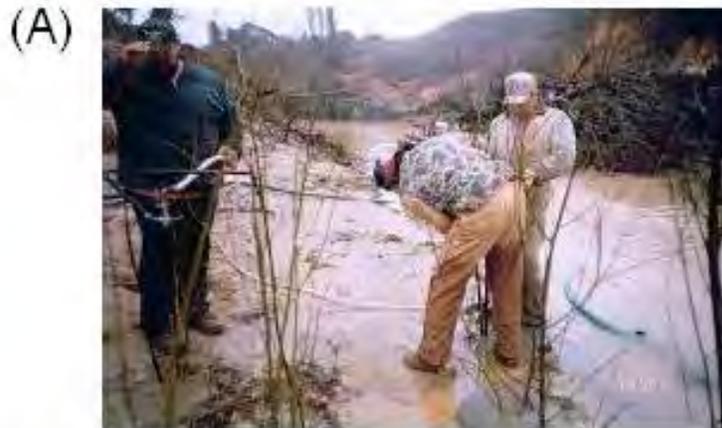
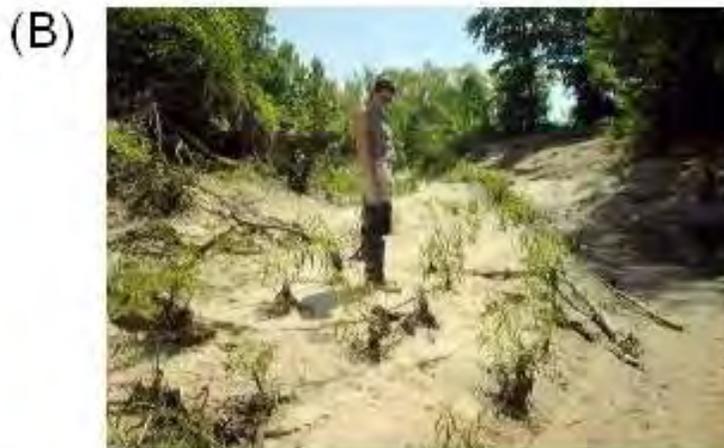
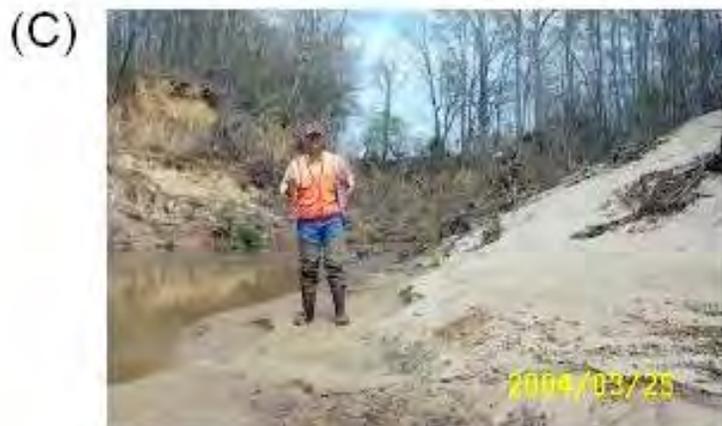
**Fig. 5.** Willow cuttings planted at Little Topashaw Creek. (A) Willows being planted using water jetting. (B) Initial willow stand 4 months after planting, showing effects of herbivory. (C) The same location in (B) 3 yr later, showing no survivors.

Deep channel incision and the attendant flashy hydrology produced drier conditions in upper banks, particularly in banks with sandy soils, which were common even in steep banks. After two growing seasons, the mean willow survival was only ~50% in study plots that were > 0.5 m above the stream at base flow, whereas survival in lower plots averaged 86% (Pezeshki et al. 2007). The soaking of cuttings before planting was beneficial, resulting in 17% higher mean survival and 6% greater leaf chlorophyll content. The effects of soaking were most pronounced for cuttings that were subjected to

More than half of the monitored willows survived the first growing season and > 40% survived two seasons. However, a survey of all of the willow plantings at the beginning of the fourth growing season indicated that the survival rate was < 10% (Fig. 5B and C). Reasons for planting failure likely include erosion and sedimentation (channel stability), competition from exotics, and chronic herbivory by beaver (Pezeshki et al. 2007), although there were indications that limited, acute herbivory was not harmful (Li et al. 2005).

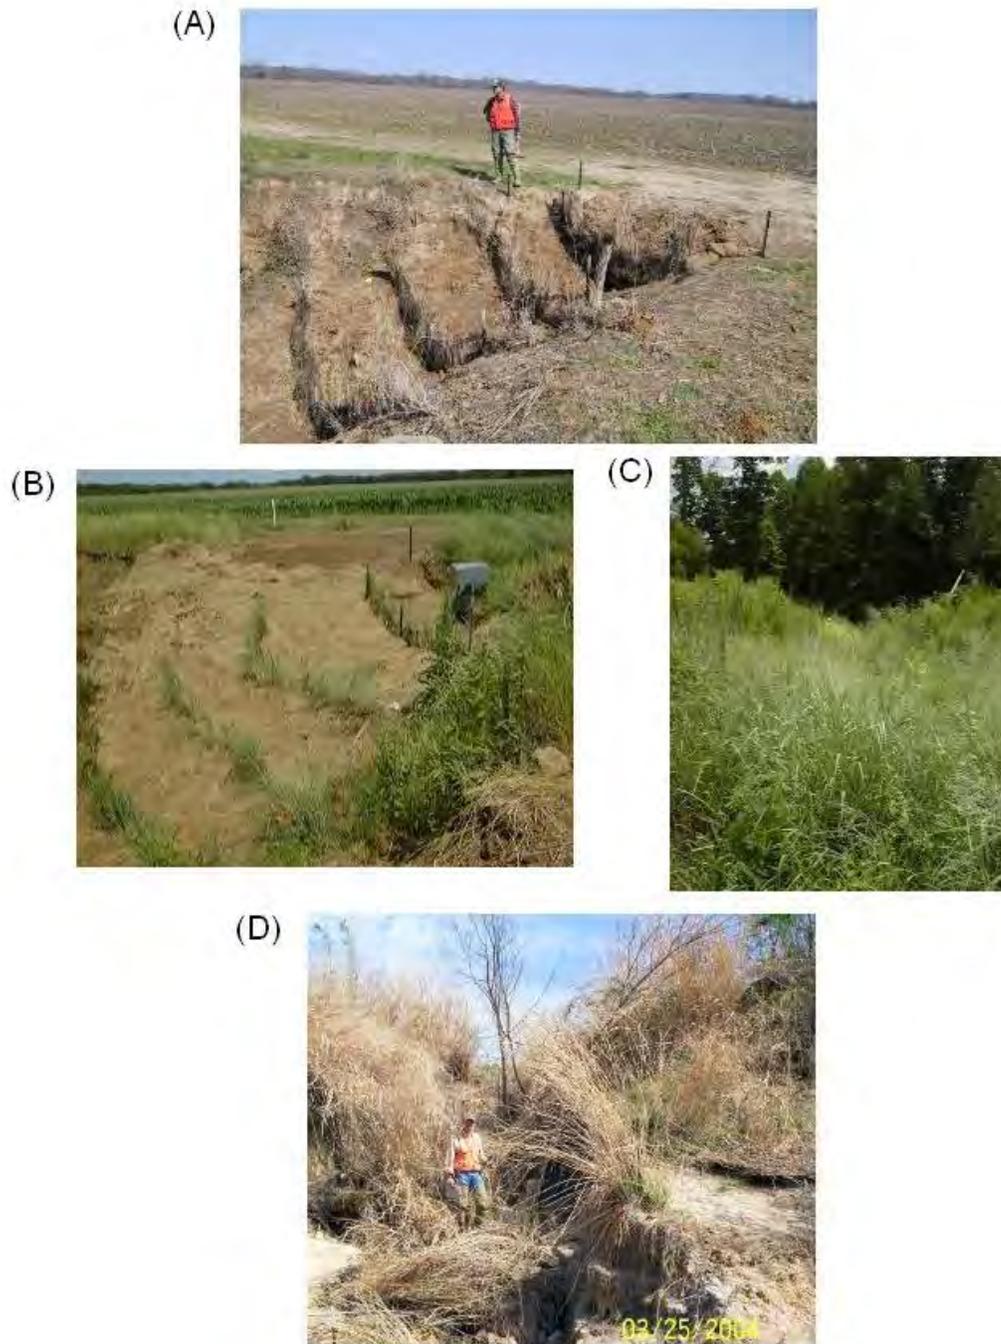
**Fig. 6.** Riparian gully stabilization using switchgrass hedges at Little Topashaw Creek. (A) Gully immediately after shaping and planting, showing silt fences placed just below each grass hedge. (B), (C) Development of grass during the first growing season. (D) View from the stream channel 3 yr after planting.

Although hedges were successfully established and effectively stabilized riparian gully side slopes (Fig. 6B and C), treated gullies were vulnerable to headcuts > 0.5 m high that advanced from the stream channel into the gully. Gully control with grass hedges failed in three modes (Dabney et al. 2004, Shields et al. 2005). The most immediate failure occurred at the gully toe, where sand bars up to 2 m deep either buried the hedges or did not provide a stable substrate for grass establishment. Large headcuts developed from the toe and progressed

upslope. The second mode of failure occurred when the gully slope was too steep to allow the formation of plunge pools between hedges, leading to direct impingement of cascading flows onto exposed bare soil surfaces (Dabney et al. 2004). This mode of failure was most common on unshaped inlets. The third and most troublesome failure mode was the gradual grain-by-grain soil detachment that eventually washed the soil away from the grass roots, leading to deep incision through the grass hedges. Visual inspection of all of the treated gullies during the sixth year after treatment showed that all

supported dense stands of switchgrass, but all were being dissected by headcuts 0.5 to 1 m high that advanced headward from the stream channel (Fig. 6D).

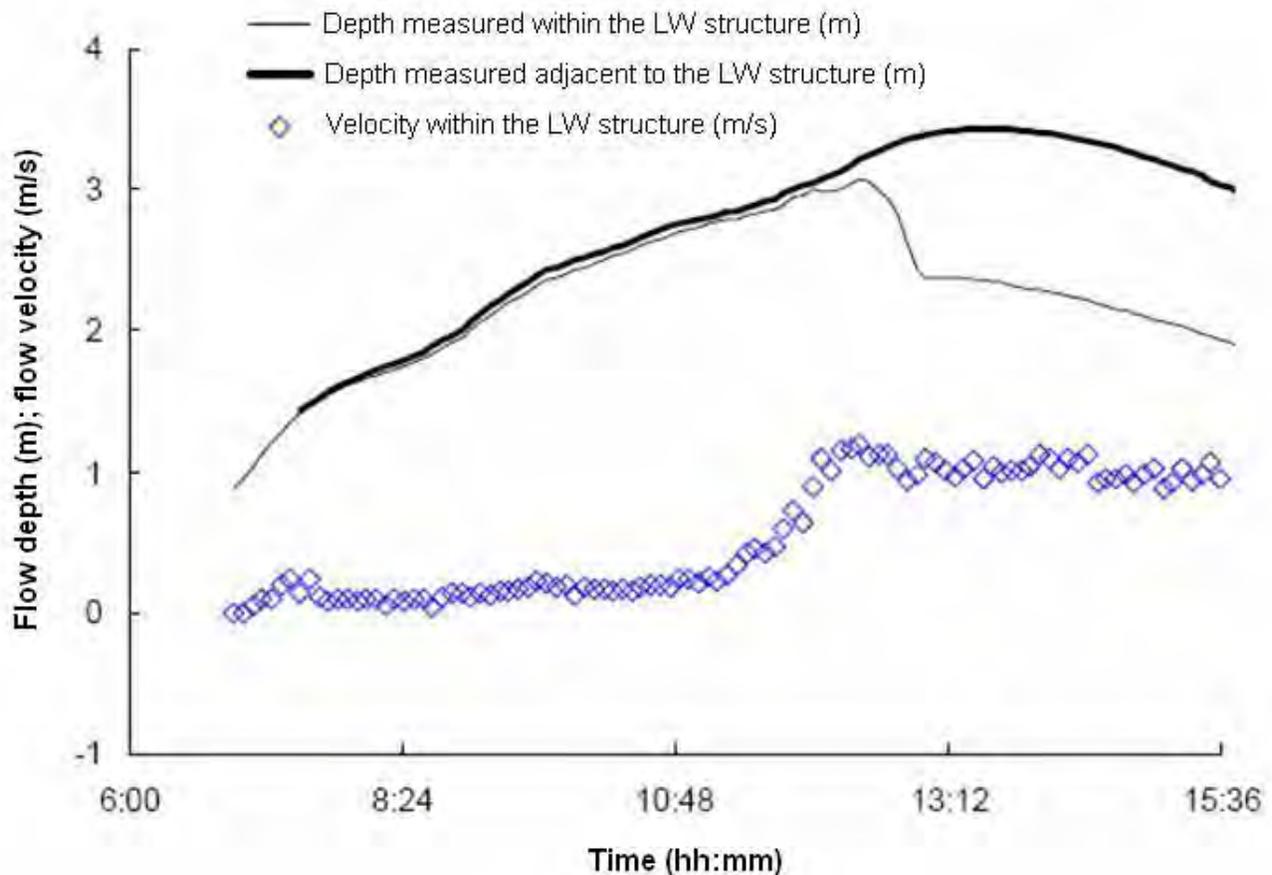
Typical failure processes are illustrated by detailed data from one LW structure. Acoustic Doppler velocity loggers recorded the depth and velocity within and adjacent to an LW structure located at the apex of a bend with a ratio of top width to bend radius of  $\sim 1.0$ . During the rising limb of a large flow event that occurred approximately 16 months after construction, part of the structure apparently shifted, allowing velocities within the structure to increase rapidly from 0.2 to 1.2 m/s, greatly exceeding the critical level for the sandy bed material and approaching the velocity recorded at the adjacent channel centerline (Fig. 9). The structure failed shortly thereafter.

**Fig. 9.** Water depth measured at the channel centerline adjacent to a large wood (LW) structure during a storm event on Little Topashaw Creek and simultaneous measurements of water depth and velocity within the structure. The sudden drop in the curve representing water depth within the structure corresponds to dislodgement of the log to which the sensor was attached. Note the increase in current velocity just prior to the movement of the log.
