Mississippi River Levee Failures: June 2008 Flood

ABSTRACT: *During the spring and summer of 2008, record rainfall in the Midwest United States led to severe flooding as water overtopped the levees bordering the Mississippi River and its tributaries. The erosion associated with the overtopping resulted in levee breaches in many places. After the flooding, a field reconnaissance team was sent to collect time-sensitive data and provide a comprehensive overview of the performance of the levees during the flooding.*

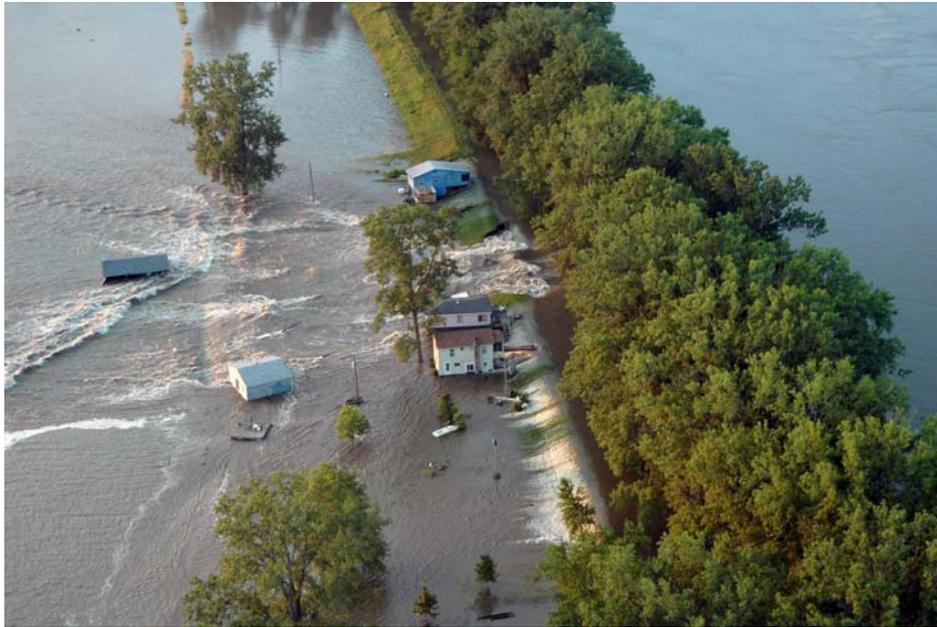
The first site visited during the 2008 Midwest Levee reconnaissance was the Winfield-Pin Oak site near Winfield, Missouri. The levee breached on June 18, 2008. A gap approximately 150 m long was created in the levee by the overtopping waters. Figure 12 is a photo taken by the St. Louis District USACE showing an aerial view as two homes were knocked off their foundations by the force of the water. Figure 13 shows the same site on September 29, 2008 during the Midwest Levee reconnaissance. It should be noted that the breach shown in Figure 13 was contained between the blue and white houses shown in Figure 12 even though overtopping was also occurring further down the levee.

Figure 12. Winfield-Pin Oak breach (USACE St. Louis District 2008).

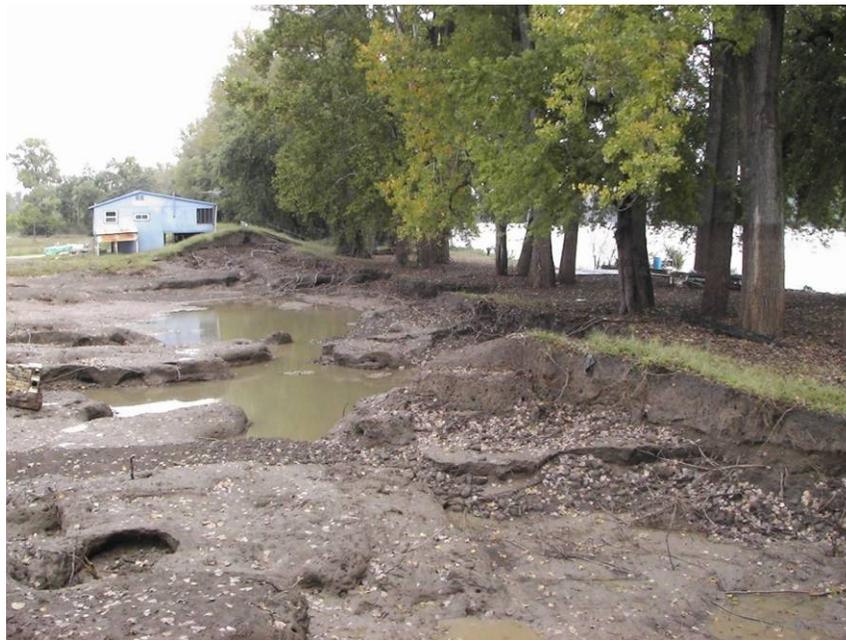
Figure13. Winfield-Pin Oak site, Missouri.

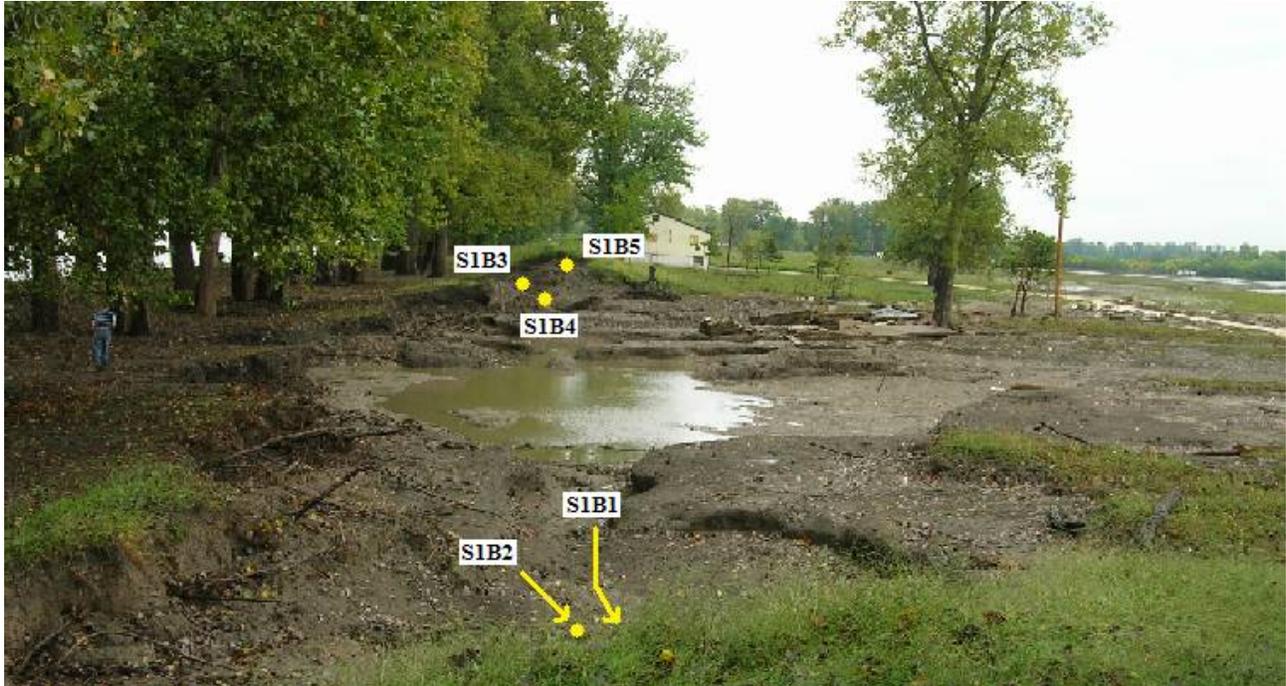
Figure 15. Boring locations Winfield – Pin Oak breach looking south.

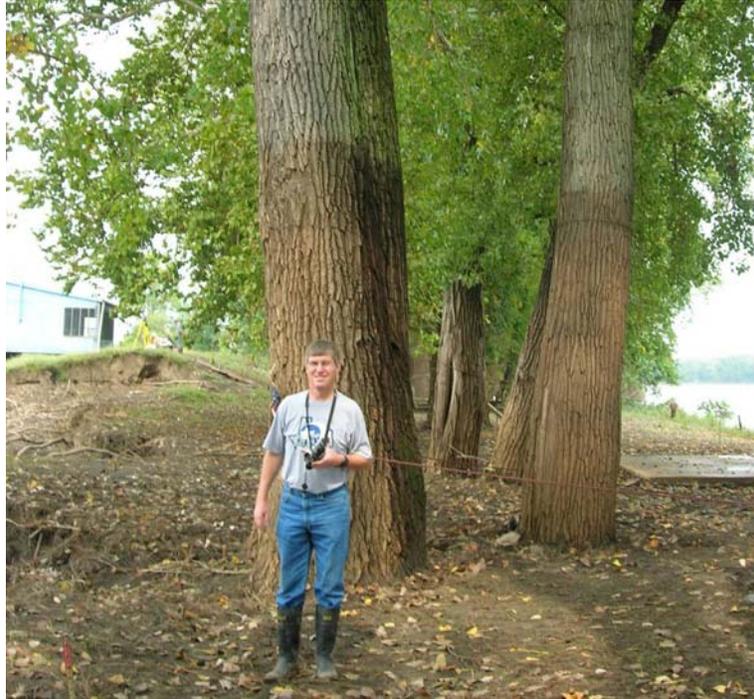
The Mississippi River runs North to South at this location. The levee borders the West river bank while the East bank is bordered by natural cliffs which provide a barrier for the flood waters and force the rising water into the levees. The water line on the trees that border the river side of the levee (Figure 16) was about 1 m higher than the existing levee crests indicating that during peak flow the water was overtopping the levee by almost 1 m. It also shows that the overtopping duration was long enough to leave a water mark or mud line on the trees.

Figure 16. High water marks on trees bordering levees.

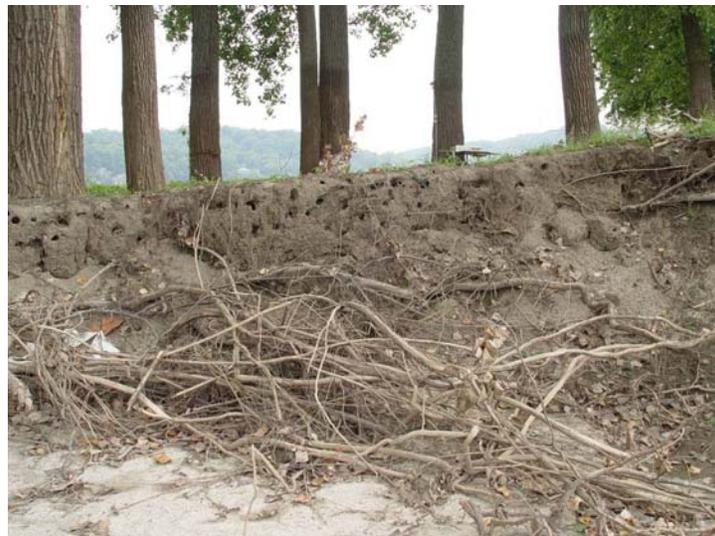
Extensive root networks and crayfish tunnels were present throughout the existing levee and breached area (Figure 17). These encroachments often encourage the formation of seepage paths through embankments.

Figure 17. Root networks and crayfish tunnels throughout the levee.

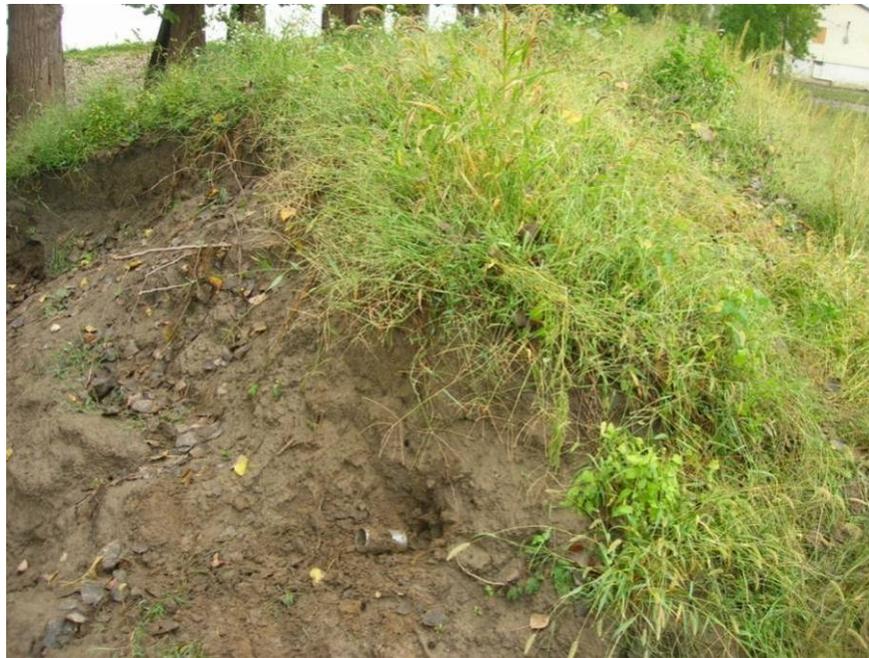
The vegetative cover at the Winfield site (Figure 18) was low to moderate density comprised and mostly of crabgrass and foxtail. While the ground cover looks somewhat established in the Figure, most of the grasses present were annual weeds rather than sod forming grasses. Such weeds are only present for a portion of the year and tend to clump leaving spaces where the soil surface is bare. In several areas there was little or no coverage.

Figure 18. Winfield – Pin Oak vegetative cover.

Foxtail is a “weed-like” summer annual plant which forms in tuft-like groupings and often develops in areas of less dense turf grass (American Lawns 2009). The ground coverage at the site must not have been dense because of the ability of the foxtail to intrude. Crabgrass is an annual grass generally found in the warmer climates. This “weed” is very invasive and can take over an area, but because it is an annual plant it will die out during a freeze. None of the grasses identified at this site are what would be considered “good” protective armoring. These vegetative conditions, however, are based on post flood observations and may not reflect the actual conditions at the time of overtopping.

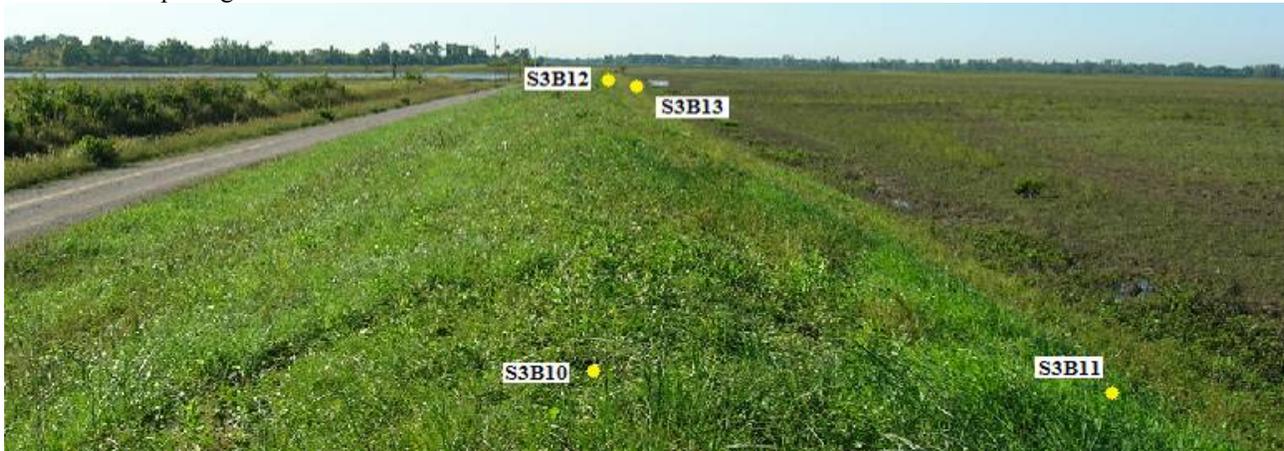
This site was unique in the fact that there was no breach in 2008. The only sign of erosion was at a box culvert that was cracked allowing water and soil to seep through. A local resident (Mr. James Pieper) informed the team that the levee was overtopped by nearly 1 m of water for three days and never failed. Four samples were collected from various locations along the levee. Because there was no actual breach, only surficial samples were taken. These samples were much harder to obtain and the soil seemed to be much stiffer than at the previous sites as can be seen by the higher Pocket Penetrometer values (Table 6) obtained at this site compared to the Winfield site. Figure 20 shows the boring locations and Table 6 presents the sample logs for this site.

Figure 20. Brevator boring locations.

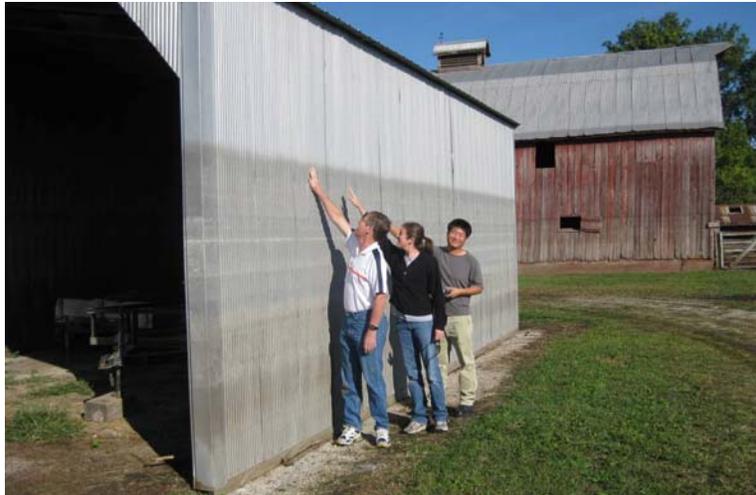
While the levees did not breach, there was still a large amount of damage to homes and equipment on the dry side of the levee due to the overtopping waters. The area enclosed by the levees at this site was much smaller compared to the other sites, so the overtopping water began to fill the internal area like a swimming pool. Figure 21 shows the high water marks on a barn located within the area surrounded by the levees. As the water on the dry side of the levee rose, the difference in elevation between the two sides decreased thereby decreasing the erosion potential. Substantial damage occurred within the internal area even though the levee performed well.

Figure 21. High water marks on barn within the Brevator levee system.

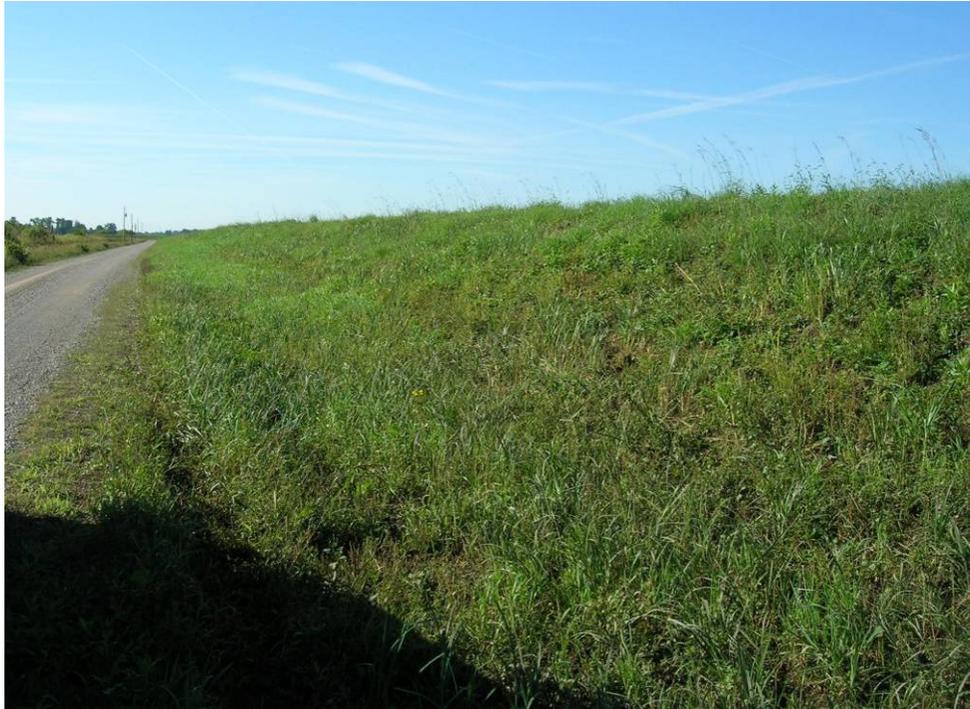
At the time of overtopping, there was substantial vegetative cover. Figure 22 shows the vegetative cover present on the levee 3 months after the flooding. It was noted that the grass was Reed Canary grass approximately 1 m tall at the time of flooding. This type of grass survived the continuous flow of water and had a positive impact on preventing erosion. The overtopping waters forced the grass to lay down essentially creating a protective cover or barrier on top of the soil surface and preventing erosion.

Further examination of the grass cover indicated that additional varieties of plants were present at the site including: Switchgrass, Smooth Brome, Reed Canarygrass, and Foxtail. The consistency of the coverage and the root density were much higher at this site than any of the other sites.

Figure 22. Brevator vegetative cover on September 30, 2008.

The grasses found at the Brevator site seemed to satisfy all of these criteria. The recommended grasses for the Midwest include: Switchgrass, Tall Fescue, Smooth Brome and Reed Canarygrass. A percent coverage of at least 90 percent is desirable. It is also recommended that the grasses on the levee be allowed to grow to taller heights during the flood season (0.5 to 1 m). While most of the erosion prevention depends on the root system, it is not always adequate for the magnitude and duration of flows experienced during overtopping flood events.
