A review of techniques available for riverbank protection: a sustainable approach to managing bank erosion

Draft Report

**Korea Institute of Construction Technology,
Republic of Korea**

Colorado State University
Engineering Research Center
Department of Civil and Environmental Engineering
Fort Collins, Colorado 80523

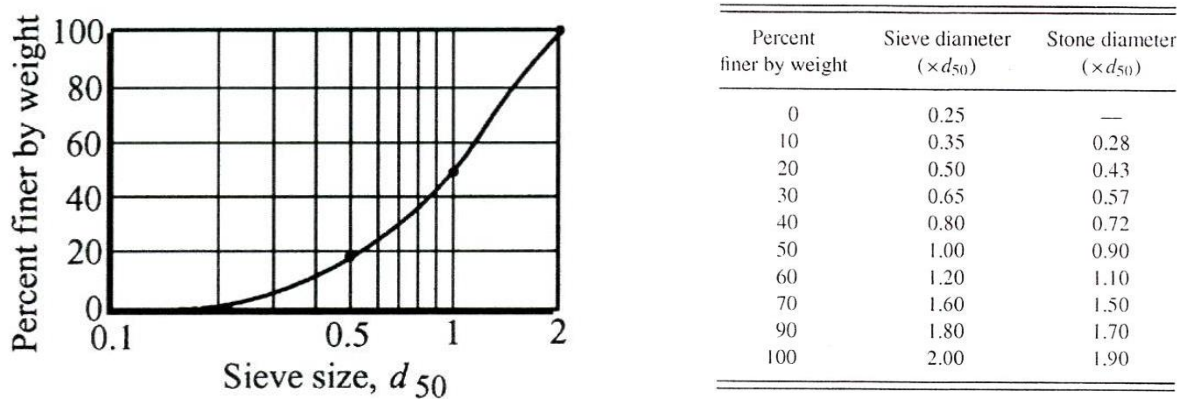
Figure 4 – suggested riprap a) gradation curve b) size gradation (Julien, 2002)

Size gradation is an important criterion in placing ripraps. A uniformly graded riprap with a median size d_{50} scours to a greater depth than a well-graded mixture with the same median size. It should be noted that riprap consisting of angular stones is more suitable than that consisting of rounded stones. The suggested riprap size gradation is shown in Figure 4.

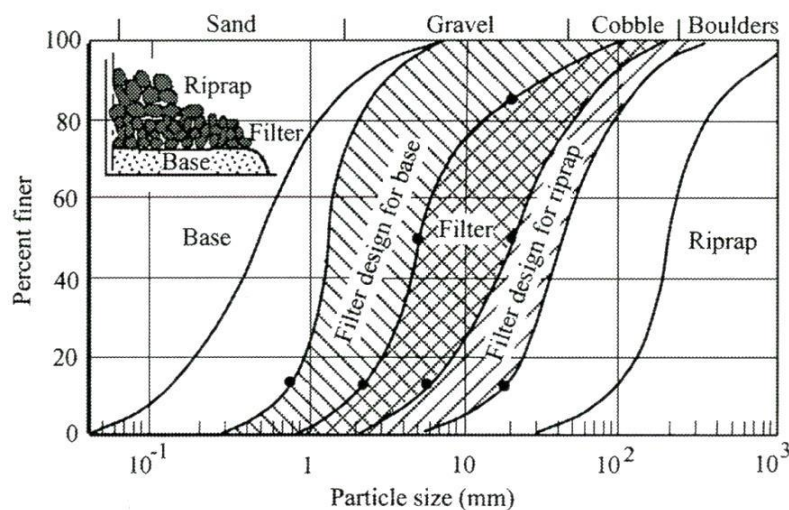
Figure 5 – Example of filter design (Julien, 2002)

It is necessary to use filters under riprap revetments to allow water to drain easily from the bank without carrying out soil particles. Filters are required when the d_{15} of riprap gradation exceeds five times the d_{85} of the bank material. The design example of filter is shown in Julien (2002) as outlined in Figure 5.

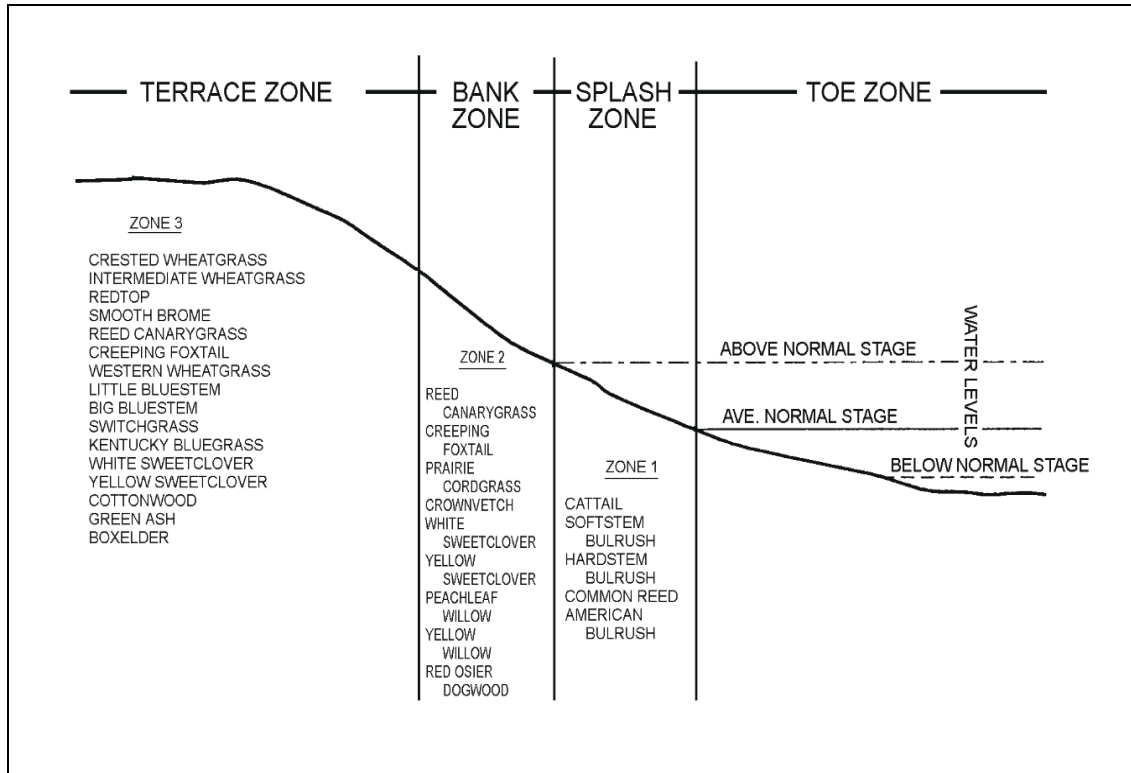
Figure 8 – Streambank zones and possible species to plant by zone (Biedenharn, 1997)

Figure 8 defines the fundamental riparian zones where the toe and bank zones form the streambank.

Streambank zones depend on the ability of certain plants to tolerate various durations of flooding and their attributes of dissipating wave and current energies. The splash zone located between normal high water and normal low water is the zone of highest stress. The splash zone is exposed frequently to wave wash, erosive river currents, ice and debris movement, wet-dry cycles, and freezing-thawing cycles. This section of the bank would be inundated throughout most of the year (at least 6 months/yr.).

The bank zone lies above the normal high-water level; yet this site is exposed periodically to wave wash, erosive river currents, ice and debris movement, and traffic by animals or humans. The site is inundated for at least a 60-day duration one every 2-3 year. The water

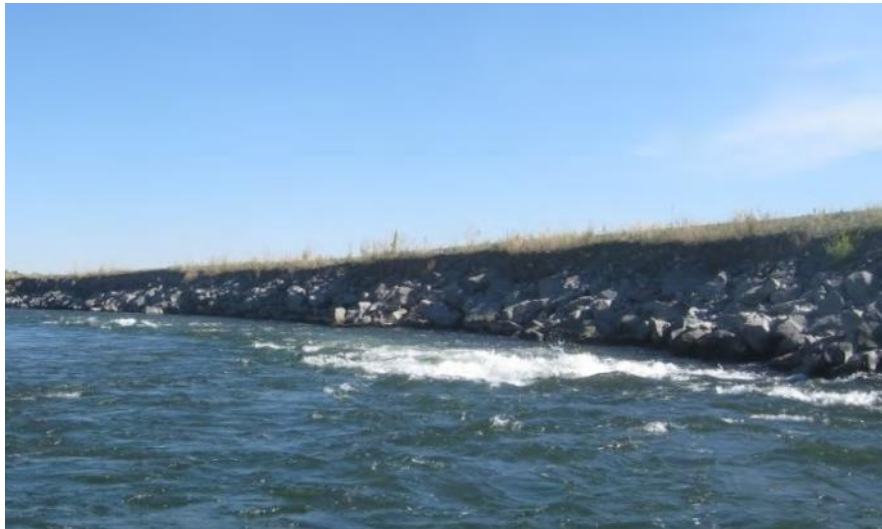
Figure 16 - View downstream of intercepted trenchfill revetment; local turbulence is from launched rock (Boyd, 2010)

As of October 2010, the project was largely intact, although the mid-bank has been locally exposed due to excessive launching of the toe rock, which is a concern for long-term stability (Figure 17). Some rock has been launched well off of the bank, creating local hard elements in the channel bed, and flow velocities remain very high against the structure.

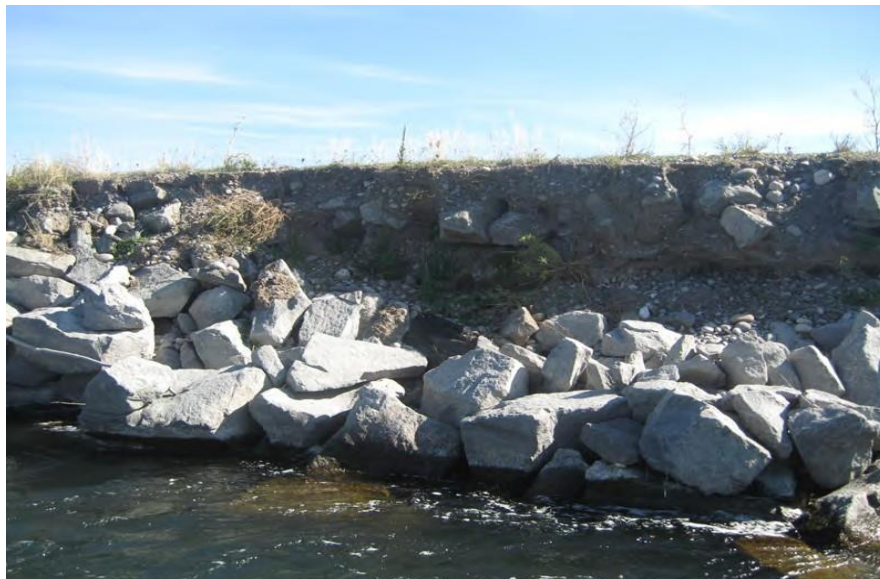
Figure 17 - View of discontinuous rock at mid-bank level (Boyd, 2010)

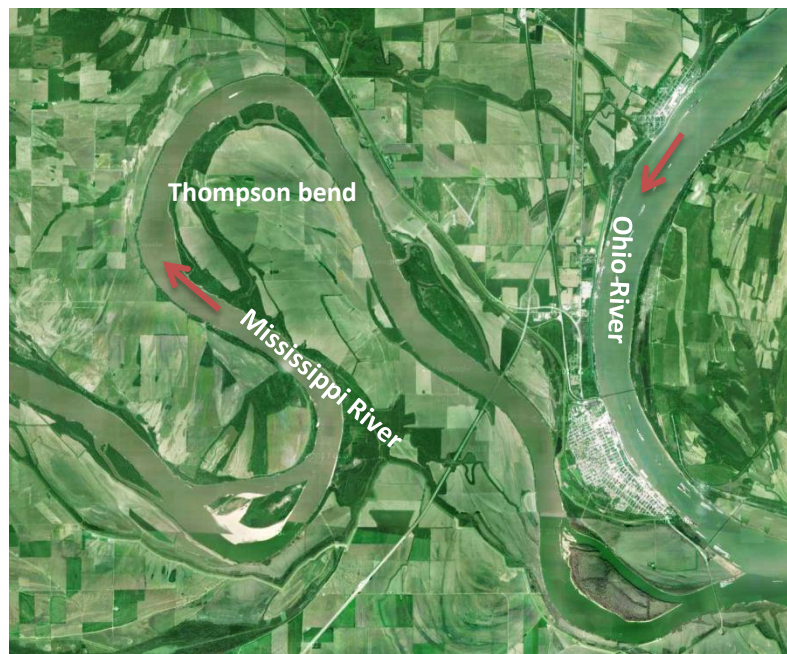
Figure 19 – Thompson Bend of Mississippi River (Google-map, 2013)

Thompson Bend clearly illustrates the vital importance that vegetation exerts on controlling overbank scour. The revegetation process began in 1985 and early 1986. The results were immediately evident during the fall flood of 1986. Very little erosion was observed. The area was tested again in the flood of 1990, when very little erosion occurred. The Thompson Bend also suffered very little visible damage during the Great flood of 1993, when record high stages occurred, and the duration of the overland flows reached an unprecedented 130 days. However, the flood took its toll on the vegetation. Numerous trees that were inundated for most of the 130 days died. Using the Google map tool, the current map of the Thompson Bend is shown in Figure 19.
