Middle Rio Grande

San Acacia Reach: Morphology and Silvery Minnow Habitat Analysis

September 2019
Plan B Technical Report

Prepared by:
Sydney Doidge

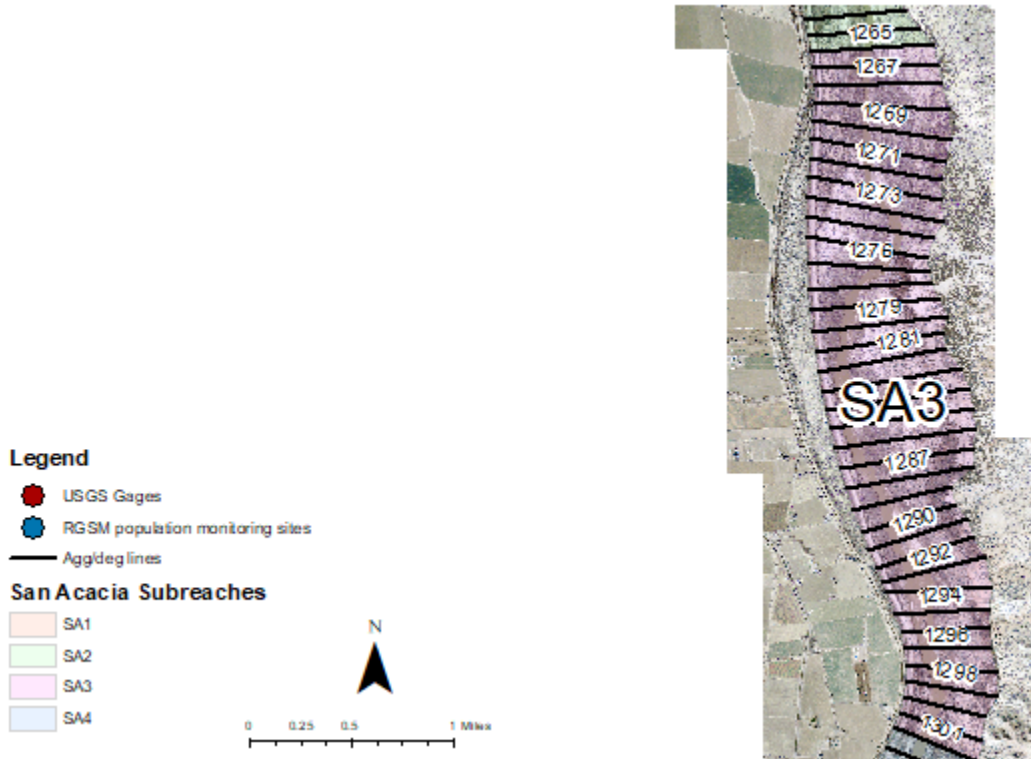
Figure 3 Subreach SA3; flow direction is north to south

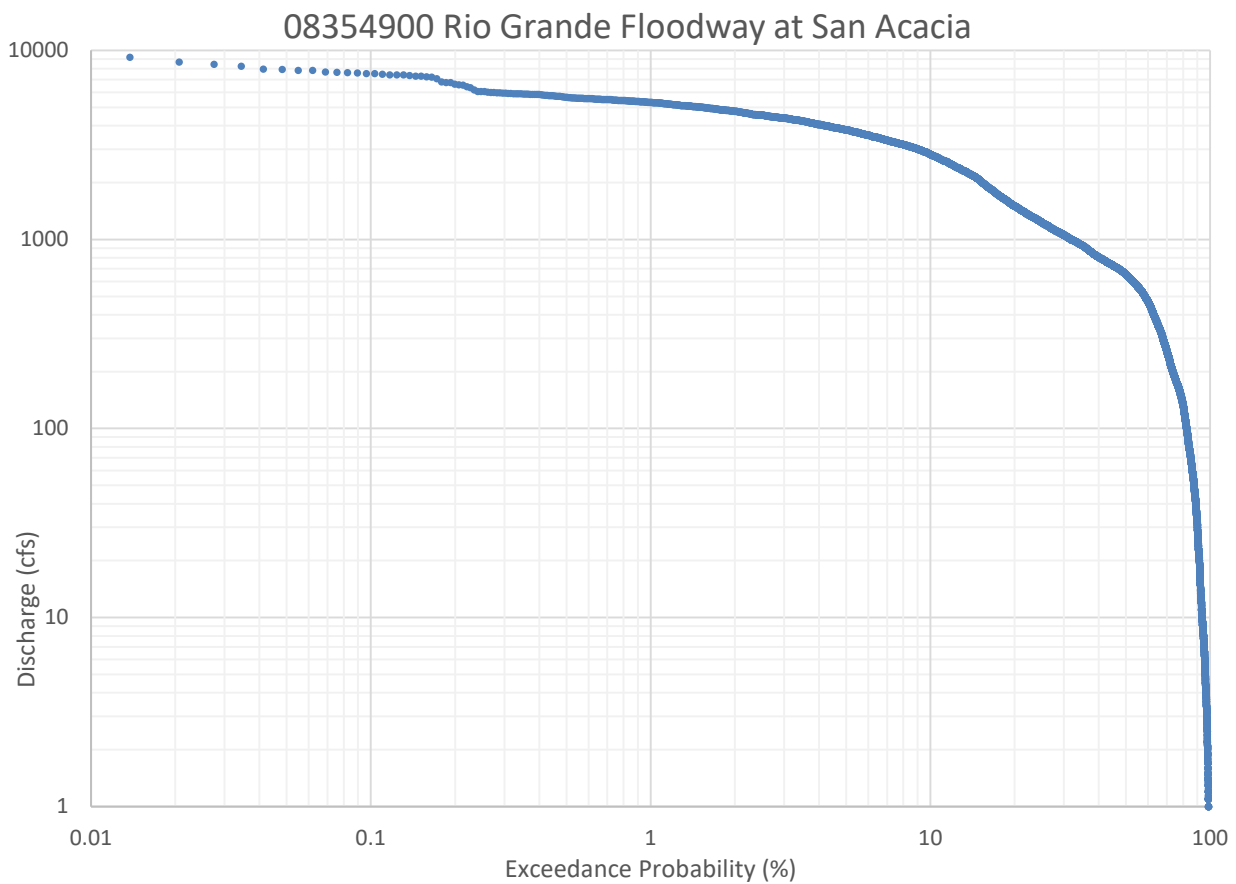
A flow duration curve was developed for the San Acacia gage for the time period 1979 to 2018 and for the Escondida gage for the entire record, 2011 to 2018. Figure 11 and Figure 12 show the flow duration curves. Table 4 shows some exceedance values calculated from these flow duration curves. Note that the values for the Escondida gage are lower except for 90% exceedance. There is a shorter period of record for the Escondida gage; as a result, it has not experienced as many high flow events as since recording began as the San Acacia gage. Water is also taken from the river for agricultural purposes at the San Acacia Diversion Dam. Finally, the higher flow value calculated at Escondida for the 90% exceedance may be attributed to a station that pumps water into the river near agg/deg line 1300, just upstream of the gaging location, thus ensuring that this section of the river maintains a higher level of flow regardless of upstream flow conditions.

Figure 11 Flow duration curve for USGS gage 08354900

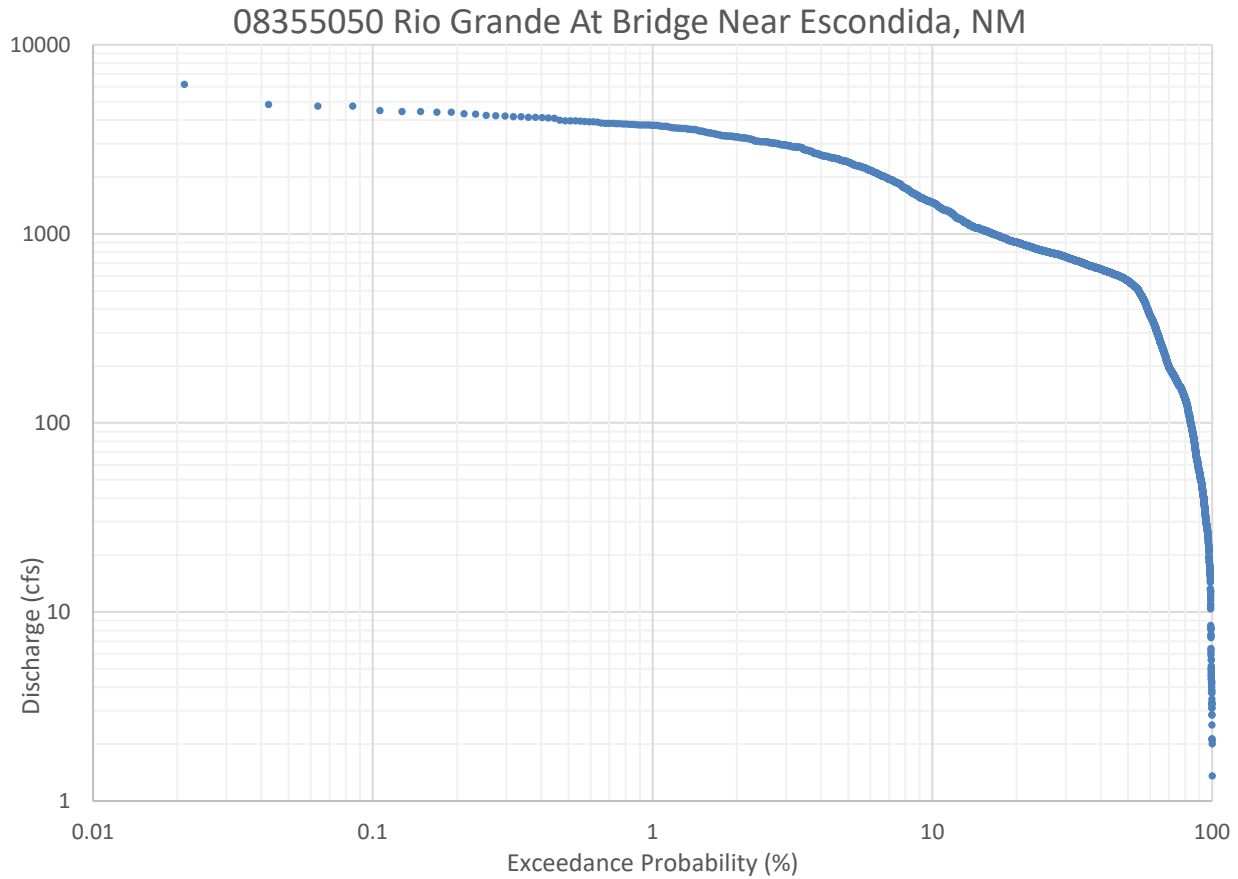
Figure 12 Flow duration curve for USGS gage 08355050

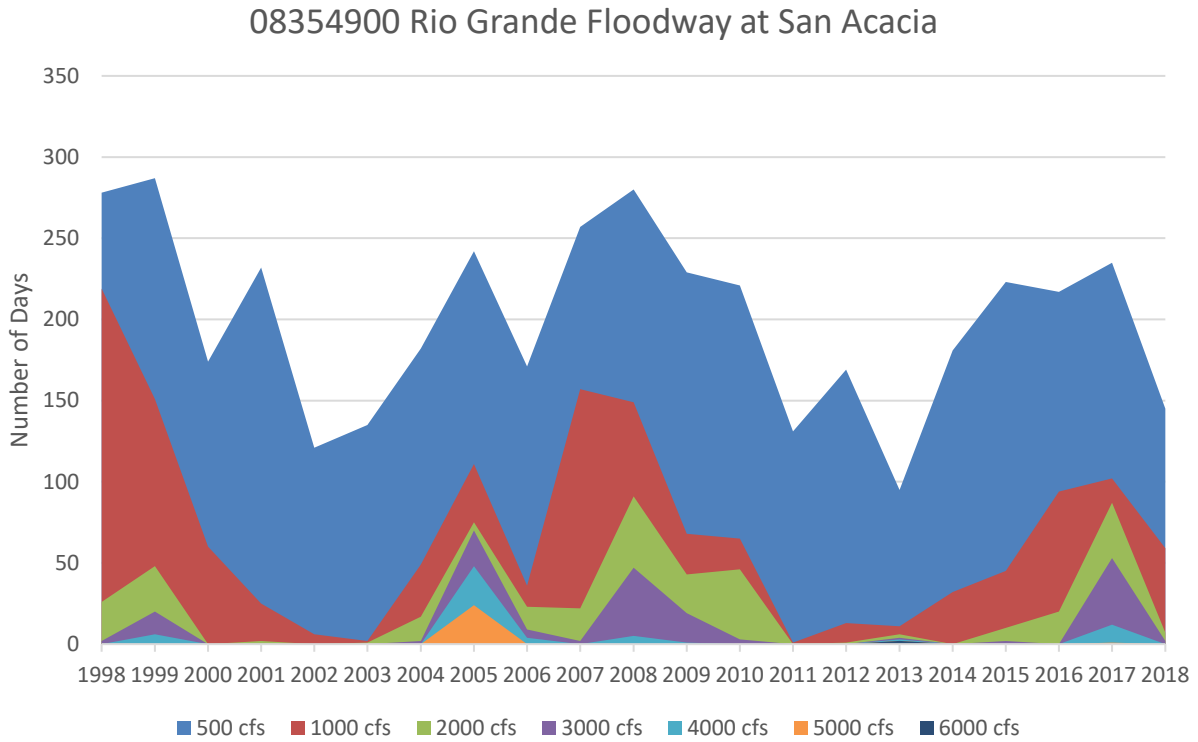
Figure 13 Number of days over a target discharge at the San Acacia gage

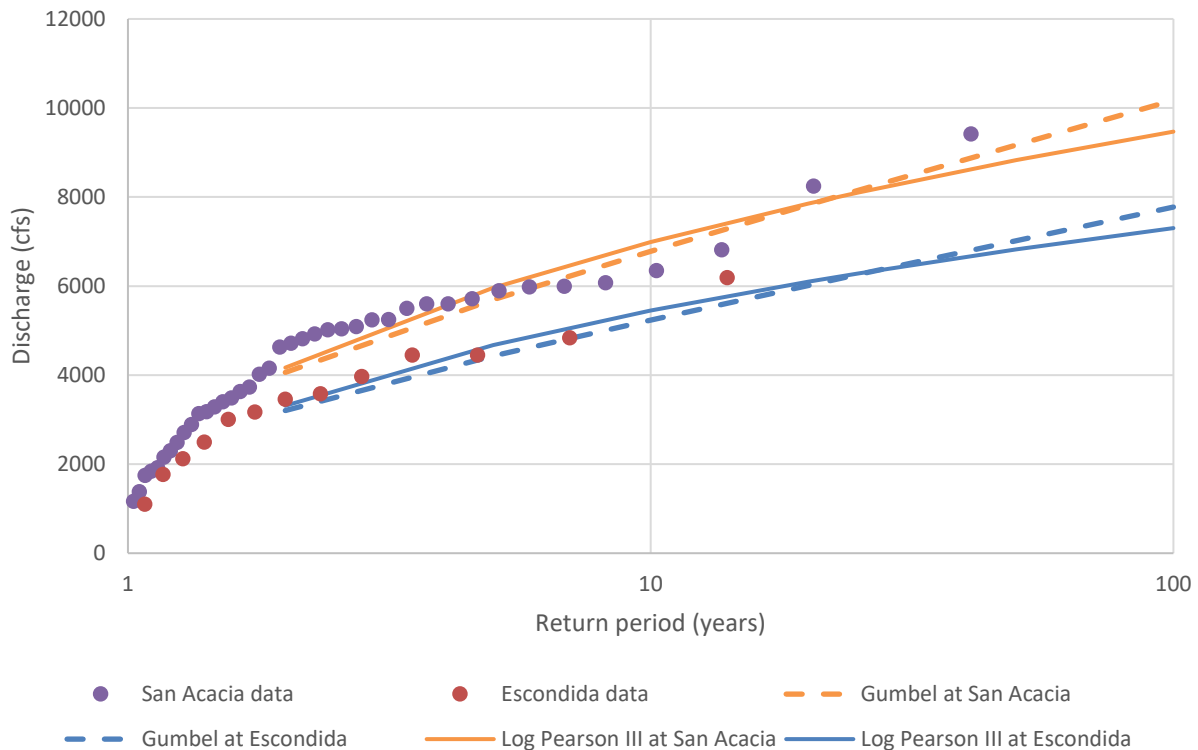
Figure 15 Flood frequency analysis

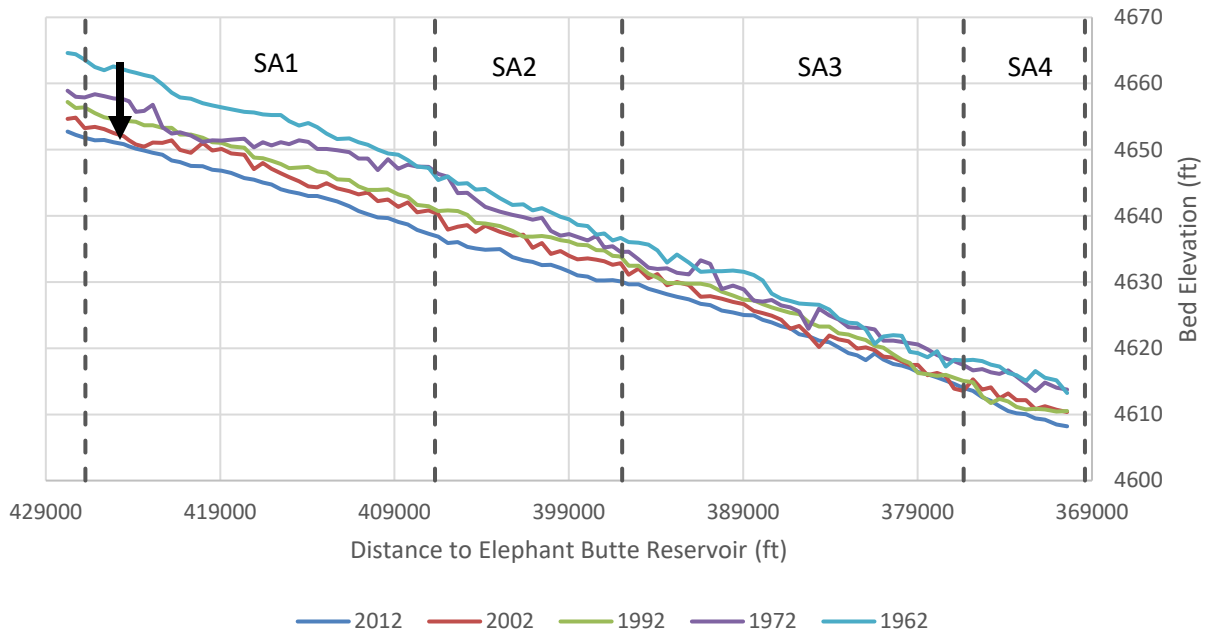
The mean bed elevation is used to compare the change in long profile in this report. Cross-section geometry at each agg/deg line was available from models developed by the Bureau of Reclamation Albuquerque Area Office. Models are available for 1962, 1972, 1992, 2002 and 2012. The 2012 model was developed from LiDAR data, but models prior to 2012 used photogrammetry techniques. All models use the NAV88 vertical datum. Figure 27 shows the long profiles of each of these years. Figure 28 shows the aggradation and degradation of each subreach.

Figure 27 Long profile of bed elevations

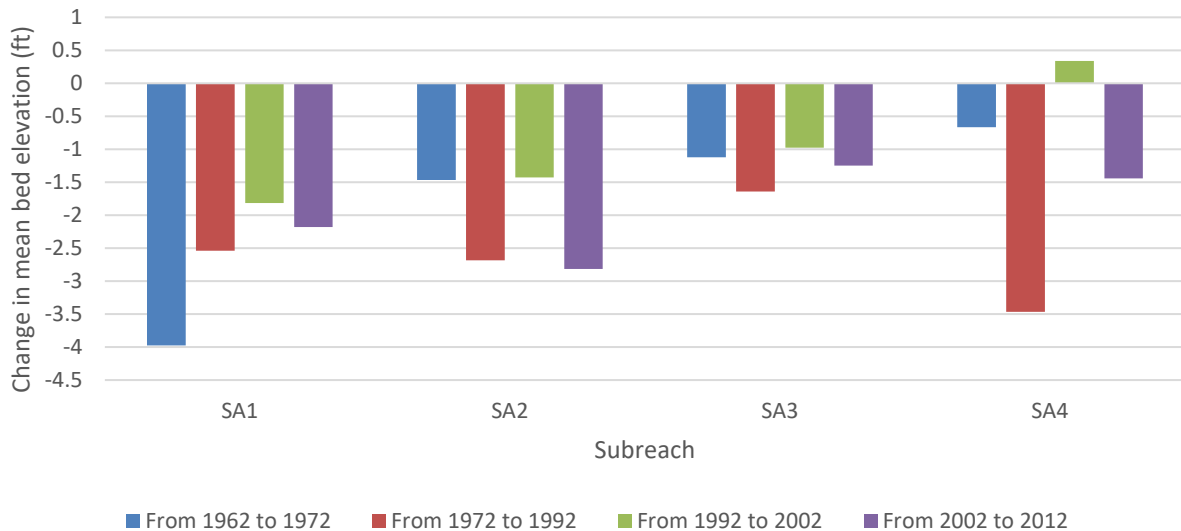
Subreach SA1 had the most degradation over the period from 1962 to 2012, almost 10.5 ft. SA2, SA3 and SA4 had degradation of 8.4 ft, 5.0 ft and 5.2 ft, respectively. The most severe degradation is at the upstream end of this subreach. It is possible that scour is occurring downstream of the San Acacia Diversion Dam if sediment is being contained behind the diversion structure. The only time aggradation occurred was in subreach SA4 from 1992 to 2002; all other measurements were degradation. The most degradation occurred between 1972 and 1992, although this is a longer period than the others. Normalized to a ten-year period, the most degradation occurs between 2002 and 2012.

Figure 28 Degradation and aggradation by subreach

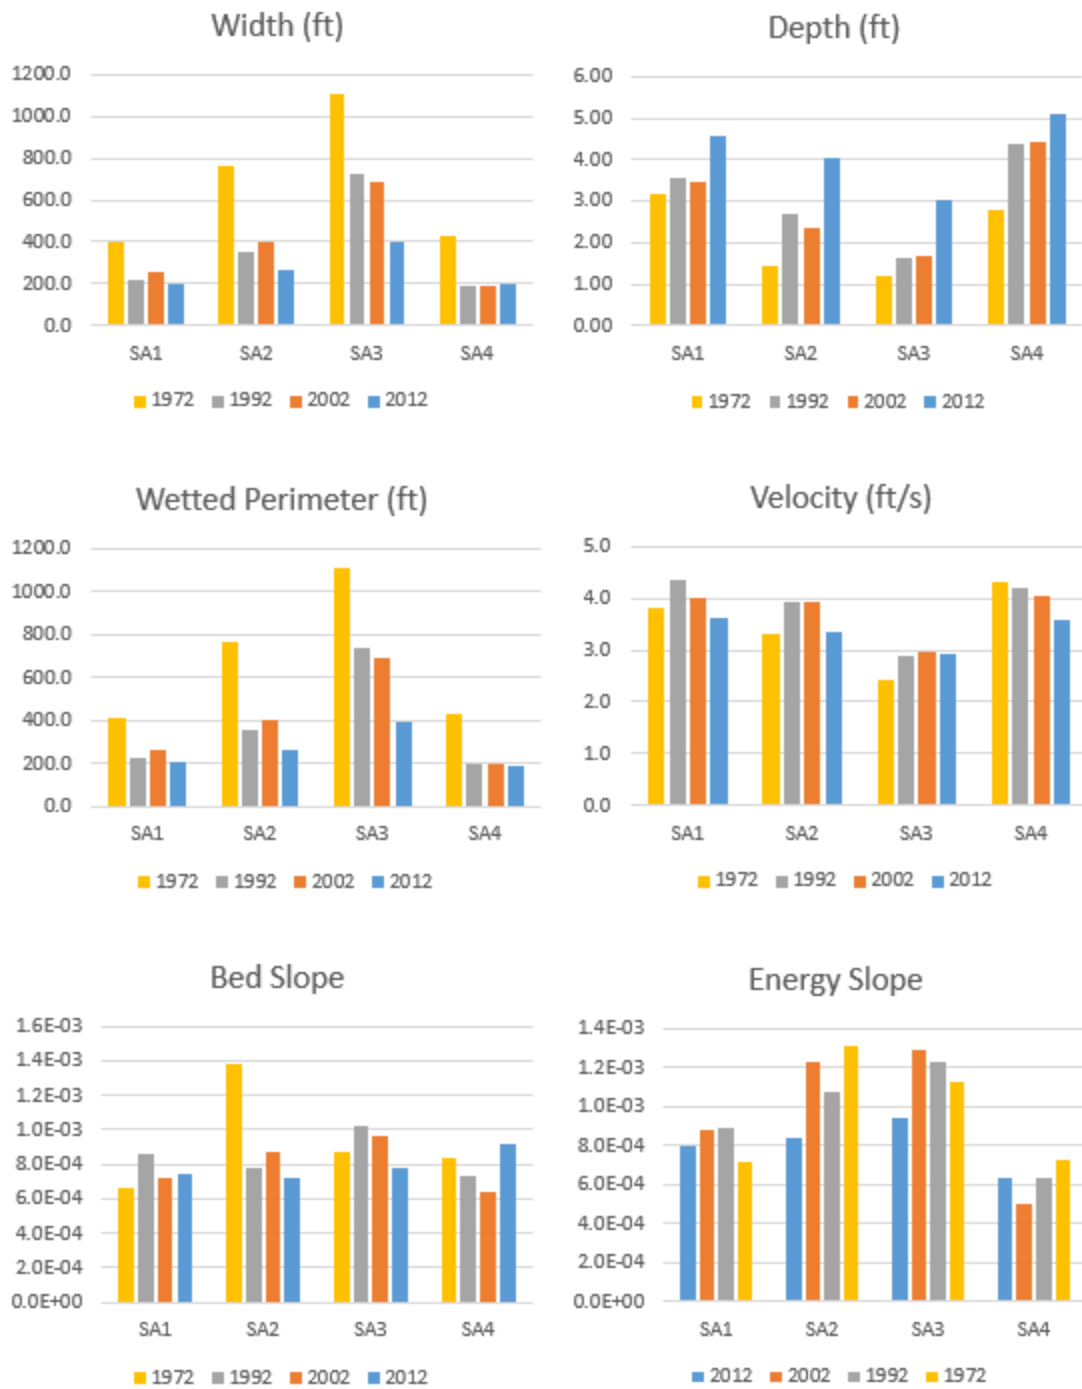
There are dramatic decreases in width and wetted perimeter from 1972 to 2012. Width and wetted perimeter are closely linked, which indicates a wide and shallow channel. Depth decreases from 1972 to 2002, but then begins to increase again in 2012. In 1972, although much of the channel was shallow and wide, there were small sections (less than 50-100 feet across) that were deeper. In 2012, although similar depths were seen, these depths tend to be more uniform across an area of a couple hundred feet. Velocity, bed slope and energy slope show few trends.

Figure 30 HEC-RAS analysis results

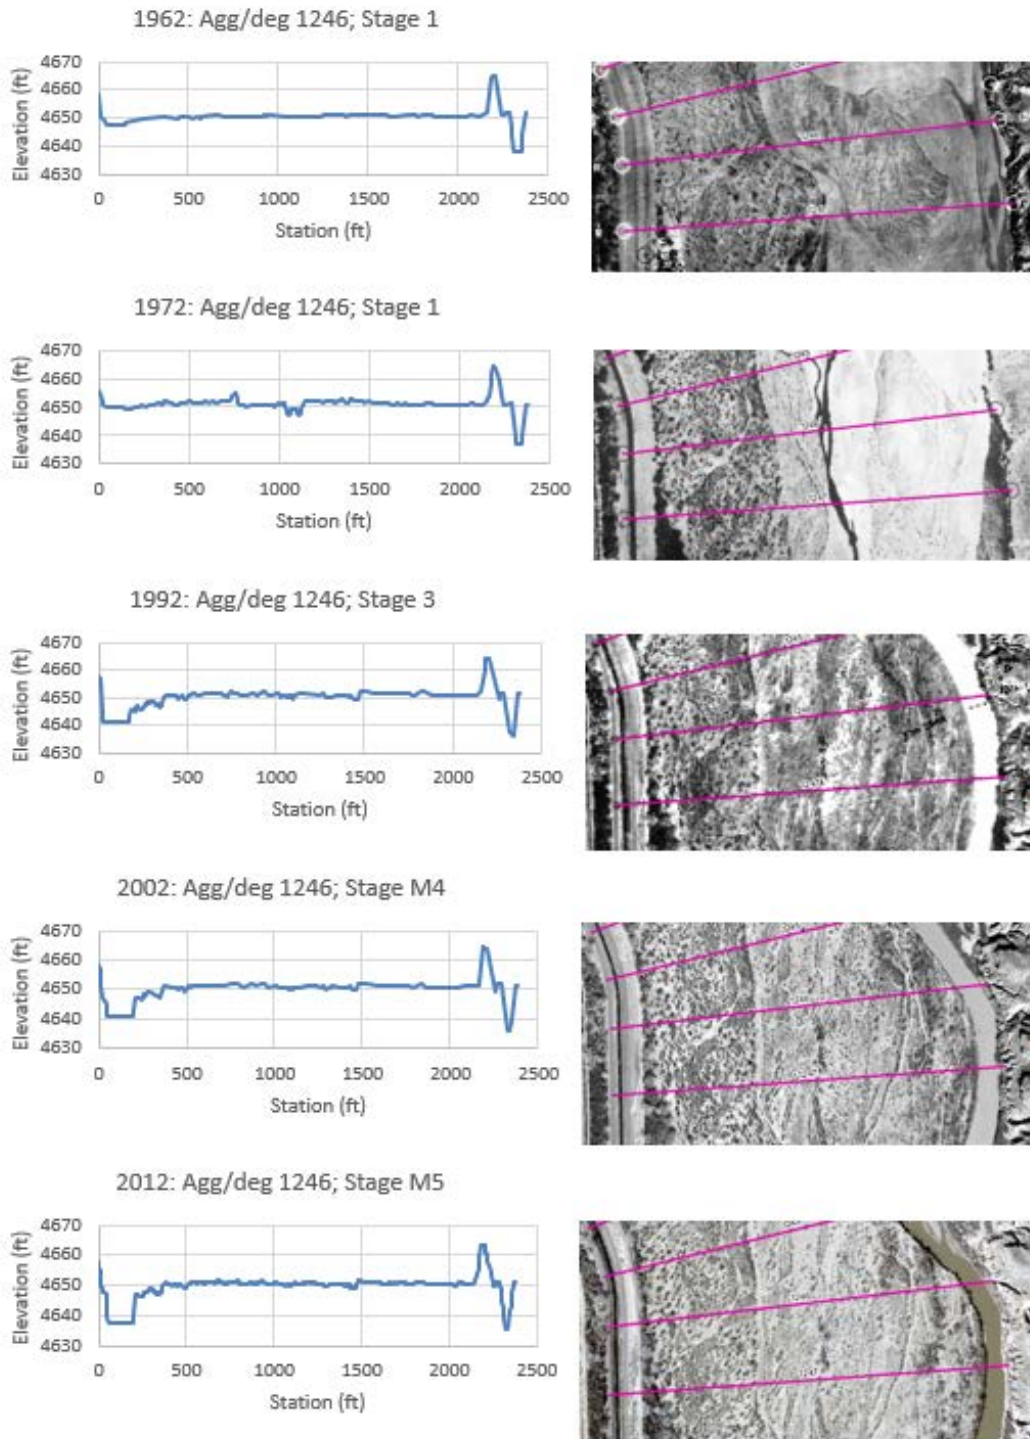
Figure 36 Evolution of cross-section 1246 from 1962 to 2012

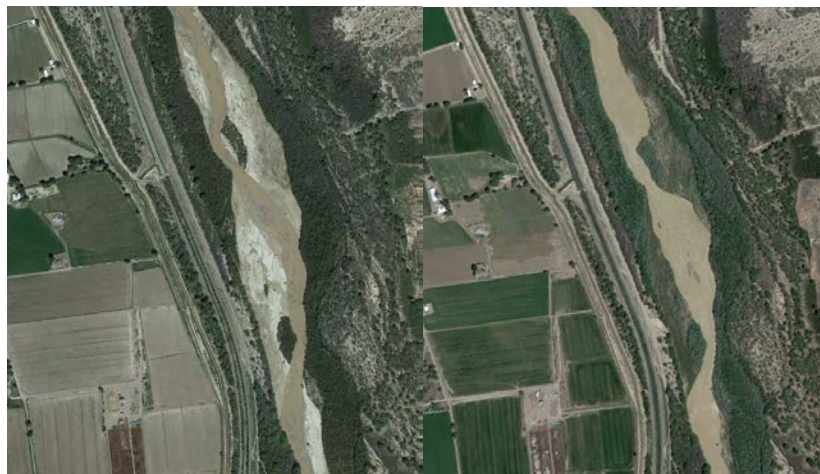
Although Subreach SA3 has changed dramatically since 1962, in comparison to the other subreaches, it is still significantly wider, as seen in Figure 25. Therefore, through 2012, it can still be classified in the early stages of the Massong channel evolution model. However, vegetation encroachment happens rapidly from 2013 to 2017, indicating that it may be proceeding to the other M-stages relatively soon, as seen in Figure XXX. Although in Figure 40, it is classified as Stage 3 in 2012, its classification today is somewhere between Stage 3 and Stage M4.

Figure 39 Subreach SA3 from October 2013 to April 2017 showing vegetation encroachment and narrowing in the main channel. Flow direction is from top to bottom, discharges unknown. Imagery from Google Earth

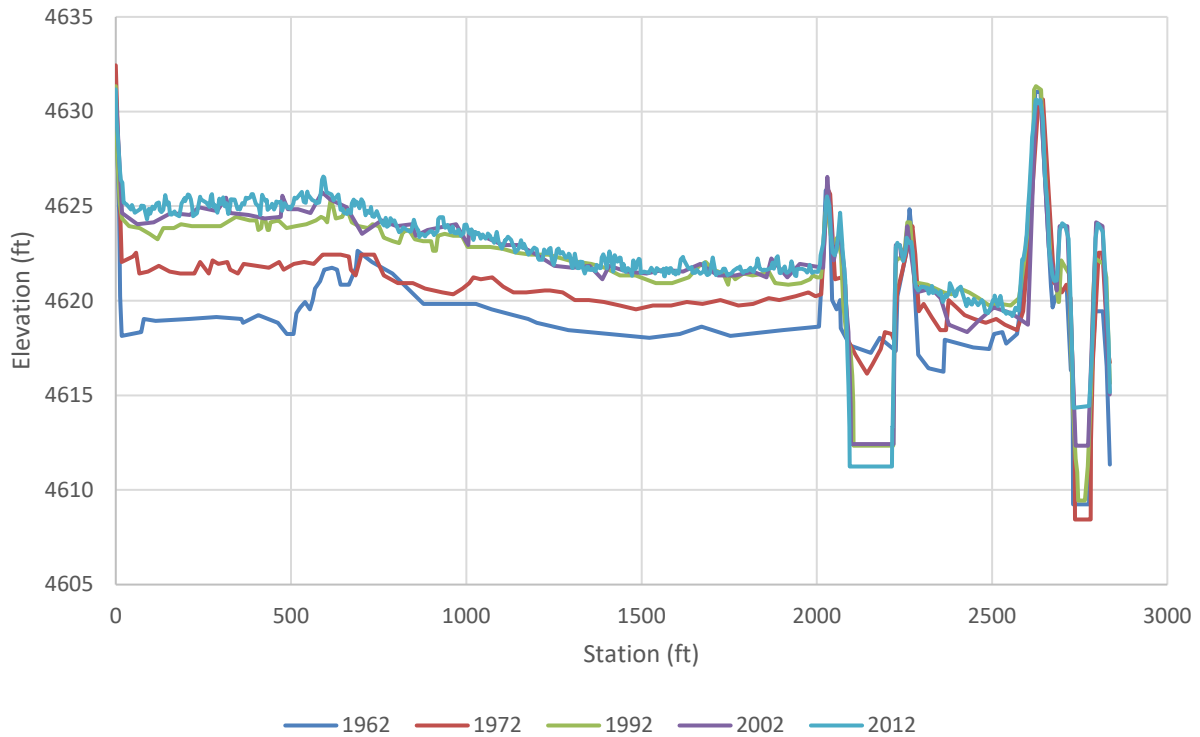
Agg/deg line 1306 from 1962 to 2012

Figure 41 Evolution of cross-section 1306 from 1962 to 2012

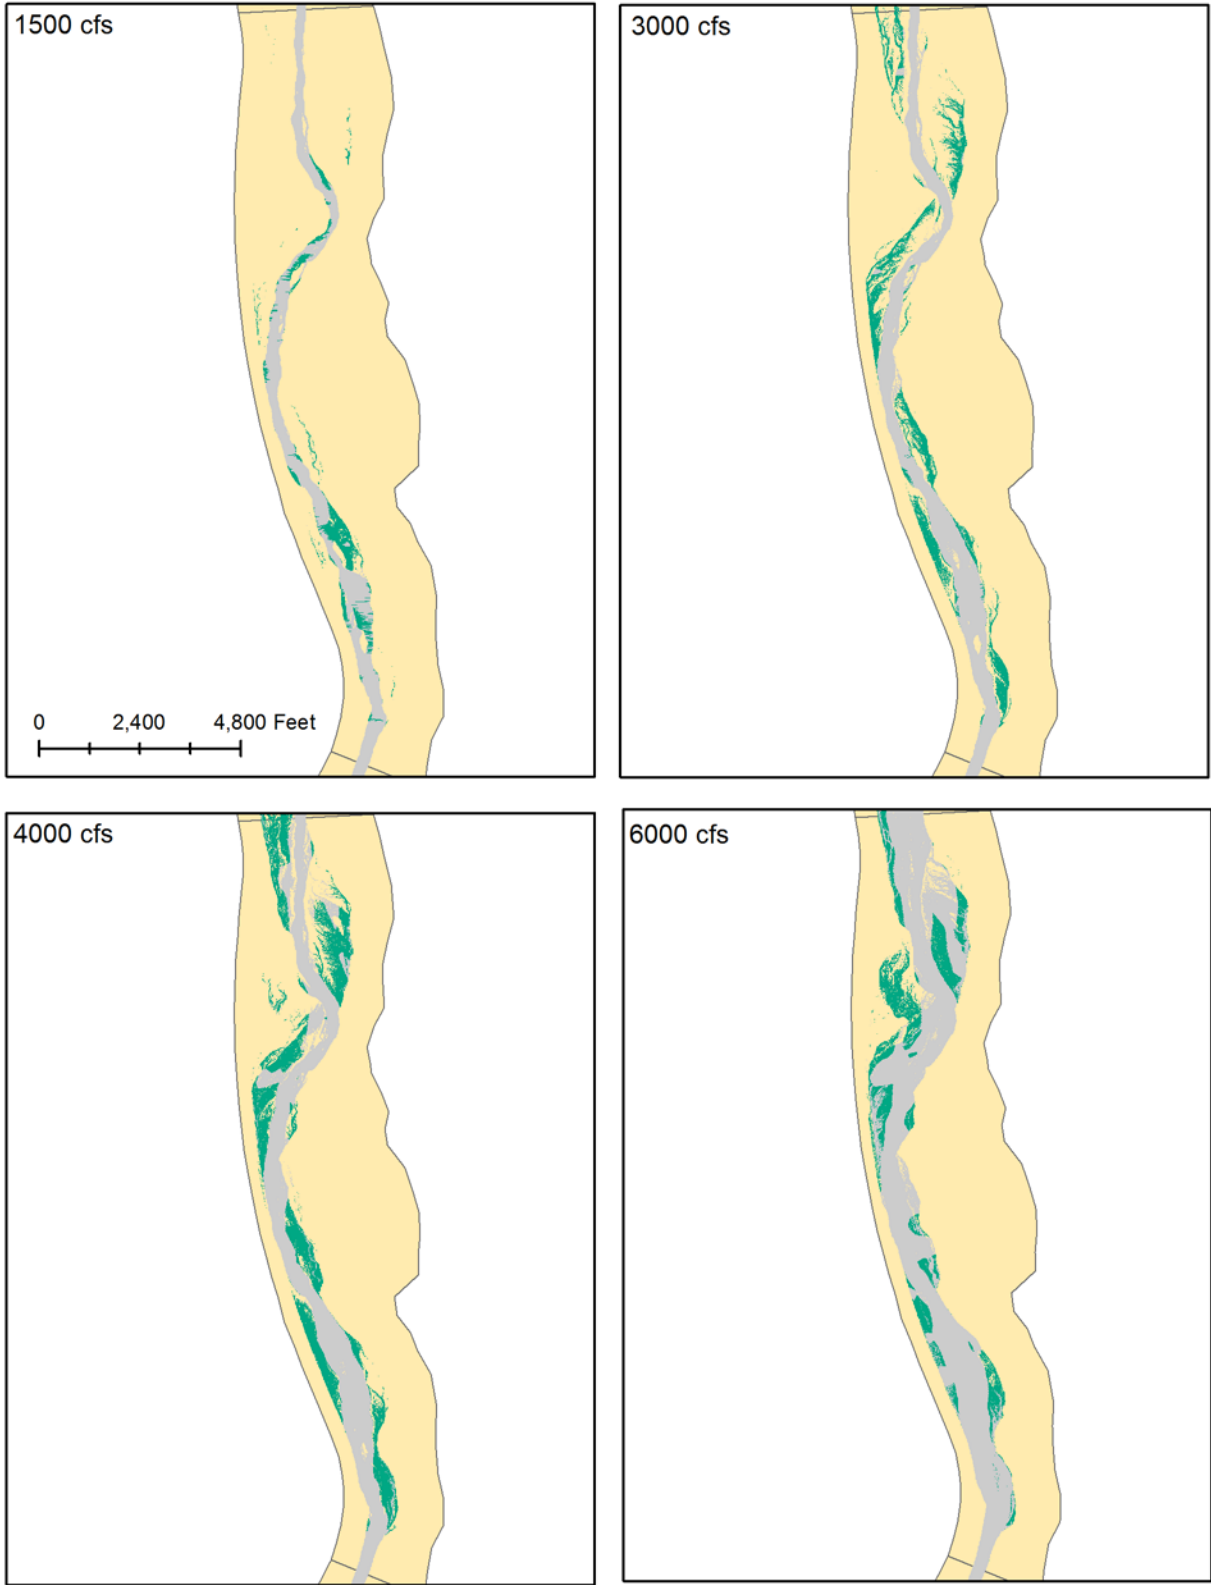
Figure 66 Juvenile habitat at subreach SA3; flow direction is from top to bottom

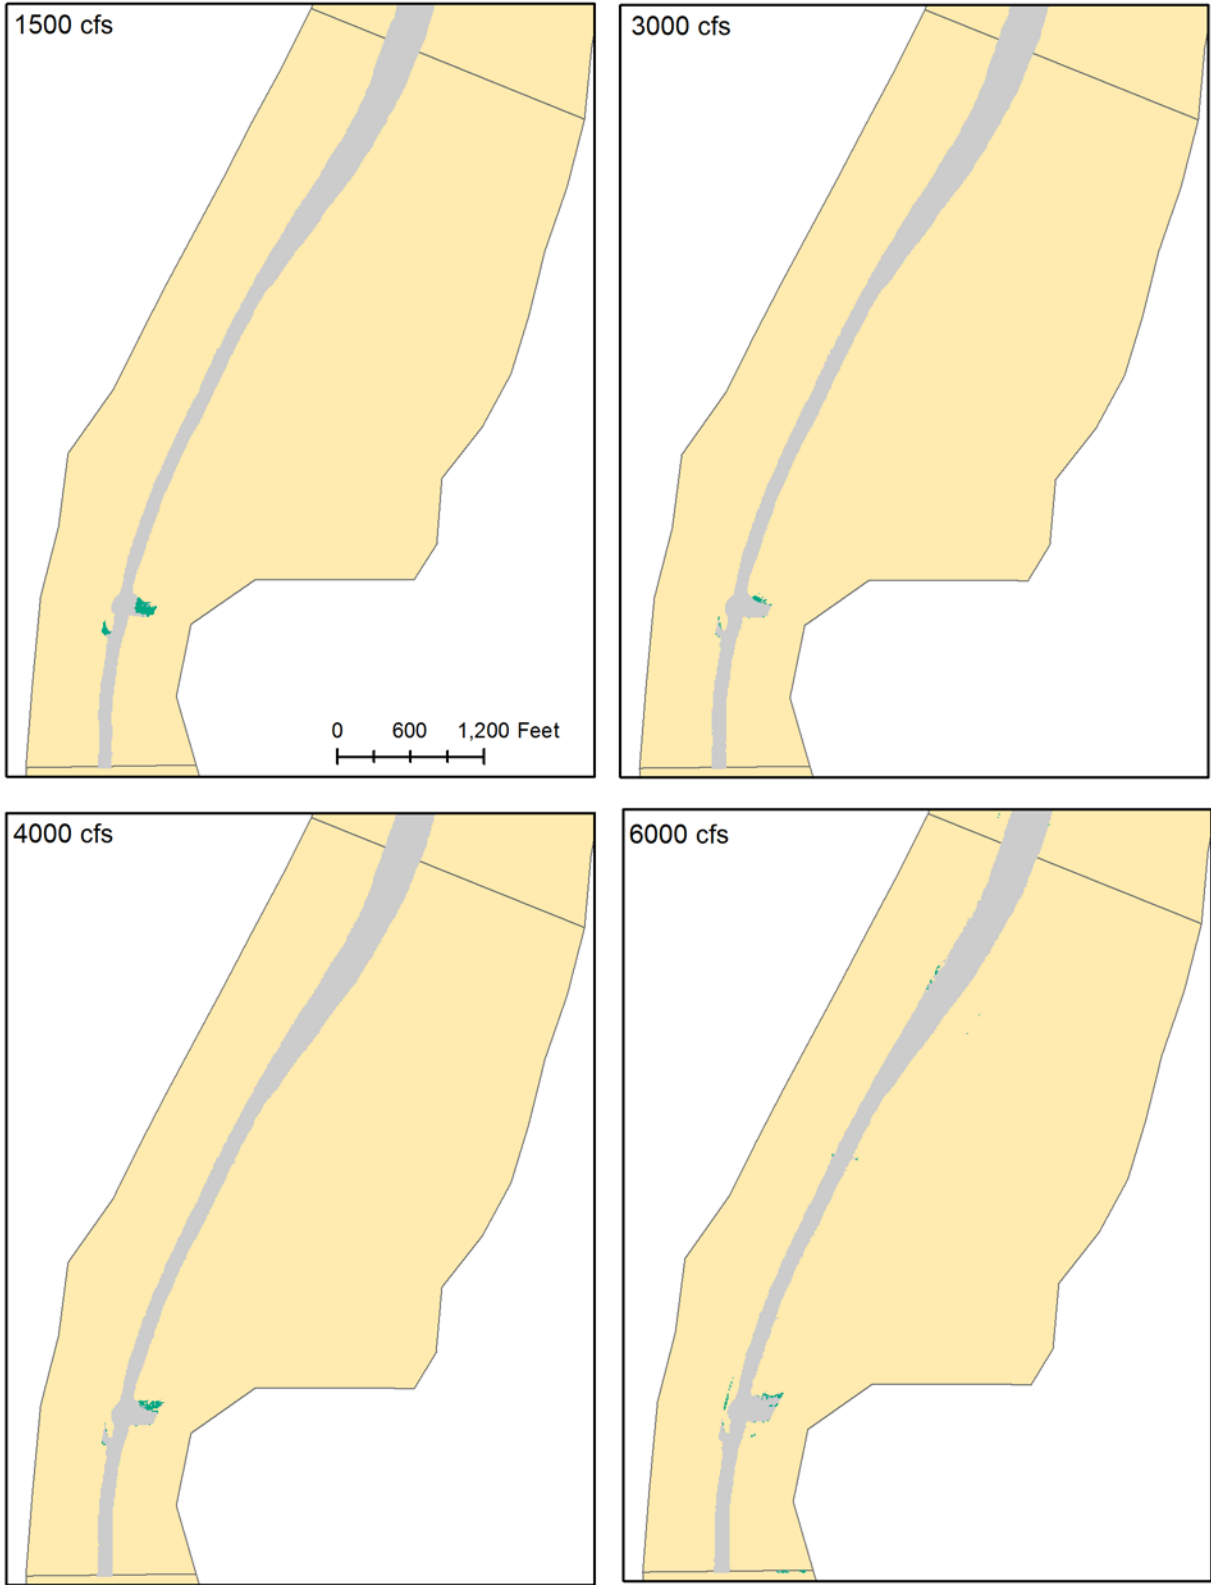
Figure 68 Juvenile habitat at subreach SA4; flow direction is from top to bottom
