Soluciones a Problemas de Ingenieria de Rios

Pierre Y. Julien

November 19, 2008
Jiutepec, Mexico

Presentation Overview

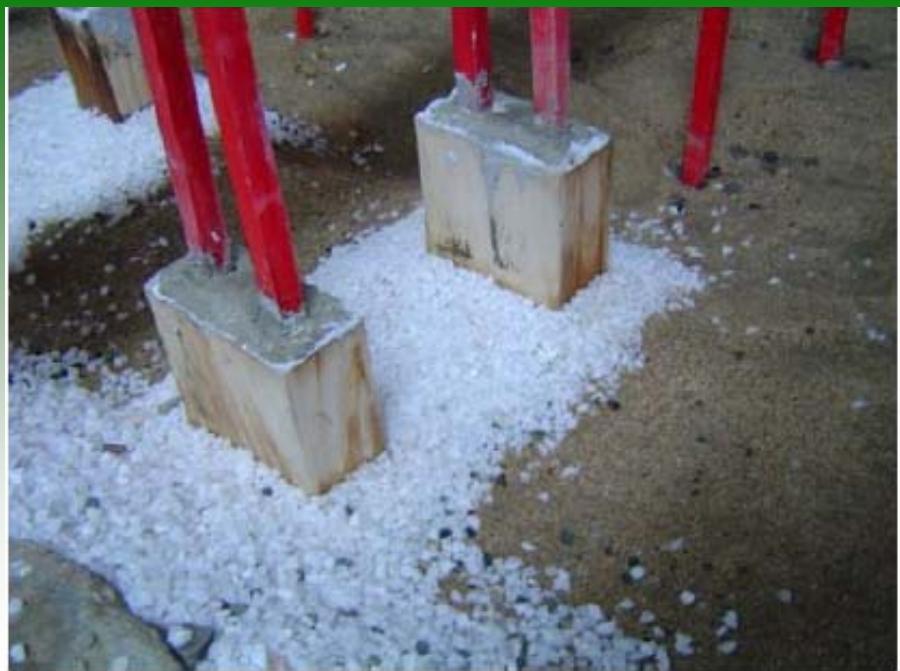
Figure 12. Experiment results with synthetic filters

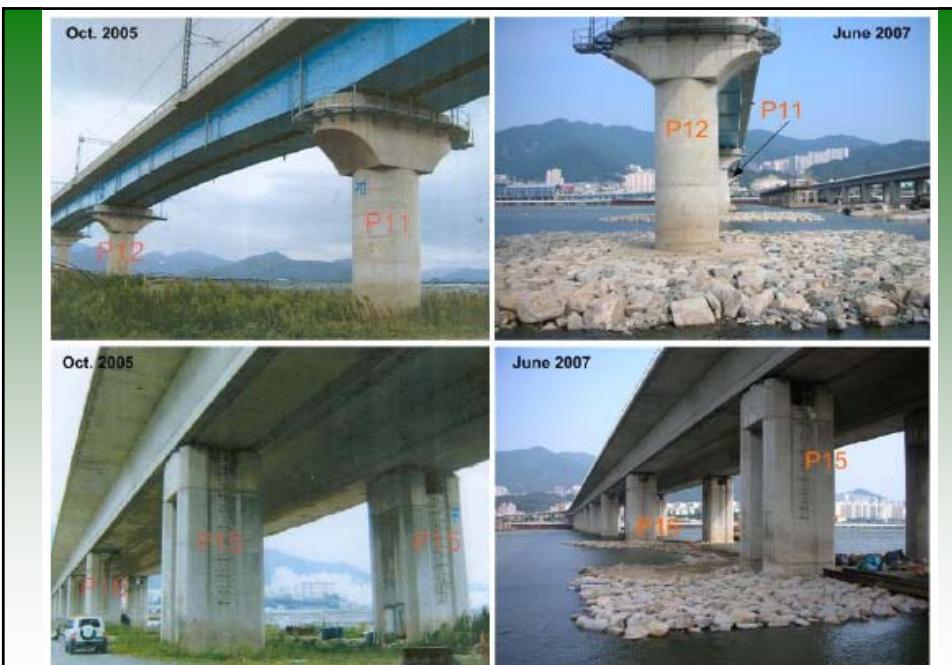
Figure 14. Gupo and Subway Bridge Piers before and after retrofitting construction

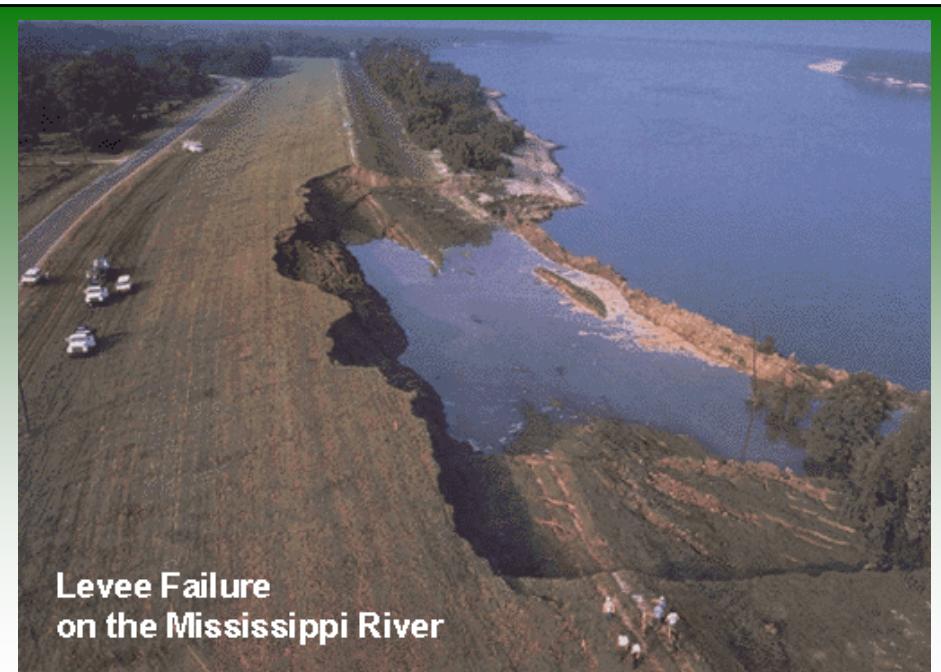
**Levee Failure
on the Mississippi River**

- Levee failure during the 1993 flood event

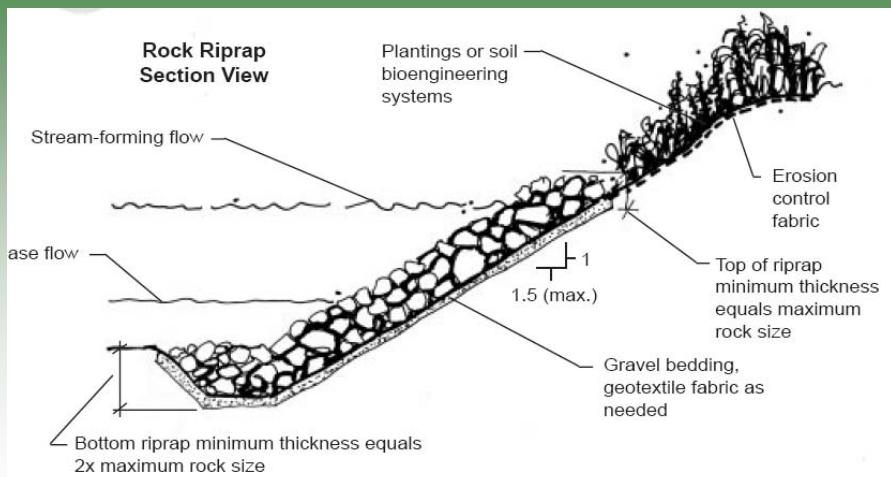
Riprap Design

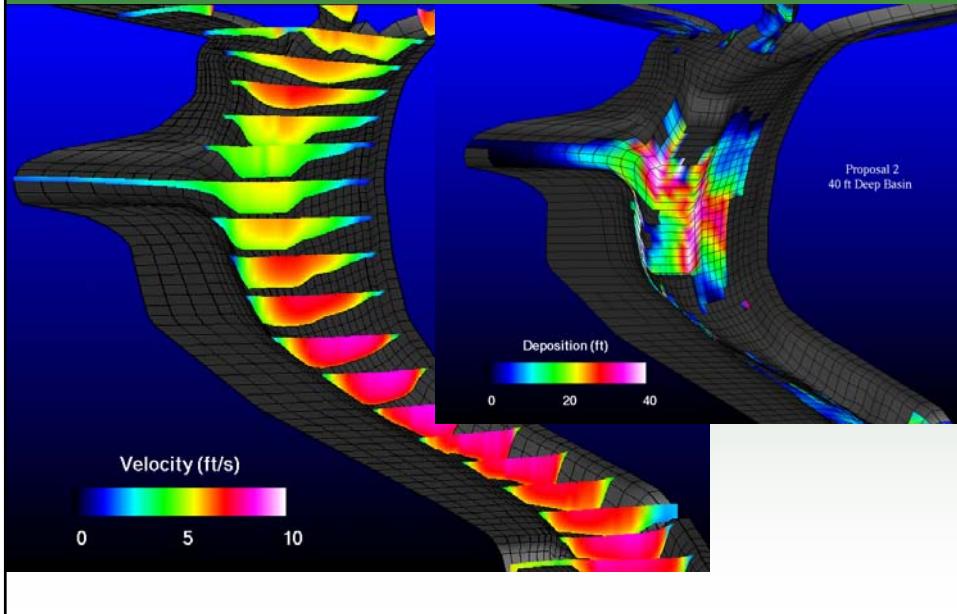
Example 3-D Model Mississippi
