Restoration of Abandoned Channels

Prepared for KICT, South Korea

Colorado State University
April 2008

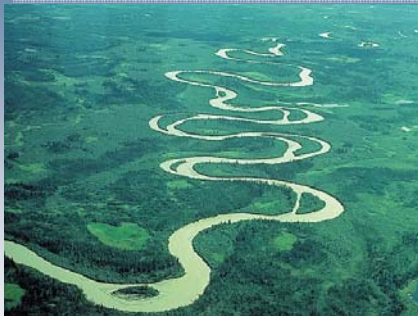
Chute Cutoff

Williams River, AK
(Photo by N.D. Smith)

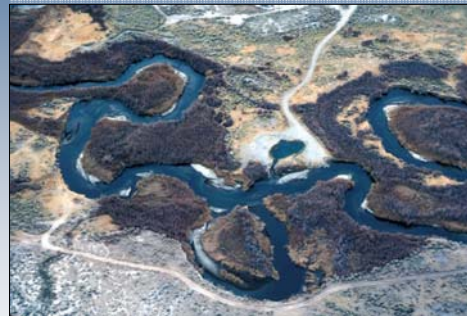
Neck Cutoff

Owens River, CA
(Photo by Marli Bryant Miller)

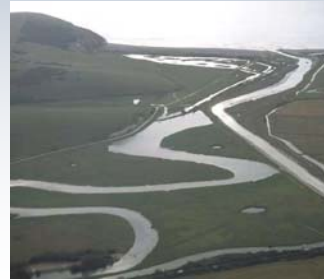
- Designed for Navigation and/or Flood Control
- Protect river path by constructing revetment upstream and downstream of outer side of meander
- Excavate small trench and build revetment on inside at meander neck
- Excavate pilot channel at meander neck from downstream to near upstream (1V:3H Side Slope, 15 to 60 m bottom width, 2 to 4 m below low-water reference plane)

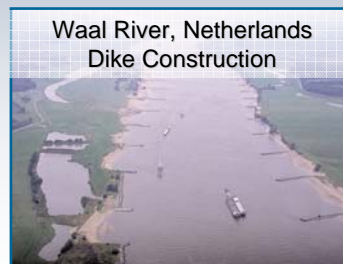
**Waal River, Netherlands
Dike Construction**

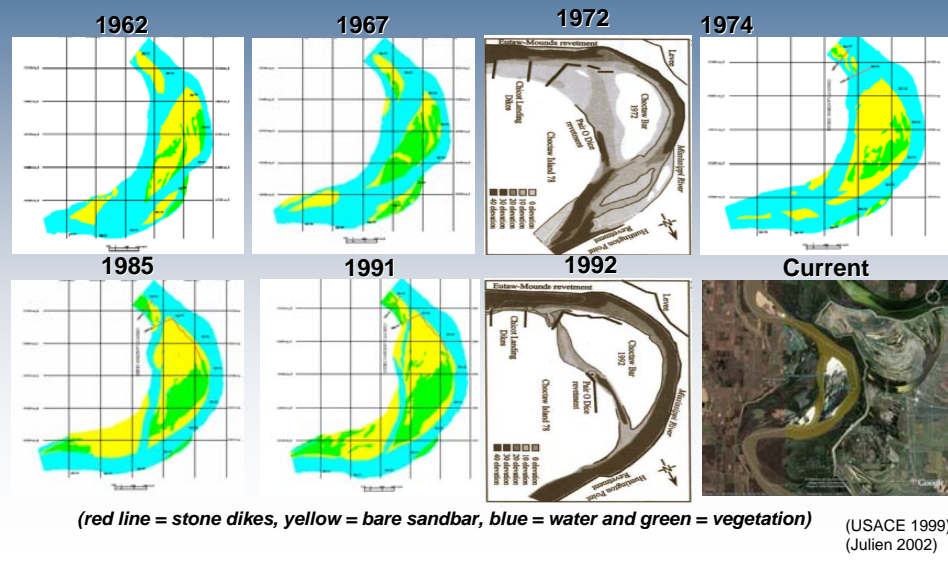
Time Change Choctaw Bar, Mississippi River

- **Choctaw Bar**
 - Stabilization the river for navigation and flood protection
 - Flow is divided due to a chute cutoff
 - 1968 a stone dike system was constructed
 - 1973 a large section of the main closure dike degraded, creating a weir, which allows significant flow in the secondary channel and caused sedimentation within the main channel requiring dredging.
 - Vegetation on the islands is natural and provide bar stabilization and wildlife habitat.
