THESIS

GEOMORPHIC ANALYSIS OF THE MIDDLE RIO GRANDE –
ELEPHANT BUTTE REACH, NEW MEXICO

Department of Civil and Environmental Engineering

Colorado State University

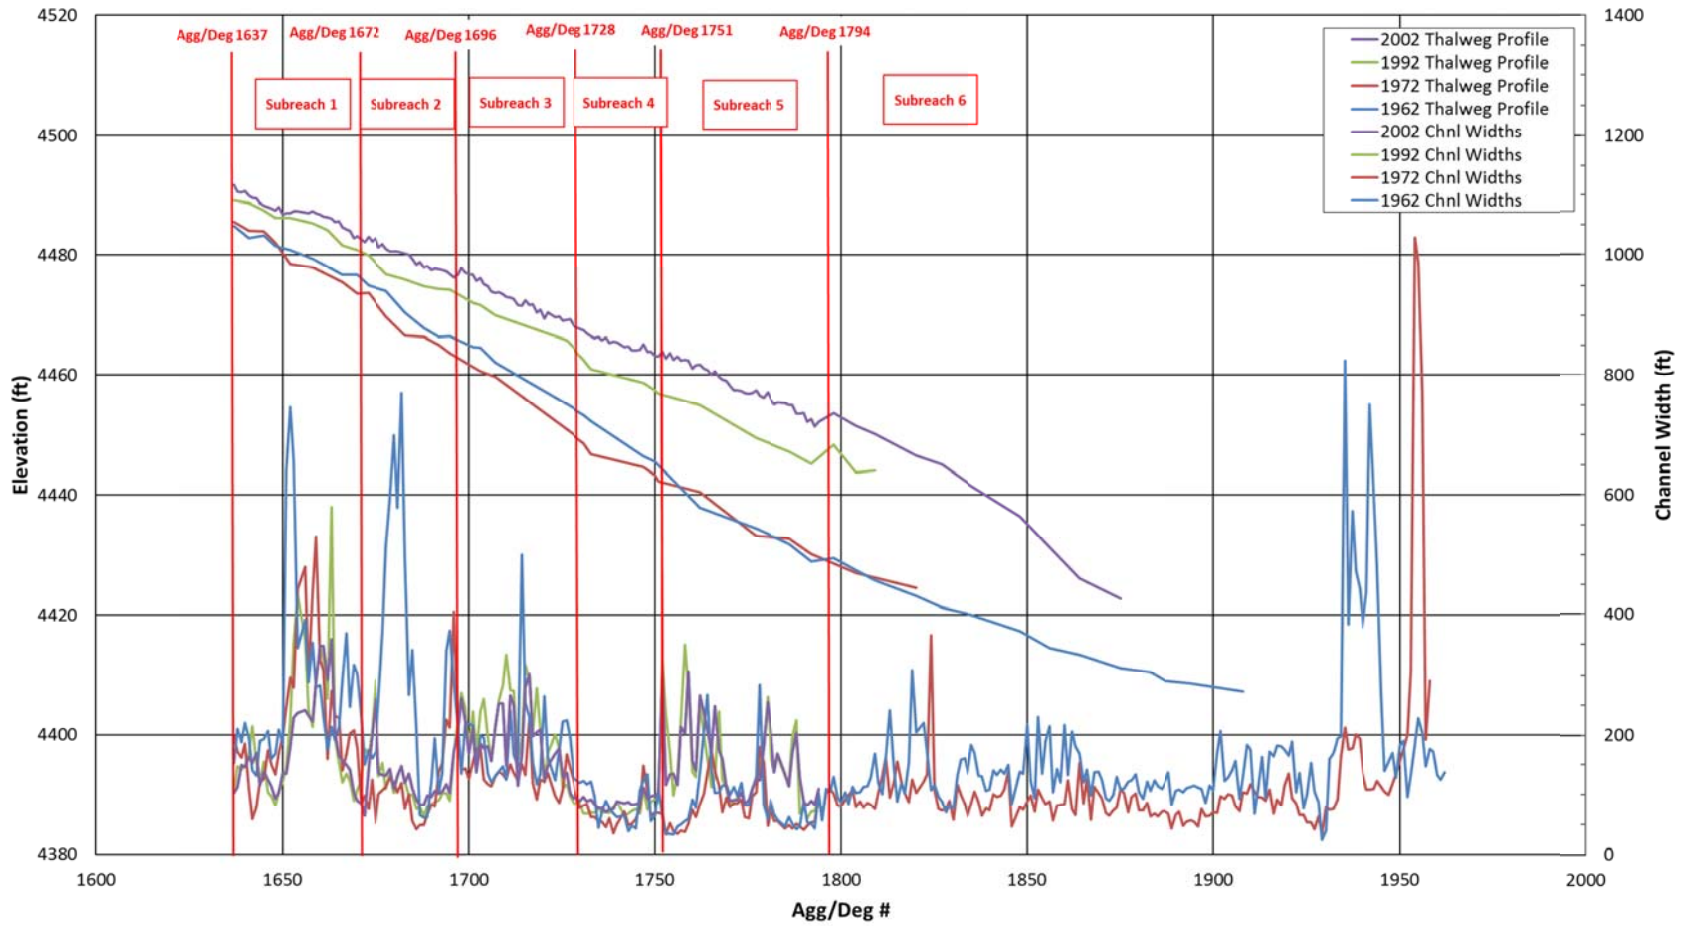
Figure 2.2 Profile of Elephant Butte Reach Widths and Thalweg at Agg/Deg Lines

To determine the subreach divisions, the active channel widths, as measured from edge of vegetation to edge of vegetation, were plotted for the entire Elephant Butte Reach for years 1962, 1972, 1992, and 2002. The thalweg at each Agg/Deg-line was also plotted for each set of years, as shown on Figure 2.2. The subreaches were chosen based on the 2002 dataset because of the abundance of both GIS and Agg/Deg Cross-section data during this year, but subreaches were confirmed using the 1962, 1972, and 1992 datasets.

There are no major slope distinctions along the Elephant Butte Reach in 2002; therefore, subreaches were primarily selected based on width trends. Subreaches 1, 3, and 5 tend to be wider than Subreaches 2, and 4 (based on 2002 data). Subreach 6 is a transitional subreach, which is sometimes river, and sometimes reservoir, depending on the level of Elephant Butte Reservoir. The first subreach begins at the south boundary of the Bosque del Apache NWR, Agg/Deg 1637, and extends to Agg/Deg 1672. The second subreach begins at Agg/Deg 1672 and ends at Agg/Deg 1696. The third subreach begins at Agg/Deg 1696 and ends at Agg/Deg 1728. The fourth subreach begins at Agg/Deg 1728 and ends at Agg/Deg 1751. The fifth subreach begins at Agg/Deg 1751 and ends at Agg/Deg 1794. The sixth, and last, subreach begins at Agg/Deg 1794 and extends to Elephant Butte Reservoir.

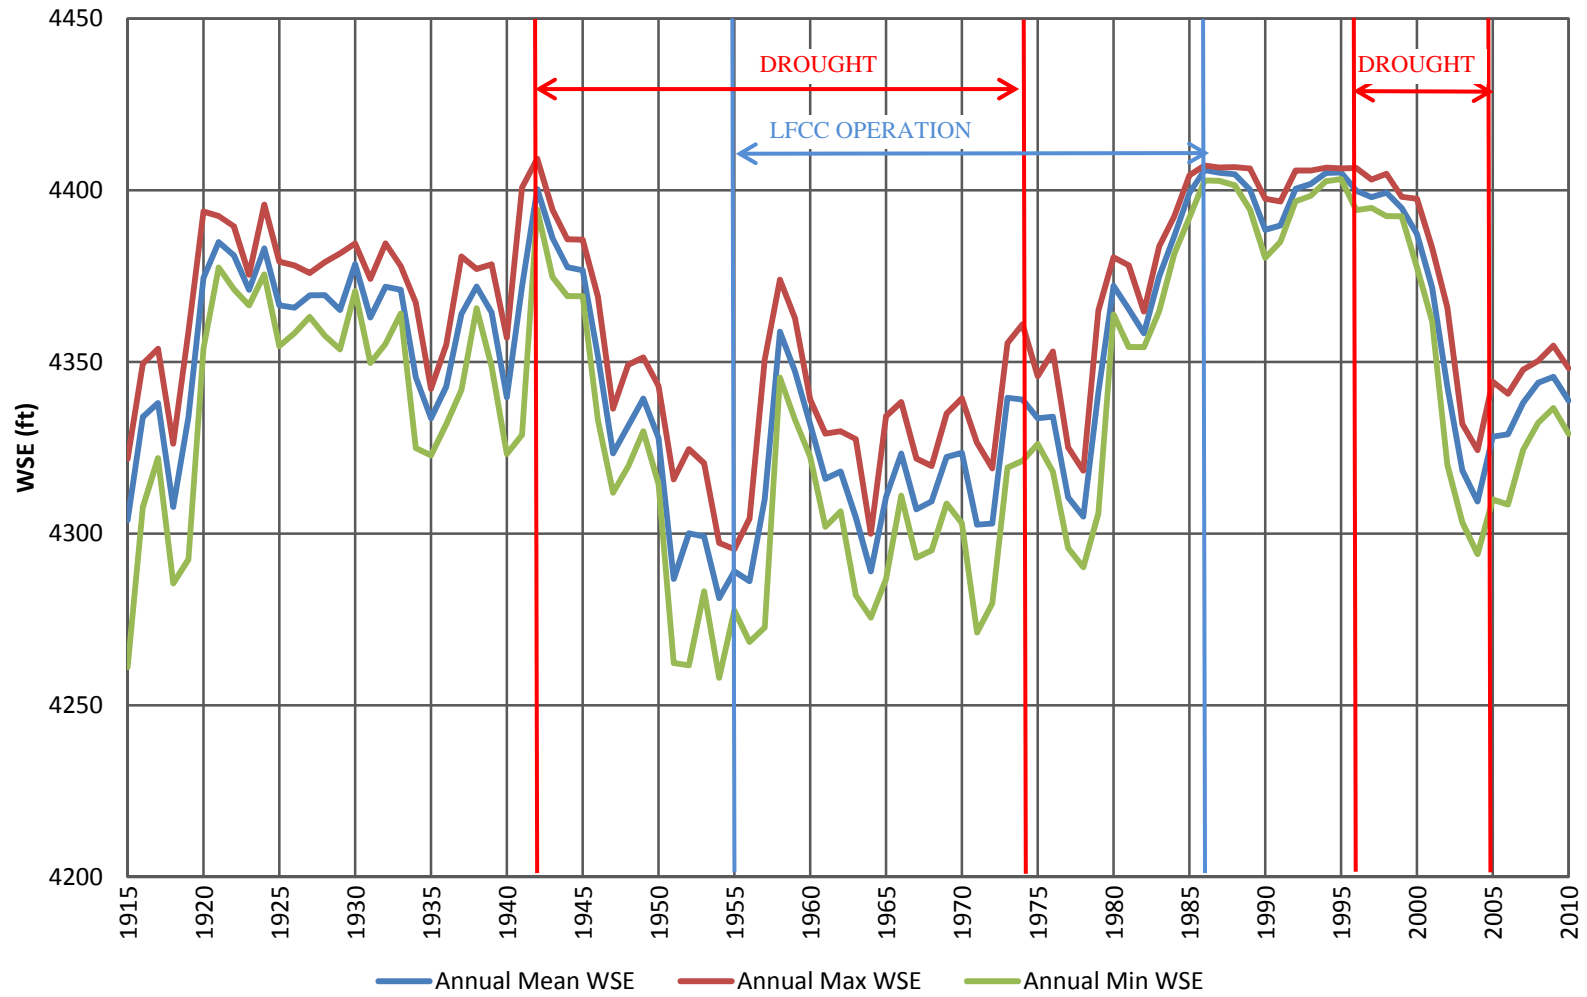
Figure 3.1 Elephant Butte Reservoir Level Time Series

A reservoir level analysis was performed for the Elephant Butte Reservoir, located at the downstream end of the Elephant Butte Reach. Figure 3.1 shows the Elephant Butte Reservoir level time series. Elephant Butte Dam construction began in 1908 and was completed in 1916, with water storage operations beginning in January of 1915 (Reclamation, 2008). The maximum water surface elevation (WSE) of Elephant Butte Reservoir is 4407.0 ft. Since its inception, the WSE behind Elephant Butte Dam has varied more than 150 ft in elevation. The reservoir was not completely filled until 1942, at which point the reservoir level dropped about 150 ft between 1942 and 1954, due to a drought which lasted from about 1942 to about 1974 (Figure 1.2). The low flow conveyance channel (LFCC), which was built to hydraulically efficiently transport water to Elephant Butte Reservoir and runs the entire length of Elephant Butte Reach, was in operation by 1955 and operated until 1986. With the operation of the LFCC during the drought, the reservoir WSE averaged between El 4331 and El 4404. By about 1977 the reservoir began to fill again until it was full, or essentially full, from 1985 to 1999, at which point another drought impacted the reservoir level, which decreased to an average WSE of about 4340 ft in 2010.

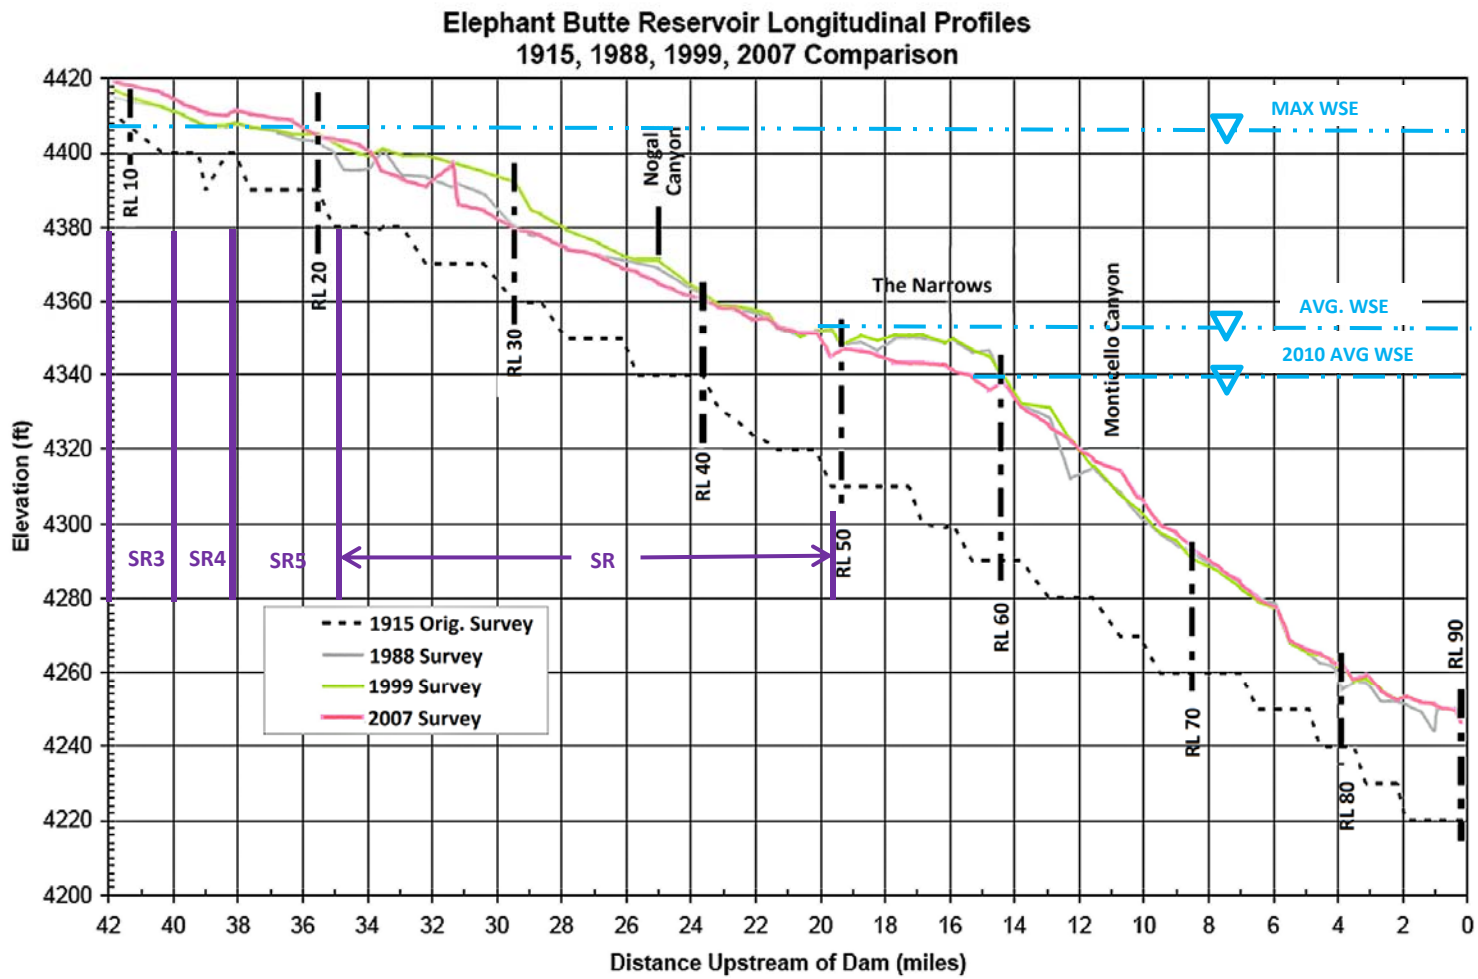
Figure 95 - Elephant Butte Reservoir Longitudinal Profiles

In 1915, when the reservoir had just begun to fill, had the reservoir been at its maximum WSE, then the upstream extent of the reservoir would have reached RL 10 (or the upstream end of Subreach 3). By 2007, the upstream extent of the reservoir at its maximum WSE would have been about RL 20 (or the upstream end of Subreach 6). This means the maximum upstream extent of the reservoir would have shifted downstream approximately 6 miles. The level of the reservoir impacts Elephant Butte Reach, due to sediment deposition as a result of an increased base-level. The longitudinal profile of Elephant Butte Reach is base-level controlled; with an increase in base-level, the channel adjusts vertically by way of sediment deposition, resulting in channel aggradation.

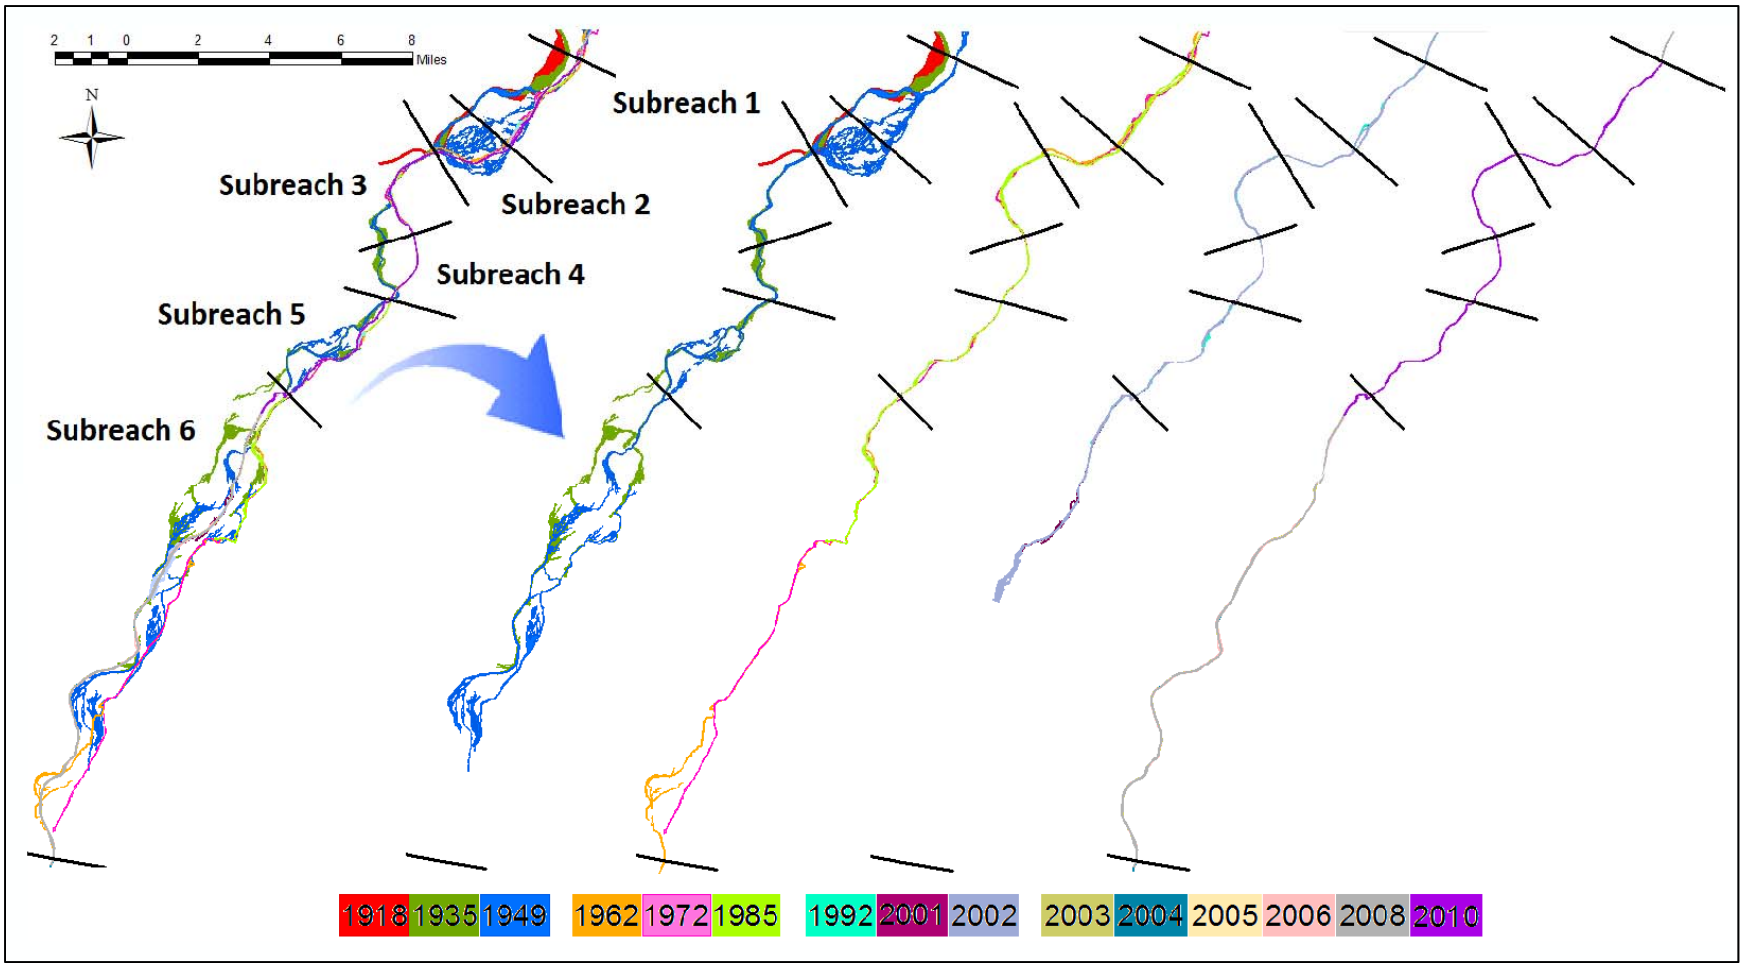
Figure 4.1 Channel Planforms from Aerial Photography

Figure 4.1 shows the channel planforms that were delineated in ArcGIS. Figure 4.2 through Figure 4.7 show magnified versions of Figure 4.1. Based on visual observations, the overall channel has narrowed and changed from a multithread channel to a primarily single-thread channel. Subreaches 1, 2, 5, and 6 have straightened and narrowed primarily between 1918 and 1962, and have remained relatively unchanged since then. The multithread characteristics of the river observed from 1928 to 1949 are not repeated after the recession of the reservoir from 2001 to 2003, because Reclamation regularly excavated pilot channels within Subreach 6 (Baird, D., Pers. Comm.).

Note that the difference between the first set of delineations, 1918-1949, is 31 years, the second set of delineations, 1962-1985, is 23 years, the third set of delineations, 1992-2002 is 10 years, and the fourth set of delineations, 2003-2010 is only 7 years. Based on a qualitative visual analysis, the first delineation comparison covers the longest time period and shows the most change and the last delineation comparison shows the shortest time period with the least change. Nevertheless, narrowing and straightening of the reach is observed over time.

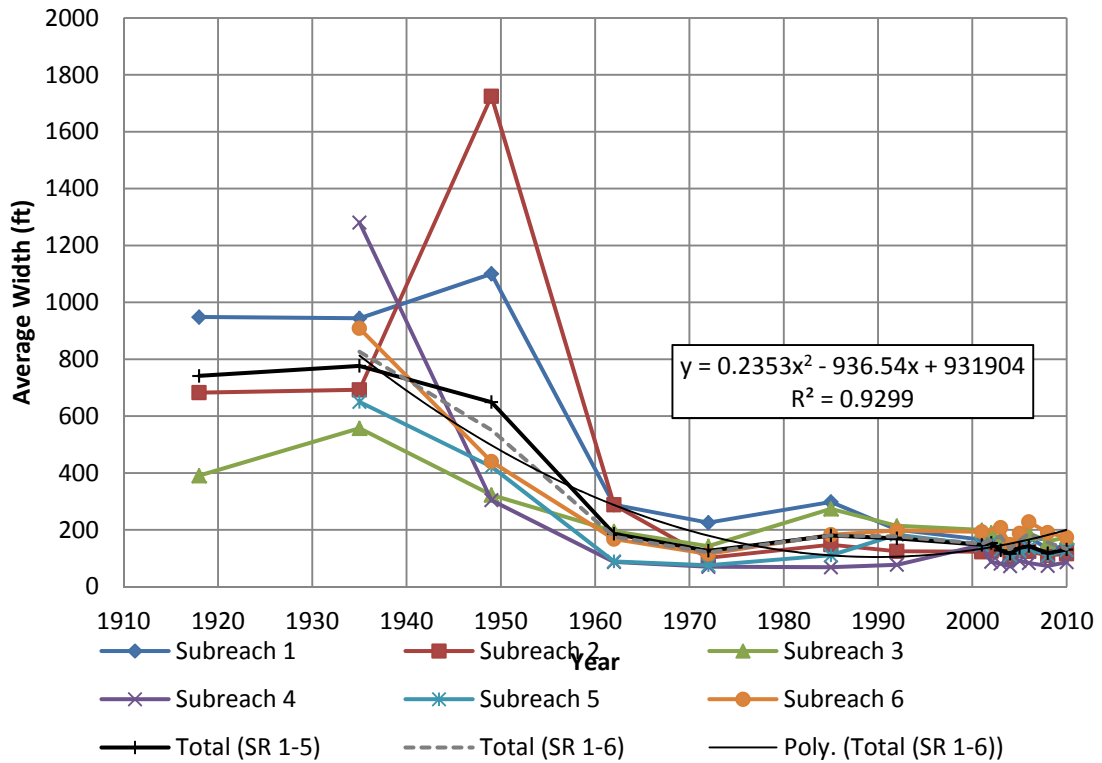
Figure 4.8 Channel Widths from GIS (1918 - 2010)

Where, x is the year, and y is the average channel width (ft).

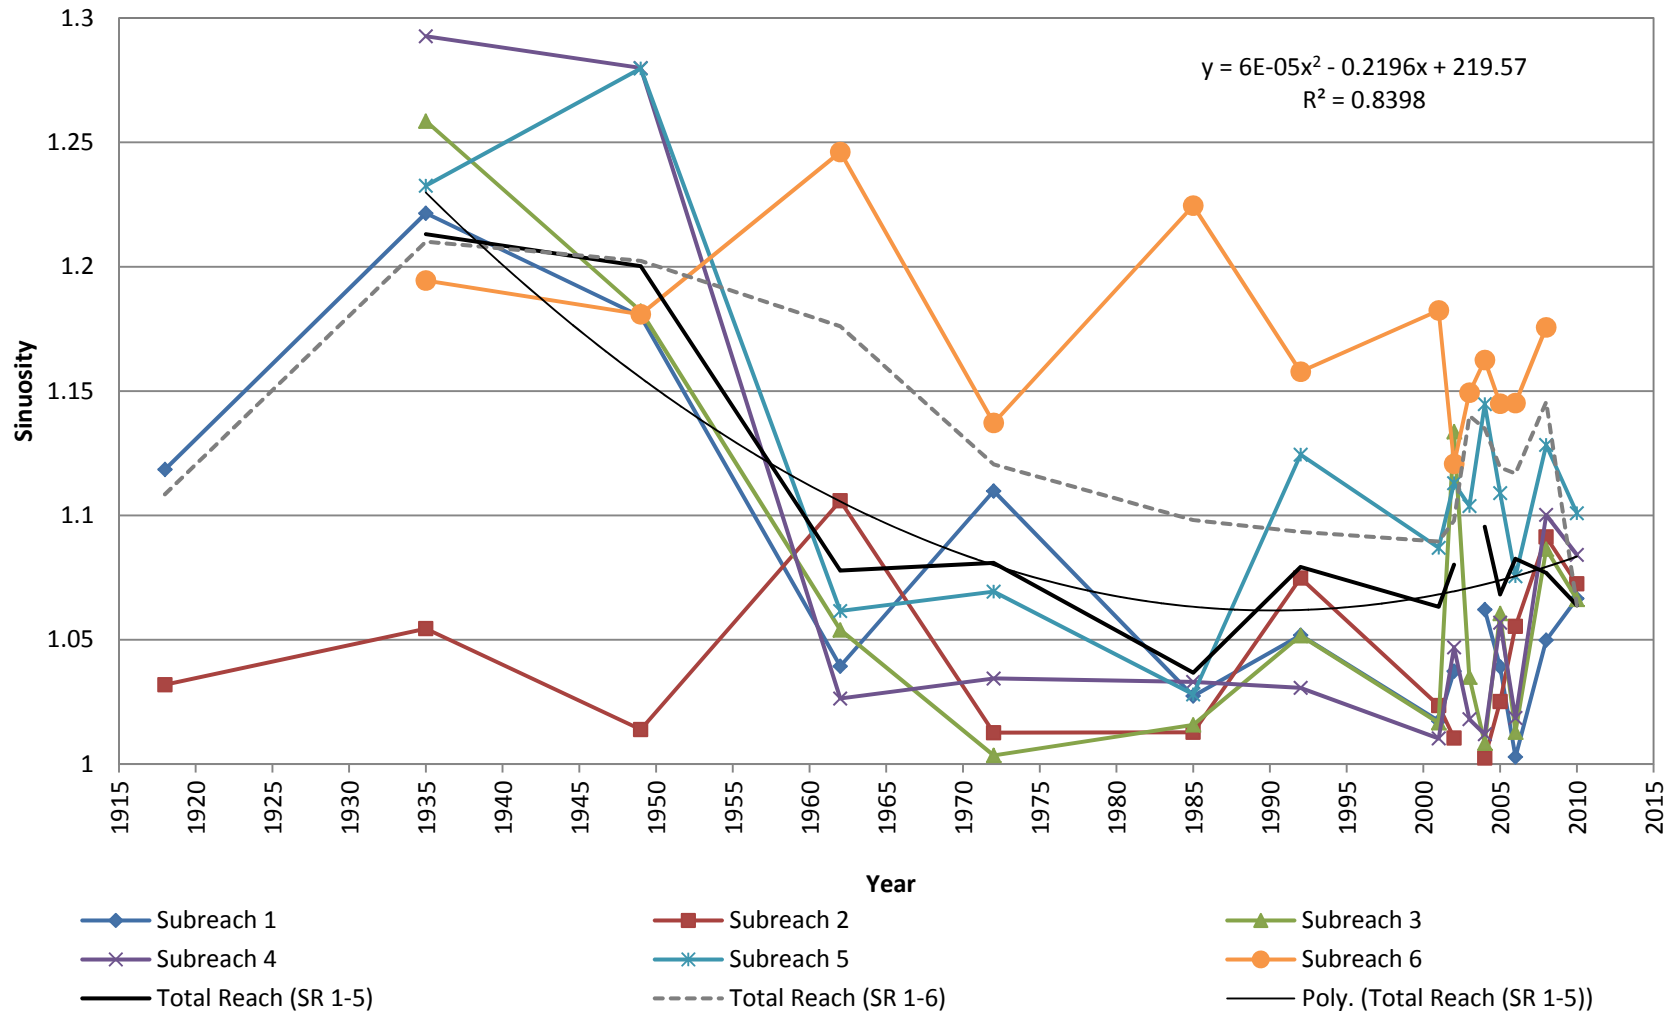
Figure 4.11 Temporal Sinuosity Trends

Where, x is year, and y is channel sinuosity (ft/ft).

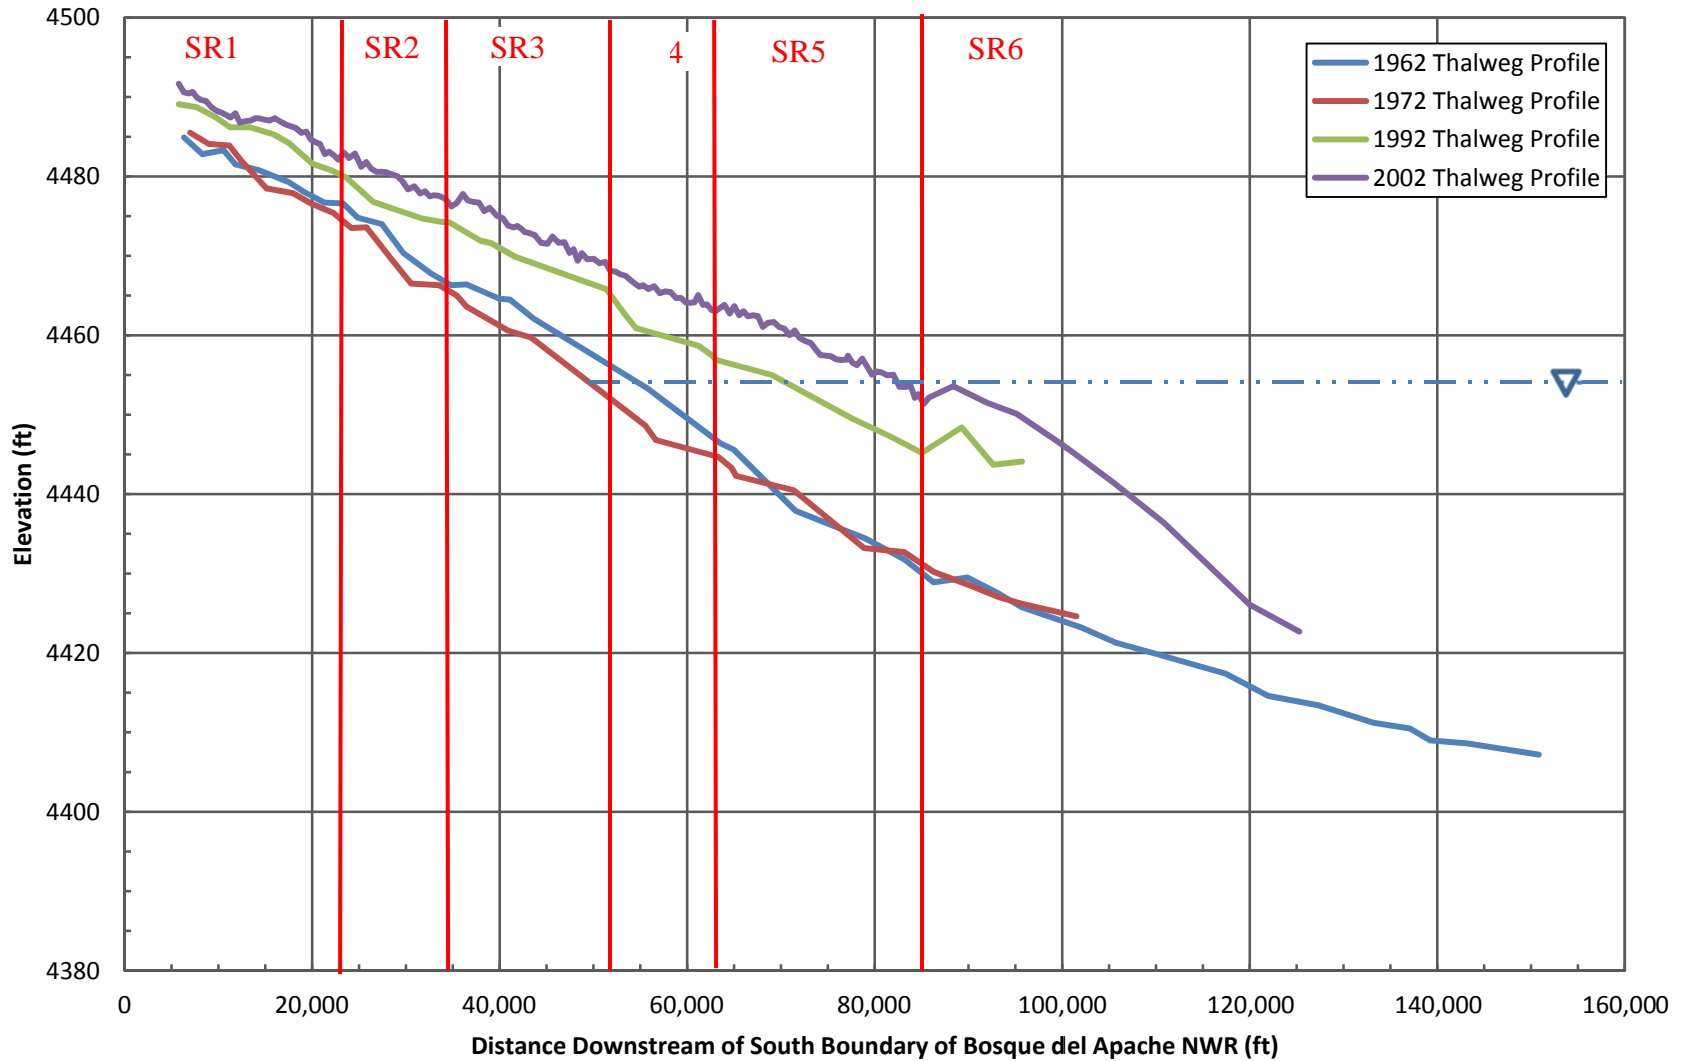
Figure 4.12 Thalweg Elevation Profile From Agg/Deg Surveys

The channel thalweg profile from the Agg/Deg survey data was utilized to demonstrate how the minimum elevation and slope of the reach has changed over time, as shown in Figure 4.12. The average bed slope for each subreach and for the entire reach was determined by first plotting the thalweg profile versus downstream distance, as measured along the estimated thalweg in GIS, and fitting a linear regression trendline to each subreach. The slope of the linear regression line was considered the average bed slope of the respective subreach. A linear regression trendline was also fit to the total reach thalweg profile, from which the slope of the regression trendline was considered the average bed slope of the total reach. This method was used for 1962, 1972, 1992, and 2002. The average bed slope for each subreach and for the entire reach is shown in Figure 4.13.

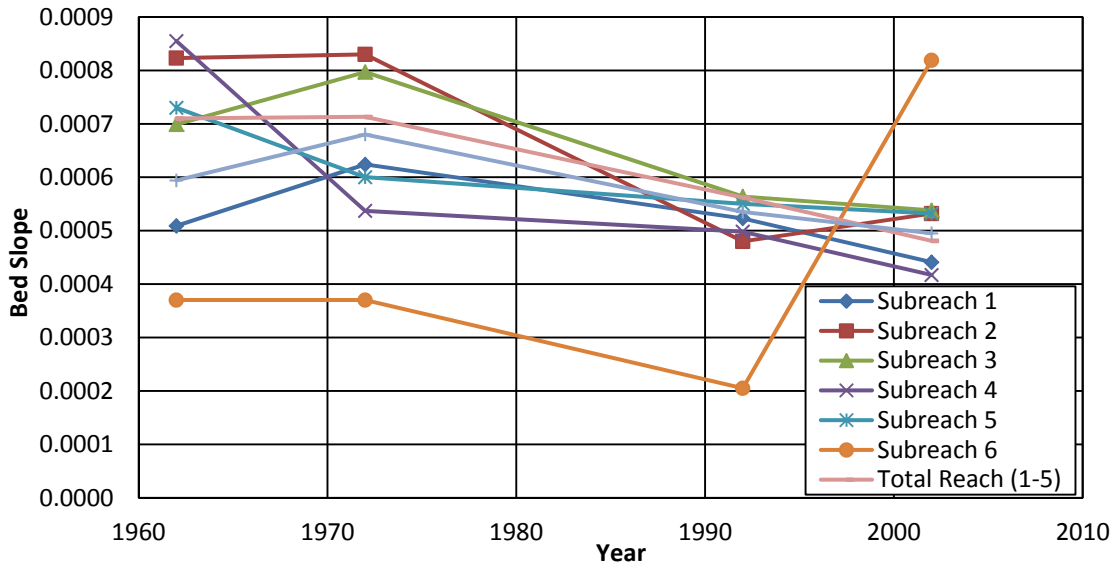
Figure 4.13 Bed Slope from Agg/Deg Surveys

Between the years 1962 and 1972, the bed slope increased between 15 and 30 percent for Subreaches 1, 2, and 3; bed slope decreased 40 and 20 percent for Subreaches 4 and 5, respectively. From 1972 to 1992, bed slope decreased between 10 and 45 percent for all subreaches. From 1992 to 2002, Subreach 2 increased 10 percent and Subreach 6 increased fourfold; all other subreaches decrease between 3 and 15 percent. The overall decrease in bed slope along the entire reach suggests aggradation has occurred between 1962 and 2002. The decrease in bed slope from 1972 to 1992 in Subreach 6 could be caused by the increased Elephant Butte Reservoir level (base-level), which increased by about 130 ft. The fourfold increase in bed slope from 1992 to 2002 in Subreach 6 could be due to the drop base-level, which dropped about 85 feet between 1992 and 2002. The longitudinal profile of Elephant Butte Reach is base-level controlled; with an increase in base-level, the channel adjusts vertically by way of sediment deposition, resulting in channel aggradation and a decrease in channel slope. It is important to note, however, that these trends could also be due to the lack of data in Subreach 6, especially in 1972 and 1992, which could skew the calculated bed slope

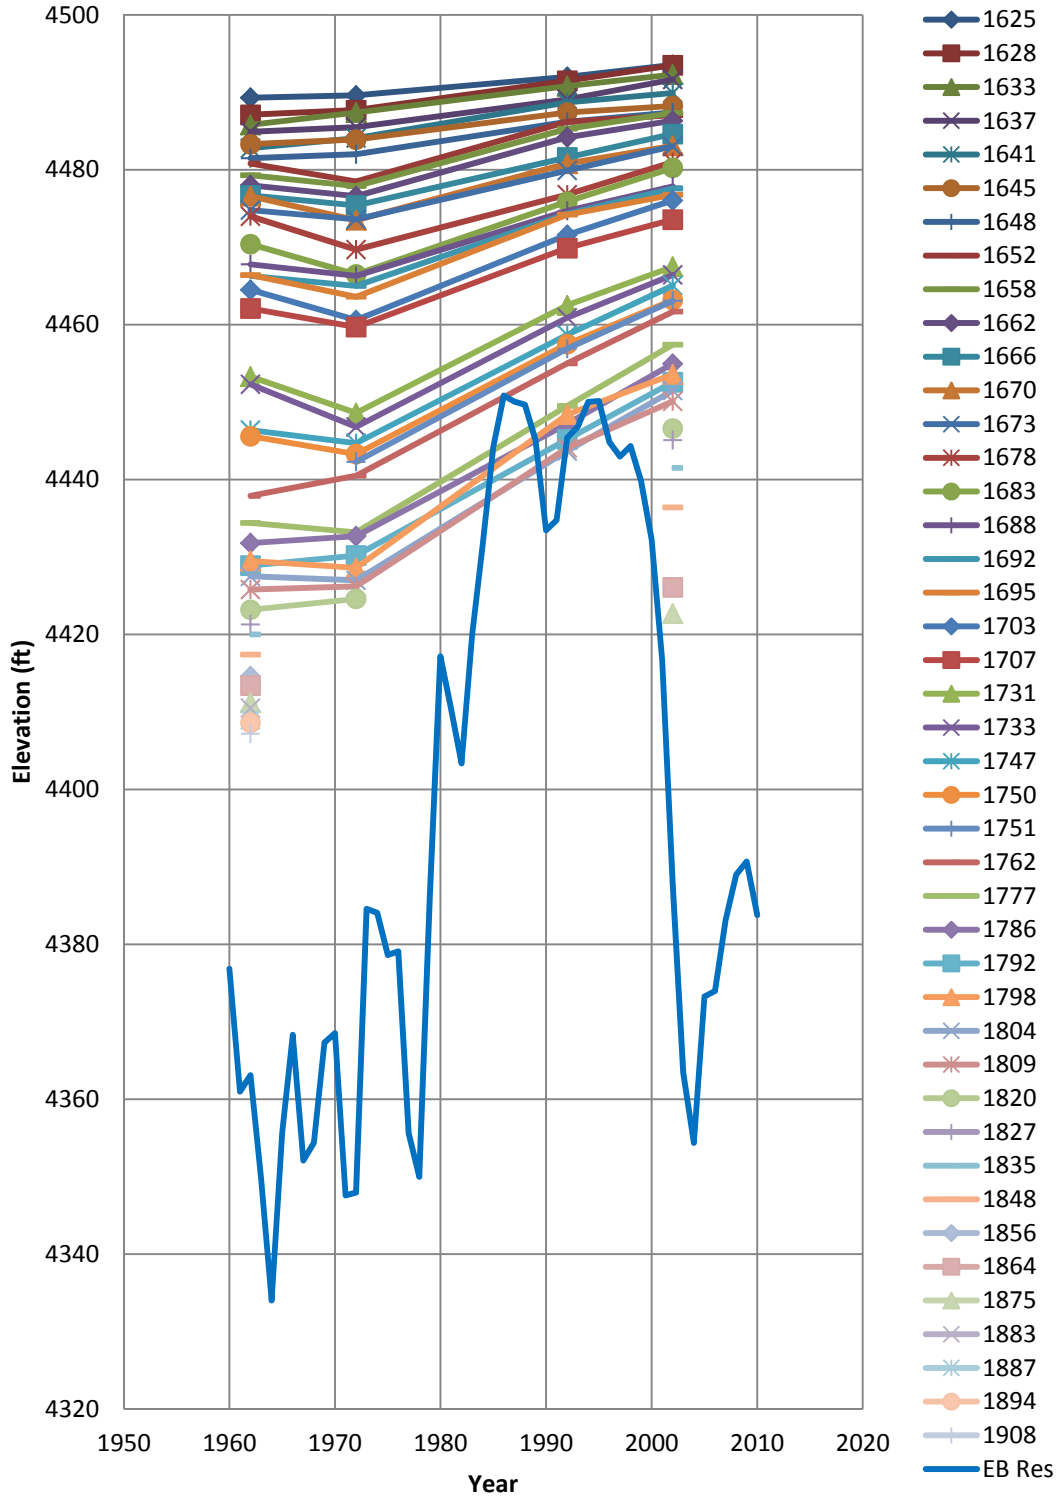
Figure 4.19 Temporal Trend in Thalweg Elevation at Agg/Deg Lines

Figure 4.19 shows the change in the thalweg elevation at selected Agg/Deg lines from 1962 – 1992. Only Agg/Deg lines with sufficient years of sample data were plotted. It can be inferred from this plot that as the reservoir level increases, the channel thalweg elevation increases at each Agg/Deg line, and that the increase in channel thalweg elevation is more pronounced in the downstream direction, closer to the reservoir.

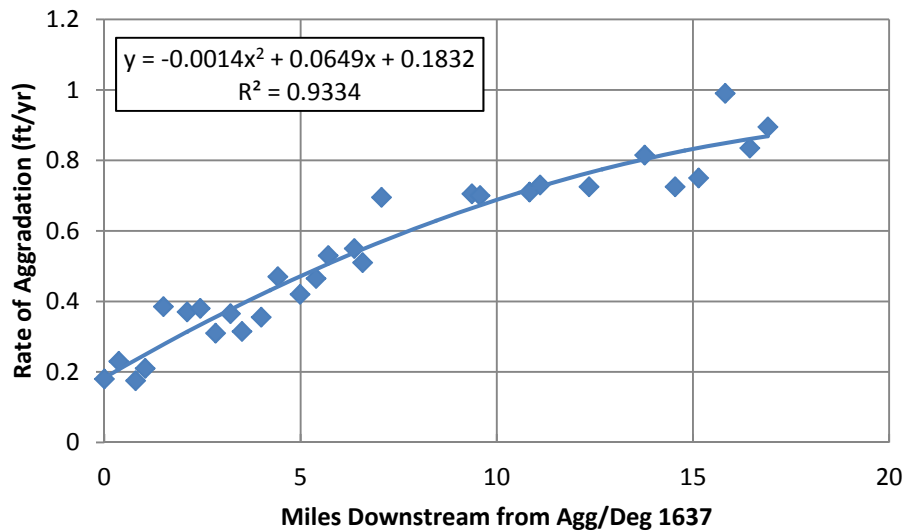
Figure 4.20 Rate of Channel Aggradation between 1972 and 1992

Where, x is the distance in miles downstream of Agg/Deg 1637 (or the upstream end of Elephant Butte Reach).

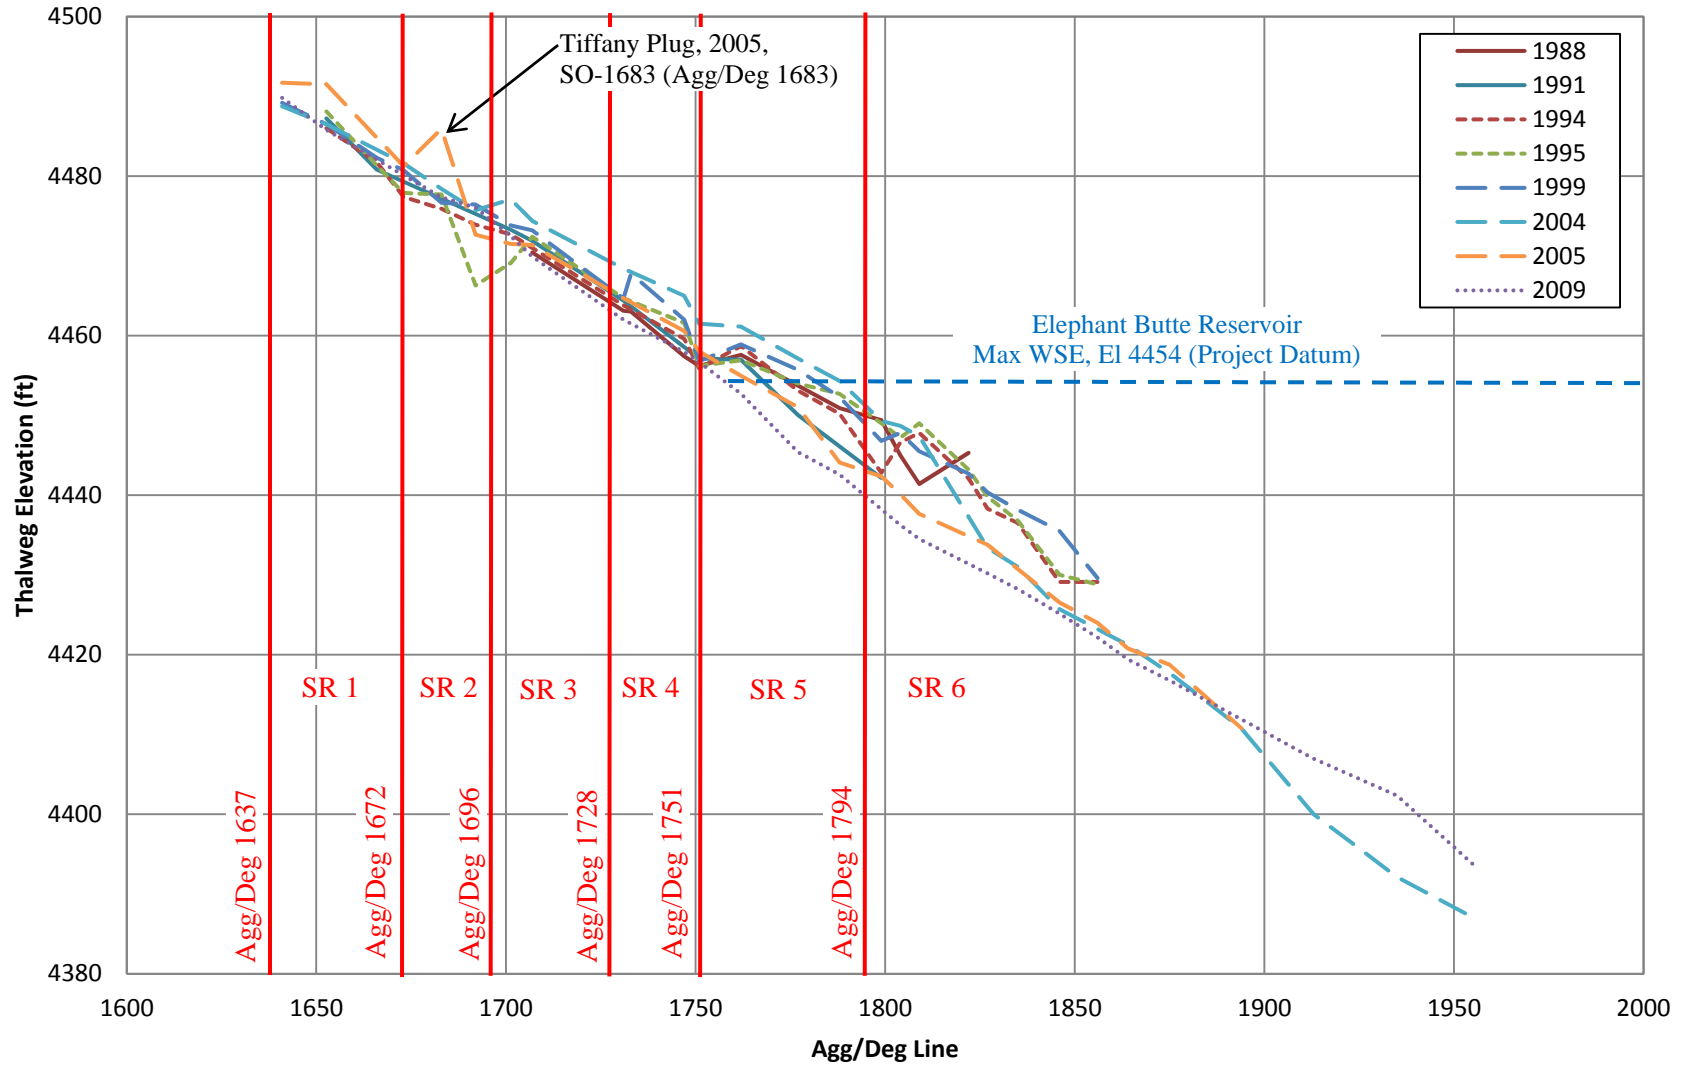
Figure 4.21 Thalweg Elevation Profile From Range Line Survey Data

trend of varying aggradation and degradation over time. One of the most notable trends from this plot is the flattening of the channel slope from 2004 to 2009 in the downstream half of the reach, which is due to the aggradation induced by a rise in base-level from 2004 to 2009. Also noteworthy is the significant aggradation in 2005 upstream of EB-10 (Agg/Deg 1707). The Tiffany Plug formed in 2005 at SO-1683 (Agg/Deg 1683), just upstream of EB-10, which can be seen in the profile. In 1995, severe degradation can be seen downstream of SO-1683 (Agg/Deg 1683), and virtually no change at SO-1683, even though a sediment plug had formed upstream of SO-1683 in 1995. This is likely explained by the timing of the survey, which seems to have occurred after the sediment plug was mechanically removed by Reclamation.

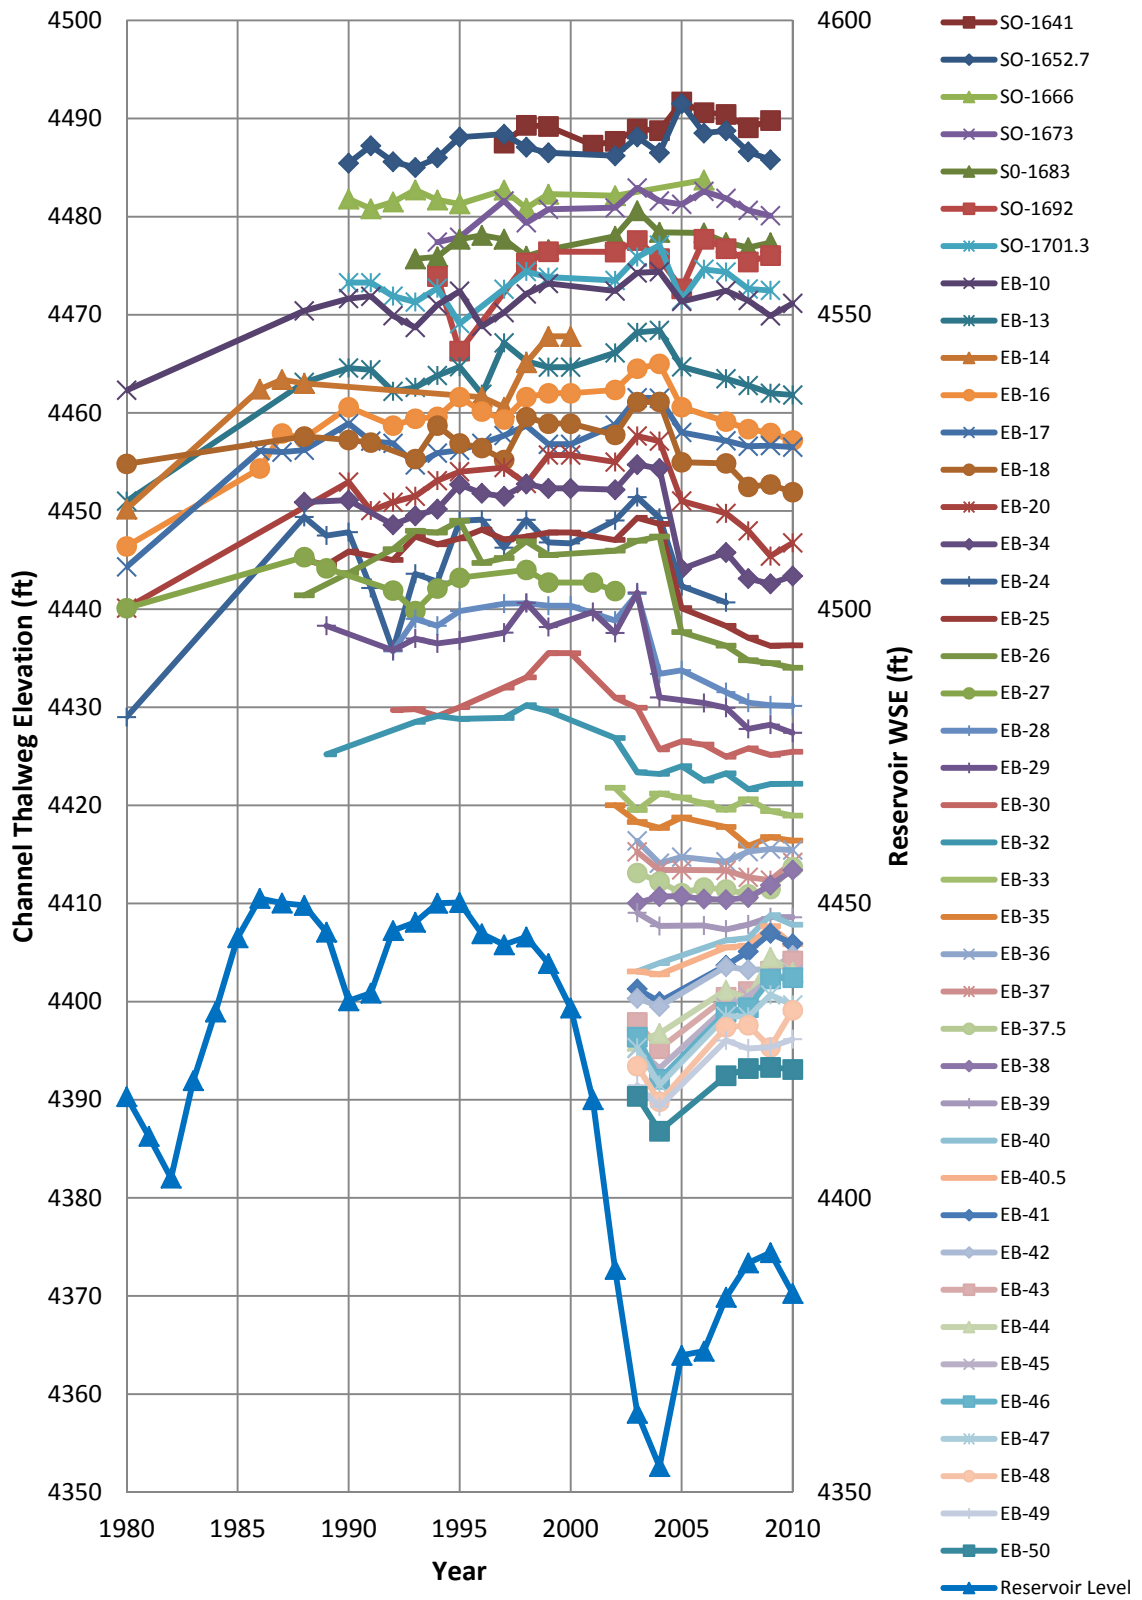
Figure 4.37 Change in Thalweg Elevation at Range Lines (1980 – 2010)

As seen in Figure 4.28 through Figure 4.36 aggradation and degradation occur across the entire channel bed, not just the thalweg. Therefore, the following analyses focus on the change in thalweg elevation temporally and spatially. Figure 4.37 shows the change in the thalweg elevation at selected range lines from 1980-2010. Only range lines with sufficient years of sample data were plotted.

From 1980 to 1988, aggradation occurred at all range lines for which there is data. From 1988 to 1994, the thalweg elevation alternated between increasing and decreasing elevation, typically changing no more than 3 ft in either direction. From 1994 to 1995, mostly aggradation occurs, up to 6.2 ft, near the upstream reservoir extent; degradation occurs just downstream of the 1995 Tiffany Sediment Plug at SO-1692 and SO-1701.3, 7.6 ft and 3.6 ft, respectively. From 1995 to 2002, the change in channel thalweg elevation varies between aggradation and degradation. From 2002 to 2003, aggradation occurs from SO-1641 to EB-29, ranging between 1 ft and 4 ft; degradation occurs downstream of EB-29, up to 3.5 ft. From 2003 to 2004, the channel degraded from SO-1641 to SO-1692, and from EB-20 to EB-50 by up to 10.7 ft; the channel aggraded from SO-1701.3 to EB-18 by up to 1 ft. From 2004 to 2007, aggradation occurred from SO-1641 to SO-1692, up to 2.3 ft, and from EB-40 to EB-50, up to 7.6 ft; degradation occurred from SO-1701.3 to EB-39, up to 11 ft. From 2007 to 2008, degradation occurred from SO-1641 to EB-37.5, up to 2.7 ft; aggradation occurred from EB-38 to EB-50, up to 1.4 ft. From 2008 to 2009, the channel degraded from SO-1641 to EB-37, up to 2.6 ft; the channel aggraded from EB-37.5 to EB-50, up to 4.2 ft. From 2009 to 2010, the channel varied between aggradation and degradation, ranging between -1.8 ft and 2.2 ft in elevation change.

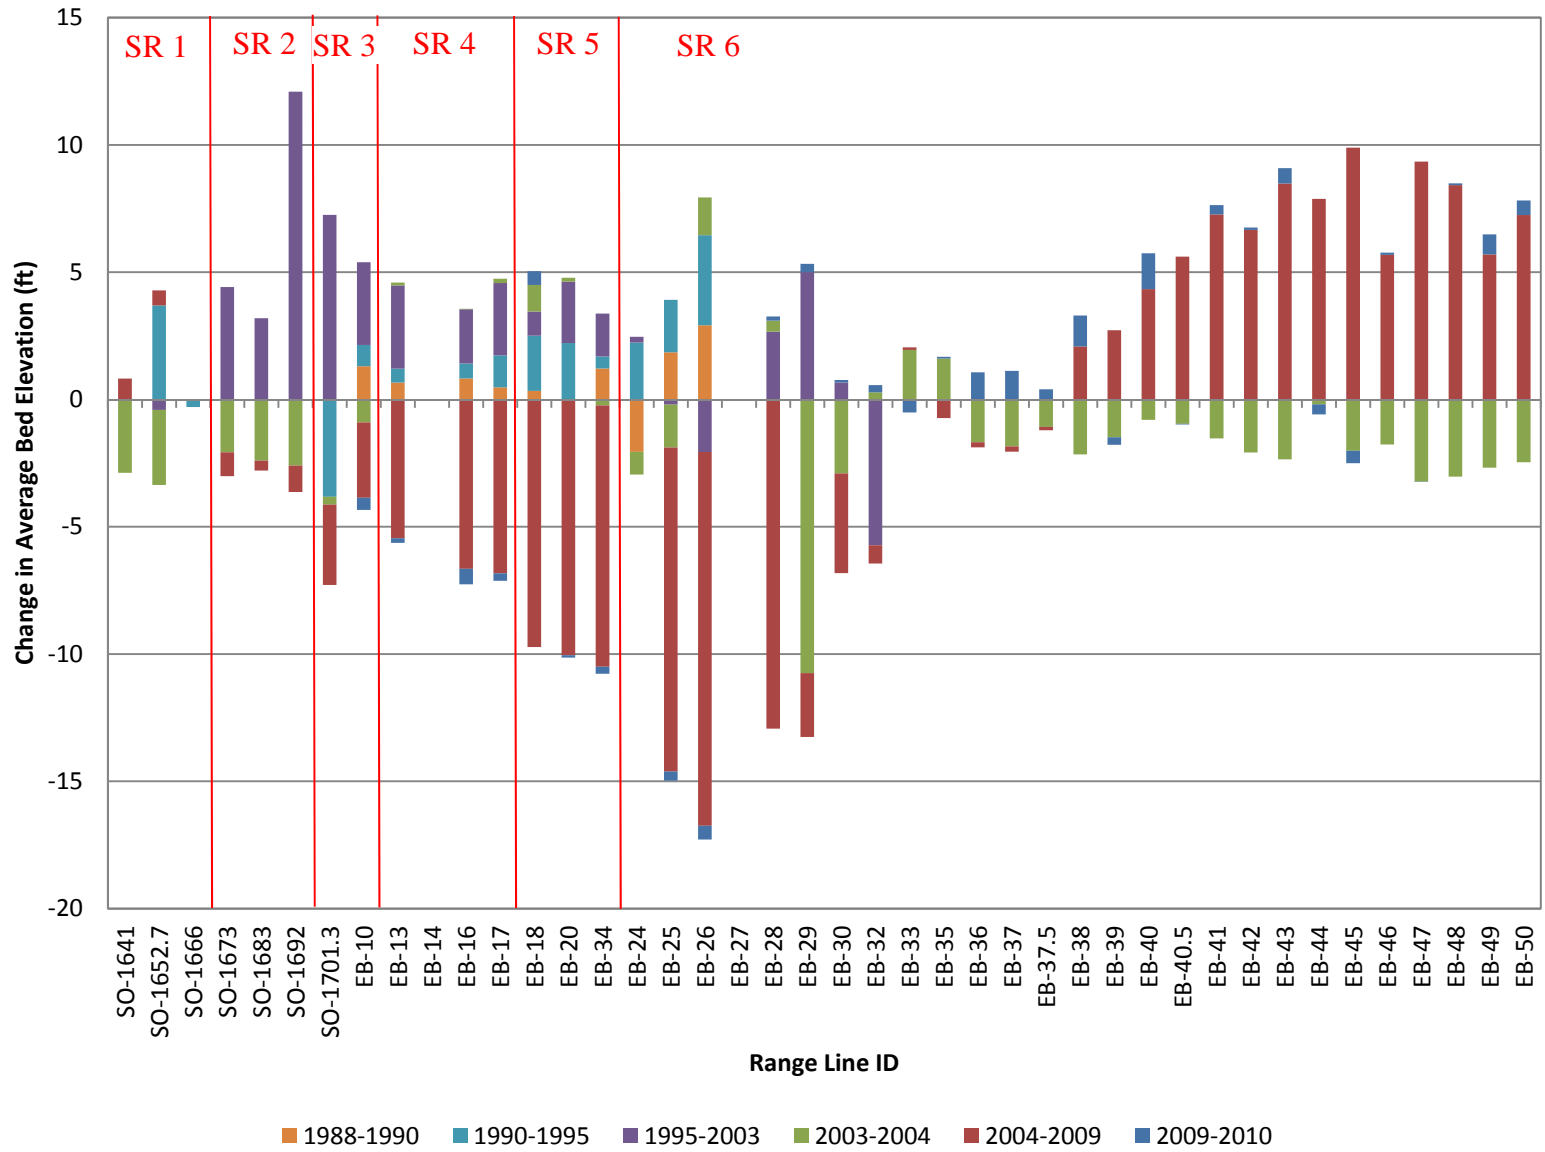
Figure 4.38 Change in Average Channel Bed Elevation at Range Lines (1988-2010)

Because data was not available each year for every range line, different ranges of years had to be used to calculate the change in elevation. This is indicated by the different colors of bars in Figure 4.38 for the change in average bed elevation analysis, and Figure 4.39 for the change in thalweg elevation analysis. The orange bars show a change in elevation for range lines between 1988 and 1990; the turquoise bars show a change in elevation between 1990 and 1995; the purple bars show a change in elevation from 1995 to 2003; the green bars show a change in elevation between 2003 and 2004; and the red bars show a change in elevation from 2004 to 2009; and blue bars show a change in elevation from 2009 to 2010. Note that each set of bars has a different time increment; this is because the selected years contain data for most of the range lines, and the year sets represent an overall aggrading or degrading trend.
