THESIS

GEOMORPHIC ANALYSIS OF THE MIDDLE RIO GRANDE –
ELEPHANT BUTTE REACH, NEW MEXICO

Department of Civil and Environmental Engineering

Colorado State University

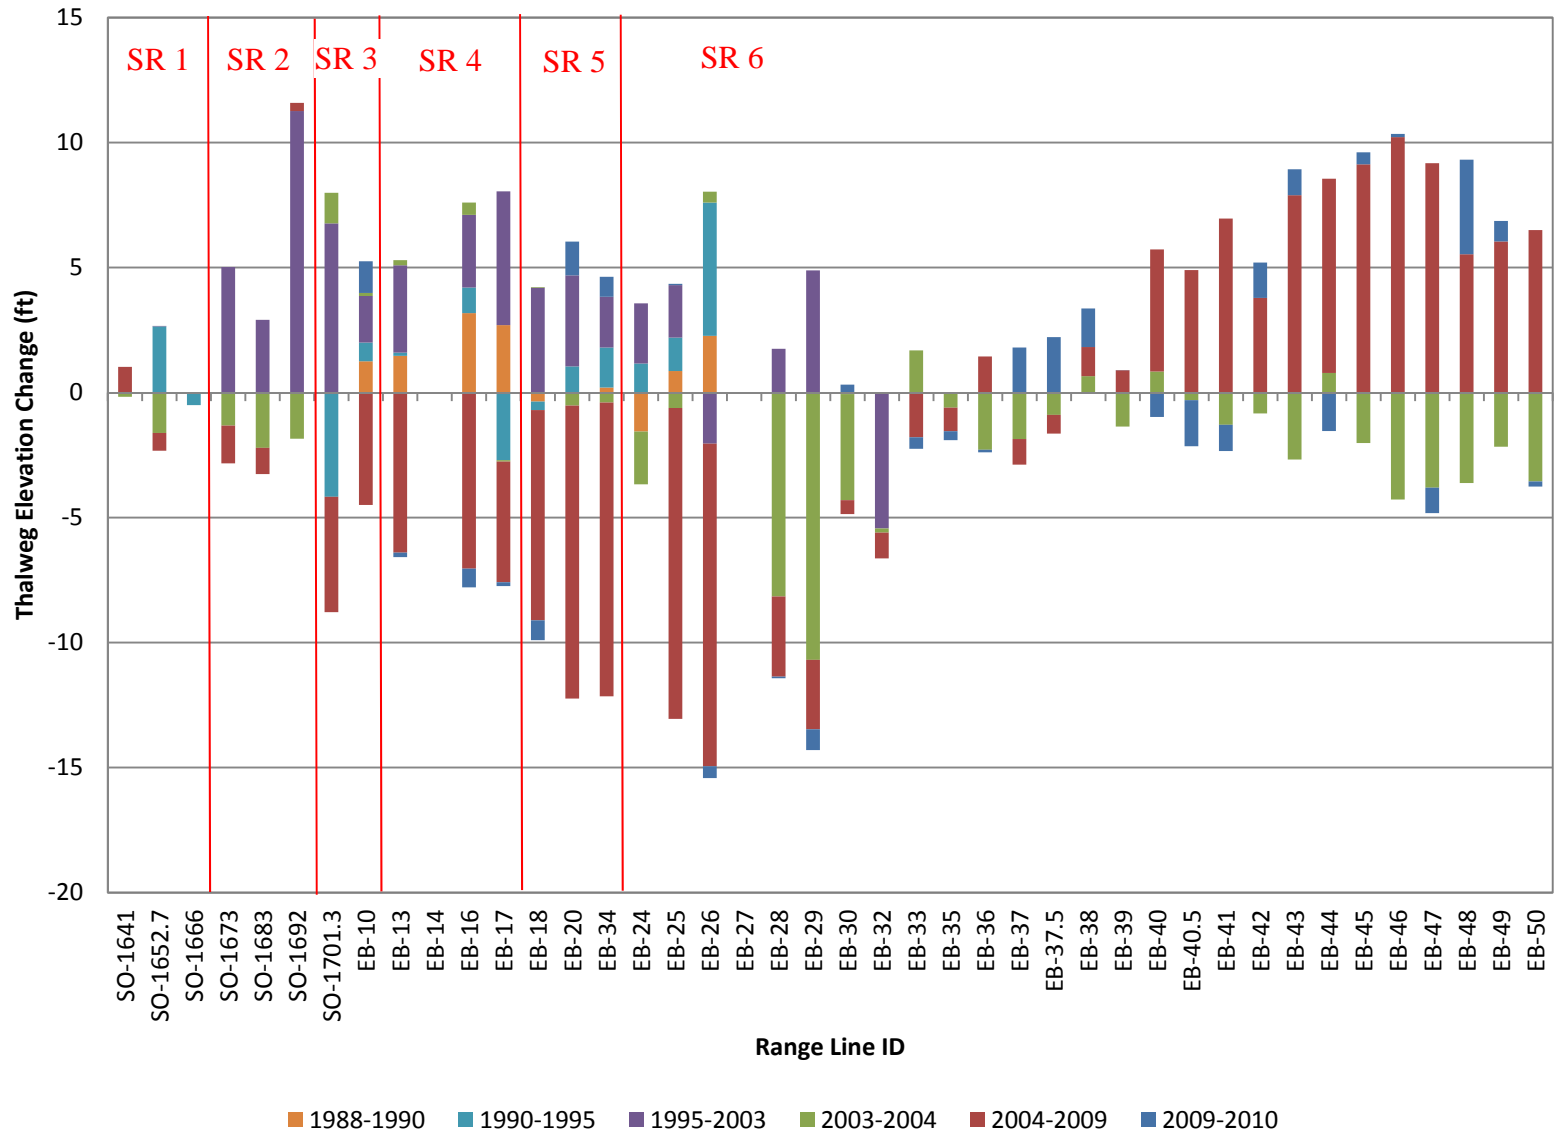
Figure 4.39 Change in Channel Thalweg Elevations at Range Lines (1988-2010)

The following observations are based specifically on the change in thalweg elevation; however, the general trends observed are similar for the change in average bed elevation. From 1988 to 1990, primarily aggradation occurred, up to 3.2 ft. From 1990 to 1995, which includes the first instances in which the Tiffany Plug formed, there is aggradation and degradation observed, depending on the range line; there does not appear to be a hinge point spatially separating aggradation and degradation. From 1995 to 2003, after the second Tiffany Plug, there is mostly aggradation between SO-1673 and EB-29, up to 11.3 ft. From 2003 to 2004, there is degradation the majority of the reach, up to 10.7 ft. From 2004 to 2009, degradation is observed from SO-1652.7 to EB-37.5, at which point aggradation is observed from EB-38 to EB-50. From 2009 to 2010, the channel alternates between aggradation and degradation along the reach profile, with the greatest magnitude of aggradation, 3.8 ft, occurring at EB-48.

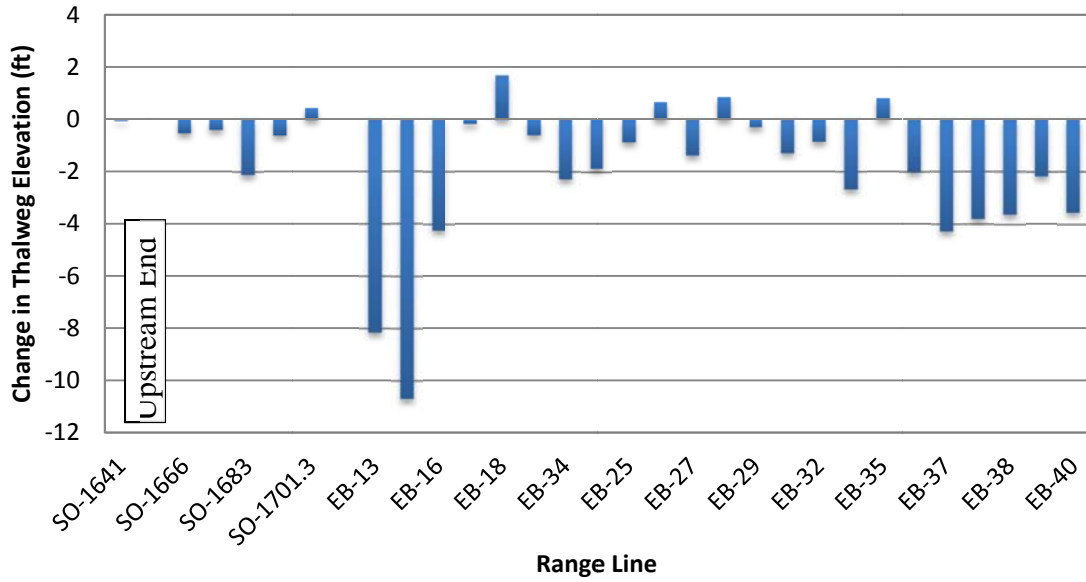
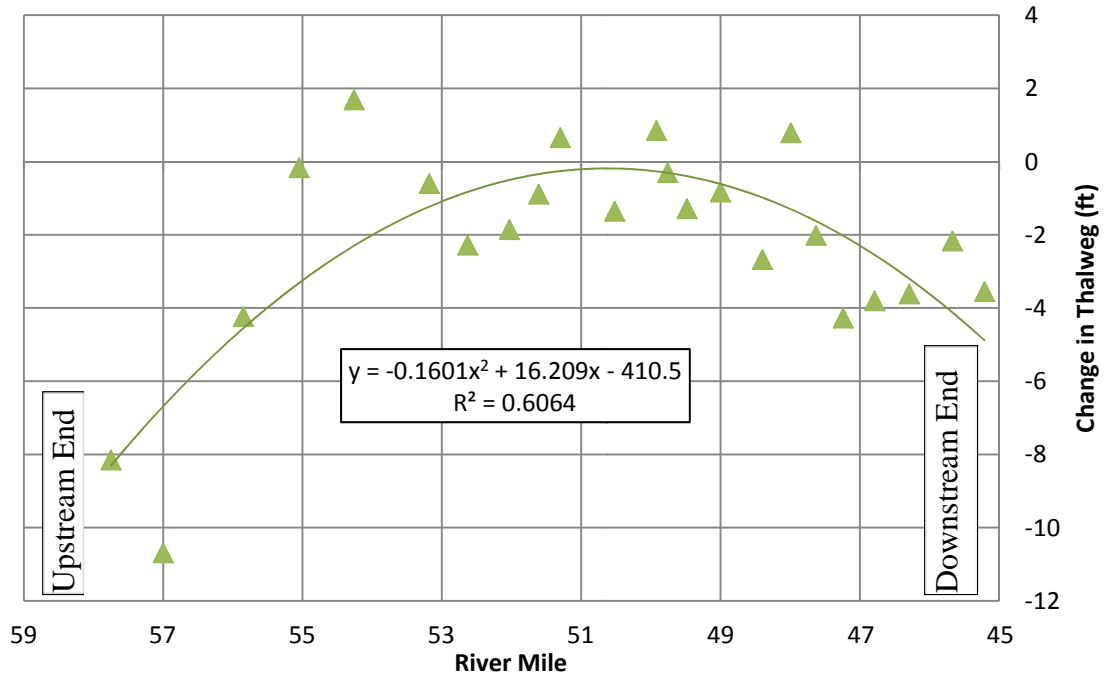
From 2003 to 2004, shown in Figure 4.40 and Figure 4.41, degradation is observed along the entire reach, except for at five range lines. The wave of degradation between EB-13 and EB-50 (Wave 3) is in response to the drop in base-level (Reservoir WSE) by about 100 ft between 1995 and 2004. Figure 4.41 shows the magnitude of degradation from 2003 to 2004 at River Miles, which is represented by the following second order polynomial equation:

Where, y is the magnitude of degradation and x is the longitudinal location along the reach in River Miles (RM, as defined by Reclamation, where measurements begin at the

downstream end of the Middle Rio Grande River); this equation is appropriate for RM 45.21 to RM 57.75.

$$(2003-2004) \text{ Rate of Degradation} = -0.1601x^2 + 16.209x - 410.5$$

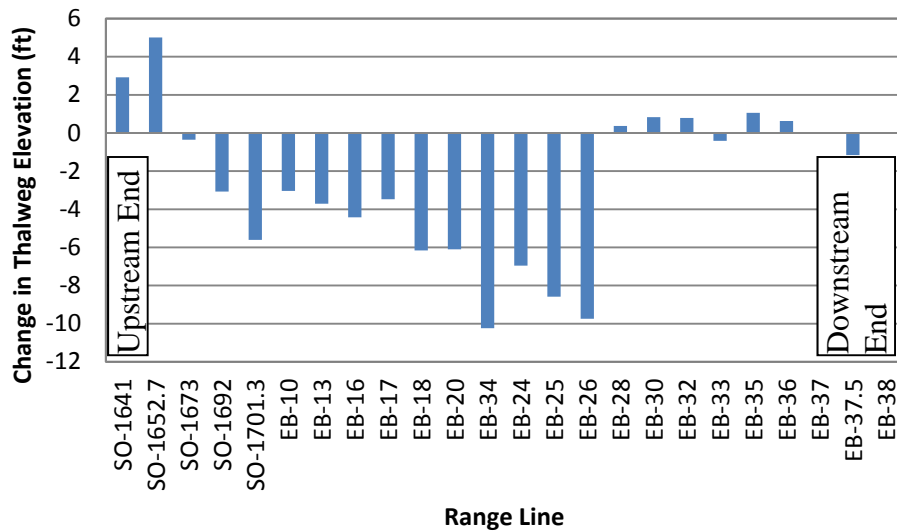
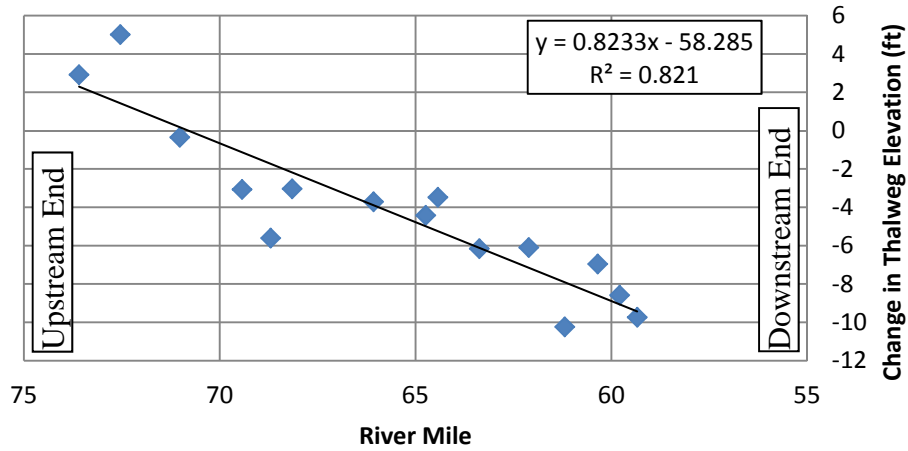
From 2004 to 2005, all of the thalweg elevations decreased between SO-line 1683 and EB-26; the decrease becomes more pronounced in the downstream direction between these range lines, as seen in Figure 4.42 and Figure 4.43. From 2004 to 2005, SO-lines 1641, 1652.7, and 1683 increased. The wave of degradation between SO-1683 and EB-26 (Wave 3) is in response to the drop in base-level (Reservoir WSE) by about 100 ft between 1995 and 2004. Figure 4.42 shows the magnitude of degradation from 2004 to 2005 at River Miles, which is represented by the following linear equation:

Where, y is the magnitude of degradation and x is the longitudinal location along the reach in River Miles; this equation is appropriate for RM 59.34 to RM 73.59.

$$(2004-2005) \text{ Rate of Degradation} = 0.8233x - 58.29$$

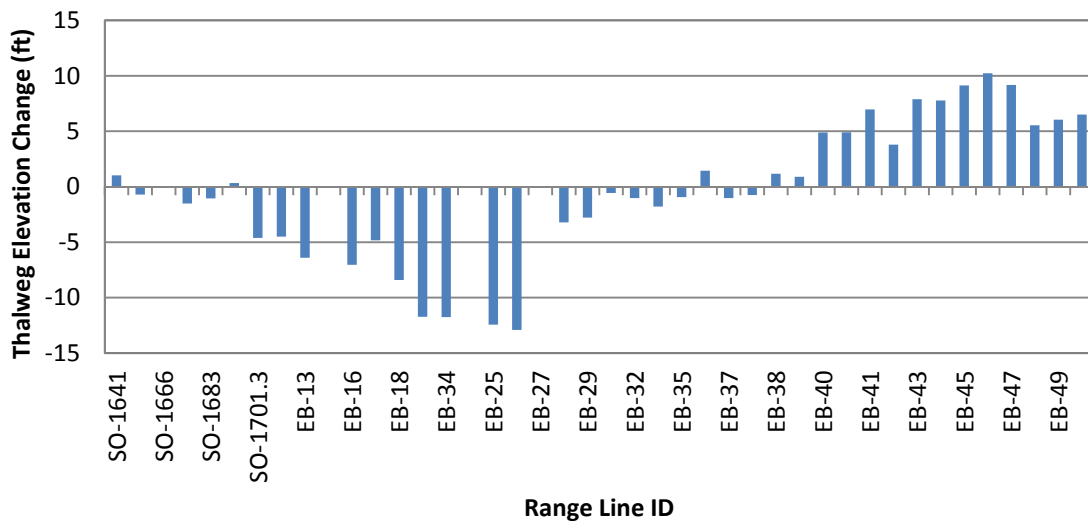
Figure 4.44 Change in Thalweg Elevation from 2004 to 2009

From 2004 to 2009, shown in Figure 4.44, degradation is observed from SO-1652.7 to EB-37.5, at which point aggradation is observed from EB-38 to EB-50. These two trends represent two distinct waves of thalweg elevation changes in response to base-level changes, Wave 3 and Wave 2, respectively.

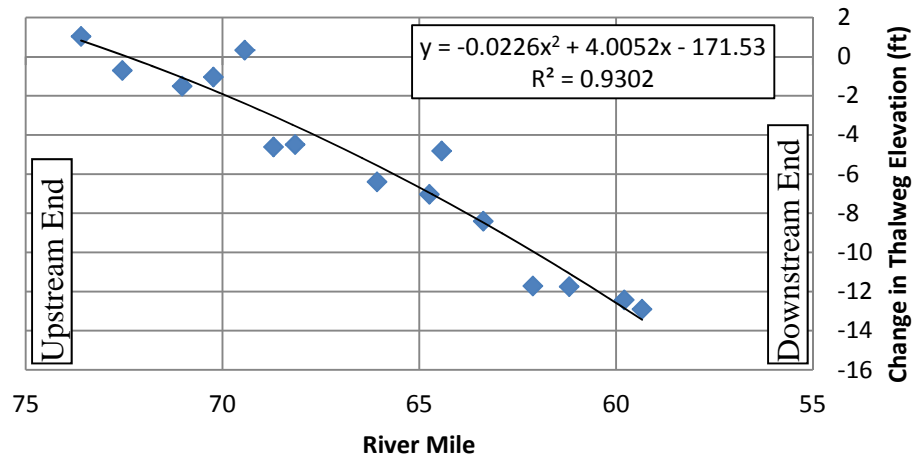
Figure 4.45 Magnitude of Degradation from 2004 to 2009

The wave of degradation between SO-1701.3 and EB-26 (Wave 3) is in response to the decrease in base-level by about 100 ft between 1995 and 2004. Figure 4.45 shows

the magnitude of degradation from 2004 to 2009, which is represented by the following second order polynomial equation:

Where, y is the magnitude of degradation and x is the longitudinal location along the reach in River Miles; this equation is appropriate for RM 45.21 to RM 52.03.

$$(2004-2009) \text{ Rate of Degradation} = -0.0226x^2 + 4.0x - 171.53$$

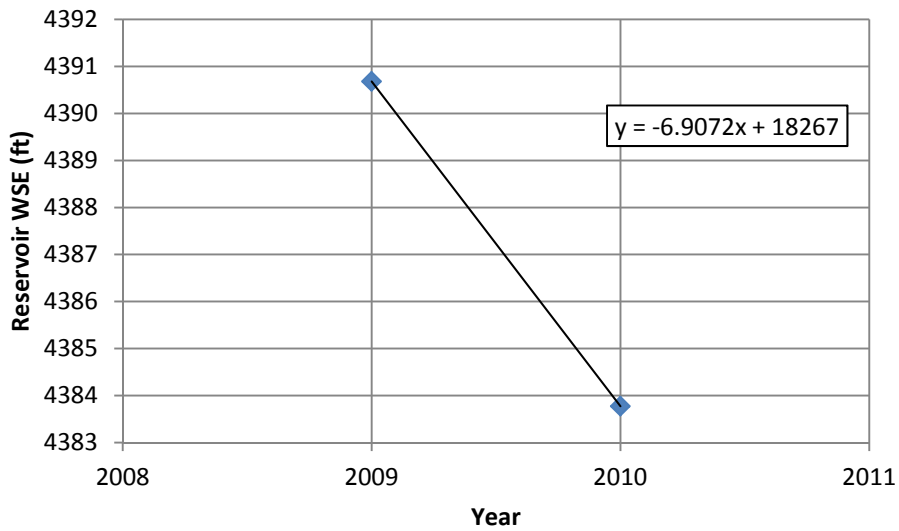
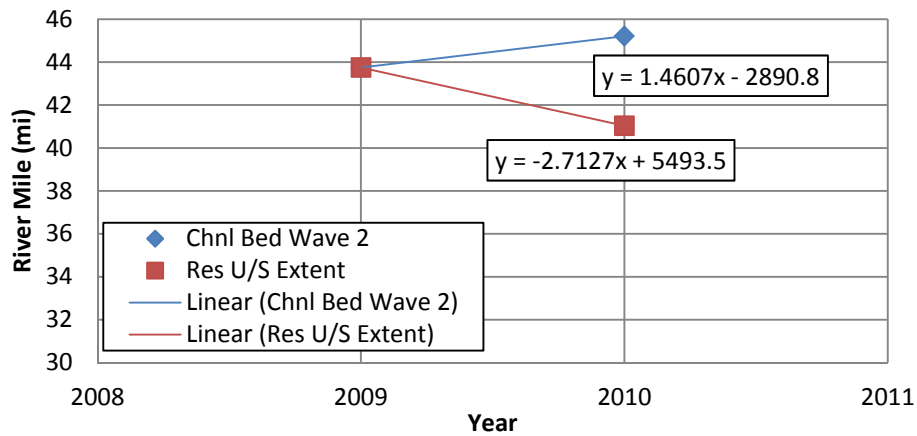
elevation change from 2009 to 2010, which induces Wave 1 degradation. Figure 4.48 shows the rate of Wave 1 propagation upstream as a result of the decrease in WSE (base-level) from 2009 to 2010. The wave propagated upstream at a rate of 1.46 miles/year with a decrease in base-level of 6.9 ft/year, and the upstream extent of the reservoir receded 2.71 miles/year.

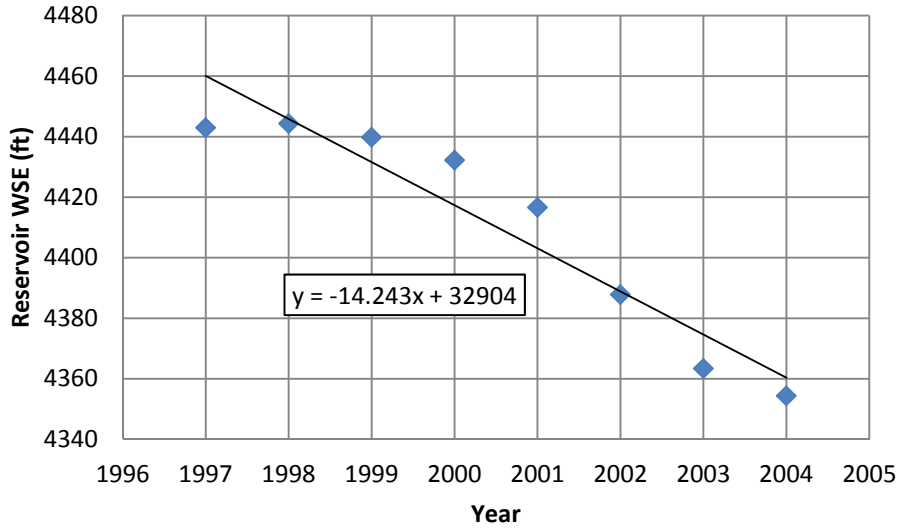
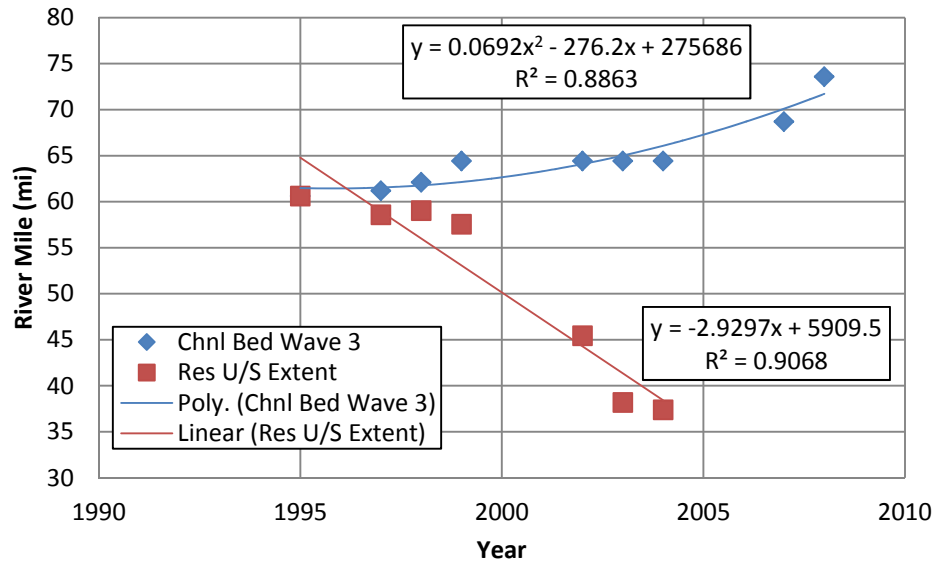
Wave 3 resulted from a decrease in base-level from 1997 to 2004. Figure 4.51 shows the reservoir water surface elevation change from 1997 to 2004, which induced Wave 3 degradation. Figure 4.52 shows the rate of Wave 3 propagation upstream as a result of the decrease in WSE (base-level) from 1997 to 2004. With a decrease in base-level of 14.2 ft/year, Wave 3 propagated upstream according to the following second order polynomial:

Where, y is the upstream-most River Mile at which degradation occurs as a result of a decrease in base-level of 14.2 ft/year, and x is the year at which River Mile y begins to degrade. The upstream extent of the reservoir receded at a rate of 2.9 miles/year.

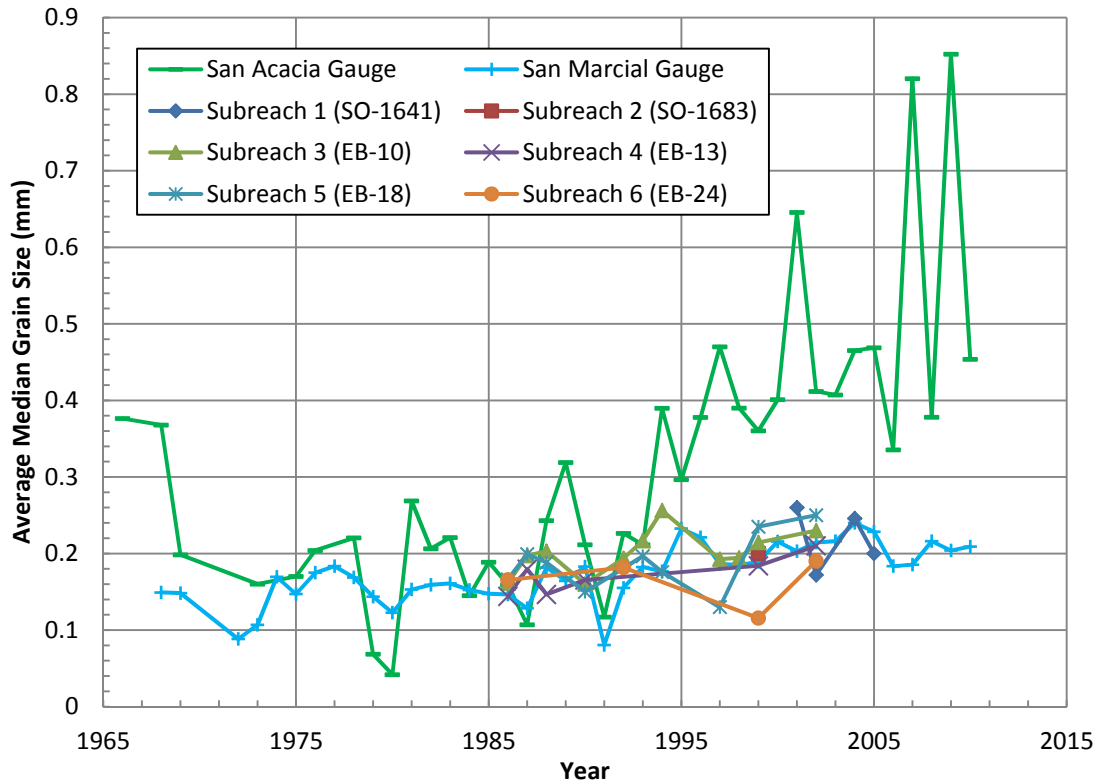
Figure 4.64 Average Median Bed Material Grain Size Temporal Trends

Figure 4.64 shows the change over time of the average median bed material grain size in each subreach and at the San Acacia and San Marcial gauges, located 44 miles upstream of the study reach and within the study reach, respectively. Figure 4.65 shows the average median bed material grain size trends for each subreach from 1986 to 2005.

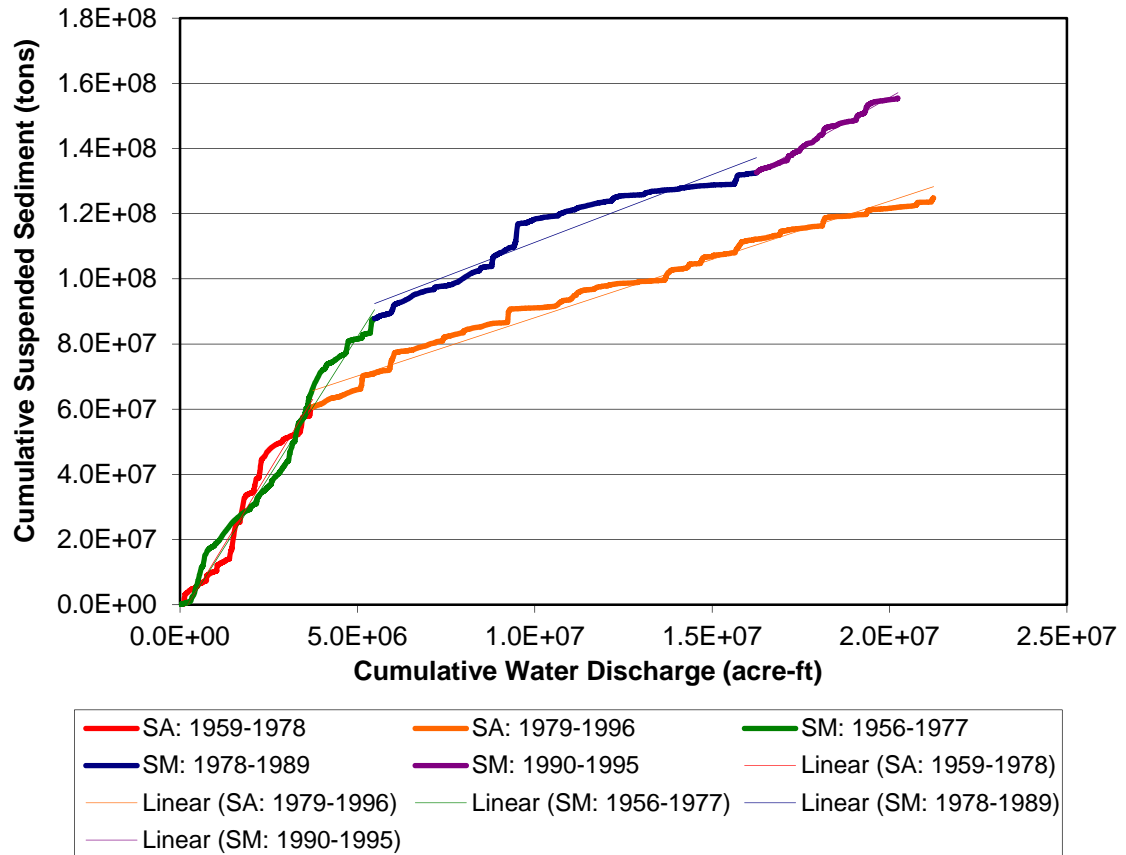
Figure 4.68 Suspended Sediment Concentration Double Mass Curves (Larsen et al. 2007)

Double mass curves were developed at each gauge to show the changes in suspended sediment concentration over time, as seen in Figure 4.68.
