# Middle Rio Grande Elephant Butte Reach Report:

Morpho-dynamic Processes and  
Silvery Minnow Habitat from  
the Southern Boundary of the  
Bosque Del Apache National Wildlife Refuge to  
the Elephant Butte Reservoir

May 2022  
Final report prepared for the  
United States Bureau of Reclamation

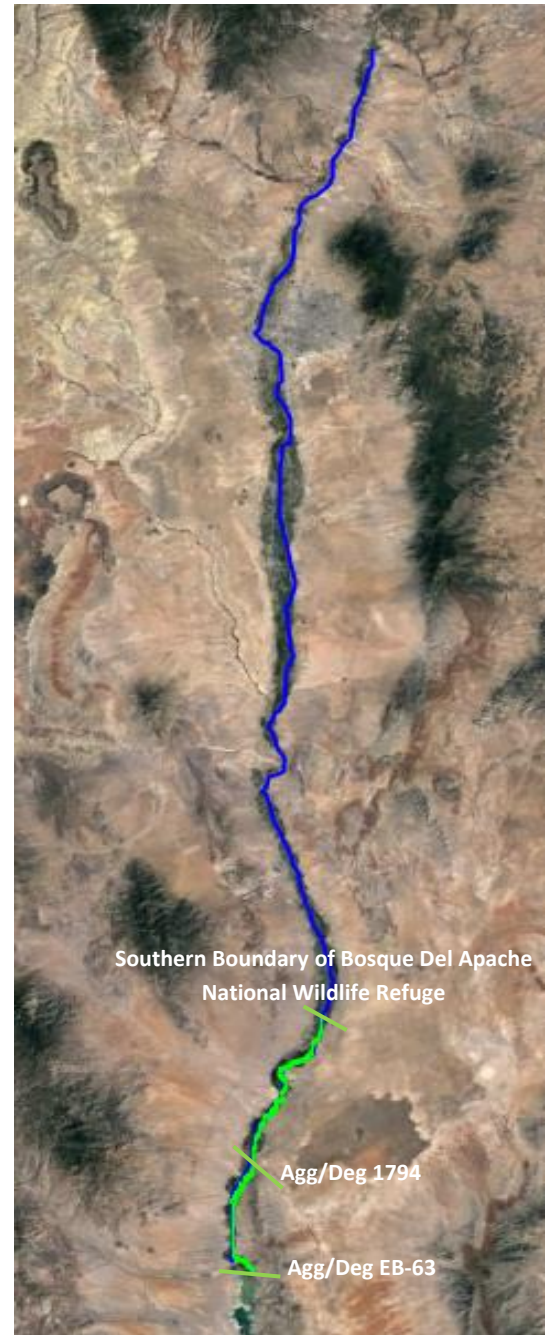
Figure 1 Map with the Middle Rio Grande outlined in blue. It begins at the Cochiti Dam (top) and continues downstream to the Narrows in Elephant Butte Reservoir (bottom). The lime green highlights the Elephant Butte reach.

The purpose of this research/study is to evaluate the morpho-dynamic conditions of the Middle Rio Grande (MRG) which extends from the Cochiti Dam to the Narrows in Elephant Butte Reservoir. The report focuses on the Elephant Butte Reach, which begins at the southern boundary of the Bosque Del Apache Wildlife Refuge near San Antonio, New Mexico, and continues downstream to the Elephant Butte Reservoir near Truth or Consequences, New Mexico (Figure 1).

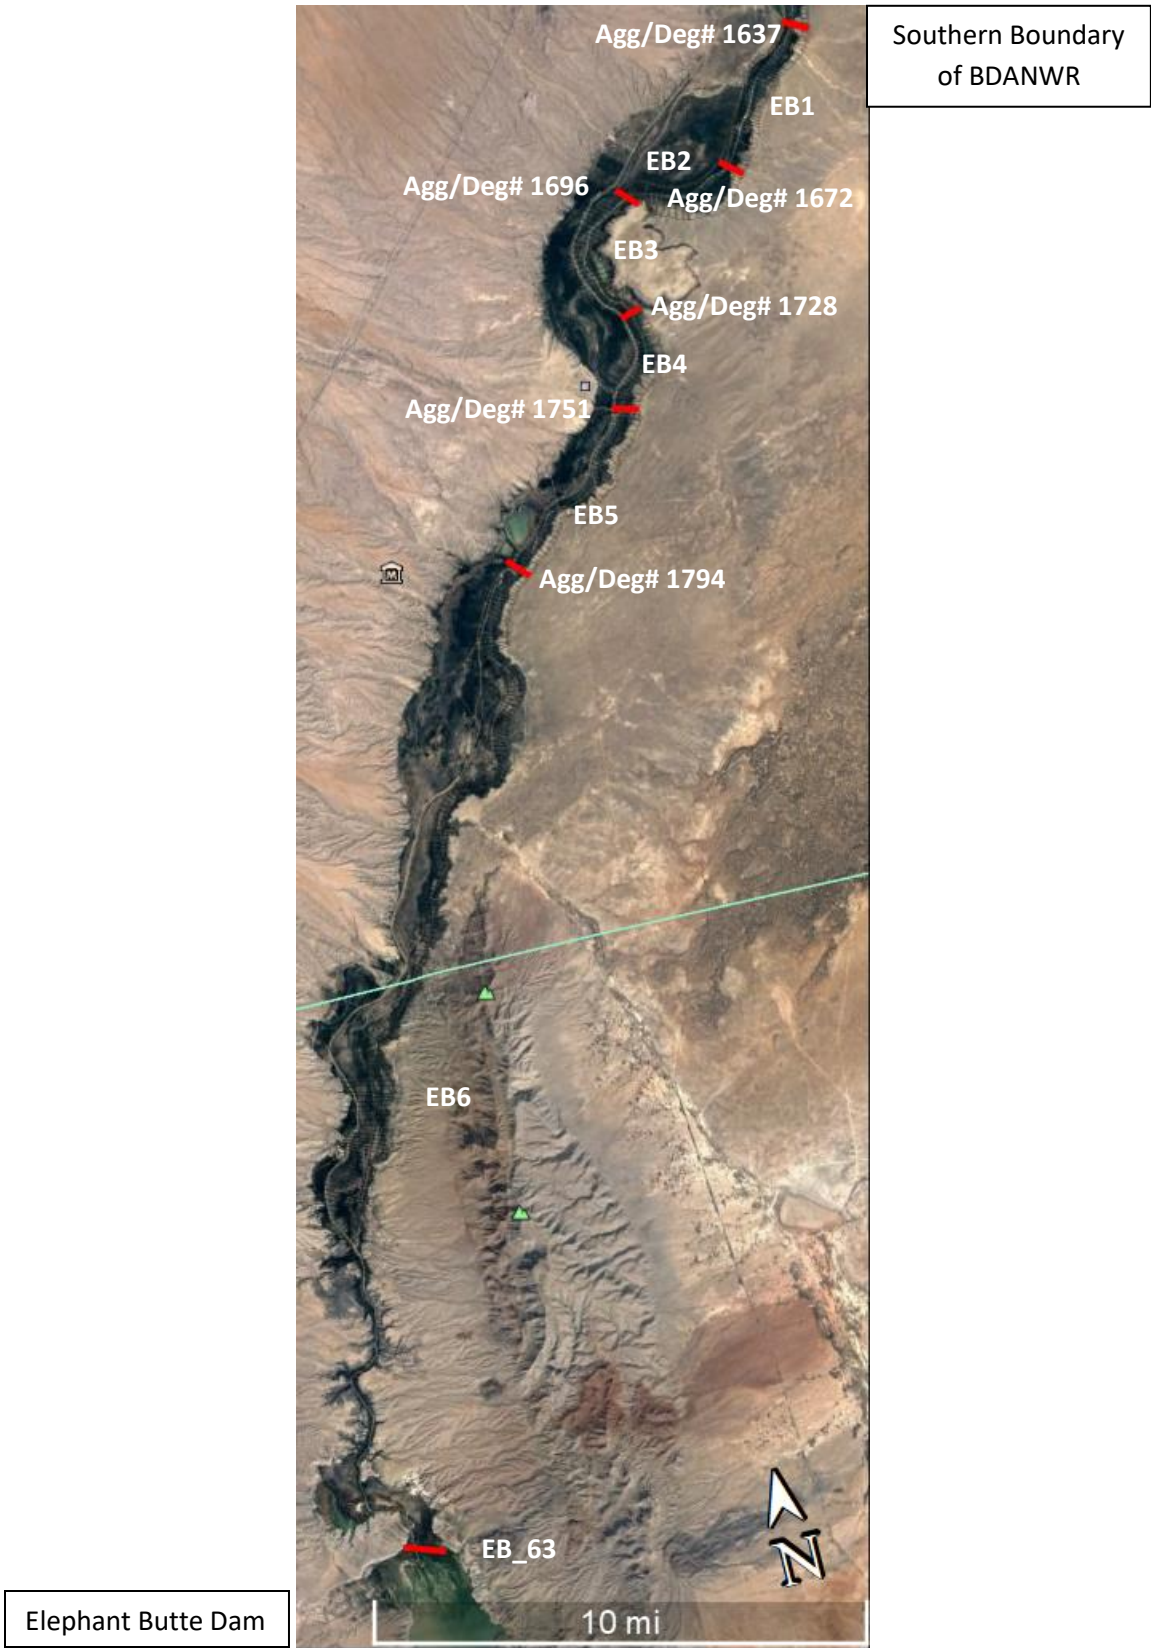
Figure 4 Overall Elephant Butte Subreach Delineation

Figure 3 shows the cumulative width analysis to delineate the Elephant Butte Reach into its respective subreaches. Subreach Elephant Butte 1 (EB1) extends from the Bosque Del Apache National Wildlife Refuge (agg/deg line 1637) downstream to where there is a change in slope of cumulative width plot and the river gets narrower (agg/deg line 1672). Subreach EB2 continues from this decrease in slope of cumulative width and ends just before the San Marcial Bridge where the slope of the cumulative width increases (agg/deg line 1696). Subreach EB3 continues until about the end of the large radial bend where the river gets narrower (agg/deg line 1728). Subreach EB4 continues from this location until there is an expansion in the river (agg/deg line 1751). Subreach EB5 begins at the expansion of the river and ends where the formal low flow conveyance channel stops (agg/deg line 1794) and the agg/deg delineation data available from 1962 to 2002 ends. Lastly, subreach EB6, continues from this point (agg/deg line 1794) to the Elephant Butte reservoir (EB-63). The EB reservoir range line naming convention begins in the narrows of Elephant Butte are used to determine the deposition volume of sediment in the reservoir. Subreach six, EB6, is not split up into subsequent subreaches because of an absence of historical cross-sectional data. Therefore, this subreach will be kept together as whole and will only be included where possible in the report when enough data is available for comparison. The subreaches are shown in Figure 4 through 6. The subreach delineation is summarized in Table 1. Aerial images with every agg/deg line labeled are included in Appendix A. Tracey Owen's (2012) delineation can be seen in Figure A-14.

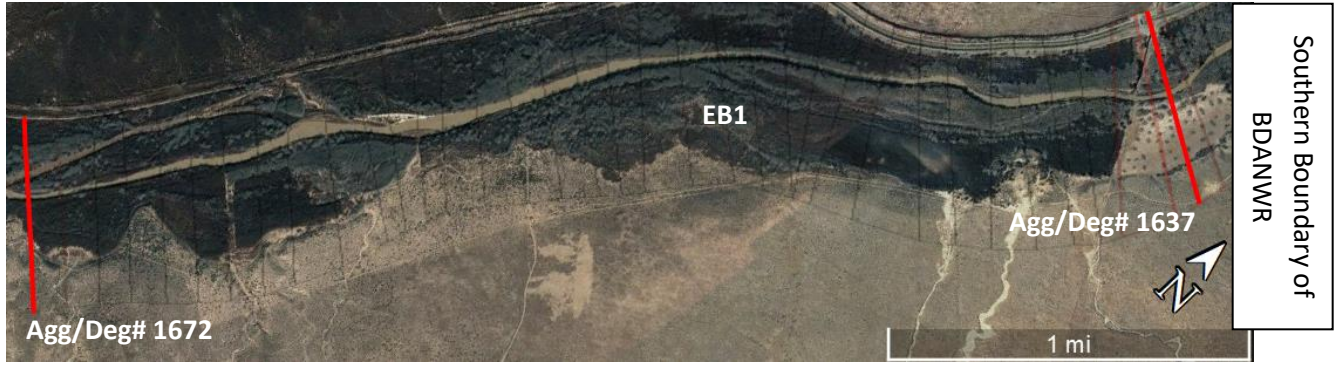
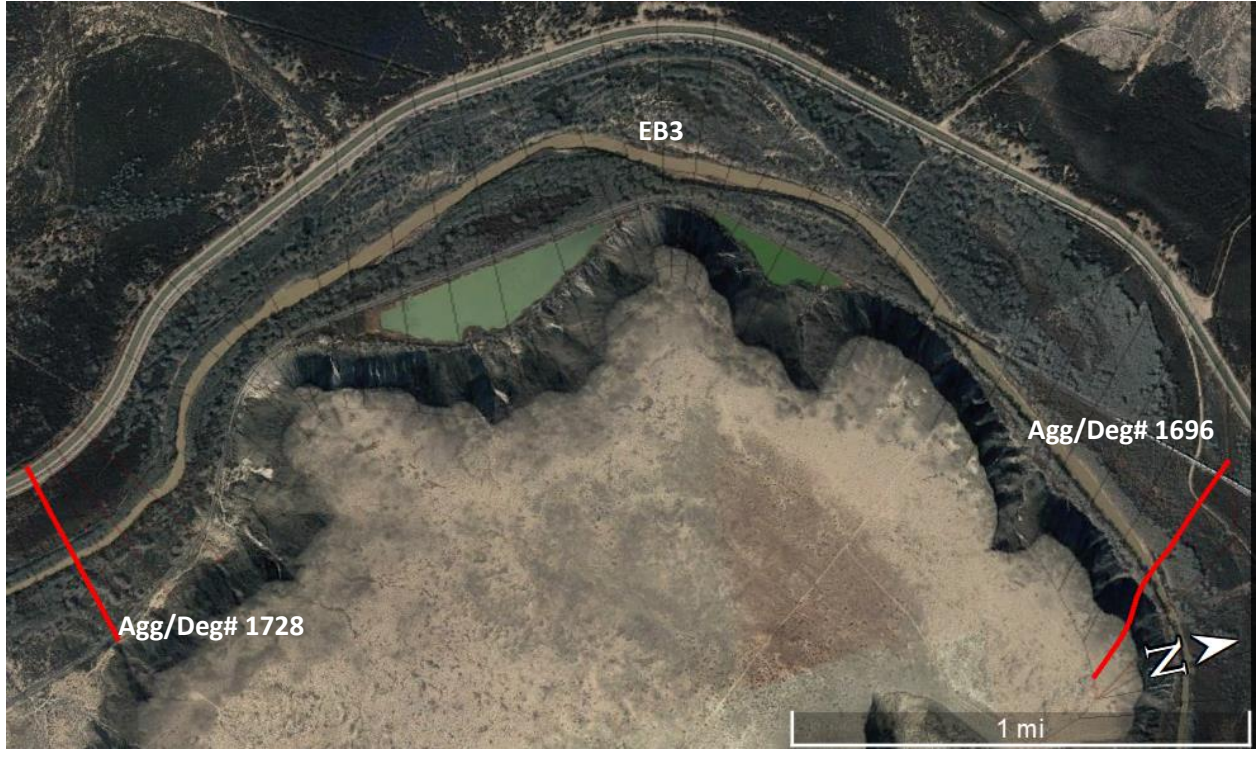
Figure 5 Subreaches EB1 through EB3 Delineation Magnified

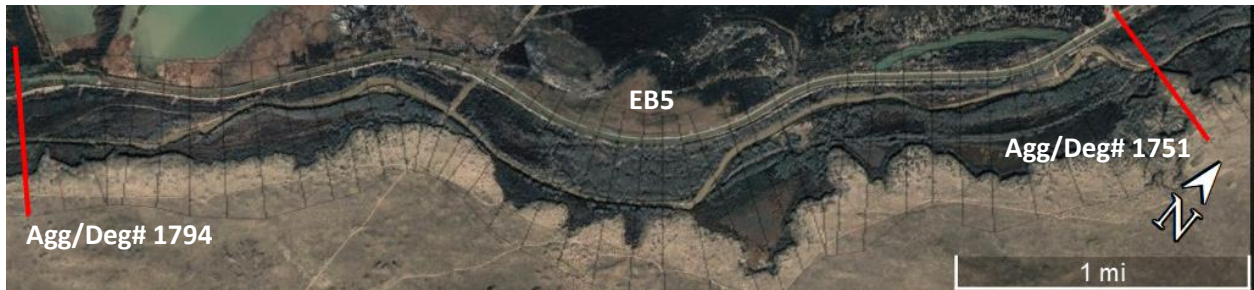
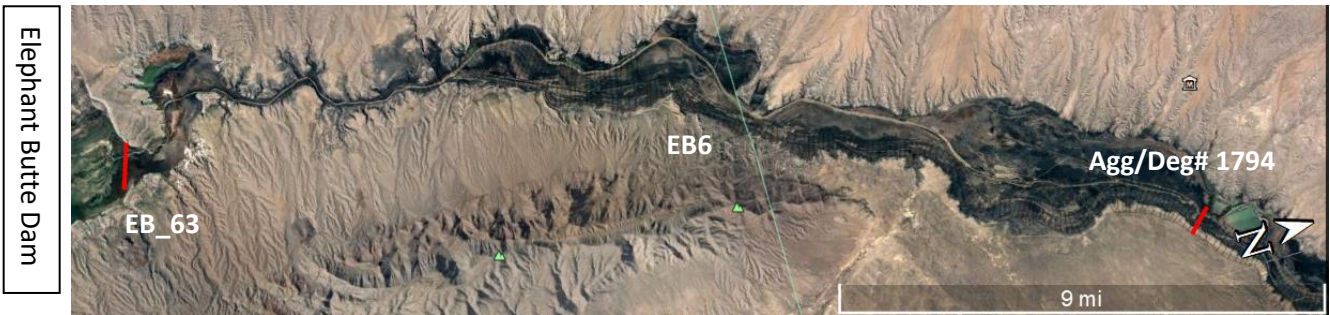
Figure 6 Subreach EB4 through EB6 Delineation Magnified

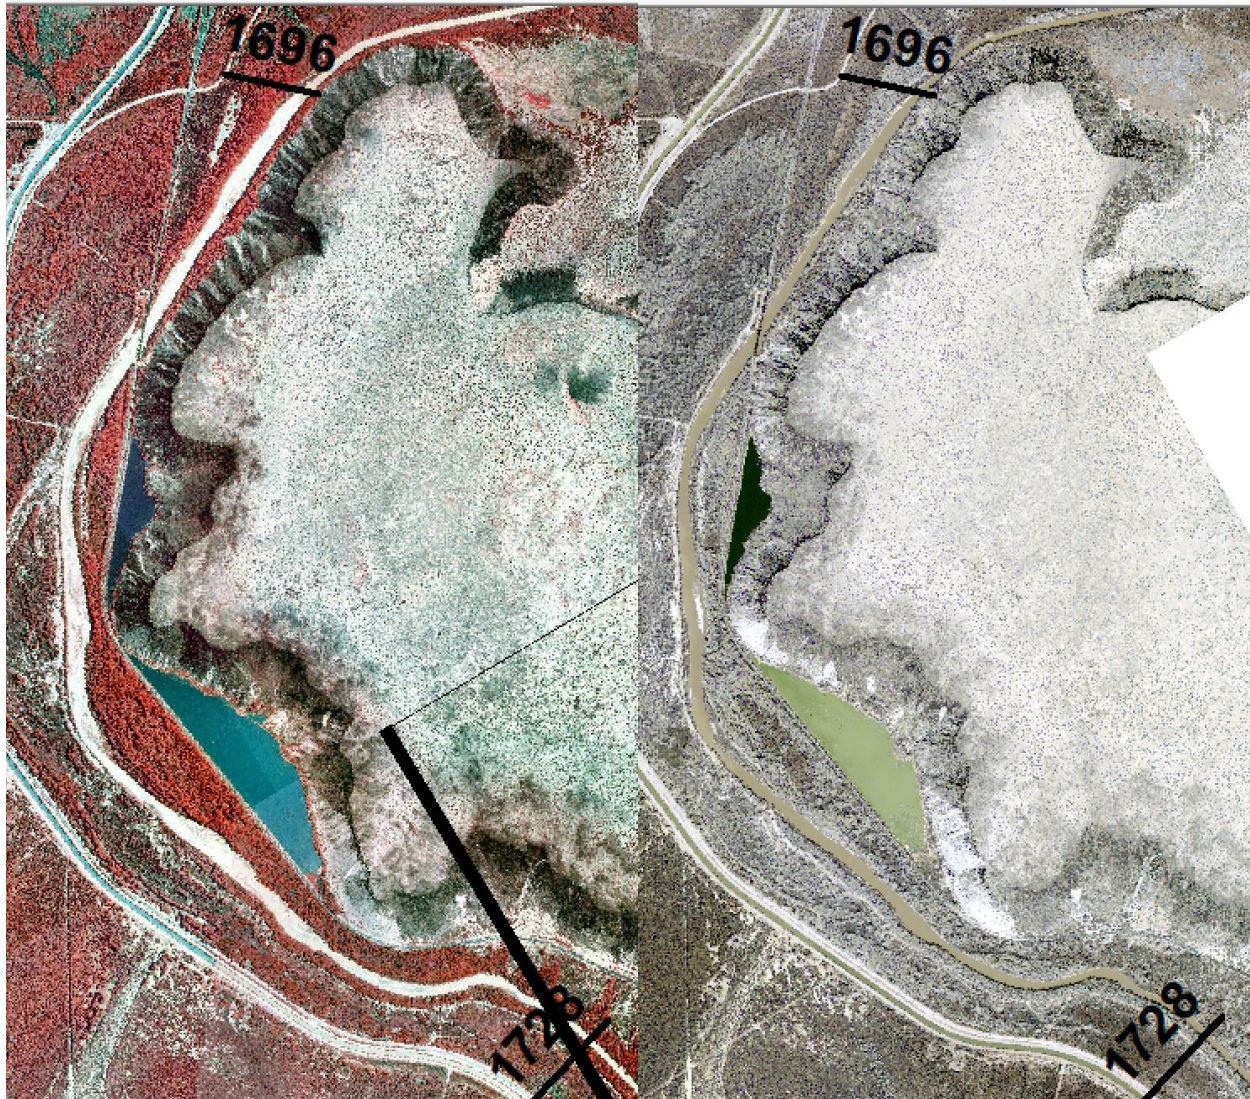
*Figure 47 Aerial Photograph of subreach EB3 when multiple alternating bars, point bars, and islands were present in 2002 (left) and in 2012 (right) after vegetation encroachment.*

Based on the analysis of the digitized planforms, the years 1935 and 1949 appeared to have a slight increase in number of mid-channel bars and islands. Majority of the Elephant Butte Reach has had around 1 channel with some instances of a mid-channel bar or island. This shows that pre 1949 there typically was a few more geomorphic features in the river. Figure 47 shows an aerial photograph comparison of subreach EB3 between 2002 and 2012. The aerial imagery from 2002 shows that there is a lot less vegetation along the banks of the river exposing point bars and alternate bars along the banks. These have the potential to become mid-channel bars depending on how the river evolves under environmental conditions. In 2012 there is vegetation encroachment. This will decrease the number of point bars and alternate bars along the banks. Overall the Elephant Butte Reach is currently almost all a single threaded channel.

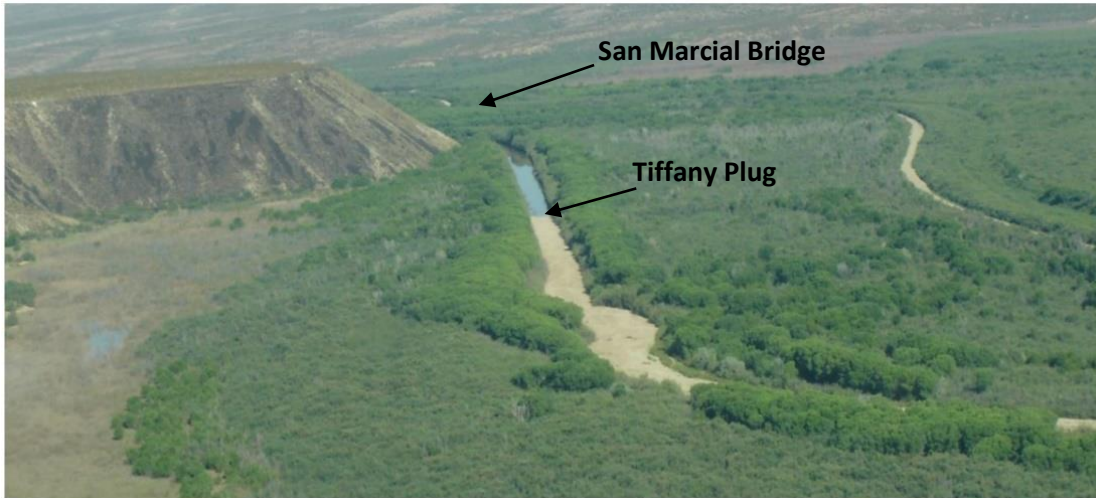
*Figure 54 Downstream view of the 2005 Tiffany Plug (Owen et al., 2011)*

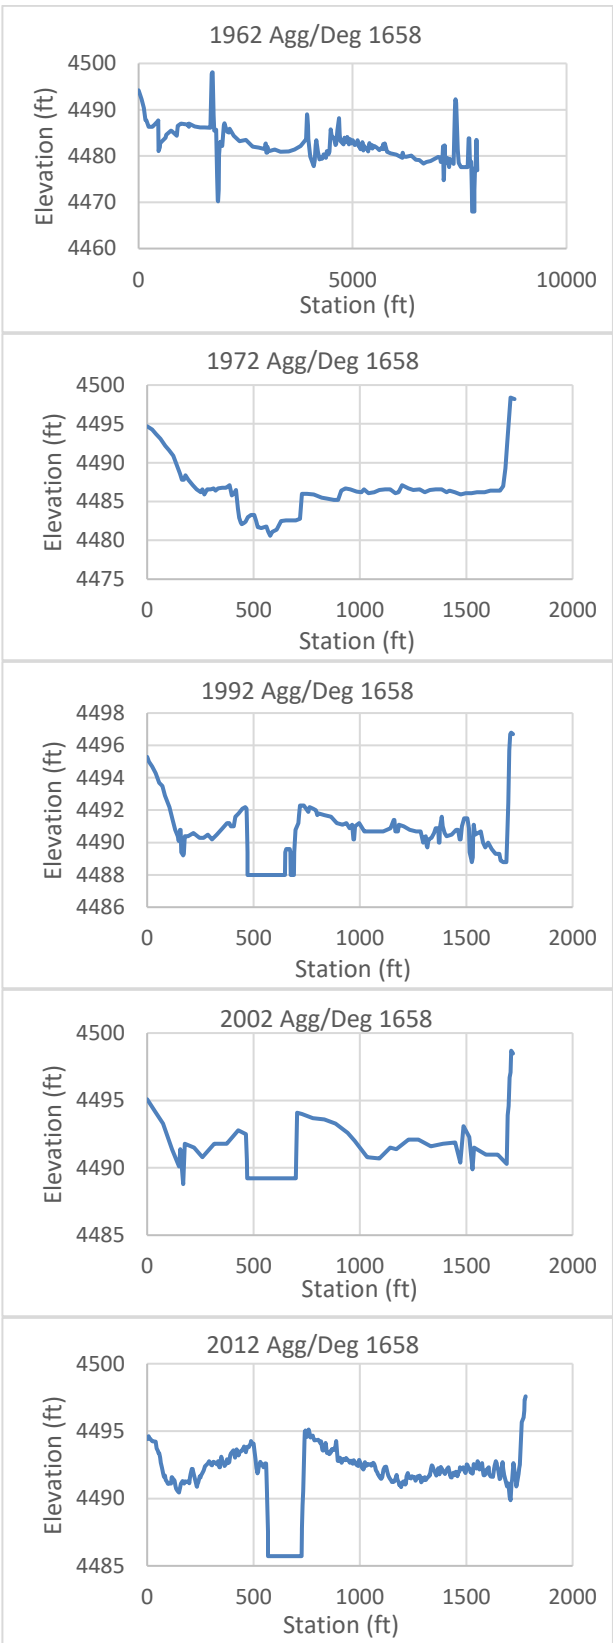
Figure 56 Subreach EB1: historical cross section profiles and corresponding aerial images

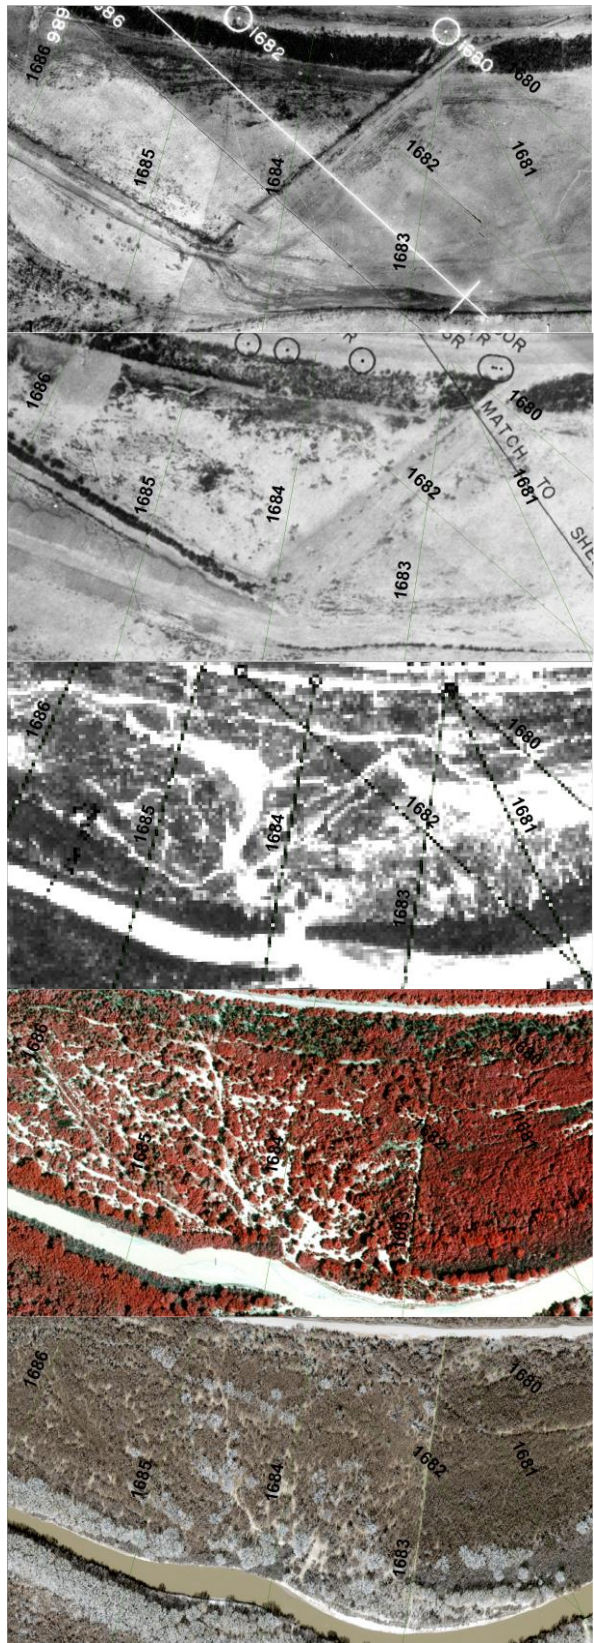
Figure 58 Subreach EB2: historical cross section profiles and corresponding aerial images

Subreach EB2 has had a lot of activity and has change over the time interval of 1962 to 2012. The river has seen major aggradation and degradation, hydraulic depth change, and perching. Subreach EB2 shows that the river sediment capacity was exceeded causing the river to deposit sediment from 1972 to 2002. This caused a large amount of sediment deposition onto the banks creating perching of the channel, creating natural levees. The main channel filled with sediment as well, decreasing the hydraulic depth. This would indicate that sediment supply exceeded the rivers transport capacity. The river shows slight migration between 1972 and 1992. The stages displayed here indicates stage 3 and A4, thus showing slight signs of lateral migration and aggradation of the main channel. From 2002 to 2012 the river starts to incise and changes to a degrading state. When the main channel incises, the natural levees stay, and the required flow rate to achieve bankfull increases. From 2002 to 2012 the evolutionary model stage present is an M4 stage where the transport capacity of the river exceeds the sediment supply. It is important to note that the Tiffany Plug did occur in EB2 in 1991, 1995, and 2005 (Shrimpton, 2012). There may be no indications of evulsion due to pilot channels that were dug to prevent the river from changing locations. The cross section shows the cycle of degradation (1962 to 1972, stage 3), to aggradation (1972 to 2002, stage 3 migrating, A4 main channel), back to degradation of the main channel but aggradation / deposition of sediment on the banks (2002 to 2012, A4 overbank, M4 main channel). The cross-section profile is shown in Figure 57 and a side-by-side view of the cross section and aerial imagery is shown in Figure 58.

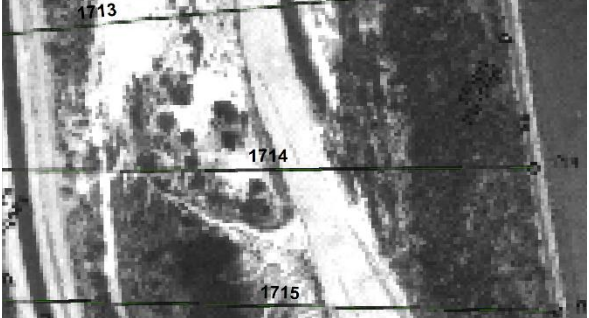
Figure 60 Subreach EB3: historical cross section profiles and corresponding aerial images

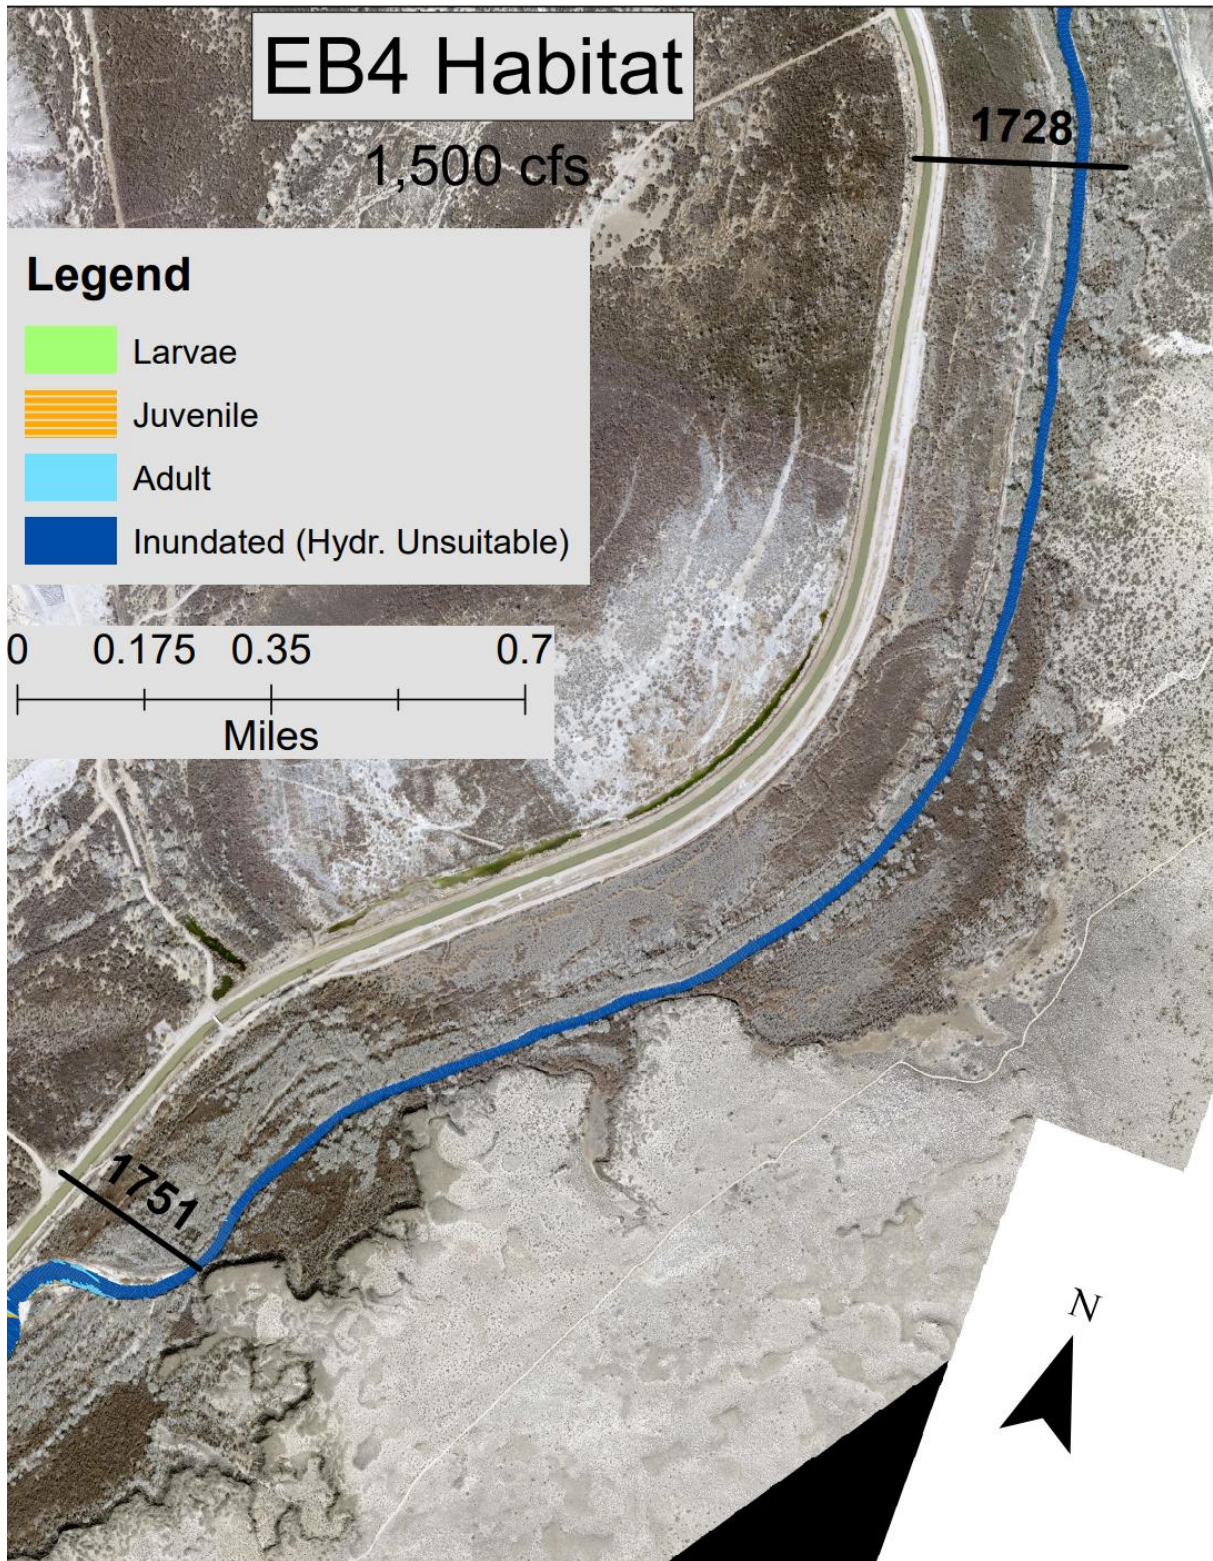
Figure E- 4 RGSM Habitat in subreach EB4 at 1500 cfs with hydraulically suitable areas labeled for larvae (green), juvenile (orange), and adult (light blue) and unsuitable inundated areas in dark blue.

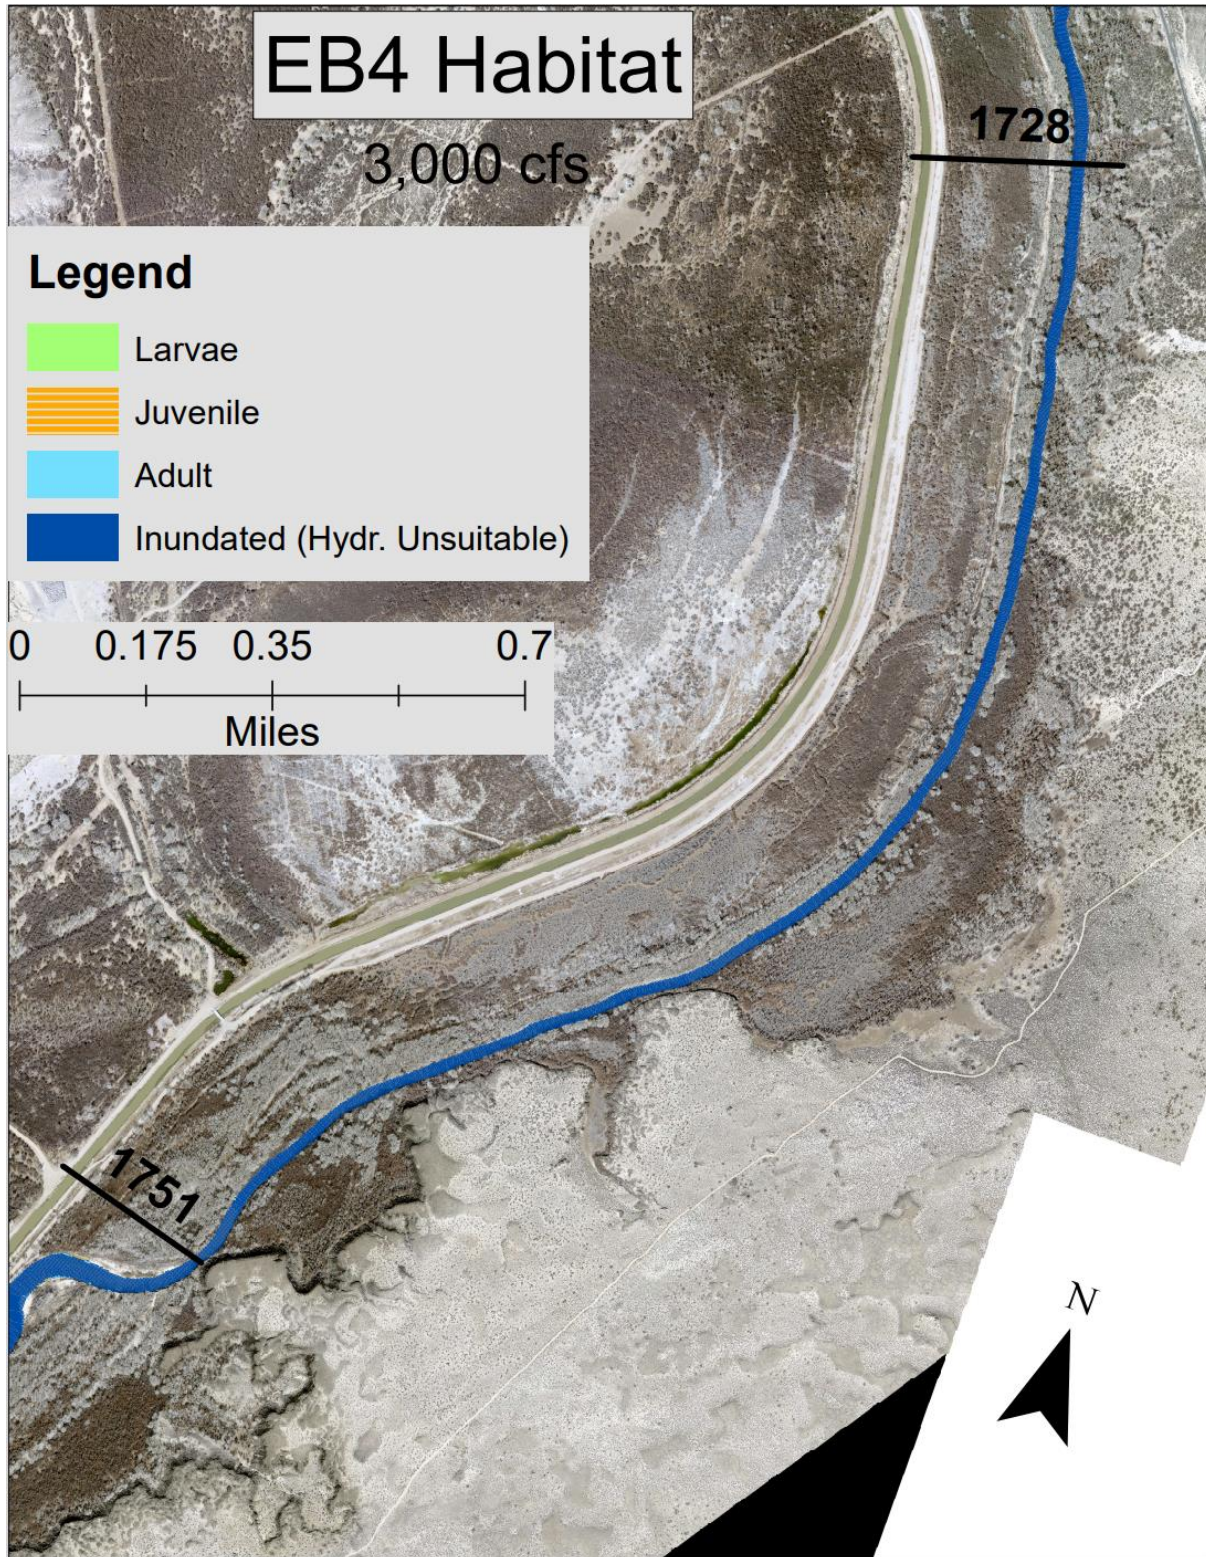
Figure E- 15 RGSM Habitat in subreach EB4 at 3000 cfs with hydraulically suitable areas labeled for larvae (green), juvenile (orange), and adult (light blue) and unsuitable inundated areas in dark blue.
