# Middle Rio Grande Bernalillo Report:

Morpho-dynamic Processes and  
Silvery Minnow Habitat from  
Hwy 550 Bridge to  
Montaño Road Bridge

Final: April 2023  
Final report prepared for the  
United States Bureau of Reclamation

Colorado State University  
Engineering Research Center  
Department of Civil and  
Environmental Engineering  
Fort Collins, Colorado 80523

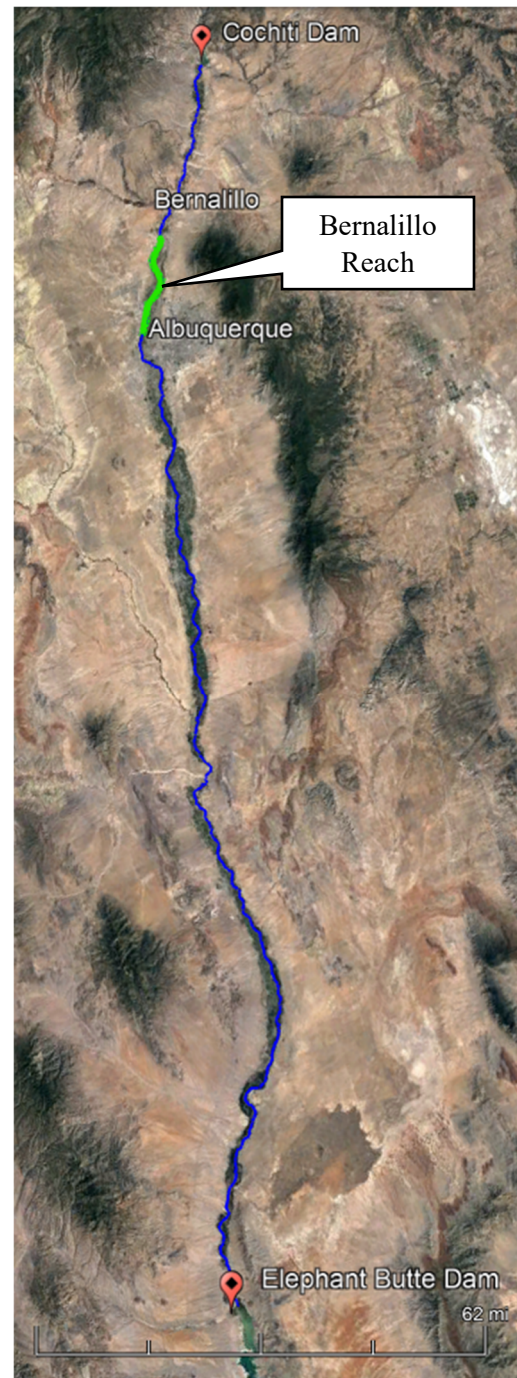
*Figure 1-1: Map with the Middle Rio Grande outlined in blue. The Bernalillo Reach is highlighted in lime green. (Google Earth)*

The purpose of this reach report is to evaluate the morpho-dynamic conditions of the Middle Rio Grande (MRG) which extends from the Cochiti Dam to the Narrows in Elephant Butte Reservoir. This report focuses on the Bernalillo Reach, which begins at the Highway 550 Bridge crossing in Bernalillo, New Mexico and ends Montañito Road Bridge crossing in Albuquerque, New Mexico. See **Figure 1-1** for a reach location map.

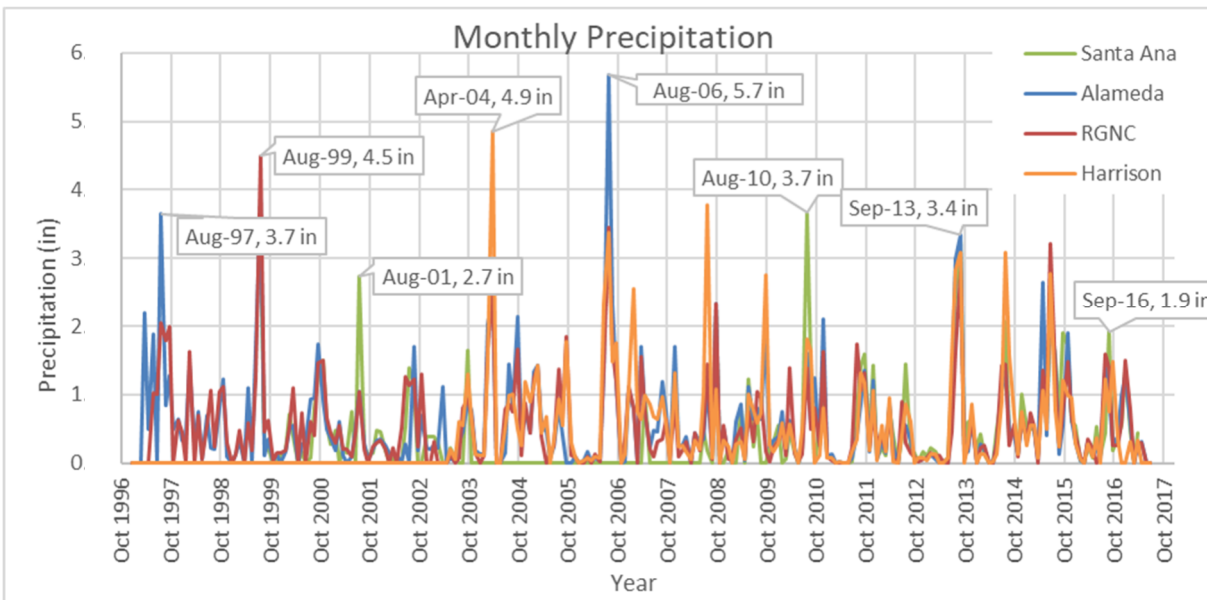
*Figure 2-2 Monthly precipitation at four gages near the Bernalillo and Montañito reaches*

The monthly precipitation data is shown in **Figure 2-2**. The highest precipitation peak, 5.7 inches of rainfall, occurred in August of 2006 at the Alameda gage. A general trend was observed with the highest precipitation values occurring during the monsoon season (late July through early September). A cumulative rainfall plot of the monthly precipitation data, **Figure 2-3**, shows that individual rain events can greatly affect the overall trend of the data. It further highlights the monsoonal rains, which create a “stepping” pattern with higher rainfall in August and September and lower levels throughout the rest of the year. The same pattern is observed across all the gage sites indicating rain patterns around the Bernalillo and Montañito reaches are spatially consistent. From the two gages with the longest period of record, Alameda, and RGNC, the cumulative rainfall pattern is similar until 2006. Since then, the Alameda gage has received slightly more precipitation (10 inches) than the RGNC gage.

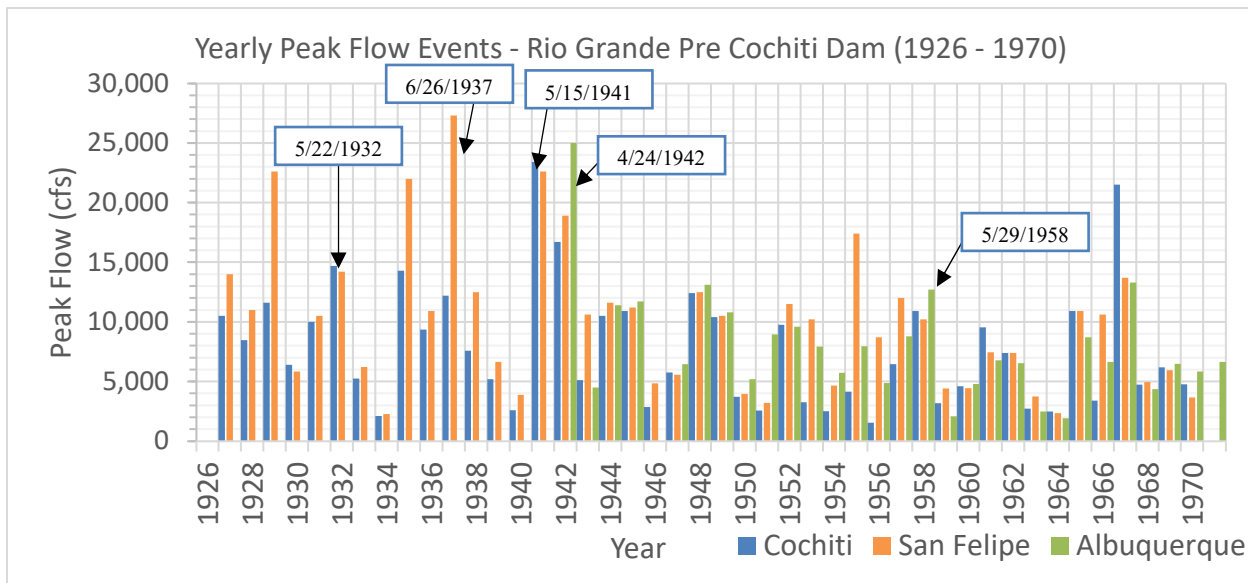
Figure 2-7 Yearly peak flow events for the Rio Grande before Cochiti Dam at USGS Gages 08314500, 08319000, and 08330000 from 1926-1970.

Yearly peak flow events for the Cochiti, San Felipe, and Albuquerque gages are shown in **Figure 2-7** and **Figure 2-8**. These peak flow events were determined from average daily flow data. **Figure 2-7** shows the yearly peak flow events prior to the Cochiti Dam completion in 1970, while **Figure 2-8** shows the peak events after dam completion to present day. Like the raster hydrographs shown above, these graphs show a clear distinction between pre- and post-dam conditions. In the 44 years of gage record prior to Cochiti Dam completion there were 11 flood events with peak daily flows larger than 10,000 cfs. In the 52 years of gage record after dam completion, peak flows became less variable and have not peaked above 10,000 cfs.

The flood of record at the San Felipe gage occurred in June of 1937, with a peak of 27,300. Two notable flood events also occurred in series in May of 1941 and the following April of 1942, with peak flows of 22,600 cfs and 18,900 cfs, respectively, at the San Felipe gage. The 3 years between 1983 and 1985 show larger than normal spring flood events, with a peak flood at 10,200 cfs in May 1985 at the Cochiti gage. The more recent larger flood events occurred in May of 2017 and June of 2019, with peak flows of 8,180 cfs and 6,260 cfs, respectively, at the San Felipe gage.

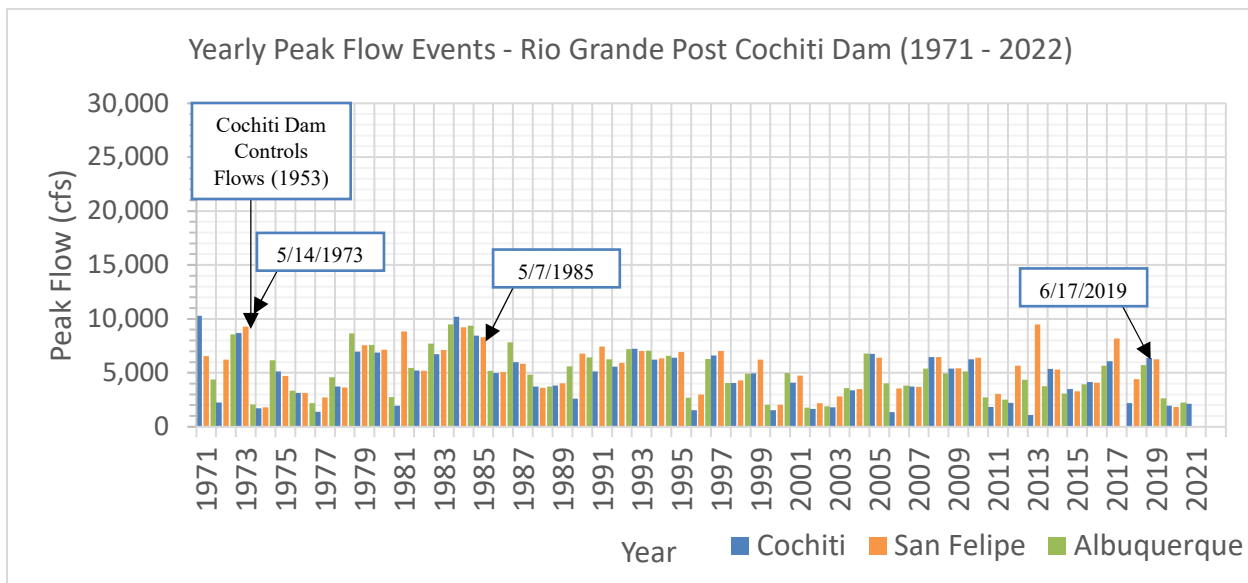
Figure 2-8 Yearly peak flow events for the Rio Grande after Cochiti Dam at USGS Gages 08317400, 08319000, and 08330000 from (1970-present).

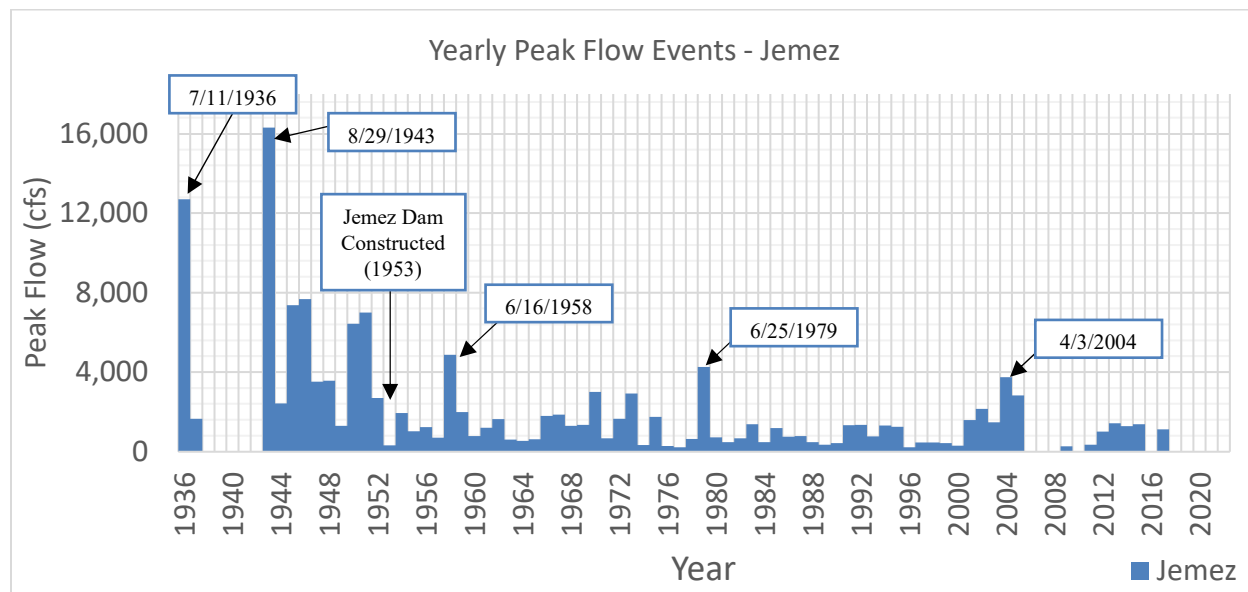
*Figure 2-9 Yearly peak flow events for the Jemez River*

Yearly peak flow events for the Jemez River gages are shown in **Figure 2-9**. The flow record does appear to show dam influence on peak flow rates for the Jemez River caused by completion of the Jemez Dam in 1953. The largest flood event for the period of record occurred in August of 1943, with a peak flow rate of 16,300 cfs. After the dam completion, the largest peak flow occurred in June of 1958, with a peak flow of 4,870 cfs.

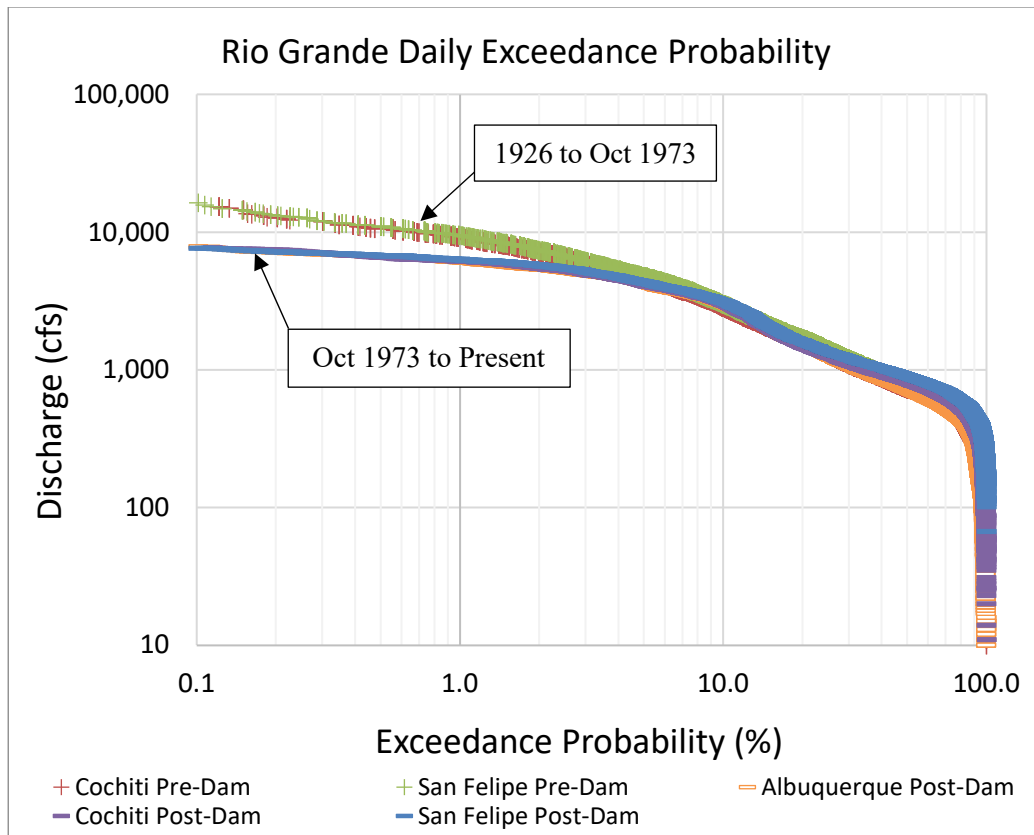
Figure 2-17 Flow duration curves for the Rio Grande gages before and after dam construction.

Flow duration curves were developed using the mean daily discharge values for the Cochiti, San Felipe, Albuquerque, and Jemez River gages. **Table 2-2** shows the probabilities of daily exceedance values calculated from the flow duration curves for a range of exceedance probabilities. The gage records were split between pre- and post- construction of the Cochiti Dam for the Rio Grande gages. Gage records were similarly split for the Jemez River gages to account for any differences in flow conditions before and after the completion of the Jemez Dam. The curves for the Rio Grande gages are shown in **Figure 2-17**, and the curves for the Jemez River gages are shown in **Figure 2-18**.

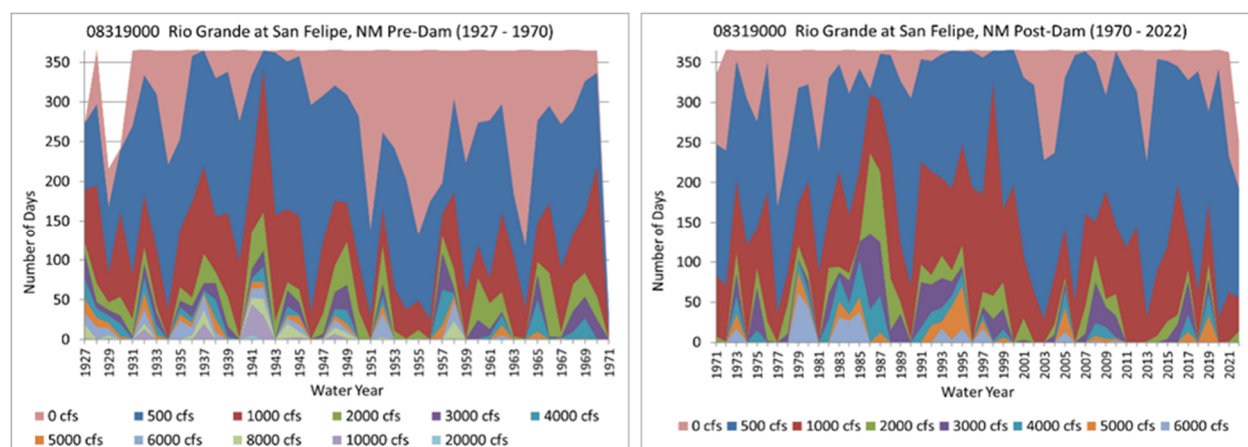
*Figure 2-19 Number of days greater than an identified discharge at the San Felipe gage before (left) and after (right) dam construction.*

The most notable difference observed in the San Felipe graphs before and after Cochiti Dam construction is that pre-dam flow conditions saw a greater number of days above 6,000 cfs. The graphs also seem to indicate that the years between 1979 and 1999 show a greater number of days (around half of the year, on average) above 1,000 cfs. These graphs also give a good indication of dry years. For example, between 2003 and 2006, fewer than 50 days of the year saw flows greater than 1,000 cfs. In general, the larger flows become less frequent after 2001.

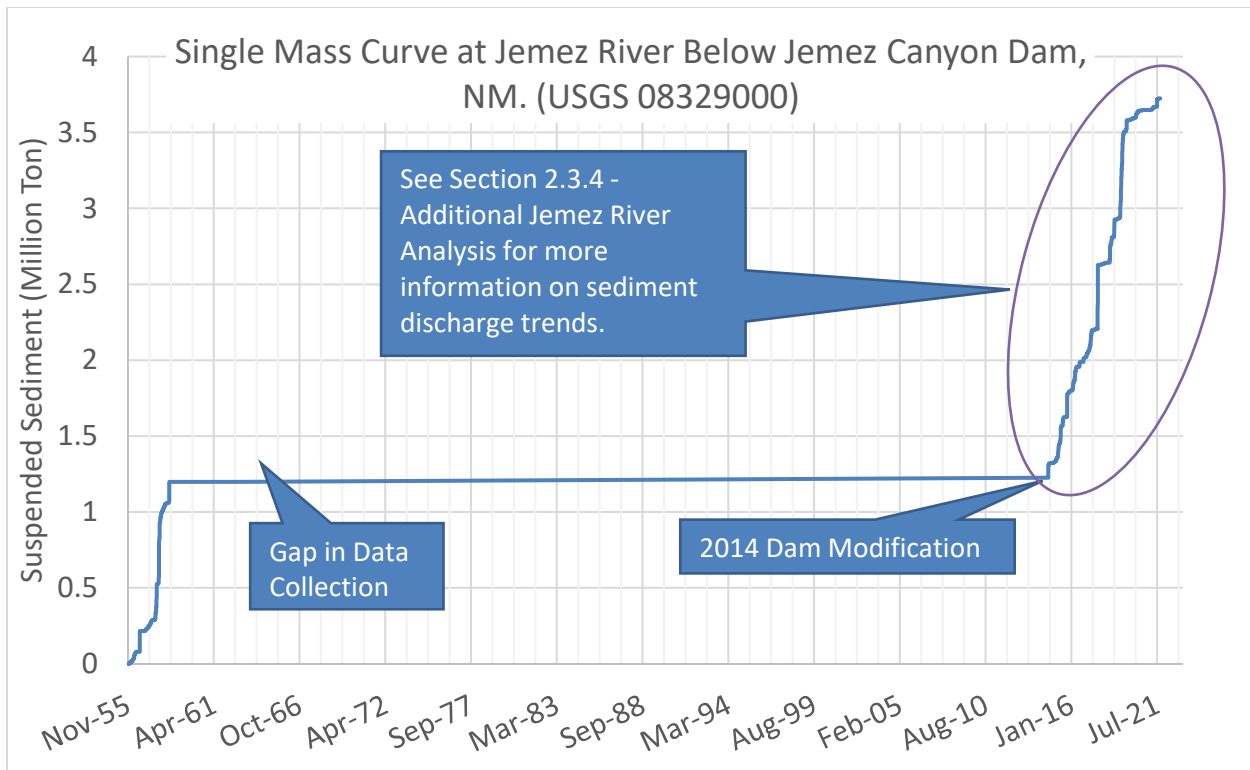
Figure 2-21 Suspended sediment discharge single mass curve for USGS gage 08329000 at Jemez River Below Jemez Canyon Dam, NM

The single mass curves show changes in daily sediment volume over a given time period. The slope of the line of the mass curve gives the mean sediment discharge, while breaks in the slope along the single mass curve show the changes in sediment flux. The Cochiti Dam began controlling flows in 1973 and was completed in 1975. Downstream of Cochiti, at the Albuquerque gage, there is a large decrease in the mean sediment discharge after 1973 and the historical Bernalillo gage data showed large mean sediment discharges before 1973. The correlation shows that the construction of Cochiti Dam had a dramatic impact on the sediment discharge going through the MRG. The mean sediment discharge at the Cochiti gage after construction is relatively low and consistent compared to other inputs to the system. The horizontal steps in **Figure 2-22** demonstrate that the water is relatively sediment free and clear between events, which indicates that a majority of the sediment upstream of Cochiti is getting stopped at the dam. There are no major tributaries that enter the MRG below Cochiti, however there are several small arroyos that enter the river and two flood-controlled channels (Towne 2007). As mentioned in **Section 1.1**, the ephemeral tributaries are the primary source of sediment input into to MRG (Fitzner 2018). Other sources of sediment include bed erosion as the channel degrades and bank erosion during channel migration.

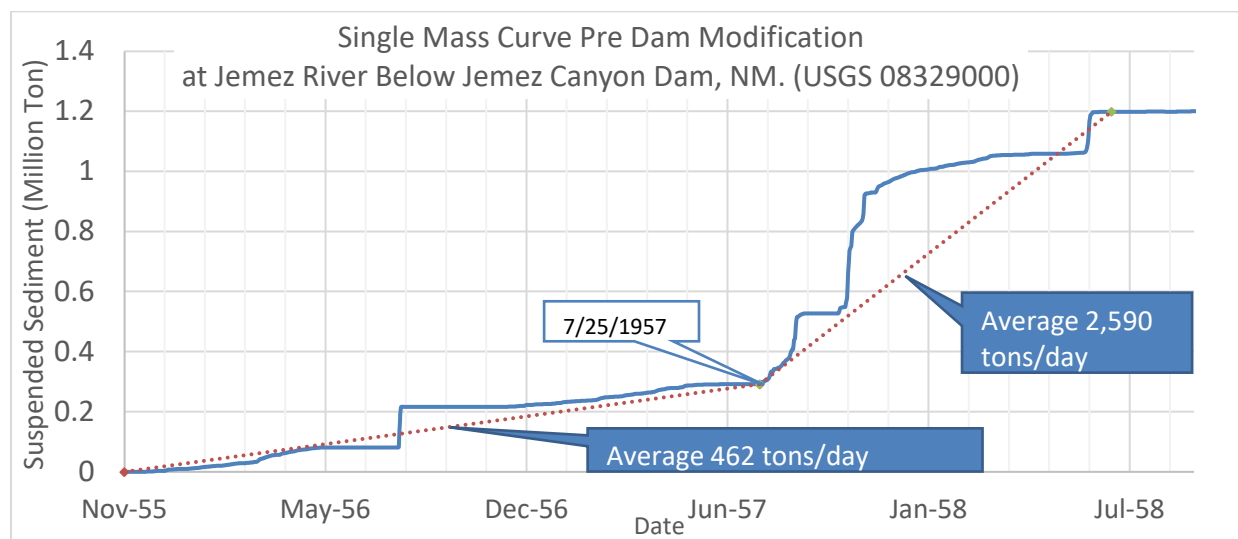
Figure 2-35 Suspended sediment discharge single mass curve for USGS gage 08329000 at Jemez River Below Jemez Canyon Dam, NM – Pre-Dam Modification

The Jemez River is a major tributary of the Bernalillo and Montañño reaches. The Jemez Dam was constructed in 1953. Sediment data was not collected prior to the construction of the dam. In 2014, the Jemez Dam underwent a modification that included a low flow channel. This modification and the subsequent effects on the suspended sediment were analyzed. **Figure 2-35** and **Figure 2-36** below show the single mass curves before and after the dam modification. It is important to note that there was a gap in sediment data collection between the years 1958-2014. It should be noted that while this analysis provides some insight into the sediment and flow characteristics for the Jemez River, the gaps in sediment data and the limited 7 years of record following modification of the Jemez Dam make it difficult to draw any definitive conclusions regarding impacts of the modification at this time.

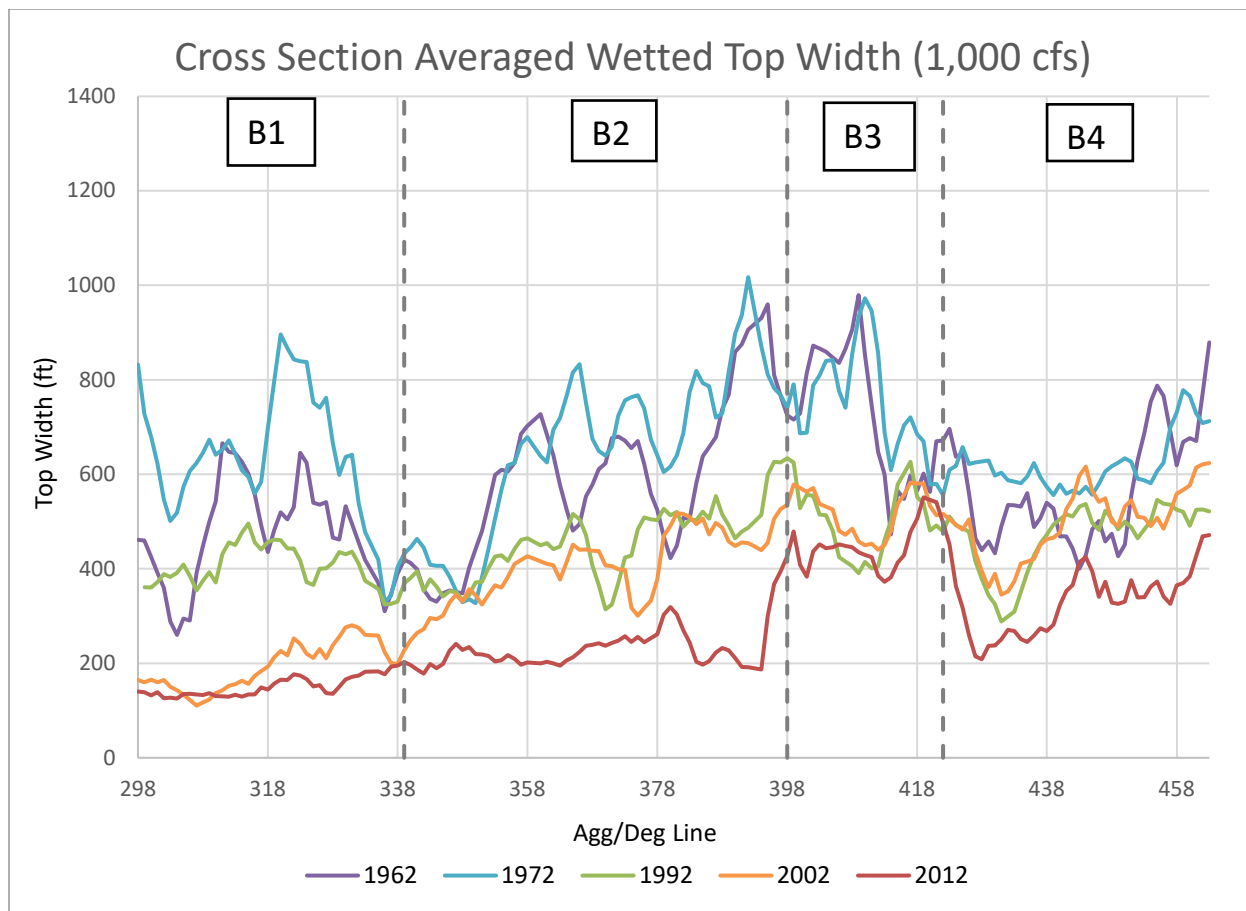
*Figure 3-1 Moving cross-sectional average of the wetted top width at a discharge of 1,000 cfs.*

**Figure 3-1** shows the moving cross sectional averaged top wetted width at 1,000 from the HEC-RAS model results. The moving cross sectional averaged width at each section is calculated by averaging the width for five cross sections at a time. These five cross sections include the cross section, two sections upstream, and the two sections downstream. The top width shown at each agg/deg line comes from the moving average from five consecutive cross sections: the identified agg/deg line, two upstream agg/deg lines, and two downstream agg/deg lines.

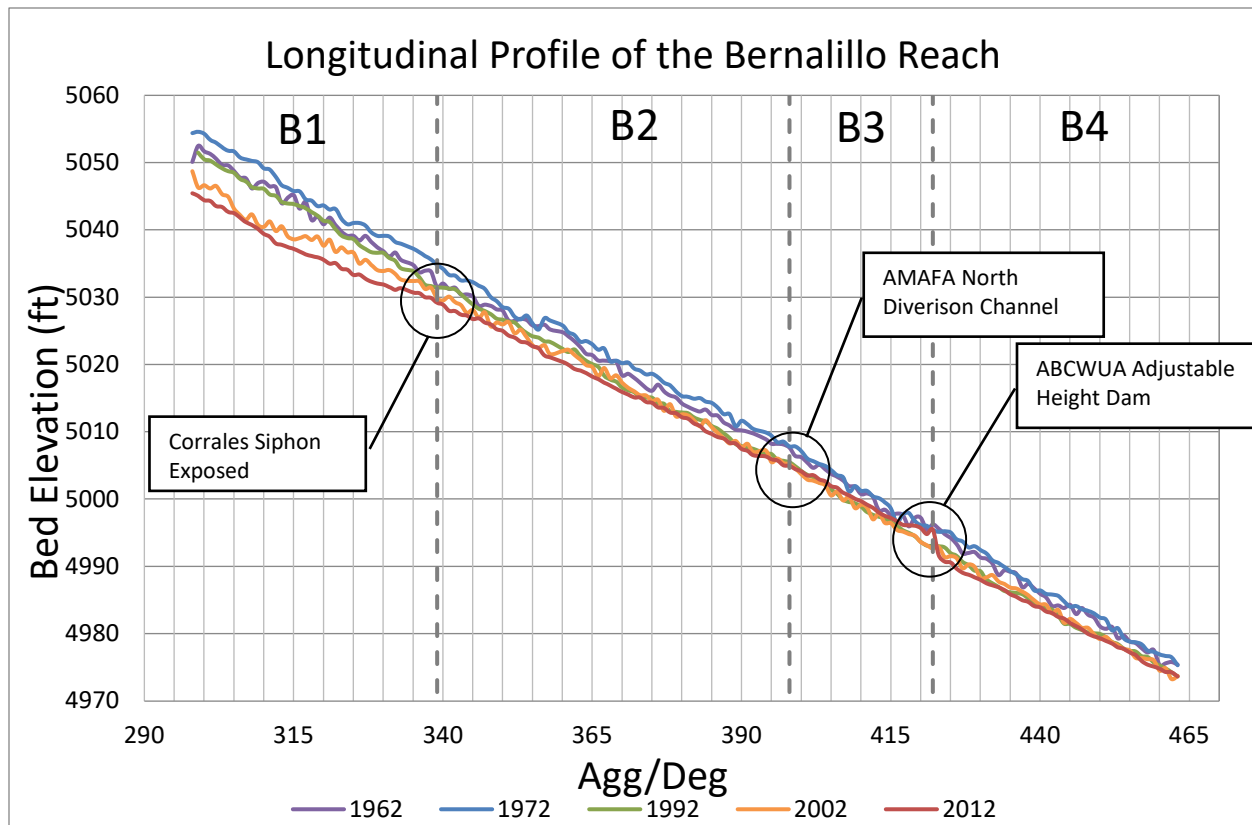
*Figure 3-10 Longitudinal bed elevation profile.*

control by helping maintain channel width and islands and controlling the aggradation/degradation trends. It is important to note that the 2012 longitudinal profile crosses the 2002 longitudinal profile in the vicinity of the outfall, highlighting the effects of the increased sediment load from the outfall and the backwater effects from the islands. The ABCWUA Adjustable Height Dam, built in 2005, can also act as a temporary grade control. During the 2012 data collection, it appears that the dam was in the up position, though this is just a snapshot in time and the channel bed responds to changes in the dam height.

In Subreaches B1, B2, and B4, a similar pattern of aggradation and degradation occurs throughout all years. Between the years 1962 to 1972, aggradation occurs through all subreaches. From 1972 to 2002, the river sees degradation in all subreaches. The rise in bed elevation from 2002 to 2012 in Subreach B3 is most likely a result of the increased sediment load from the AMAFA North Diversional Channel outfall and the temporary backwatering impacts of the ACBWUA Adjustable Height Dam. It appears that the upstream aggradation is contained within Subreach B3 and does not affect B1 and B2 subreaches. Upstream and downstream of B3, in Subreaches B1, B2, and B4, the degradation seen in the previous years has continued.

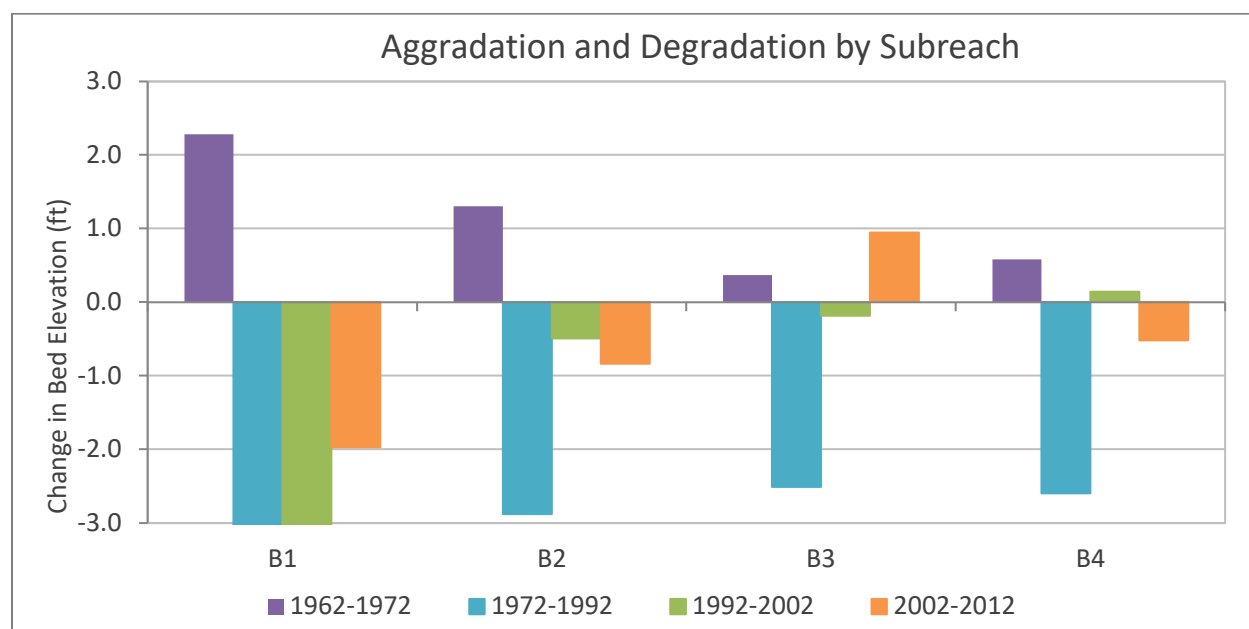
*Figure 3-11 Aggradation and degradation by subreach*

These trends can be observed and are analyzed in **Figure 3-11**, which shows the main channel aggradation and degradation of each subreach. The aggradation and degradation were found by first finding the average minimum channel elevation for each subreach and then subtracting the average bed elevation of the earlier year from the later year. A positive number indicates aggradation, and a negative number indicates degradation. This figure visualizes a direct comparison of trends in bed elevation between time intervals within individual subreaches. The period of 1962 to 1972 was the only period where there was aggradation throughout the entire Bernalillo Reach. This period of aggradation was followed by two periods, 1972 to 1992 and 1992 to 2002, of general degradation throughout the entire reach, which was heavily influenced

by the construction of Cochiti dam. There was some aggradation seen in B4 during the period of 1992 to 2002, but it is minor. The period of 2002 to 2012 were generally periods of degradation in all subreaches with exceptions in B3 which is due to the sediment load from AMAFA North Diversion outfall and temporary backwatering effects of the ABCWUA Adjustable Height Dam. The aggradation and degradation described in this section defines the channel slopes. For more detailed information on the channel slopes and how they have influenced the change in planform over time, see **Section 3.9**. The aggradation and degradation within the reach also impacts channel width (see **Section 3.2**) and bed material (see **Section 3.4**).

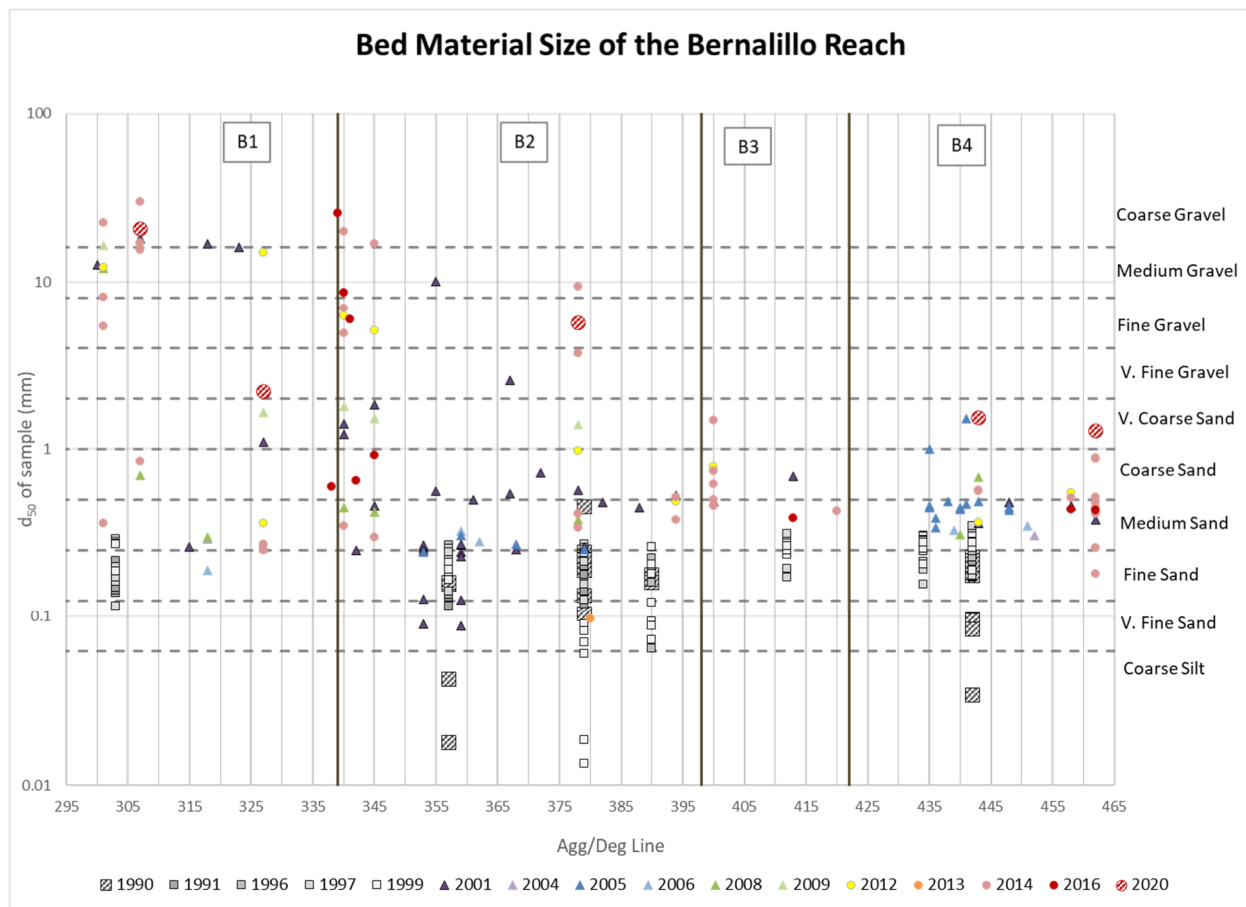
*Figure 3-13 Median grain diameter size of samples taken throughout the Bernalillo Reach*

Throughout the reach, the median diameter size of the samples typically varies between 0.0625 millimeter and 2 millimeter for the years in which data were collected. However, larger grain sizes, up to coarse gravel, were found in the upstream stream subreaches, B1 and B2, particularly in more recent years. **Figure 3-14** shows how the average bed material has changed over time in each subreach. In general, there has been a trend of the bed material coarsening over time. However, for a majority of the Bernalillo Reach, the grain size diameters correspond with classifications of fine sand to fine gravel, emphasizing the majority of Bernalillo Reach is a sand-bed river with some coarse silt and some gravels.

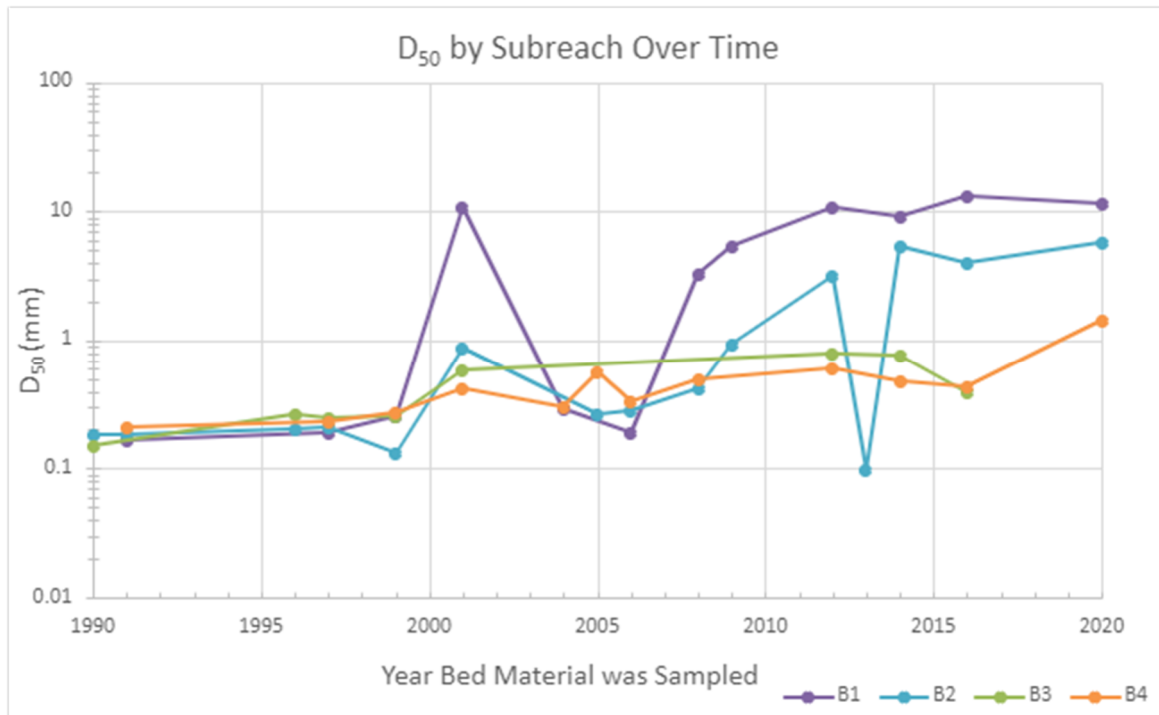
Figure 3-14 D50 change over time by subreach

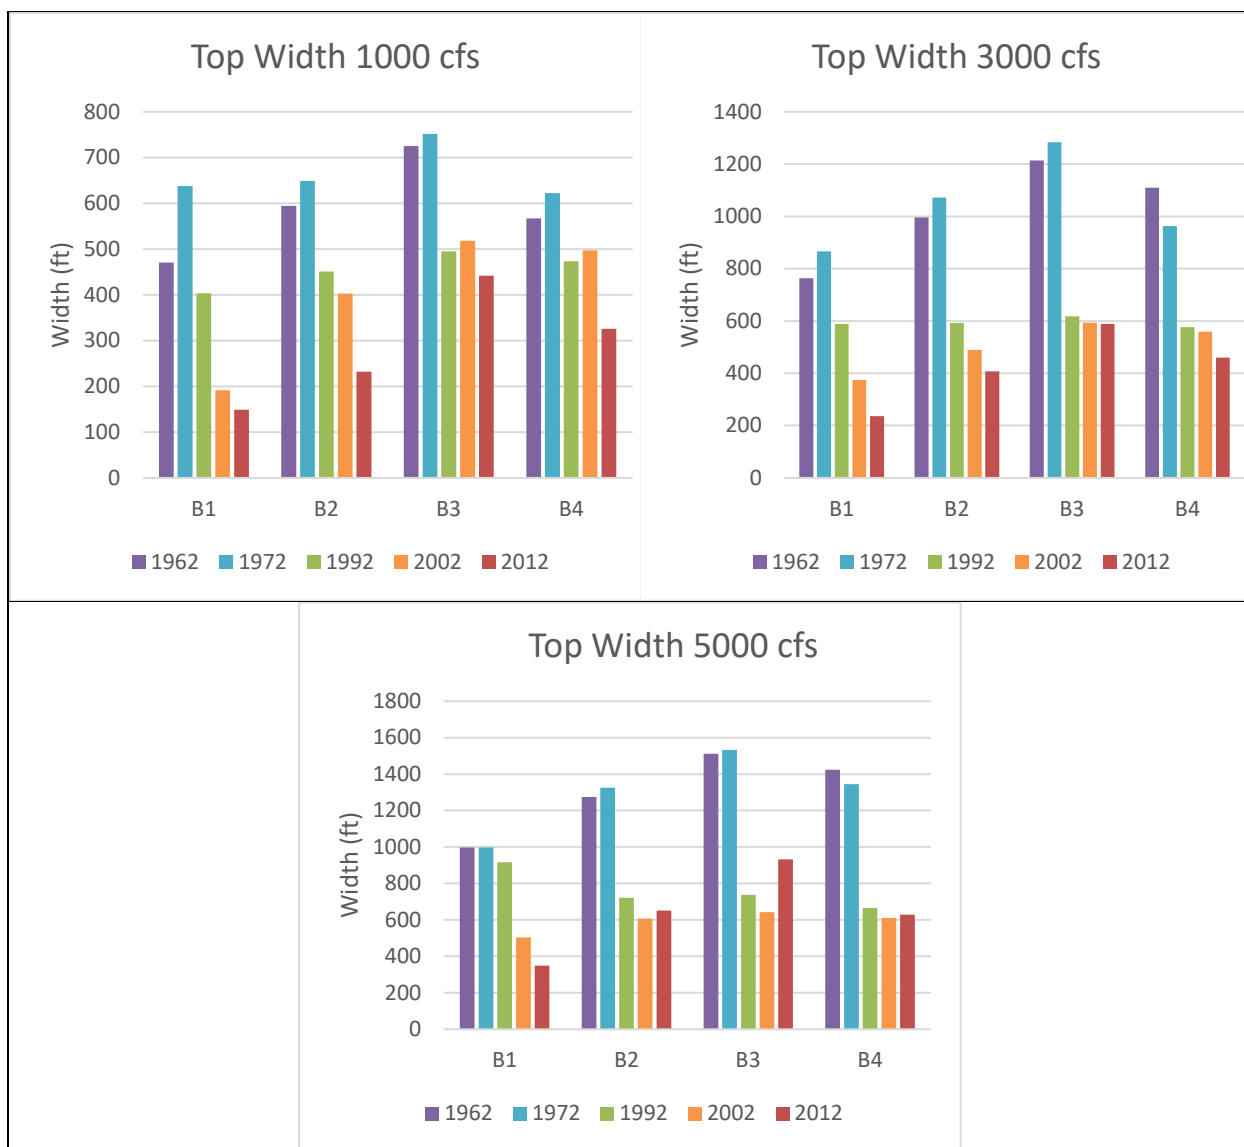
Figure 3-16 HEC-RAS Wetted top width of channel at 1,000 cfs (top left), 3,000 cfs (top right), and 5,000 cfs (bottom middle)

Because top width and hydraulic depth are typically inversely related for the same discharge, it is expected that the change in hydraulic depth results over time will have the opposite trend that the change in wetted top width results showed from subreach to subreach. **Figure 3-17** shows the HEC-RAS calculated hydraulic depths (area over top width) at discharges of 1,000 cfs, 3,000 cfs, and 5,000 cfs. In general, the HEC-RAS calculated results are similar to what is expected at 1,000 cfs. However, at 3,000 cfs and 5,000 cfs, the hydraulic depth in B1 should be higher in 1962 than in 1972 because the river is wider in 1972 than 1962.

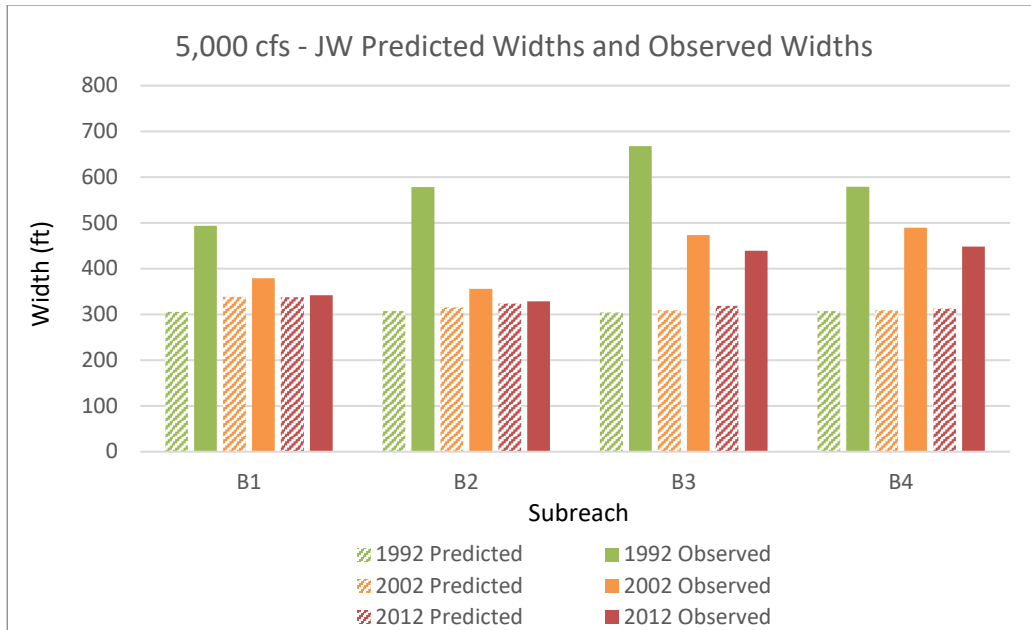
Figure 3-22 Julien and Wargadalam predicted widths and observed widths of the channel for 5,000 cfs

The predicted JW widths are narrower than the observed widths for all subreaches in the Bernalillo Reach – this indicates that the equilibrium width is narrower than the observed 2012 width. This predicted equilibrium channel width is about 300 ft. The percent error decreases from 1992 to 2012, see **Figure 3-22**, from a maximum error of 54% to 30% respectively. However, Subreaches B1 and B2 show very small percent differences for 2012, indicating that the subreaches could be reaching equilibrium. The sources of error are: a single discharge (bankfull) is used when a spectrum of discharges flow through the MRG, some D50 values are not associated with the years calculated (though large changes in grain size are required to see substantial changes to predicted width), and these equations are based on single-thread channels (the MRG is naturally a braided system). It is important to note that the JW equations represent a river whose morpho-dynamics are in equilibrium. The morpho-dynamic equilibrium assumes there would be no aggradation or degradation occurring.

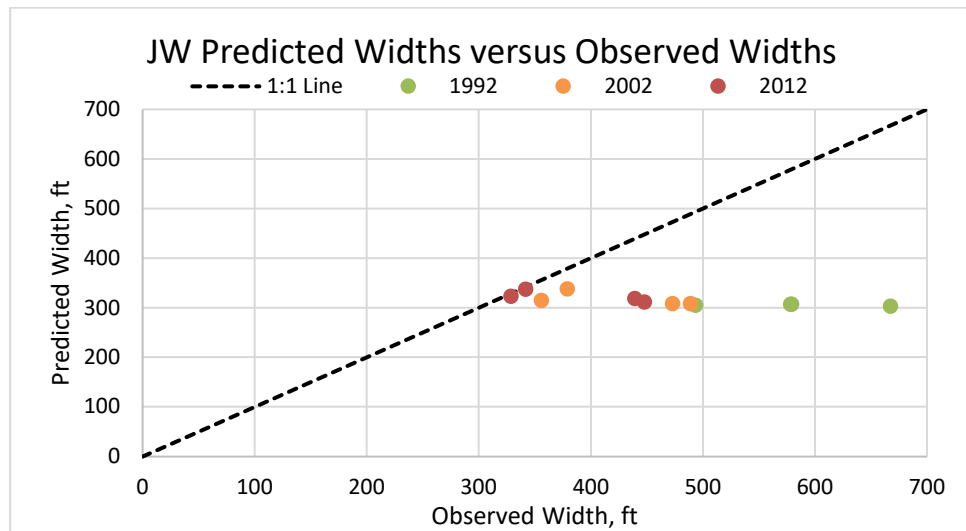
Figure 3-23 Julien and Wargadalam predicted widths versus observed widths with 1:1 line for 5,000 cfs

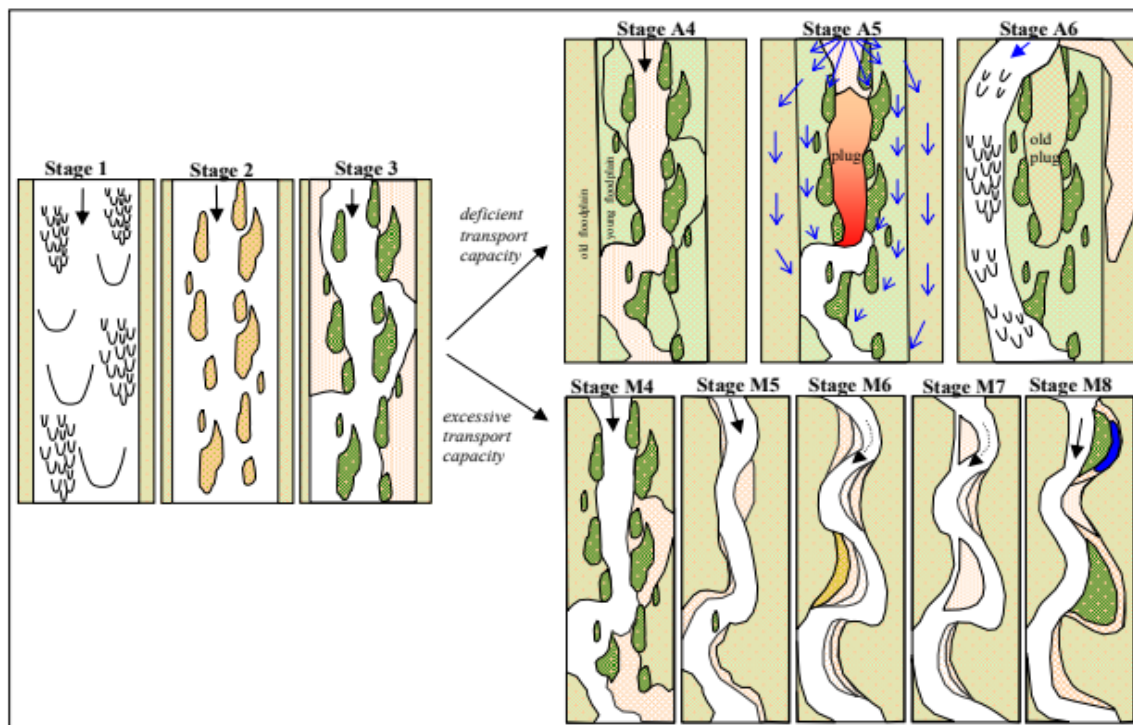
Figure 3-24 Planform evolution model from Massong et al. (2010). The river undergoes stages 1-3 first and then continues to Stages A4-A6 or stages M4-M8 depending on the sediment transport capacity.

The sediment transport capacity then becomes the determining factor of the future course of the river to either an aggrading river or a migrating river. A deficiency in sediment transport capacity, meaning the sediment supply is exceeding the transport capacity, leads to *aggradation* in the main channel and the flow eventually shifts onto the lower surrounding floodplain (**Stages A4-A6**). This typically forms in areas where the reach slopes are less than 0.0007 ft/ft. When the sediment transport capacity exceeds the sediment supply, bank material erodes both laterally and vertically, leading to a *meandering* river (**Stages M4 to M8**). This typically happens where average channel slopes are larger than 0.0009 ft/ft. Transitions or complex combinations between the M stages and the A stages can occur, typically in areas where the average channel slope adjusts or in areas where neither A nor M stages dominate (typically where slopes are between 0.0007 ft/ft and 0.0009 ft/ft). However, a reset to Stage 1 always requires a large, prolonged flood to overcome the vegetation encroachment and widen the floodplain (Massong et al., 2010).

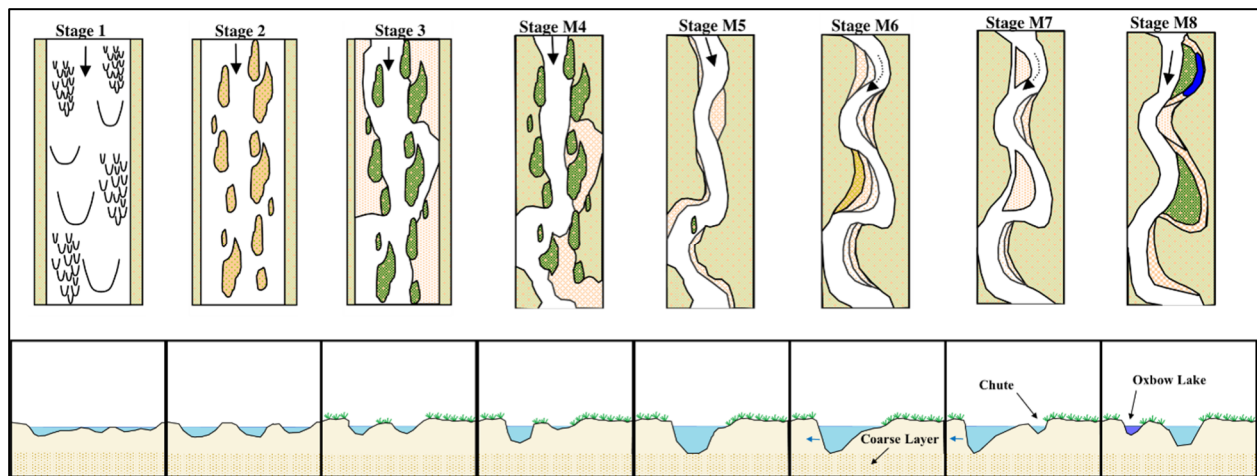
*Figure 3-25 Planform evolution model from Massong et al. (2010) applied to channel cross sectional view left to right looking downstream (modified by Brianna Corsi, 2022)*

**Figure 3-25** shows the stages for a meandering river course in plan view (Massong et al. 2010) as well as cross-section view. During **Stage M4**, a dominant channel is typically established, while secondary channels begin to aggrade and will only become inundated during higher flows. Vegetation begins to encroach into these secondary channels, and they begin to transition from a channel to floodplain. During **Stage M5**, the channel continues to incise until the channel reaches a stable slope or runs into a coarser bed layer. This form is generally single threaded and straight or slightly sinuous. The channel may begin to meander, as shown by **Stage M6**, if the channel thalweg is below the root zone. This allows for erosion of the bank material beneath the soil layer that is more consolidated by roots. Meanders progress and typically form side channel cuts (chutes) through the point bar on the inside of the bend (**Stage M7**). These gradually become larger until it eventually able to convey all of the flow, leading to the eventual abandonment of the old channel. The old channel fills with sediment and becomes part of the floodplain (**Stage M8**). Note that the plan view classification system has been expanded to include representative cross sections for each stage.

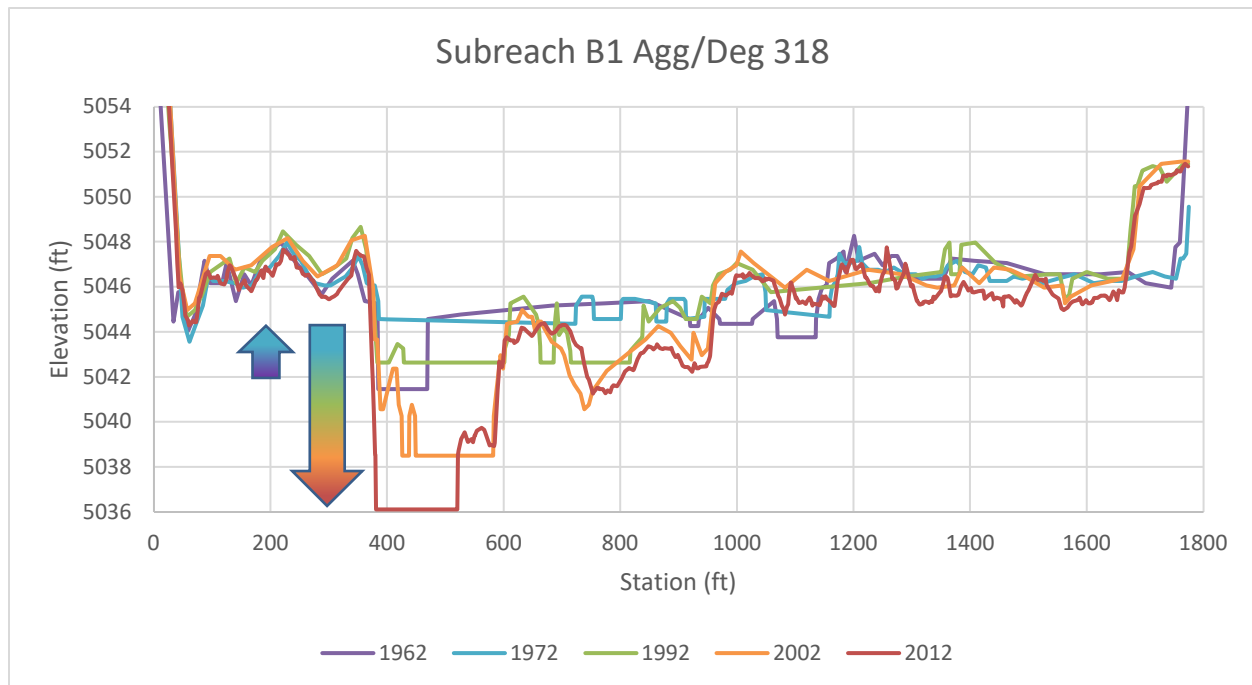
*Figure 3-26 Subreach B1: Channel evolution of representative cross section Agg/Deg 318. Significant channel degradation and narrowing occurred between 1972 and 2012.*

section shows no clearly defined low flow channel. Between 1972 and 2012, the channel gradually degraded, narrowed, and became more clearly distinguishable from the floodplain. The channel dropped by 2 feet in the 20-year period between 1972 and 1992, by 4 feet in the 10-year period between 1992 and 2002, and another 3 feet in the 10-year period between 2002 and 2012, for a total of around 9 feet of degradation in 40 years at this cross-section. Subreach B1 shows the greatest drop in channel bed of the four subreaches within the Bernalillo Reach.

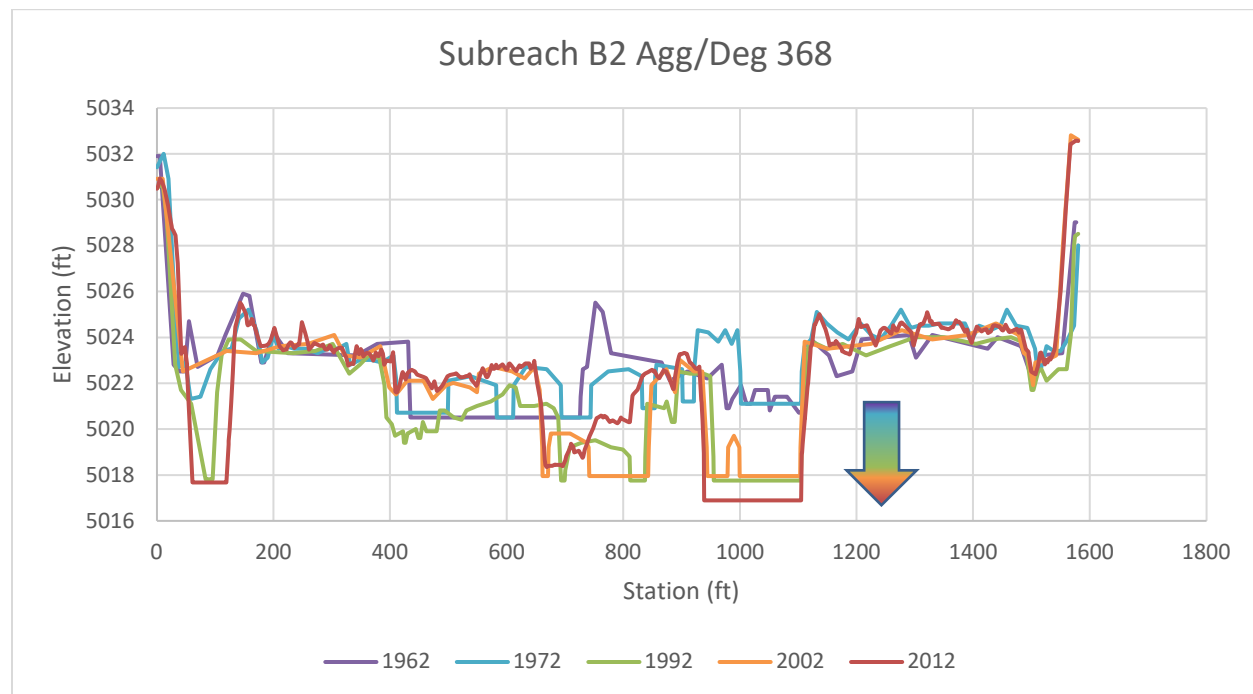
*Figure 3-28 Subreach B2: Channel evolution of representative cross section Agg/Deg 368. Significant channel degradation and narrowing occurred between 1972 and 2012. Note: it appears that the side channel thalweg at station 100 ft was missed in the 2002 survey.*

Subreach B2 is currently bound by potential grade controls, the Corrales Siphon on the upstream end, and the AMAFA North Diversion Channel outfall on the downstream end. In Subreach B2, the channel neither aggraded nor degraded between 1962 and 1972 at Agg/Deg 368. Between 1972 and 2012, the channel gradually degraded, narrowed, and became more clearly distinguishable from the floodplain. Approximately 3 feet of degradation occurred between 1972 and 1992. The channel and floodplain remain relatively static between 1992 and 2002, with approximately 2 feet aggradation filling a side-channel within the left floodplain (between stations 400 ft and 600 ft). Between 2002 and 2012, the right channel degrades by 1 foot and becomes more dominant, while the left channel (between stations 650 ft and 850 ft) begins to shrink. A total of 5 feet of degradation occurred in the 40 years between 1972 and 2012.
