# Middle Rio Grande Bernalillo Report:

Morpho-dynamic Processes and  
Silvery Minnow Habitat from  
Hwy 550 Bridge to  
Montaño Road Bridge

Final: April 2023  
Final report prepared for the  
United States Bureau of Reclamation

Colorado State University  
Engineering Research Center  
Department of Civil and  
Environmental Engineering  
Fort Collins, Colorado 80523

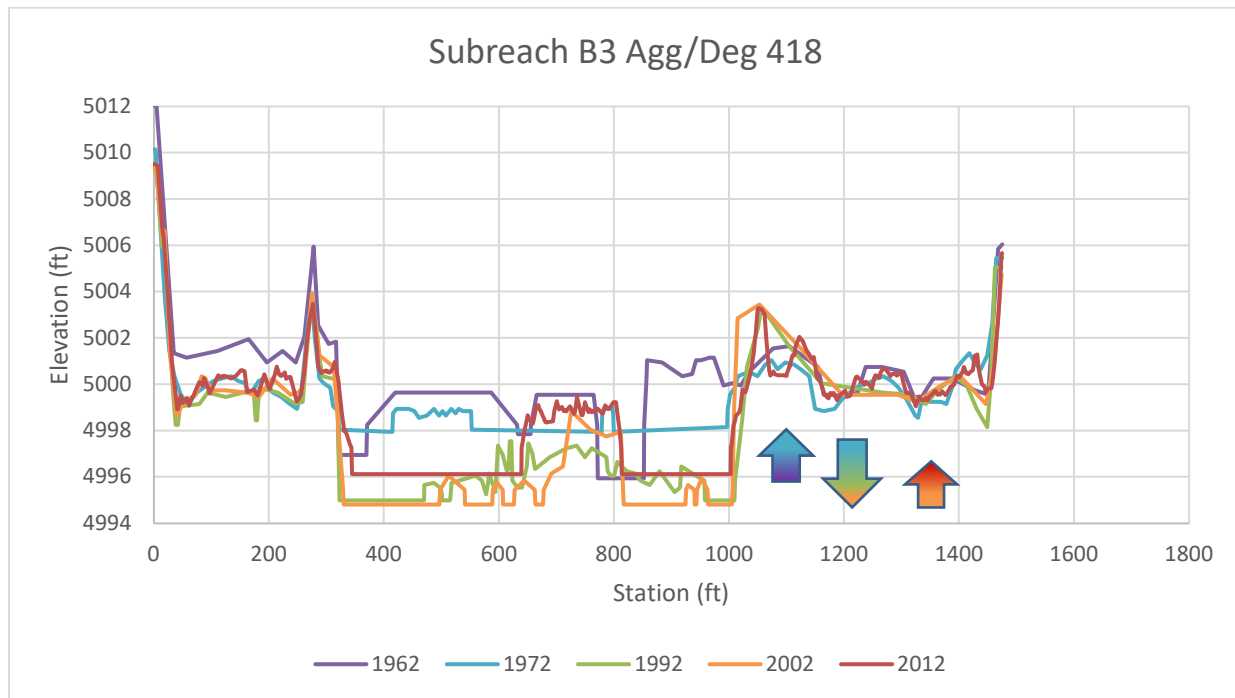
*Figure 3-30 Subreach B3: Channel evolution of representative cross section Agg/Deg 418. Note less degradation and narrowing than seen in Subreaches B1 and B2.*

In Subreach B3, the channel aggraded by 2 feet between 1962 and 1972 at Agg/Deg 368. The 1962 cross-section shows a more clearly defined low flow channel that is approximately 60 feet wide and 2 foot deep. In contrast, the 1972 cross-section shows no clearly defined low flow channel. Between 1972 and 1992, the channel degraded by 3 feet and became more clearly distinguishable from the floodplain. The channel and floodplain remain relatively static between 1992 and 2002, with approximately 1 foot of aggradation at the mid-channel island between stations 700 ft and 800 ft. Between 2002 and 2012, 1 foot of aggradation has occurred in the channel. This is due to construction of the ABCWUA Adjustable Height Dam in 2005, which is located approximately 2,000 feet downstream of Agg/Deg 418 at Agg/Deg 422. While approximately 2-3 feet of net degradation has occurred in this reach over the last 40 years, the channel width has not been impacted as significantly as the channel in Subreaches B1 and B2.

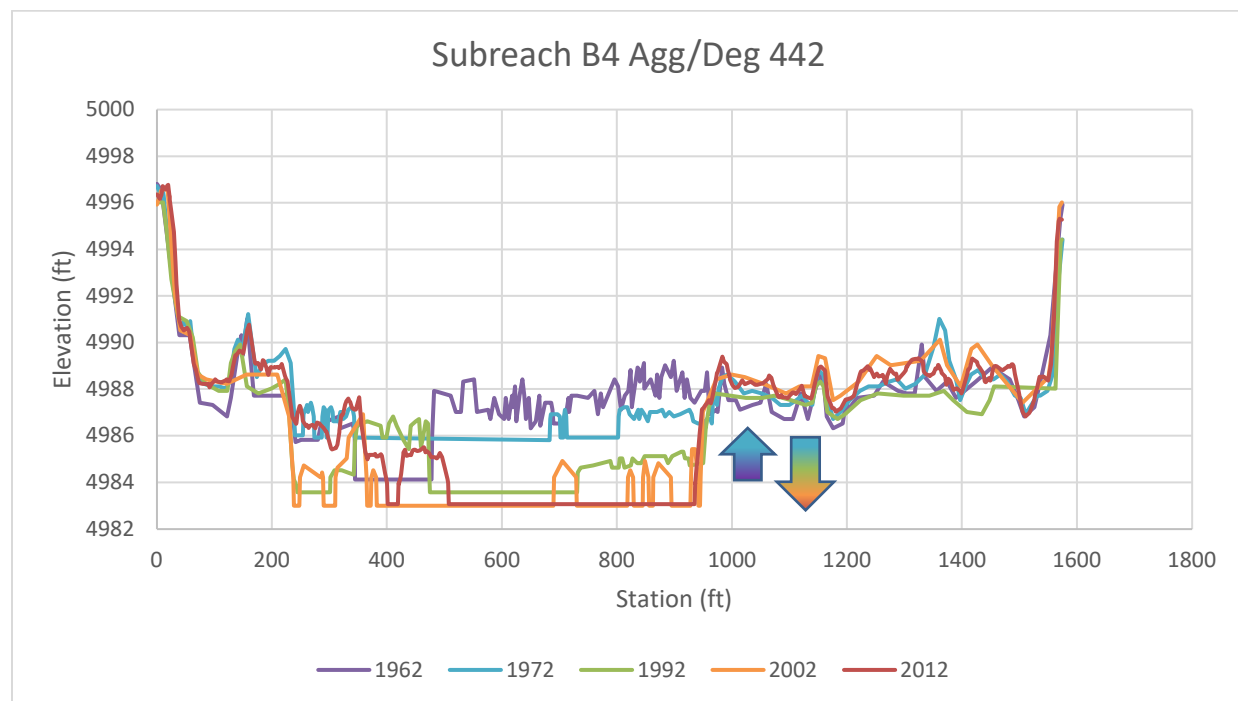
*Figure 3-32 Subreach B4: Channel evolution of representative cross section Agg/Deg 442.*

In Subreach B4, the channel aggraded between 1962 and 1972. The 1962 cross-section shows a more clearly defined low flow channel that is approximately 100 feet wide and 2 feet deep. In contrast, the 1972 cross-section shows a much wider channel with no clearly defined low flow channel. Between 1972 and 1992, the channel degraded by 2 feet and formed a deeper main channel (right) and side channel (left). Roughly 0.5 feet of degradation occurred between 1992 and 2002. Between 2002 and 2012 the channel did not degrade at Agg/Deg 442, but the left side channel, previously 100 feet wide in 2002, aggrades and becomes incorporated into the floodplain in 2012. Overall, a total of 3 feet of degradation occurred in the 40 years between 1972 and 2012.

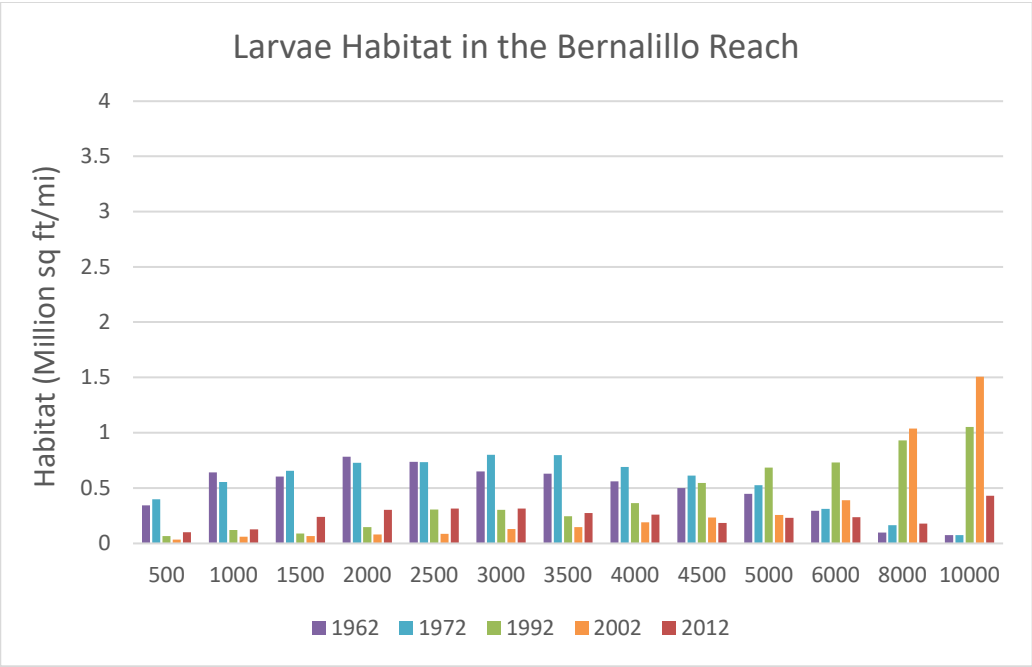
Figure 4-2 Larval RGSM habitat availability throughout the Bernalillo Reach

Throughout the Bernalillo Reach, the results follow a similar trend for larvae, juvenile, and adult stage habitat. There was more habitat availability during the years of 1962 and 1972. There is a dramatic decrease in habitat between 1972 and 1992, which corresponds to the degradation and the decrease in active top width that the reach experiences during that time frame due to the construction of Cochiti Dam. See **Section 3** for more information on the change in channel characteristics between time periods. There is limited available larvae habitat in comparison to the juvenile and adult available habitats, although it slightly increases as the flow increases through the channel and more of the floodplain is activated. As seen in **Figure 3-17 in Section 3.6**, as flow increases, the hydraulic depths do not change by a large amount, so there is more consistent habitat available.

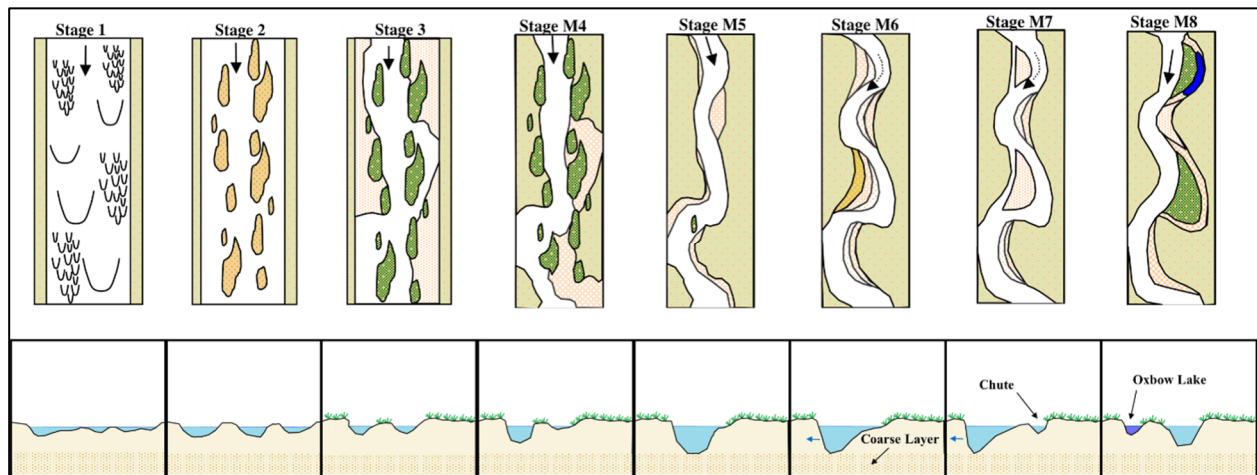
*Figure 5-1 Planform evolution model from Massong et al. (2010) applied to channel cross sectional view left to right looking downstream (modified by Brianna Corsi, 2022).*

The Massong et al. (2010) classification system was used to evaluate channel planform over time with the use of historical aerial imagery and a representative channel cross-section from each subreach. Between 1962 and 2012, the Bernalillo Reach appears to be progressing through the meandering (M) planform stages. This indicates that the Bernalillo Reach tends to have excess transport capacity, meaning that the channel tends to erode rather than deposit sediment through the reach. Factors such as channel bed coarsening and degradation progressing to a point where the bank height exceeds the root depth of the riparian vegetation are more important than slope in assessing plan view stage for reaches where the sediment supply is less than transport capacity. Signs that the Bernalillo reach on the evolutionary track towards a meandering river include channel incision and narrowing rather than aggradation, coarsening of the bed, meander planform visible within the aerial imagery, and an absence of sediment plugs. The Massong et al. (2010) Meandering (M) planform stages along with a cross-section representation is given by **Figure 5-1** (also see **Section 3.9**). Note that the plan view classification system has been expanded to include representative cross sections for each stage.

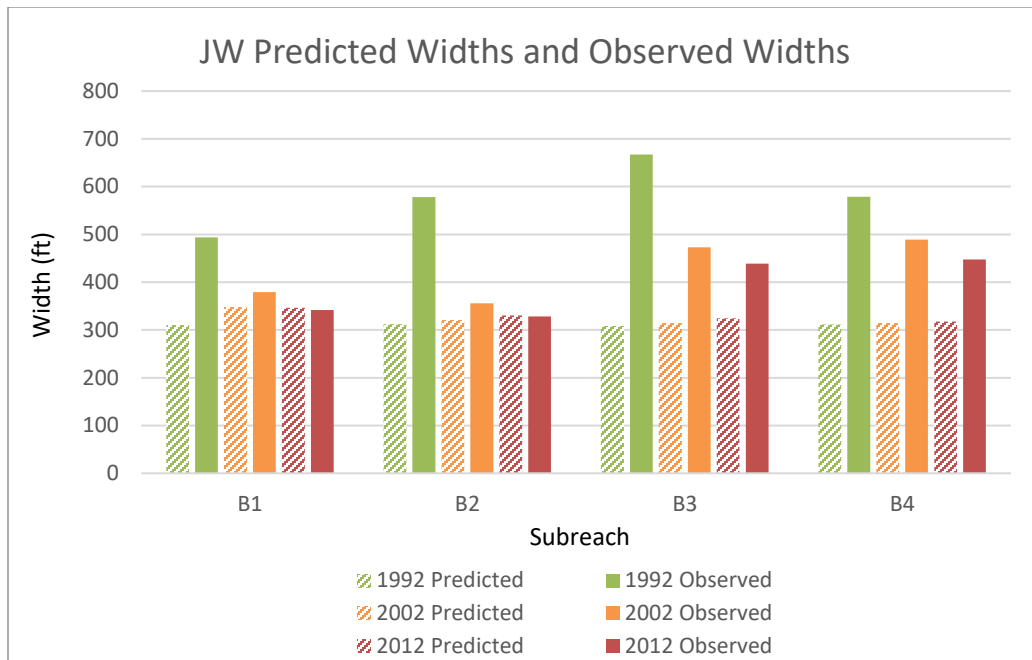
*Figure B-1 Julien and Wargadalam predicted widths and observed widths of the channel*

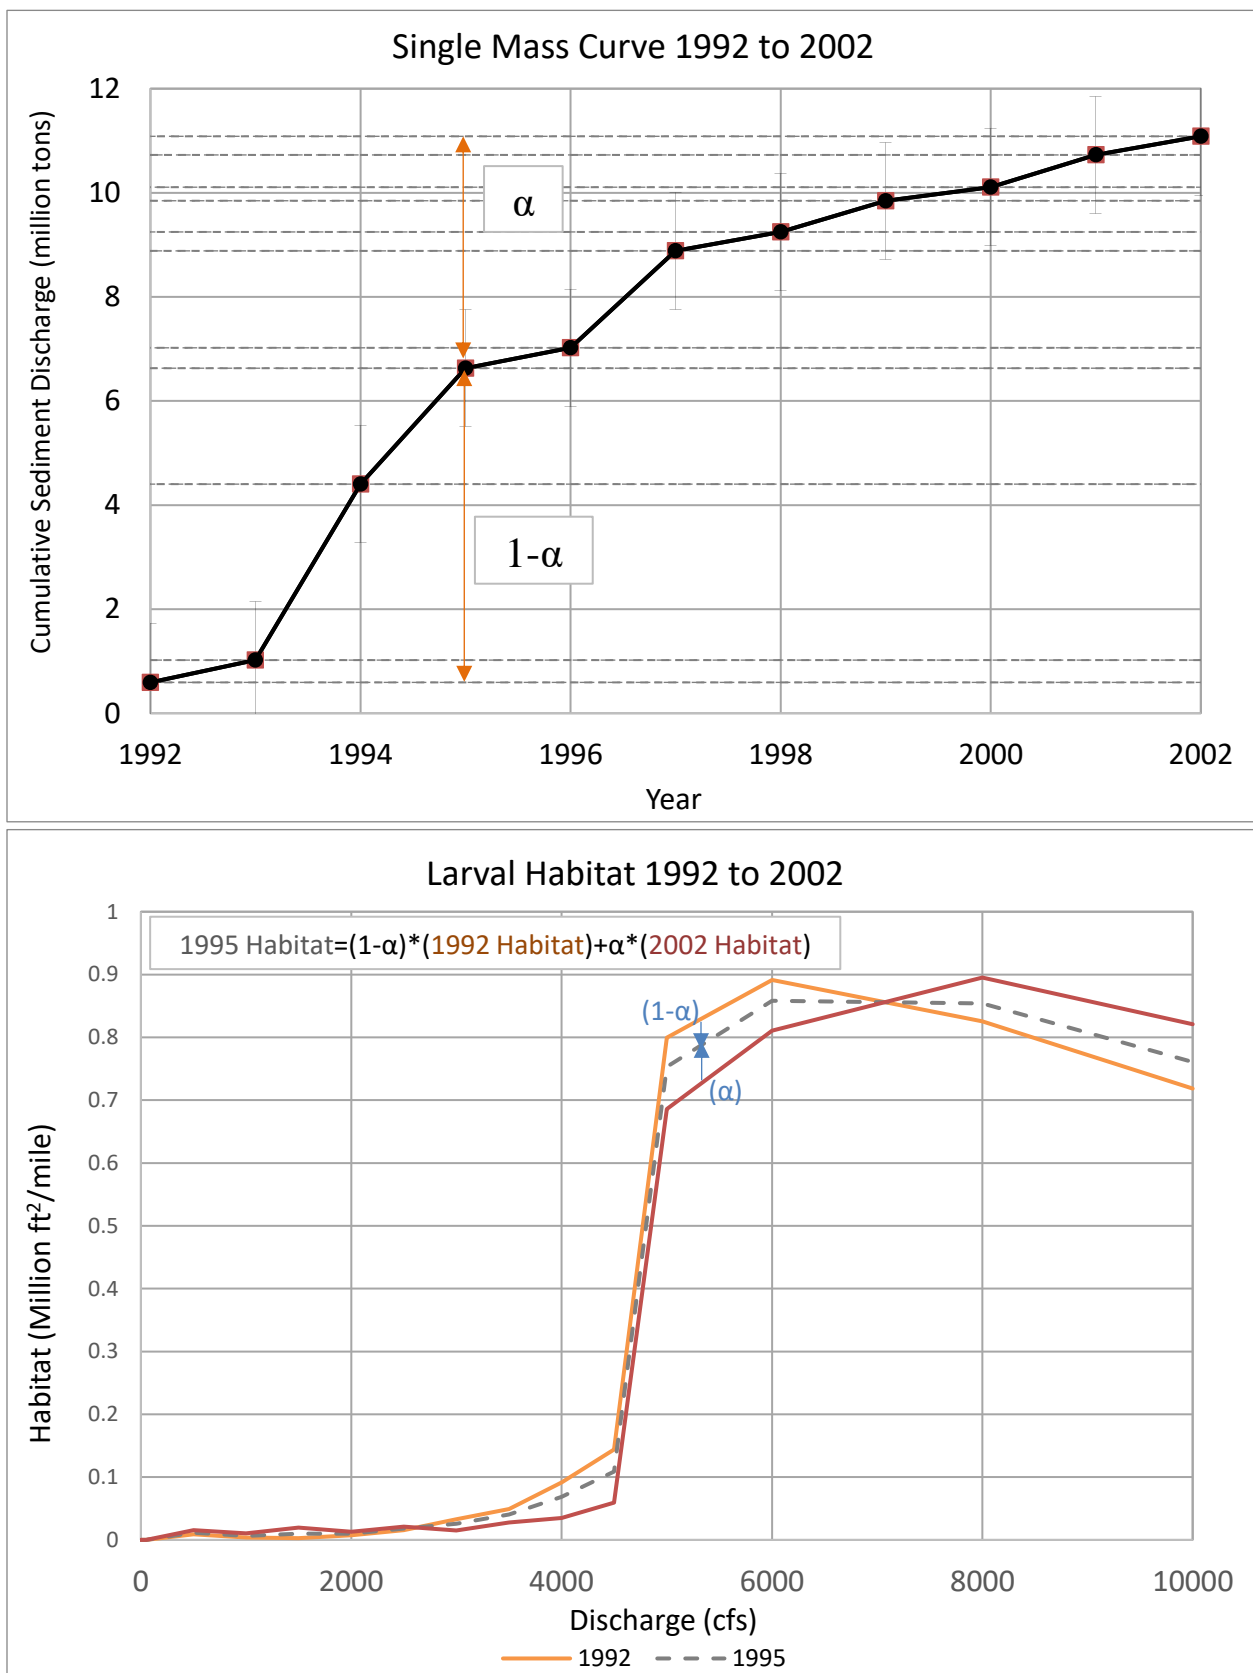
Figure C-4 Example of annual habitat interpolating using the sediment rating curve and alpha technique

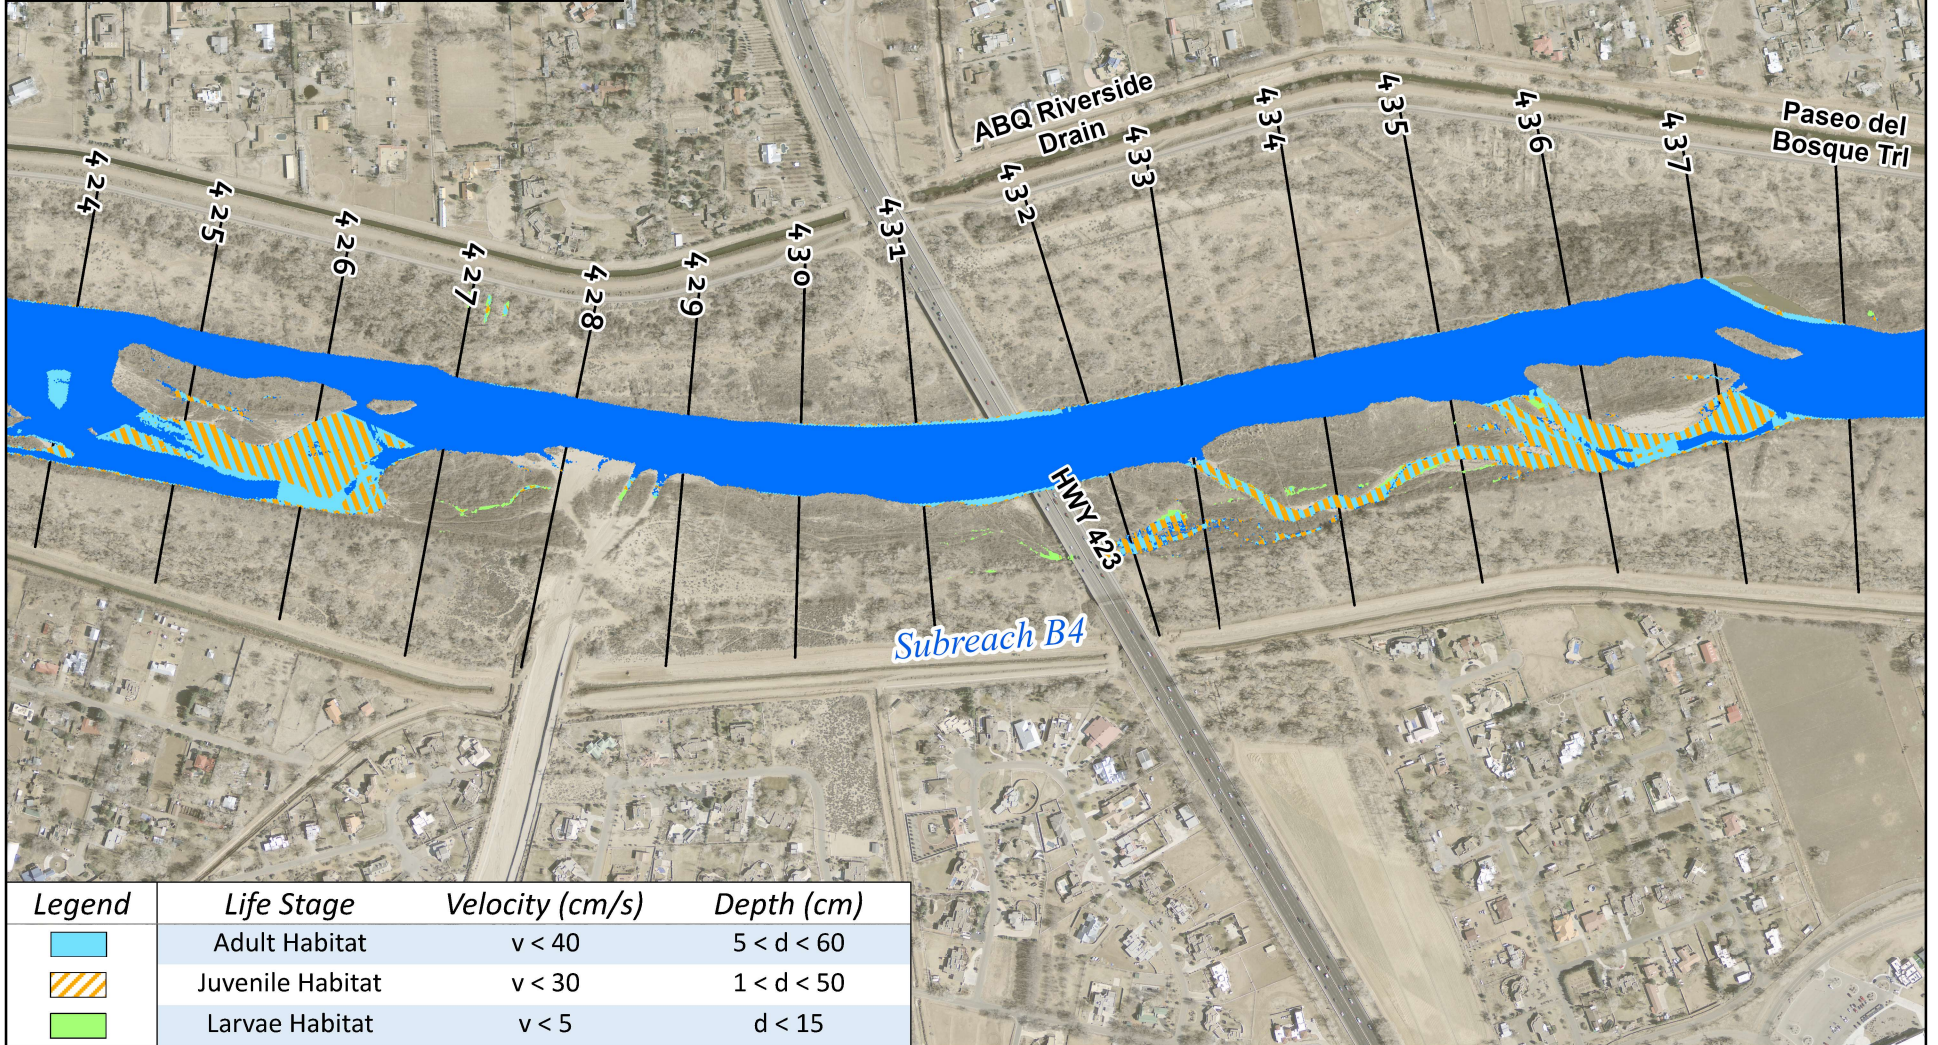
Rio Grande Habitat Map at 3,000 cfs  
Bernalillo to Montano

Legend	Life Stage	Velocity (cm/s)	Depth (cm)
 	Adult Habitat	$v < 40$	$5 < d < 60$
 	Juvenile Habitat	$v < 30$	$1 < d < 50$
 	Larvae Habitat	$v < 5$	$d < 15$
