DESIGN OF THE CAMBAMBE DAM HEIGHTENING

Keywords: Cambambe Dam, Dam Heightening and Arch Dam

Abstract. *The Cambambe hydroelectric is located in the Cuanza River, in Angola, about of 180 kilometers from the capital Luanda. In 2004, after 40 years of operation of the power plant, the owner ENE (National Enterprise of Energy) decided for carrying out the works of rehabilitation and expansion. The rehabilitation project comprised the change of the original installed capacity from 180 MW to 260 MW, subject to the raising of reservoir level. The expansion project consisted in the heightening of 20 m of the existing arch dam, the construction of a new generation circuit, a new power plant with installed capacity of 700 MW and the building of two new spillways. Finally, this project increased the installed capacity of the Cambambe Dam from 180 MW to 960 MW, doubling the generation capacity of Angola. This paper describes the development and the challenges that were overcome during the design, which construction was concluded successfully in 2016.*

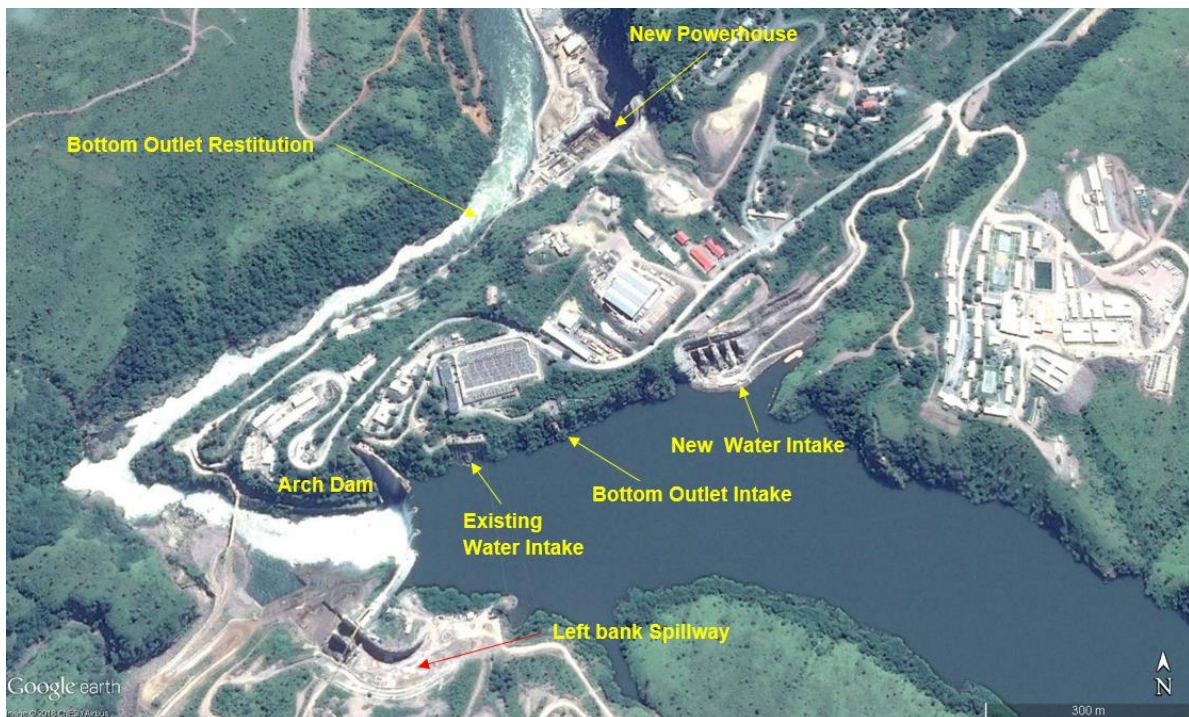
In addition, the new water intake would be located in the right bank. The Figure 3 shows an aerial image from *Google Earth* taken after the beginning of construction in 27/07/2014, where is possible to visualize the location of the main structures.

Figure 3: Cambambe Dam aerial view (*Google Earth*)

At the beginning of the Cambambe Hydroelectric project, the Portuguese engineers designed a bottom outlet excavated in the right bank (see the location in the Figure 3) to divert the flow during the dam construction. After the conclusion of the dam, this structure would be used to evacuate sediment during the reservoir operation. The bottom outlet structure has an intake in the elevation in 56 m.a.s.l and it is operated by two gates. First, a caterpillar gate 4.5 m wide and 6.7 m high designed for execute repairs along the structure and a radial gate 3.5 m wide and 6.0 m high, to control the flow.

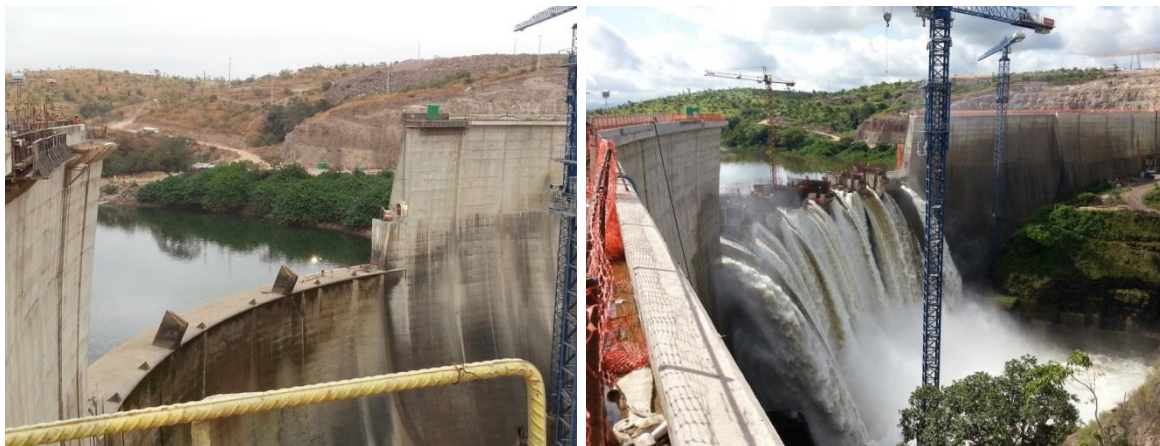
In addition, other issue was the occurrence of the floods during the construction of the orifice-type spillway. This particular load case had to be taken in account in the structural design, in order to assure the stability of the structure during the construction. The Figure 5 illustrates the start of the dam heightening process and a flood situation just after the beginning of the construction of the orifice-type spillway.

Figure 5: Pictures from the dam site during the dam heightening

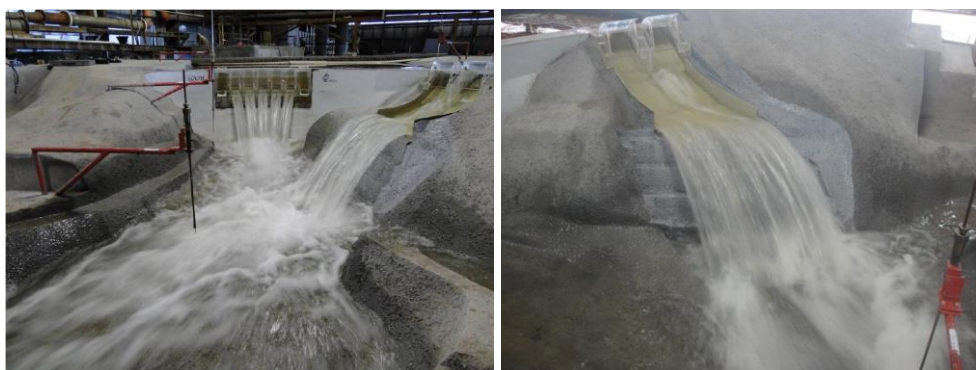
The hydraulic calculations of the spillways followed the well-known Design of Small Dams criteria (USBR, 1987)³, after that the design was consolidated with physical modeling. The physical model was built in June of 2010 at the LACTEC/CEHPAR hydraulic lab located in the city of Curitiba, state of Paraná, Brazil. This model was built in the geometric scale of 1:75, following the Froude similitude criteria and reproducing an area of 0.74 km² in the prototype, which represents an area of 132 m² in the lab. The main tests carried out were: discharge capacity with partial and total gates opening, jet trajectory, pressure in the crest and chute, pressure in the plunge pool and scour depth. The Figure 9 illustrates the running of some tests in the physical model.

Figure 9: Physical model studies

Overall, the physical model showed a satisfactory hydraulic performance of the spillways. However, near to the end of the physical model studies some adaptations were needed in the alignment of the left bank spillway approach channel. However, at this time the physical model studies were almost finished, then due the timing and cost the engineers agreed to test the modifications in the numerical models, essentially in Flow 3D®. The next topic presents the results of this numerical simulation.

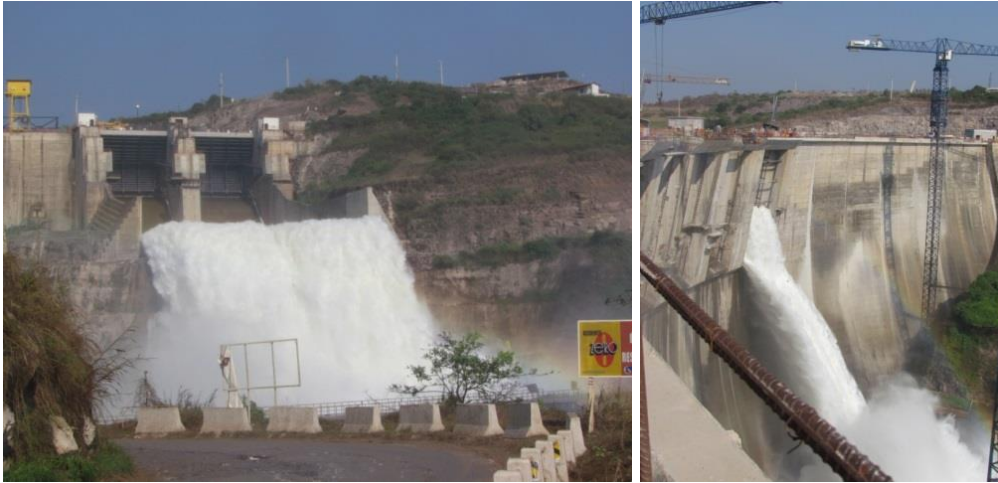
After the conclusion of the design, the spillways were built, being concluded in June of 2016. Following the end of the construction both spillways were tested successfully, as showed in The Figure 11.

Figure 11: Spillway test in 2016

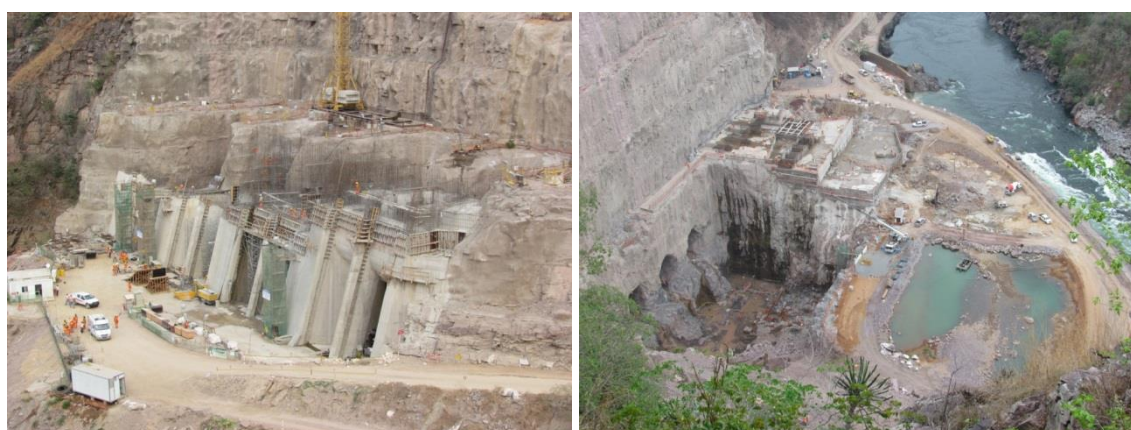
Finally, the generation circuit was built and concluded successfully in May of 2016. In order to illustrate some of the construction stages, the Figure 14 (left) shows the excavation of the powerhouse protected with the cofferdam in November of 2013 and the execution of the water intake in June of 2014 (right).

Figure 14: Generation circuit construction stages

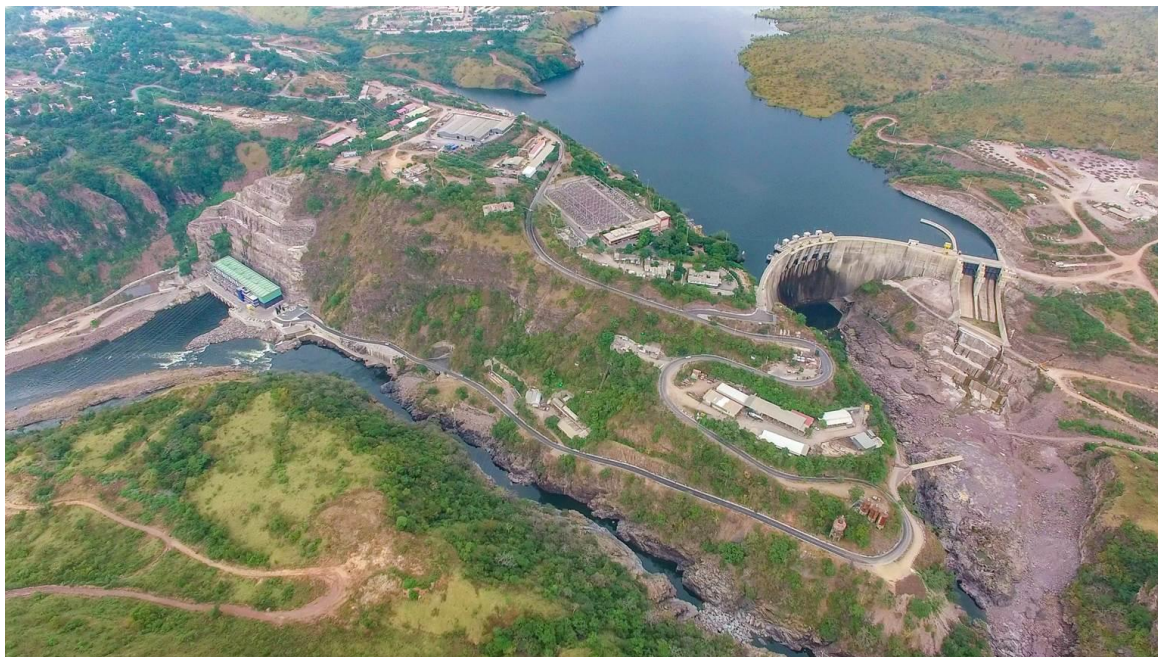
Ultimately, the conclusion of this project doubled the Angola's Generation Capacity. The Figure 15 shows an aerial view of the Cambambe Dam after the completion.

Figure 15: Aerial view of the Cambambe Dam concluded.
