DW2018 Conference Issue

Design of the Second Stage of Cambambe HPP Project

Marcos C Palu*, Rafael P G Salles† & Diego D Baptista de Souza†

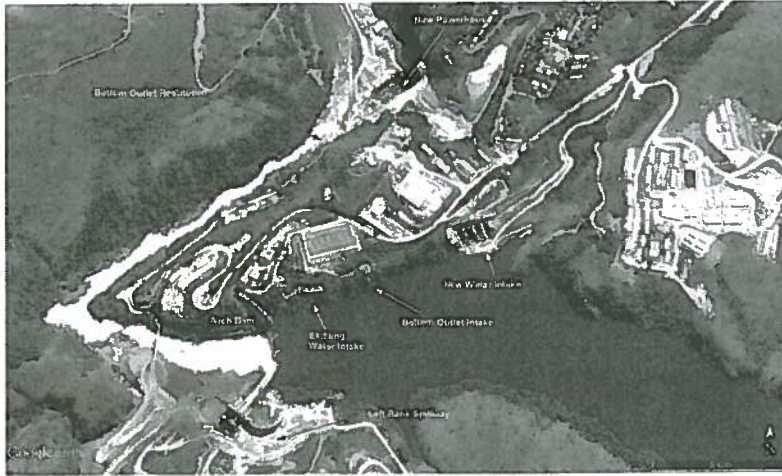
In addition, the new water intake would be located on the right bank. Figure 3 shows an aerial image from Google Earth taken after the beginning of construction on 27th July 2014, where it is possible to visualize the location of the main structures.

Figure 3. Cambambe Dam aerial view (Google Earth)

At the beginning of the Cambambe Hydroelectric project, the Portuguese engineers designed a bottom outlet excavated in the right bank (see location in Figure 3) to divert flow during the dam's construction. After the conclusion of the dam, this structure would be used to evacuate sediment during the reservoir operation. The bottom outlet structure has an intake elevation of 56masl, and is operated by two gates. Firstly, a caterpillar gate 4.5m wide and 6.7m high, designed to allow execution of repairs along the structure, and a radial gate 3.5m wide and 6m high, to control the flow.

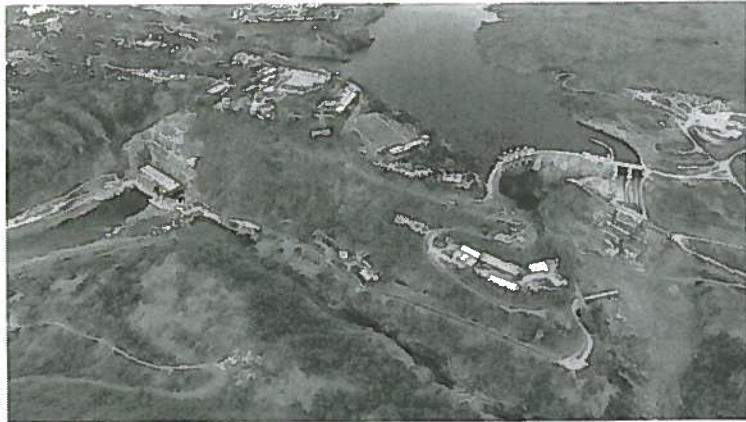
Figure 15. Aerial view of the completed Cambambe Dam

Ultimately, the conclusion of this project has doubled Angola's generation capacity. Figure 15 shows an aerial view of the Cambambe Dam after project completion.
