Middle Rio Grande Escondida Reach:

Morpho-dynamic Processes and Silvery Minnow Habitat
from Escondida Bridge to US-380 Bridge
(1918-2018)

August 2020
Master of Science
Plan B Technical Report

Prepared by:
Tori Beckwith

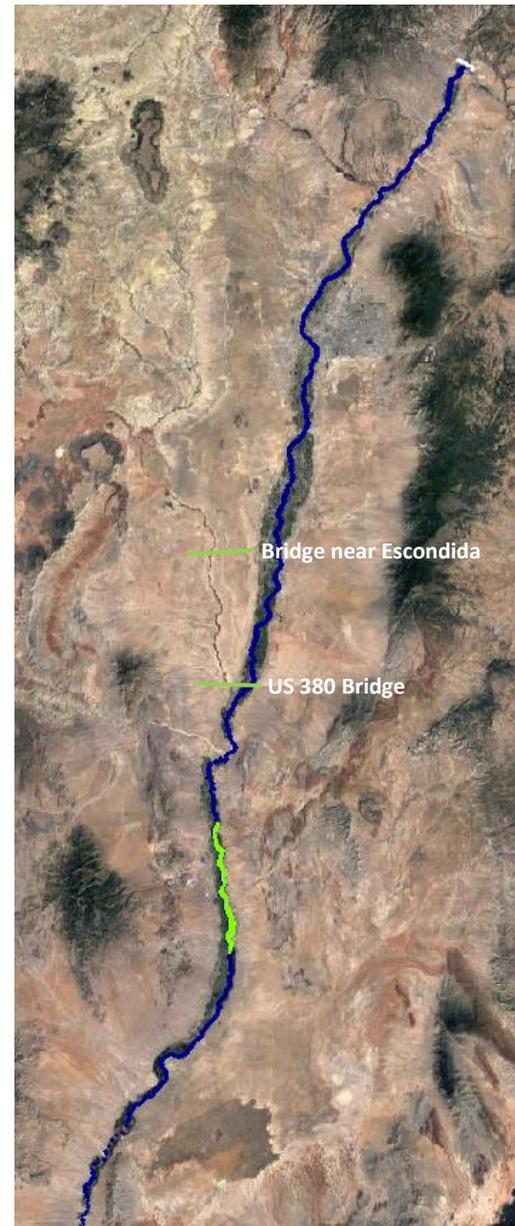
Figure 1 Map with the Middle Rio Grande outlined in blue. It begins at the Cochiti Dam (top) and continues downstream to the Narrows in Elephant Butte Reservoir (bottom). The lime green highlights the Escondida reach.

The purpose of this reach report is to evaluate the morpho-dynamic conditions of the Middle Rio Grande (MRG) which extends from the Cochiti Dam to the Narrows in Elephant Butte Reservoir. The report focuses on the Escondida reach, which begins at a bridge near Escondida, New Mexico, and continues downstream to the US 380 Bridge near San Antonio, New Mexico (Figure 1).

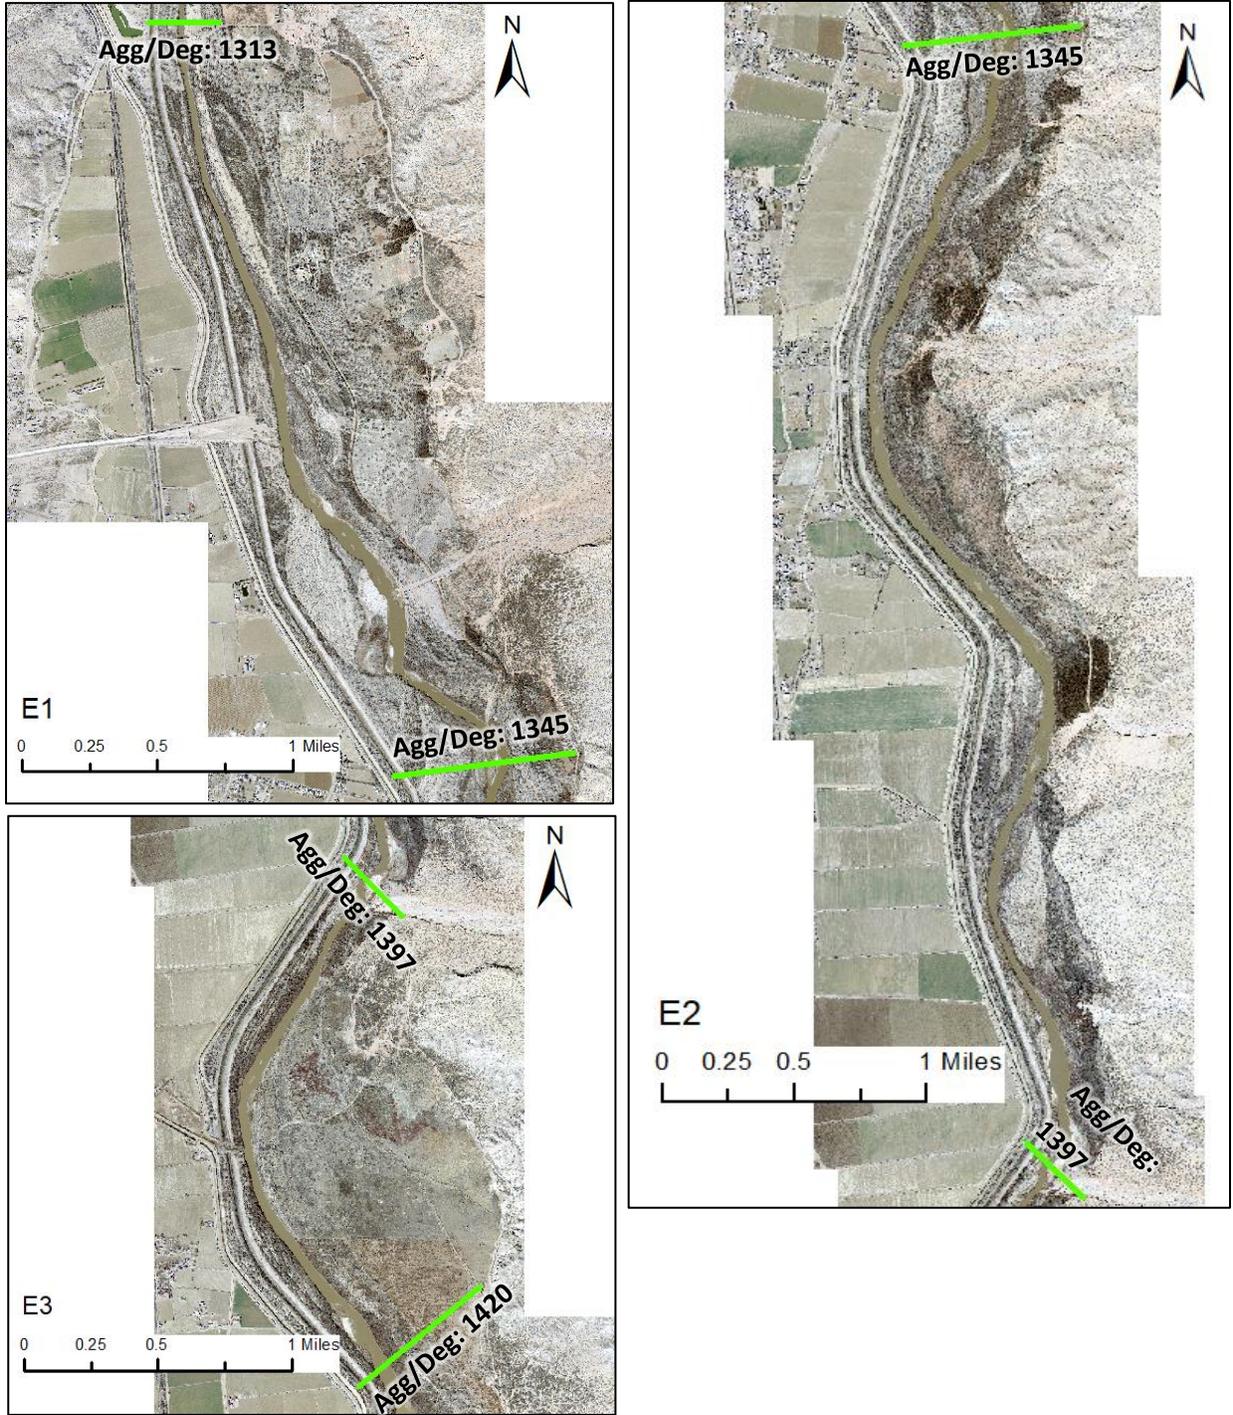
Figure 2 Subreach Delineation: Subreaches E1 (top left), E2 (right), and E3 (bottom left).

Escondida Reach		
Subreach	Agg/deg lines	Justification
E1	1313-1345	Start: Escondida Bridge End: Low Radius Bend
E2	1345-1397	Start: Low Radius Bend End: Confluence with Arroyo De Las Cañas
E3	1397-1420	Start: Confluence with Arroyo De Las Cañas End: Change in cumulative width (wider)
E4	1420-1448	Start: Change in cumulative width (wider) End: Change in cumulative width (narrower)
E5	1448-1475	Start: Change in cumulative width (narrower) End: US 380 Bridge near San Antonio, NM

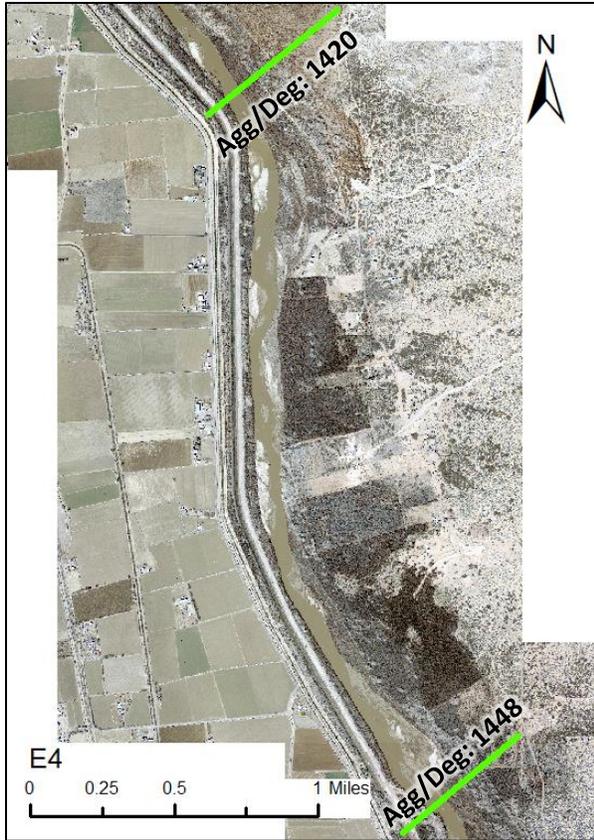
Figure 3 Subreach Delineation: Subreaches E4 (left) and E5 (right).

pumping from the Low Flow Conveyance Channel (LFCC) that waters vegetation at the nearby site. The final subreach, E5, begins at the contraction of the river and continues until the US HWY 380 Bridge (agg/deg line 1475), which also marks the end of the entire Escondida reach. The subreaches are shown in Figures 2 and 3. The subreach delineation is summarized in Table 1.

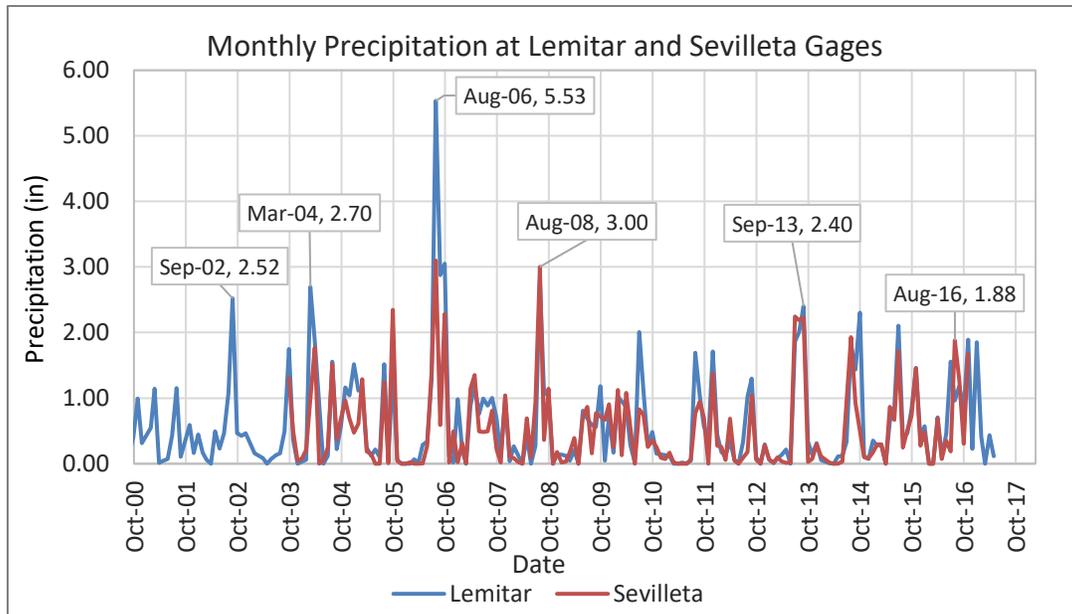
Figure 5 Monthly precipitation trends near the Escondida reach

The precipitation data are shown in Figure 5. The highest precipitation peak occurred in August of 2006 at the Lemitar gage, with 5.5 inches of rainfall. A general trend was observed with highest precipitation values occurring during monsoon season (late July through early September). A cumulative plot of rainfall (Figure 6) shows that individual rain events can greatly affect the overall trend of the data. It further highlights the monsoonal rains, which create a “stepping” pattern with higher rainfall in August and September, and lower levels throughout the rest of the year. The comparison of the cumulative precipitation at the two sites also shows that the Lemitar gage receives more precipitation than the Sevilleta gage throughout the time observed.

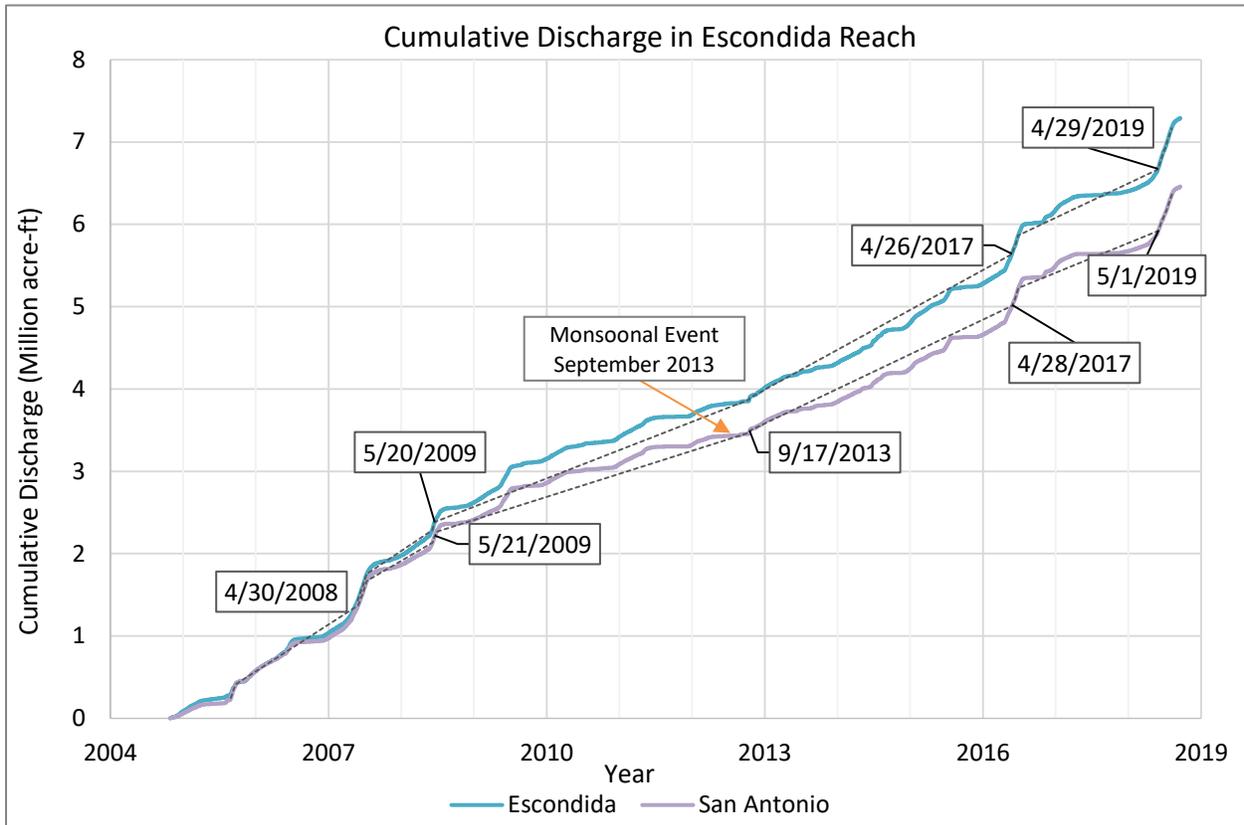
Figure 11 Discharge single mass curve at the Escondida and San Antonio gages (top) and San Acacia gage (bottom)

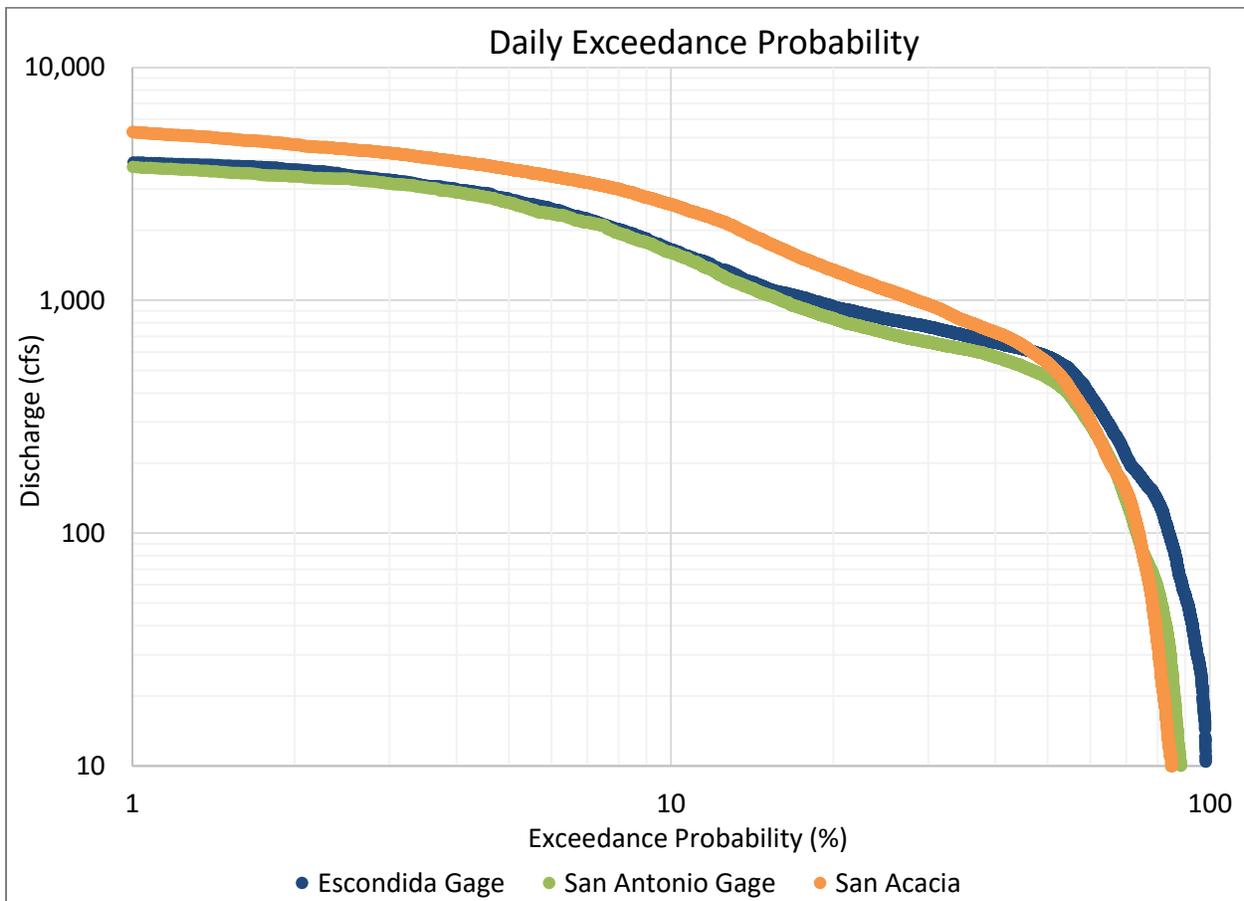
Figure 14 Comparison of flow duration curves. The Escondida and San Antonio Gage include data since the year 2005 and the San Acacia curve is based off of data post Cochiti Dam (1975).

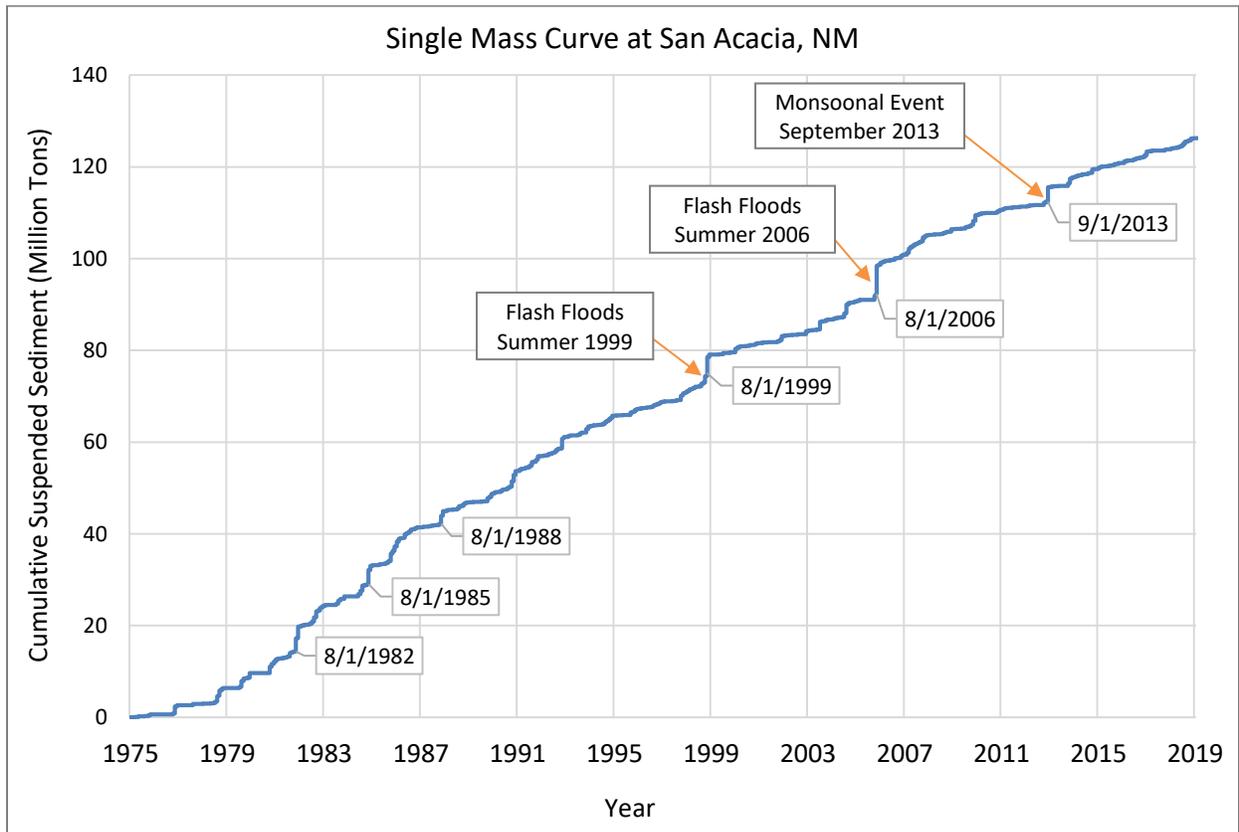
Figure 18 Suspended sediment discharge single mass curve for US 380 Bridge USGS gage Near San Antonio, NM (top) and Rio Grande Floodway at San Acacia, NM (bottom)

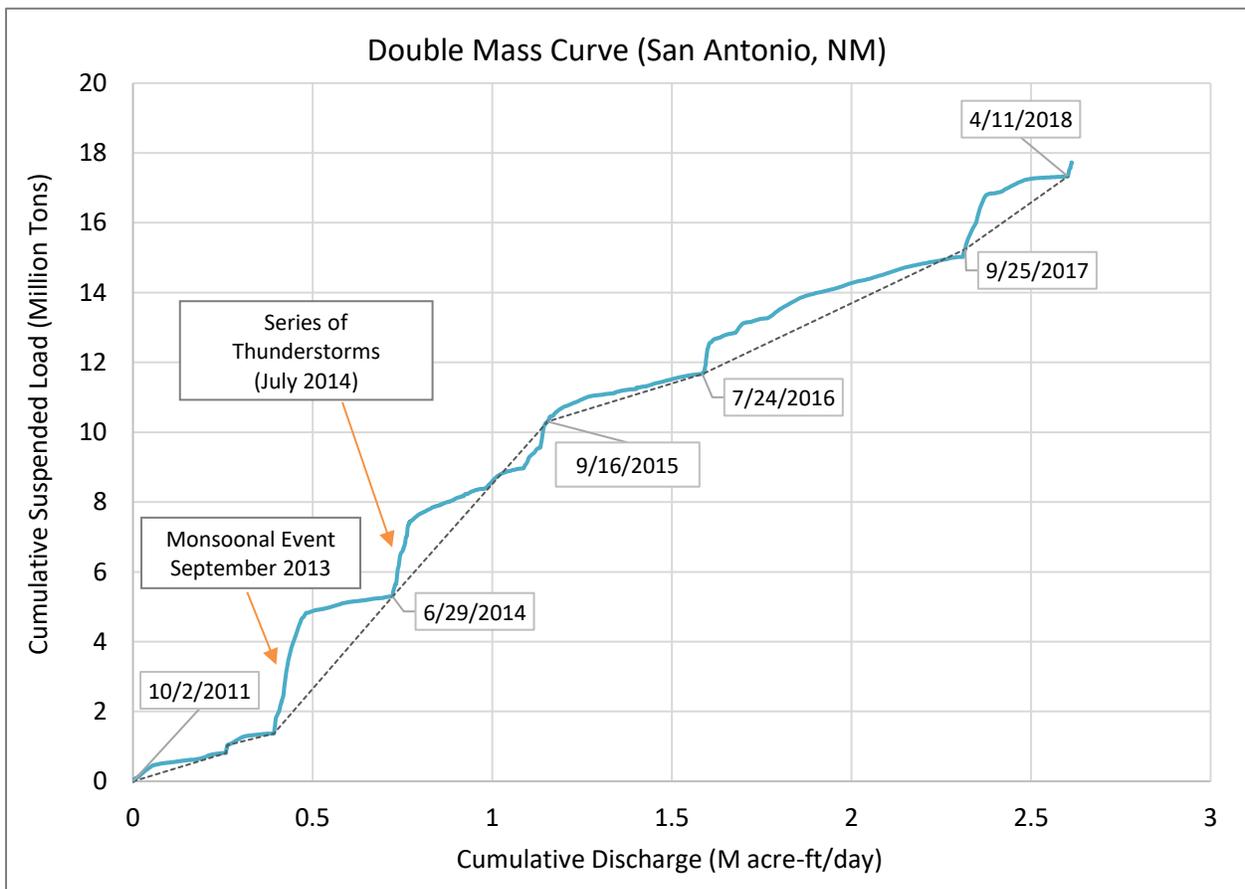
Figure 19 Double Mass Curve for the US HWY 380 Bridge Gage near San Antonio, NM

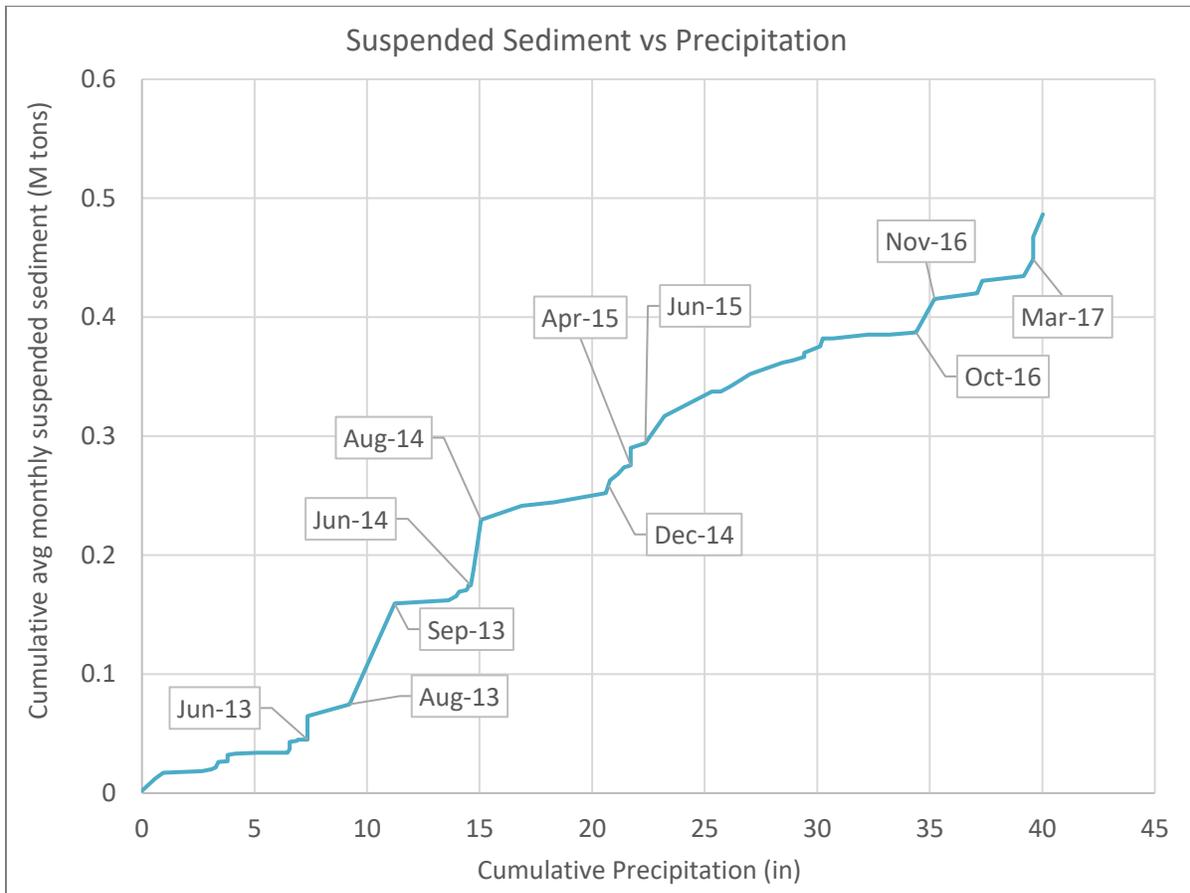
Figure 20 Cumulative suspended sediment (data from the US 380 gage at San Antonio, NM) versus cumulative precipitation at the Lemitar gage.

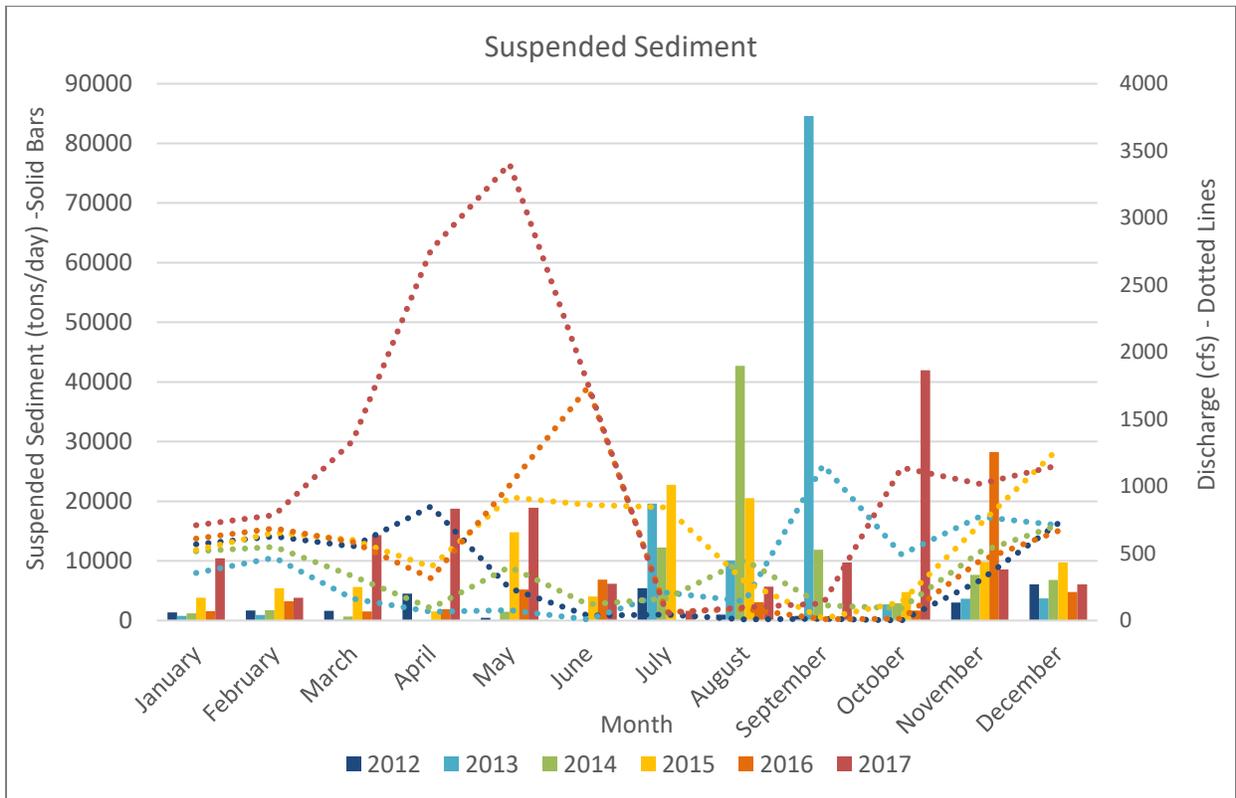
Figure 21 Monthly average suspended sediment and water discharge

A plot of monthly average discharge and suspended sediment was created for the San Antonio gage to help reveal any important seasonal trends. Figure 21 and Figure 22 show the seasonal trends of suspended sediment load and concentration, respectively, along with the discharges that correspond with the years. As seen previously, although the spring snowmelt brings some of the larger discharge volumes, the increased flows from the intense thunderstorms or monsoon seasons are what transport the most sediment. A SEMEP analysis of total sediment load in the MRG can be found in Appendix B.

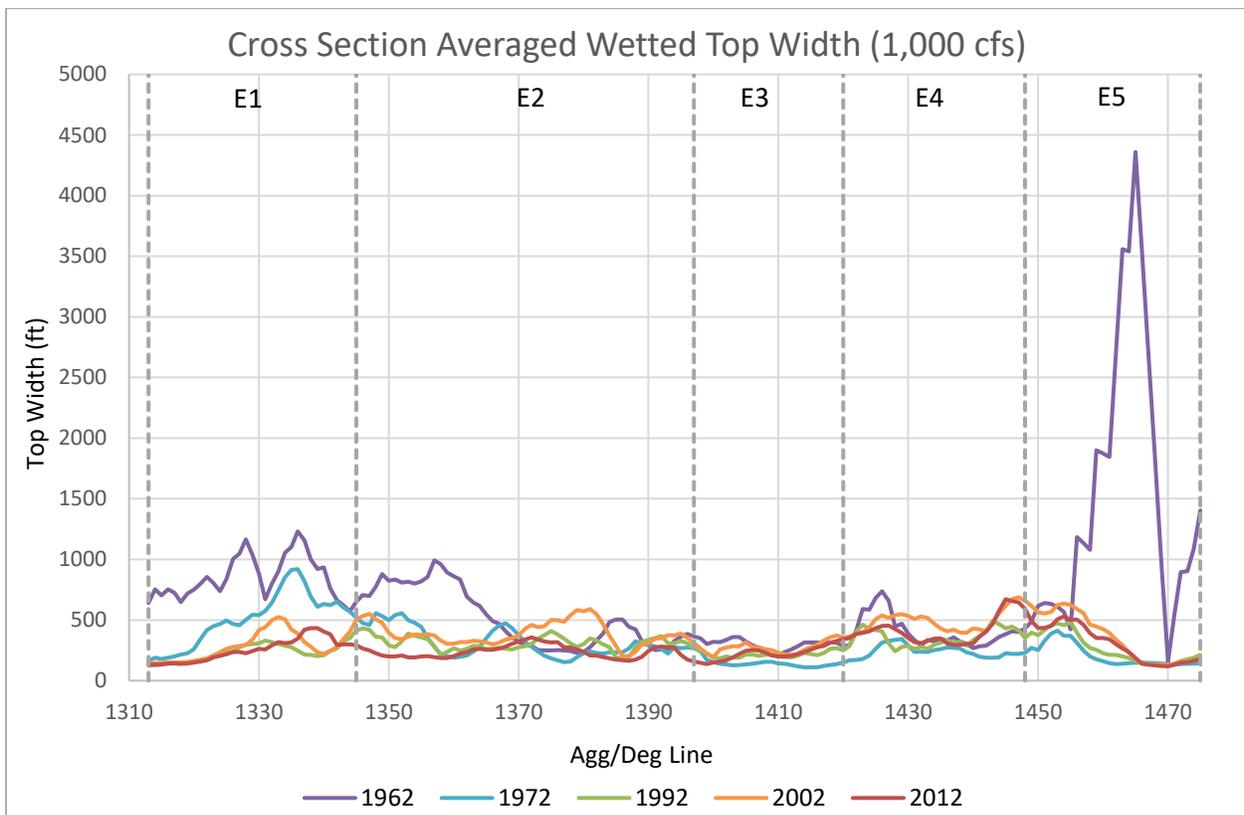
Figure 23 Moving cross sectional average of the wetted top width at a discharge 1,000 cfs

In 1962, subreach E5 has a much larger wetted top width than the other subreaches. This width comes from the perching of the channel. Water would quickly fill the channel in subreach E5 and spill out onto the floodplains. Because many of the cross sections are perched in this subreach, the width quickly increases to values between 3,500 feet to almost 5,000 feet. Degradation occurred in subreach E5 between the years 1962 and 1972, which resulted in fewer cross sections experiencing overbanking at these discharges, and therefore fewer cross sections having a large predicted top wetted width.

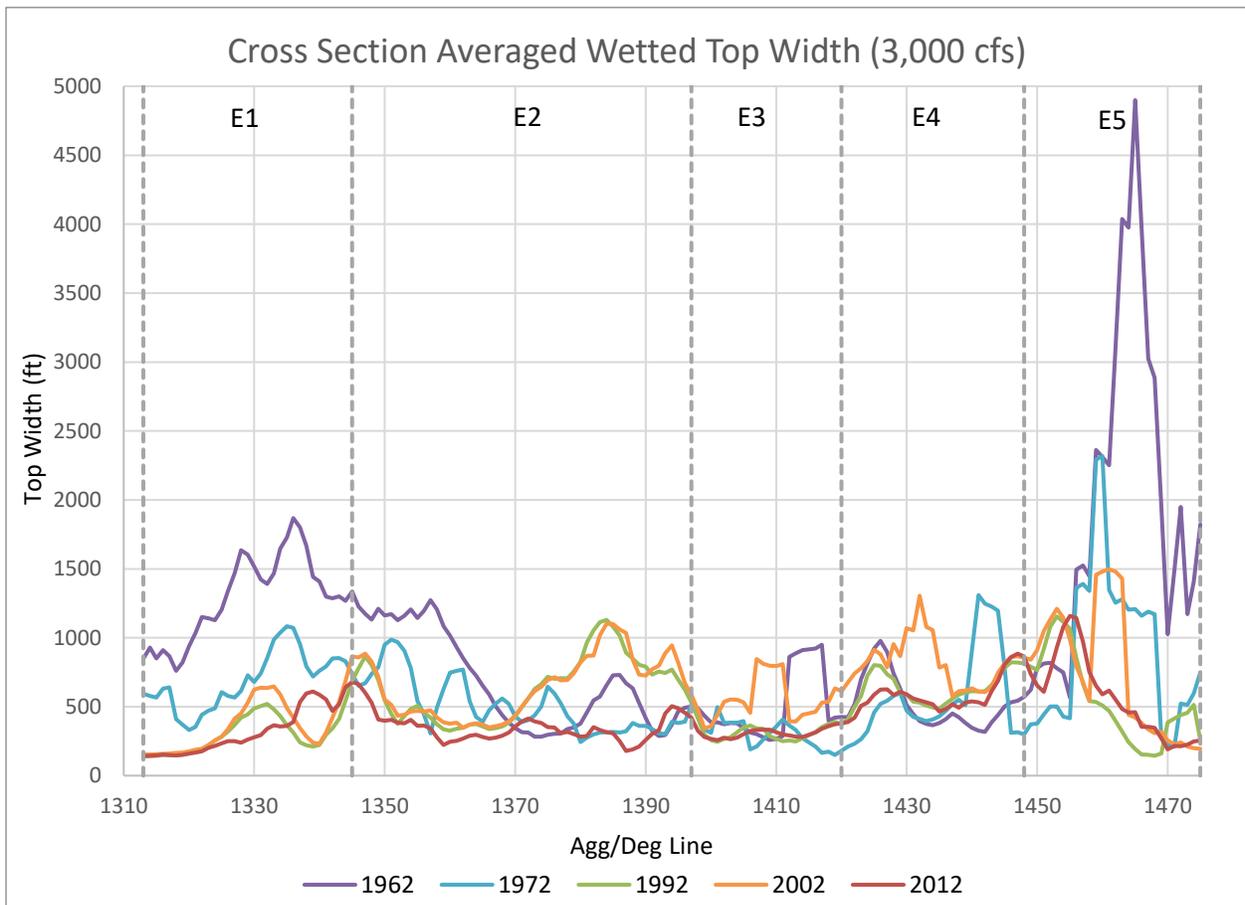
Figure 24 Moving cross sectional average of the wetted top width at a discharge 3,000 cfs

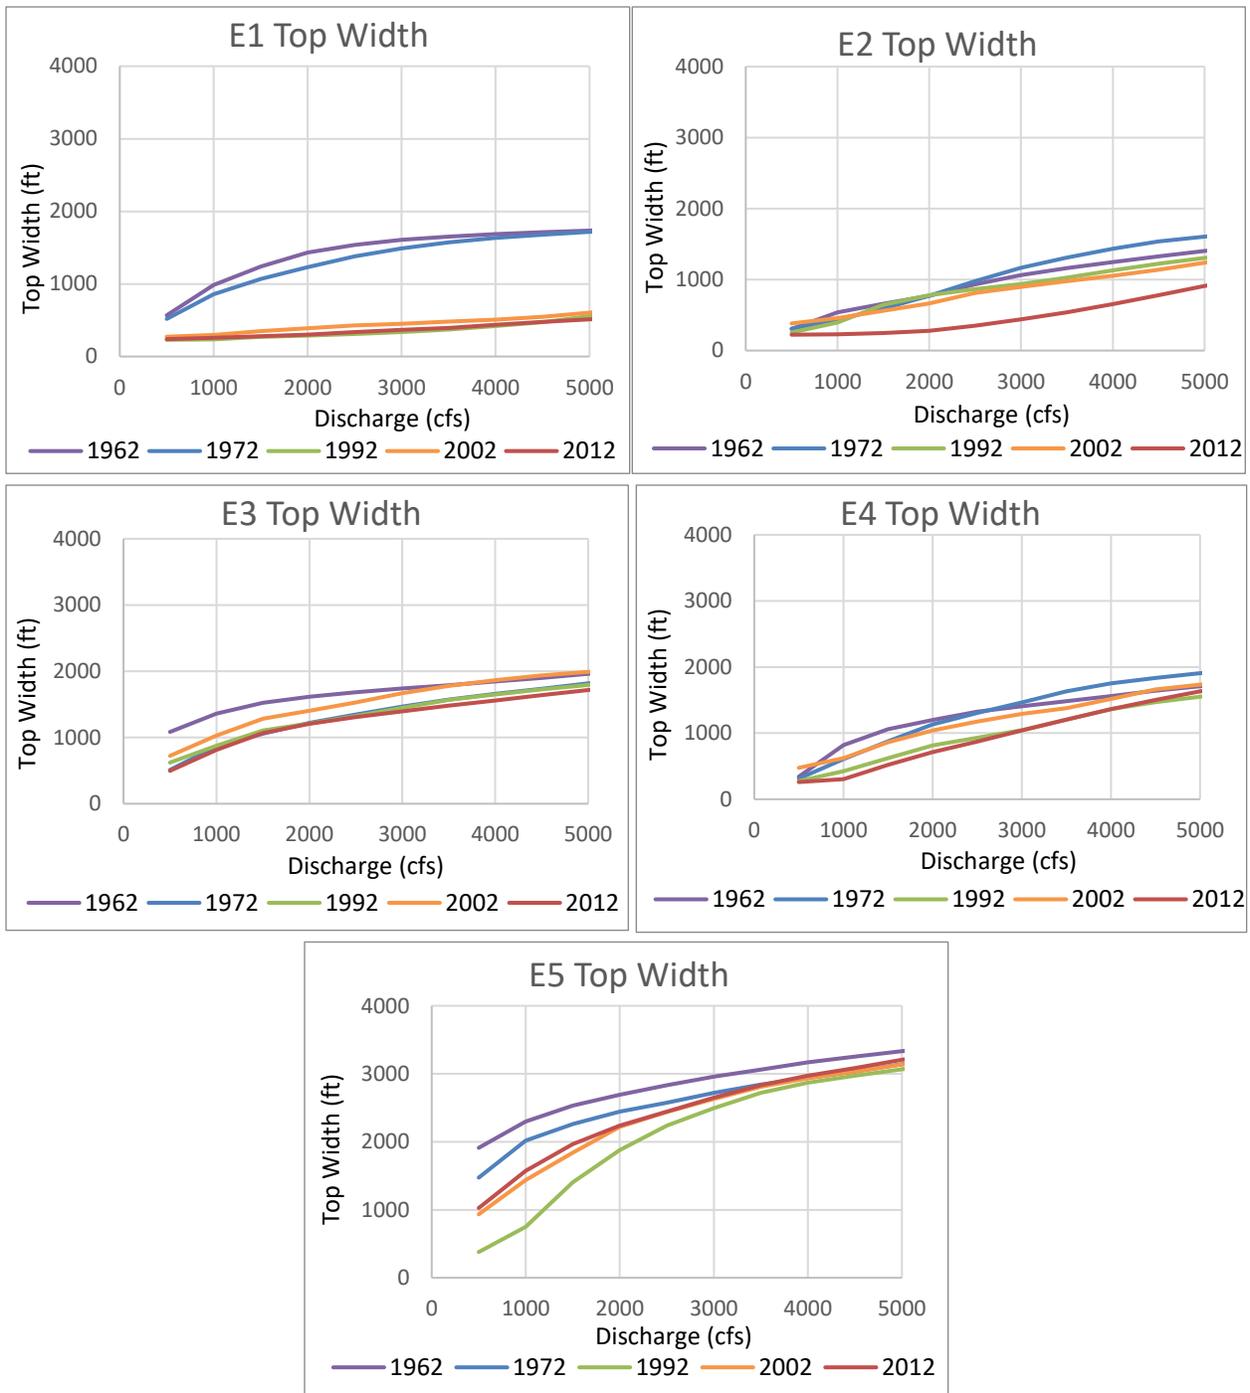
Figure 25 Average top width for E1 (top left), E2 (top right), E3 (middle left), E4 (middle right), and E5 (bottom) at discharges 500 to 5,000 cfs

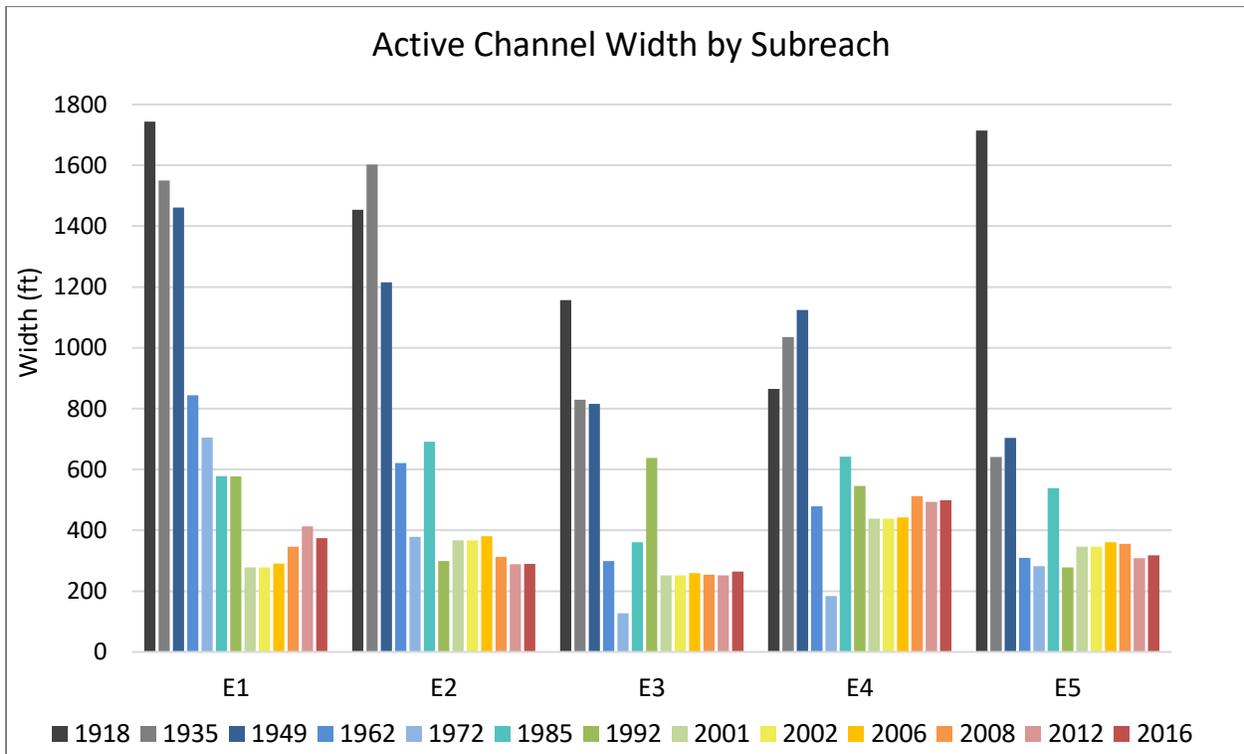
Figure 26 Averaged active channel width by subreach

The width of the active channel, defined as the non-vegetated channel, was found by clipping the agg/deg line to the width of the active channel polygon provided by the USBR's GIS and Remote Sensing Group. The widths of the active channel polygon were exported from ArcMap for each agg/deg line. Then the average width of each subreach was calculated by averaging the width of all agg/deg lines within the

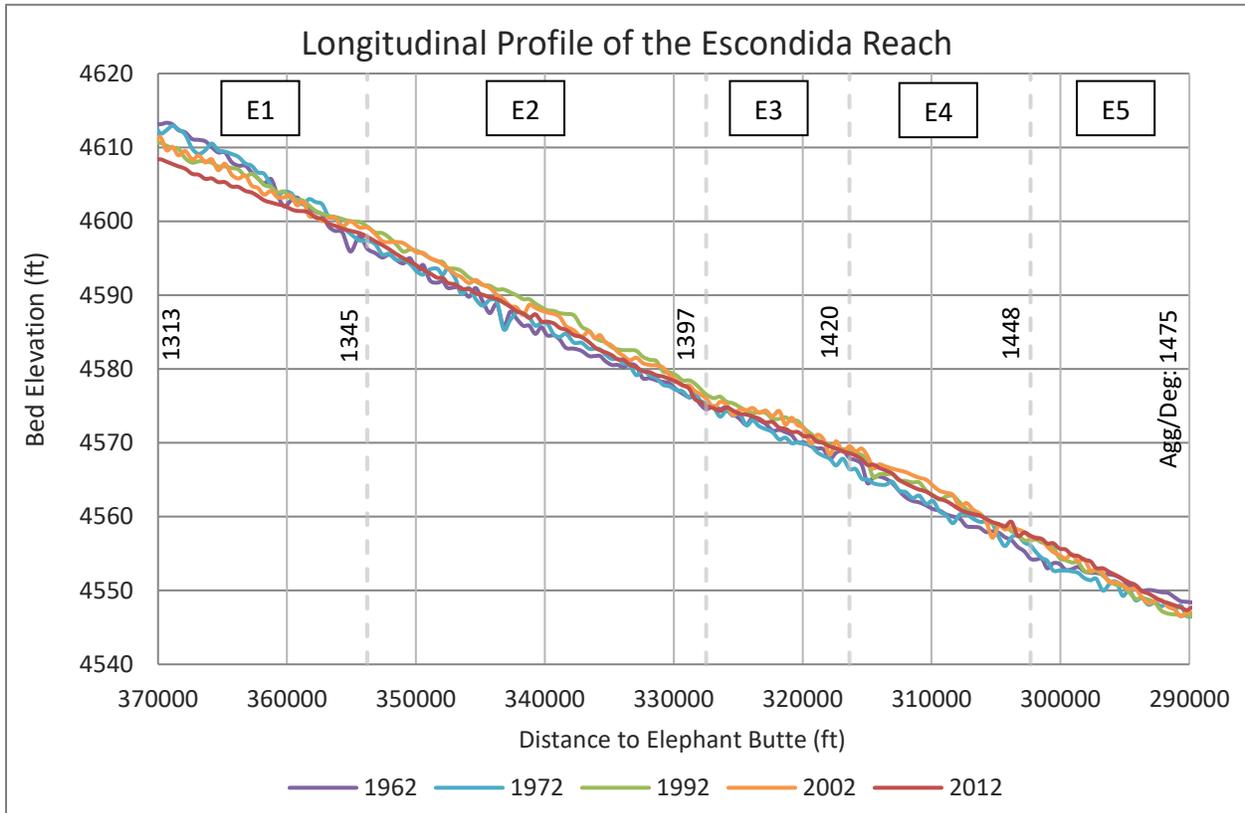
Figure 27 Longitudinal profiles of bed elevation

The Escondida reach is an interesting reach in that it contains a “pivot point” of where the MRG switches from a degrading channel to an aggrading channel. Upstream of the Escondida reach, sediment is being picked up and transported, leading to an incising river. Downstream of the Escondida reach, large amounts of sediment are being deposited leading to an aggrading bed and sediment plugs. The Escondida reach contains the section of river at which this transition occurs. At the upstream end of the reach, degradation has occurred as shown in Figure 27 and Figure 28 by the overall decrease in bed elevation from 1962 to 2012. However, further down the reach aggradation can be seen by the overall increase in bed elevation since 1962. From the earlier section on active channel width, the downstream end of the Escondida reach is stabilizing at a greater width than the upstream end of the reach. This could be because more sediment is being deposited at this location leading to a wider and shallower river.

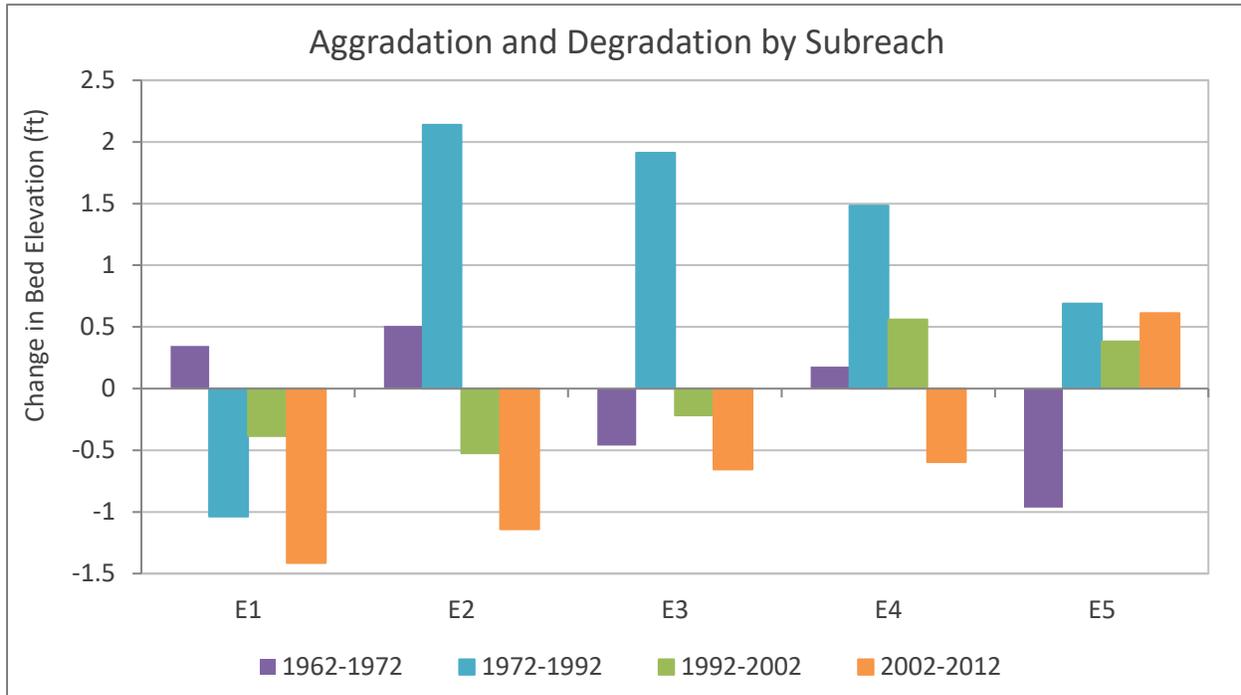
Figure 28 Degradation and Aggradation by subreach

Figure 28 shows the main channel aggradation and degradation of each subreach, which was found by first finding the average minimum channel elevation for each subreach and then subtracting the average bed elevation of the earlier year from the later year. A positive number indicates aggradation and a negative number indicates degradation. Subreach E1 has been degrading since approximately 1972 and subreach E5 has been aggrading since 1972, which supports the idea that Escondida contains an aggradation and degradation “pivot point” of the MRG. Figure 28 also shows that degradation may be

shifting downstream. In subreach E1, the channel has been degrading since the time interval spanning the years 1972 to 1992. In subreach E2, the degradation began between 1992 and 2002. The channel has also been degrading in subreach E3 since 1992 to 2002, it is possible that since there has been less degradation, it began within that time interval closer to the year 2002. In subreach E4, degradation began most recently, between the years 2002 and 2012.

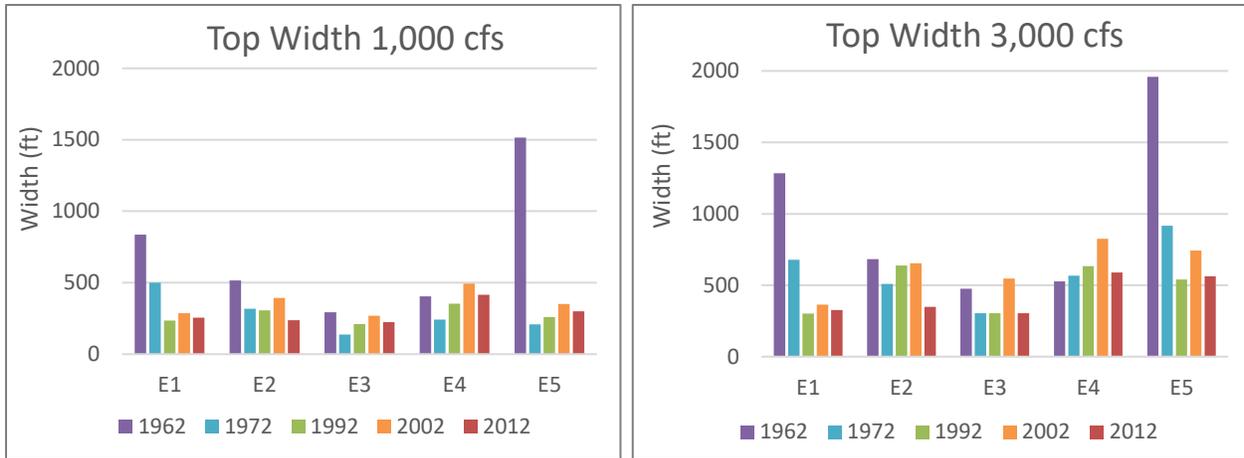
Figure 31 HEC-RAS Wetted top width of channel at 1,000 cfs (left) and 3,000 cfs (right)

Flow depth, velocity, width, wetted perimeter of the main channel, and bed slope are obtained using HEC-RAS 5.0.3 with a discharge of 3,000 cfs, which was selected based on the fact that this discharge represents bankfull conditions with limited likelihood of overbanking (LaForge et al., 2019 and Yang et al., 2019). A discharge of 3,000 cfs has a daily exceedance of 4.6% at the upstream end of the Escondida reach. Therefore, the same hydraulic geometry variables were analyzed for a discharge more commonly seen in this reach: 1,000 cfs, which has a daily exceedance of about 16%. For the plots of the hydraulic geometry variables, the values were averaged by subreach.

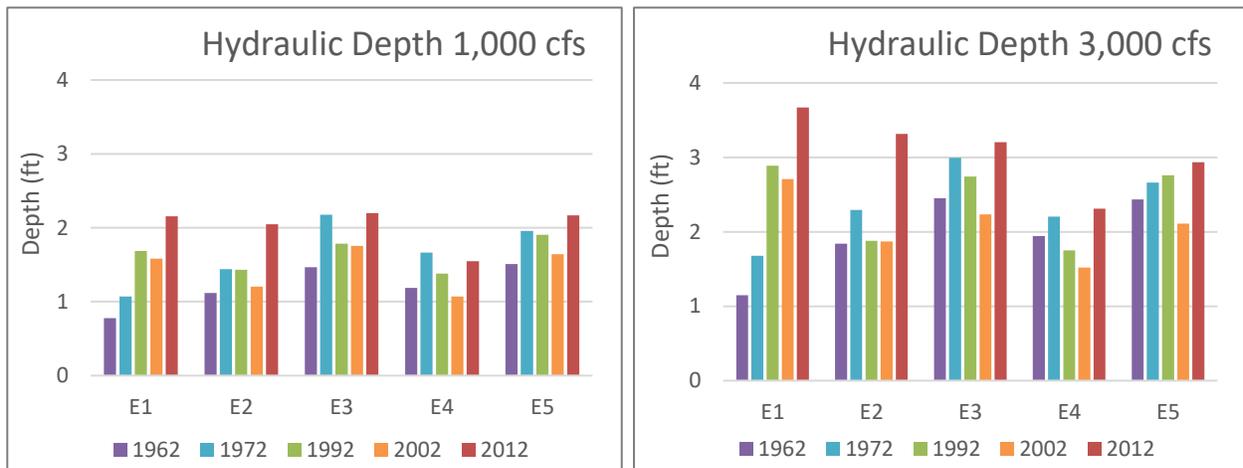
Figure 32 HEC-RAS Hydraulic depth at 1,000 cfs (left) and 3,000 cfs (right)

Because the upstream end of the Escondida reach is narrowing and degrading, an increase in flow depth would be expected. Figure 32 shows the HEC-RAS calculated hydraulic depths at discharges of 1,000 cfs and 3,000 cfs. Subreaches E1 and E2 show the greatest increase in hydraulic depth between 1962 and 2012, whereas the end of the subreach shows fluctuations resulting in only a small change in hydraulic depth of 4-7 inches. Although the downstream end of the reach is aggrading, there was also narrowing since 1962 as seen in Figure 31, which accounts for the slight increase in hydraulic depth.

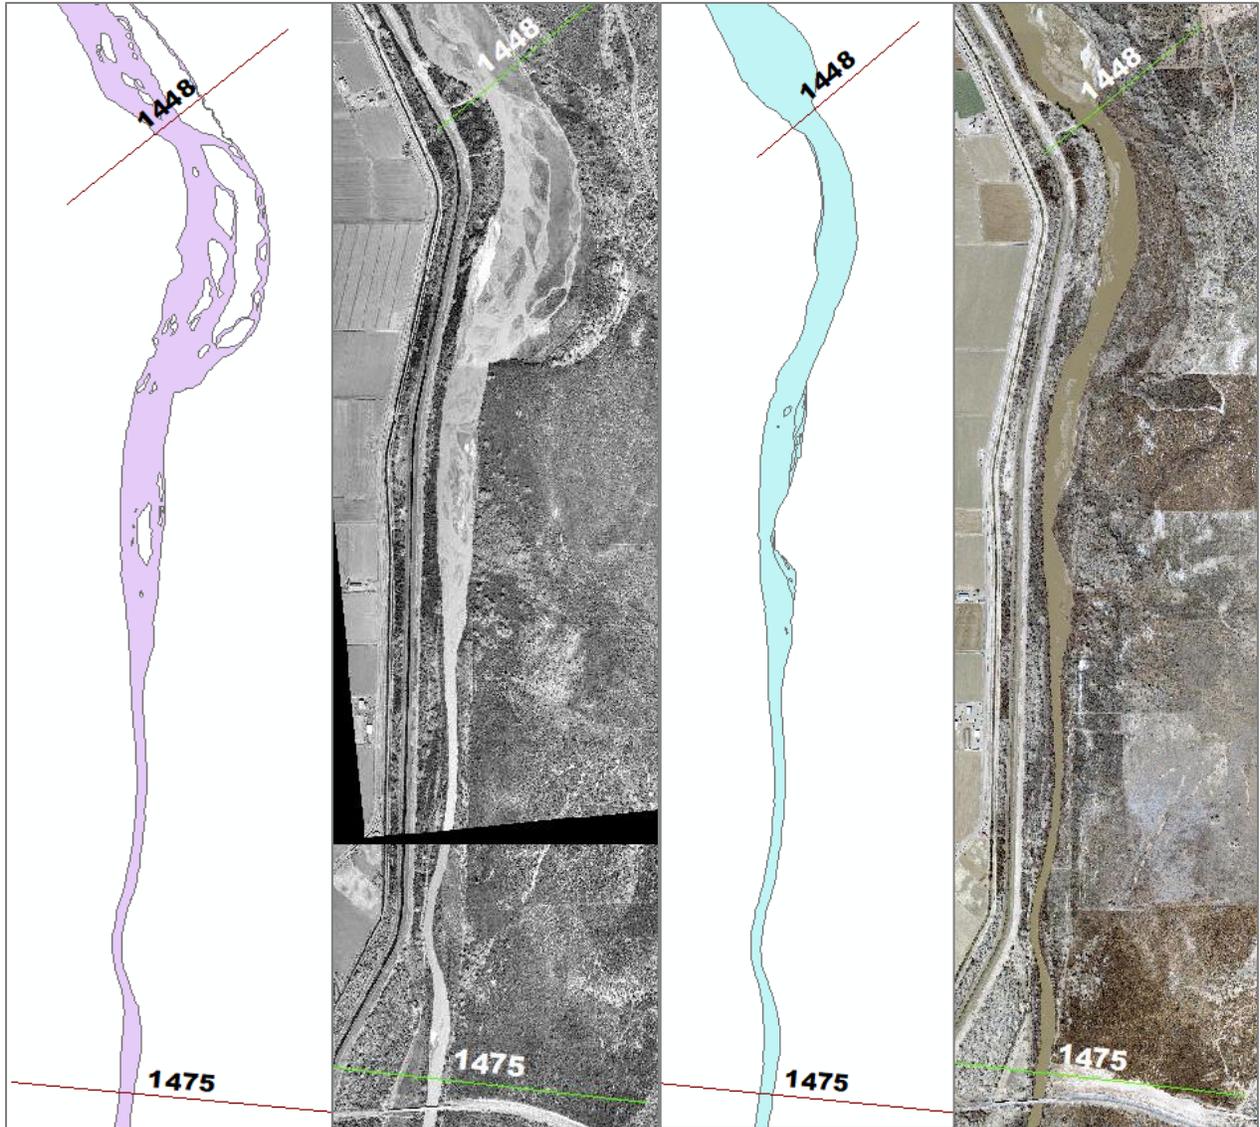
Figure 37 Digitized planform and aerial photograph of subreach E5 when multiple mid-channel bars and islands were present in 2002 (left) and in 2012 (right) after a reduction of mid-channel bars and islands.

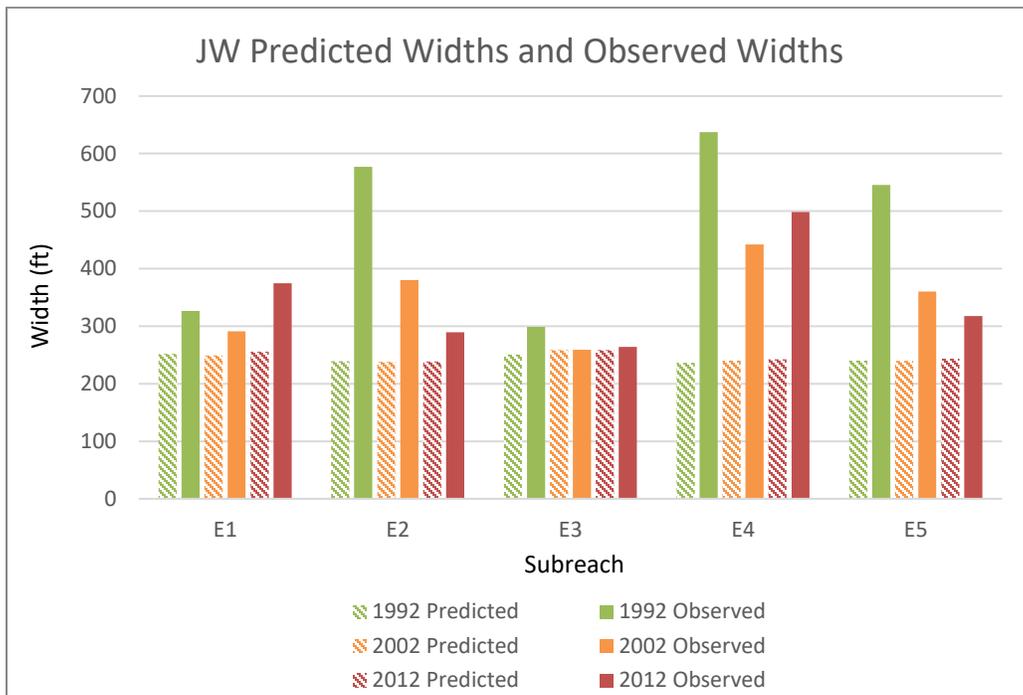
Figure 38 Julien and Wargadalam predicted widths and observed widths of the channel

Where $m = 1/\left[2.3 \log\left(\frac{2h}{D_s}\right)\right]$, h is the flow depth, W is the channel width, Q is the flow discharge, D_s is the median grain size, and S is the slope. A discharge of 3,000 cfs, the same discharge as in the previous HEC-RAS analysis, was used. The values for slope and grain size were obtained from 3.3 Bed Elevation and 3.4 Bed Material, respectively. The median D_{50} of the 1990s was used for 1992, median D_{50} of the 2000s for 2002 and median D_{50} of the 2010s for 2012. The results are compared to the observed active channel widths (from the GIS analysis of the digitized planforms) in Table 4 and plotted in Figure 38. The percent difference was calculated as:

The predicted widths are narrower than the observed widths for all subreaches but match very closely to the observed widths in subreach E3. The JW equations predict that the channel width for all subreaches will eventually narrow to around 240 to 260 feet. When calculating the predicted width of the river, the bankfull discharge was used when in reality, varying discharges would be occurring in the river. This could lead to the greater variability in the observed width values.
