Middle Rio Grande Escondida Reach:

Morpho-dynamic Processes and Silvery Minnow Habitat
from Escondida Bridge to US-380 Bridge
(1918-2018)

August 2020
Master of Science
Plan B Technical Report

Prepared by:
Tori Beckwith

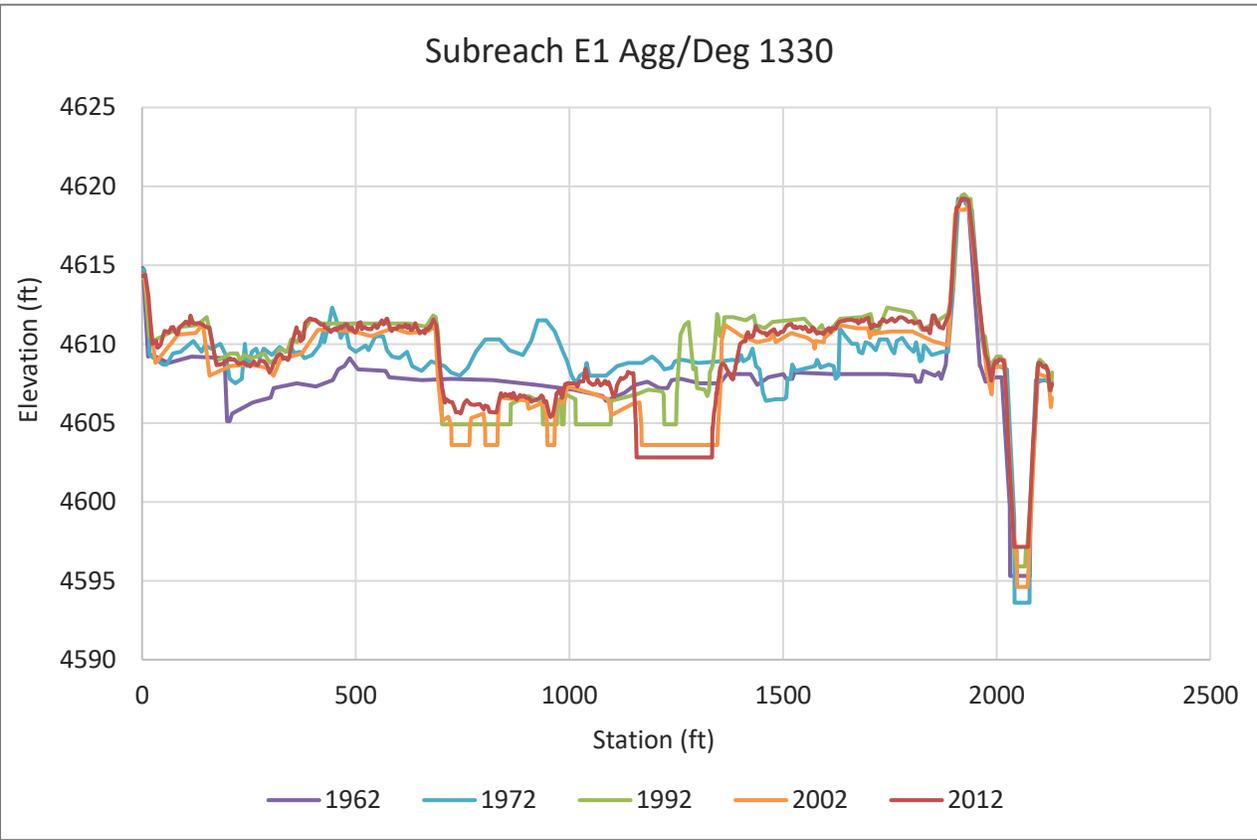
Figure 40 Channel evolution of a representative cross section from subreach E1

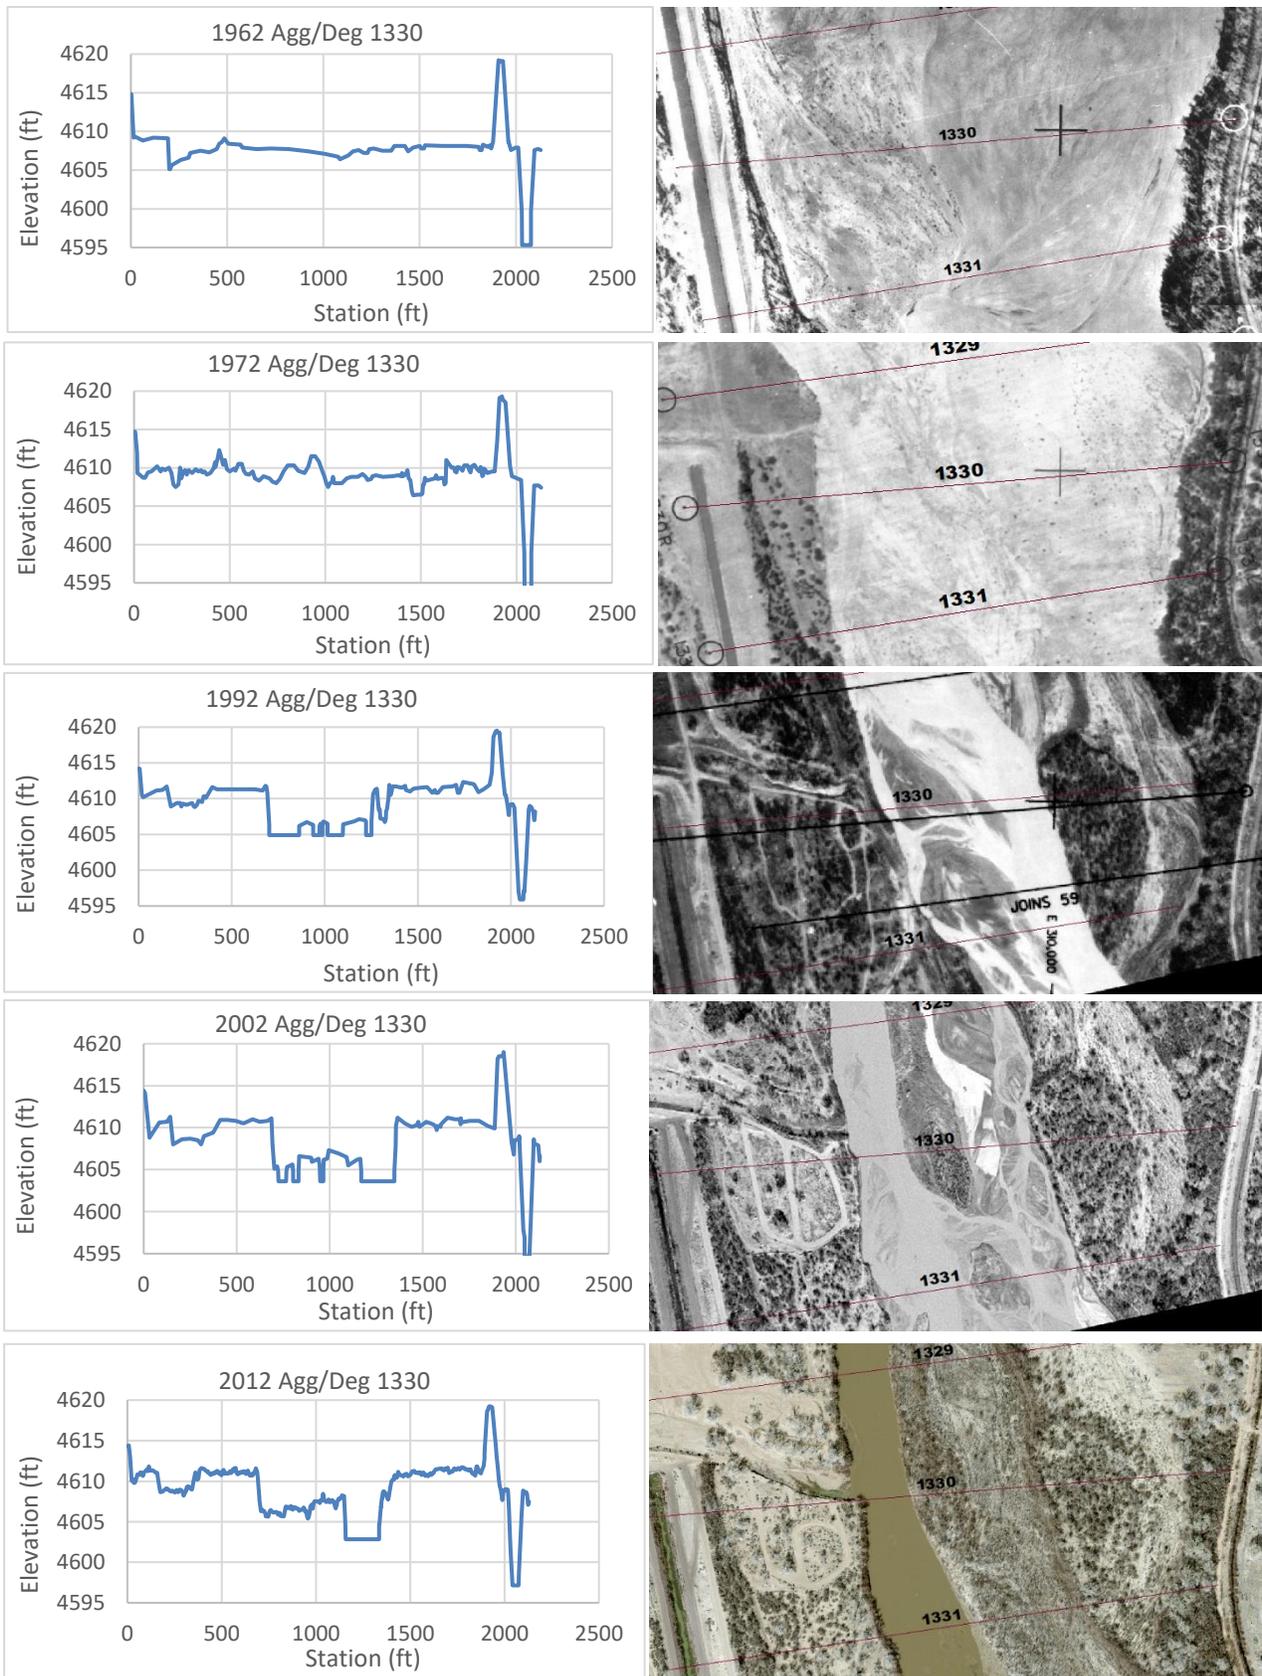
Figure 41 Subreach E1: historical cross section profiles and corresponding aerial images

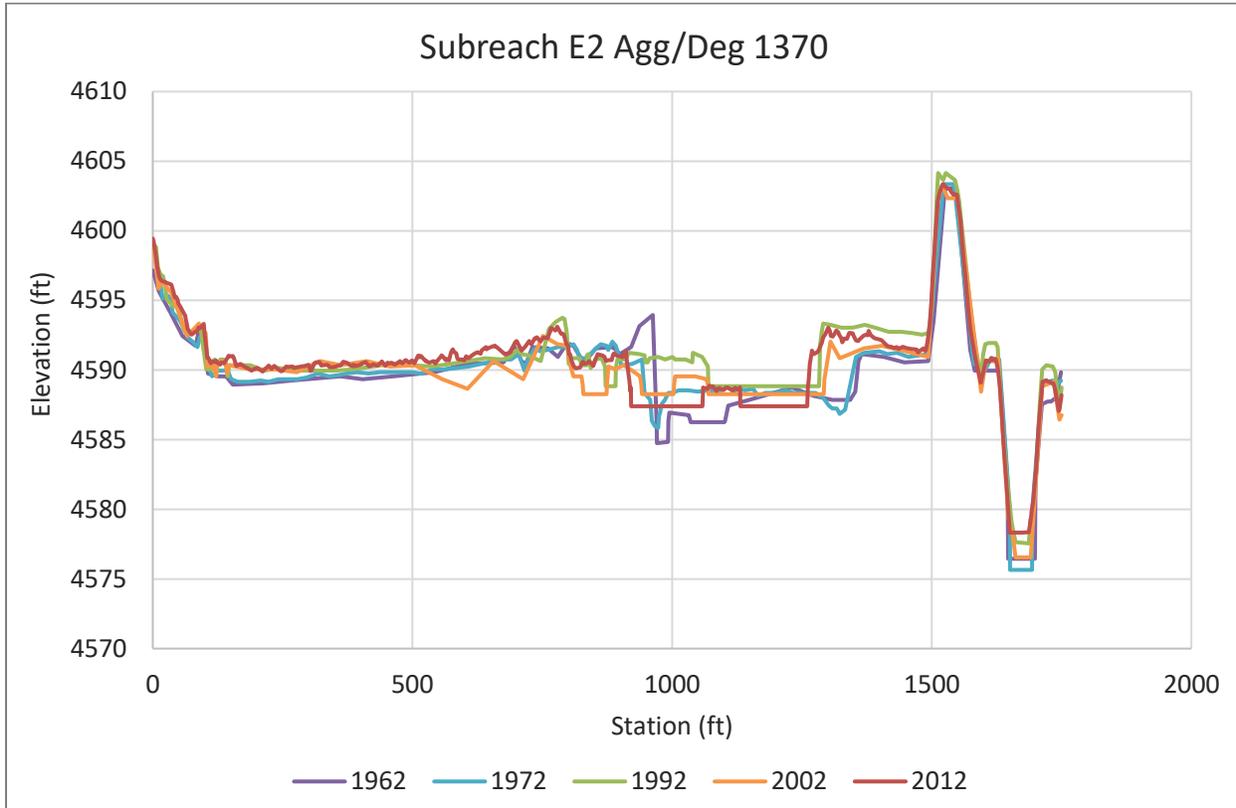
Figure 42 Channel evolution of a representative cross section from subreach E2

Subreach E2 appears to have a channel that is constantly shifting laterally but hasn't seen significant aggradation or degradation. Between 2002 and 2012, the channel did not migrate quite as much, but began to incise indicating it could be in the M4 stage, beginning to form a more dominant channel. The cross-section profile is shown in Figure 42 and a side by side view of the cross section and aerial imagery is shown in Figure 43.

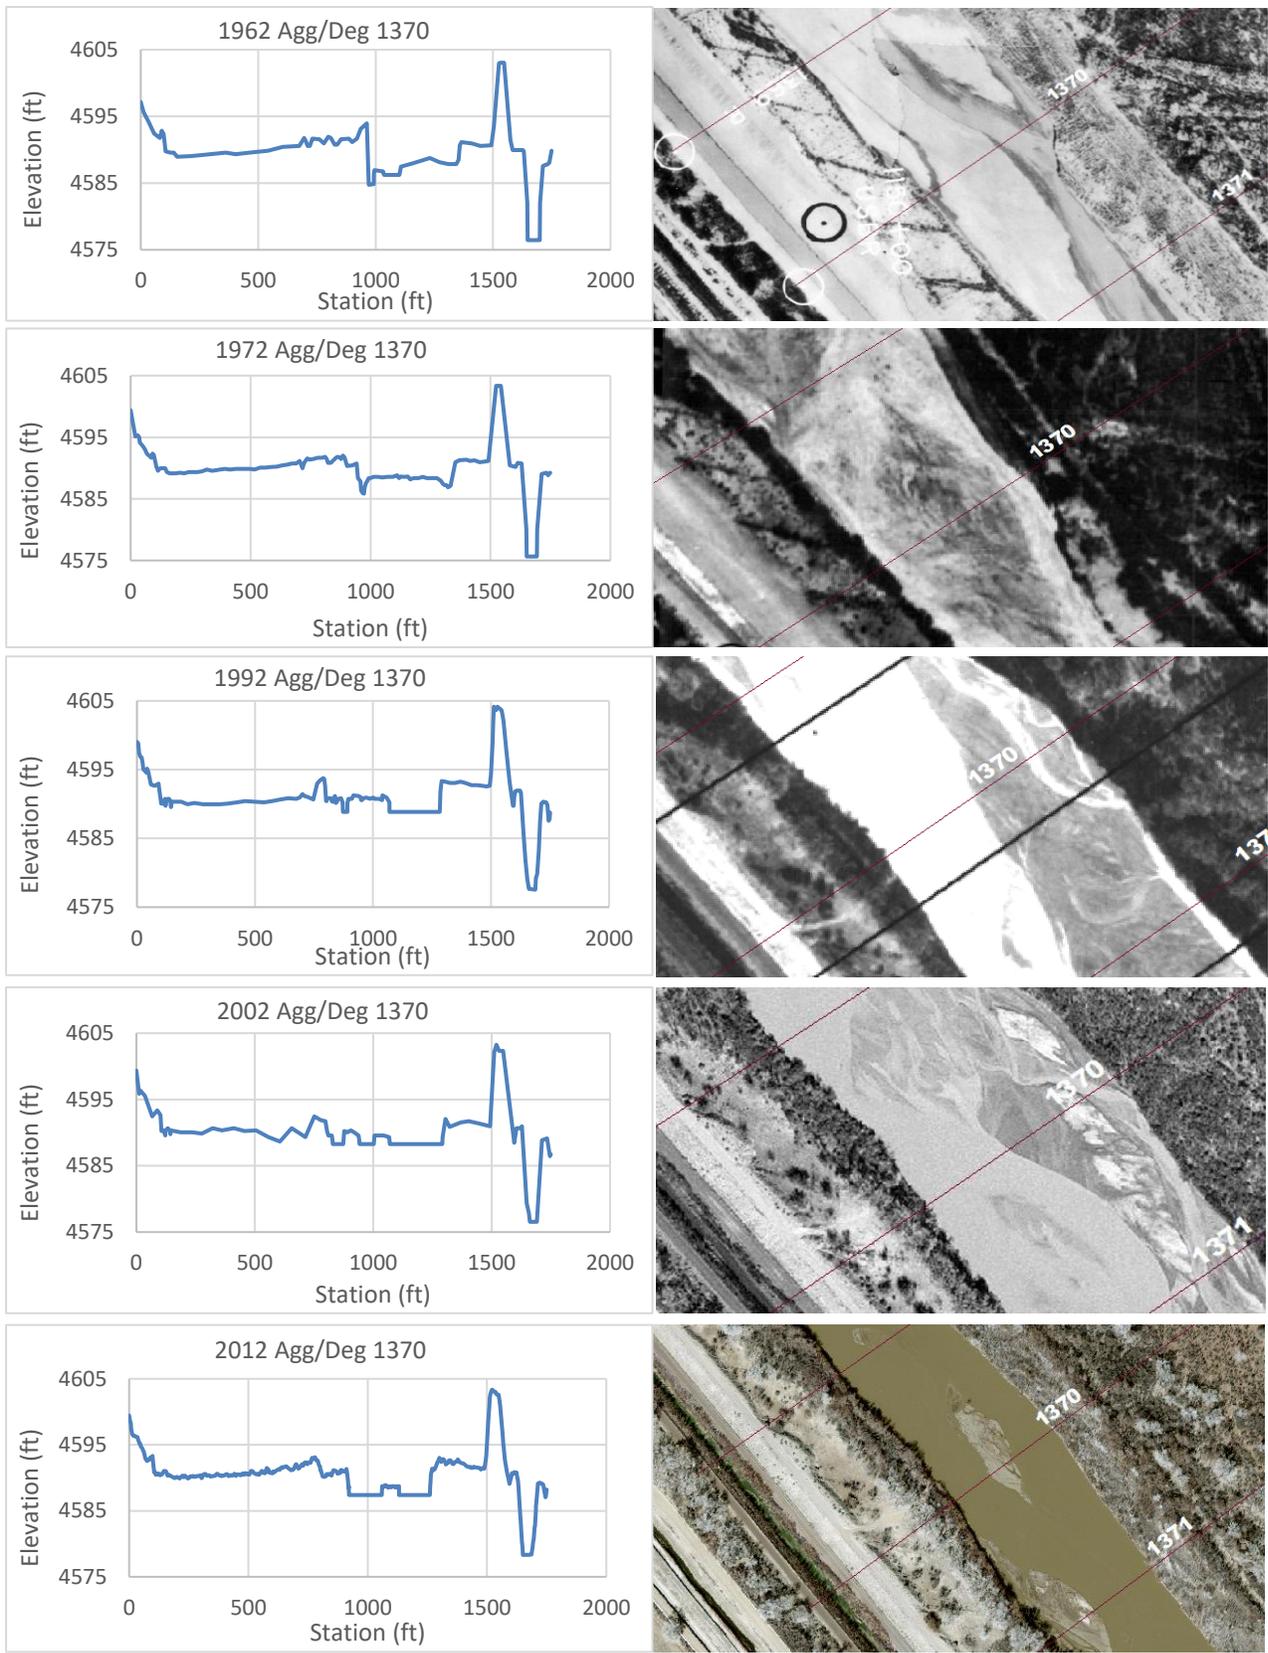
Figure 43 Subreach E2: historical cross section profiles and corresponding aerial images

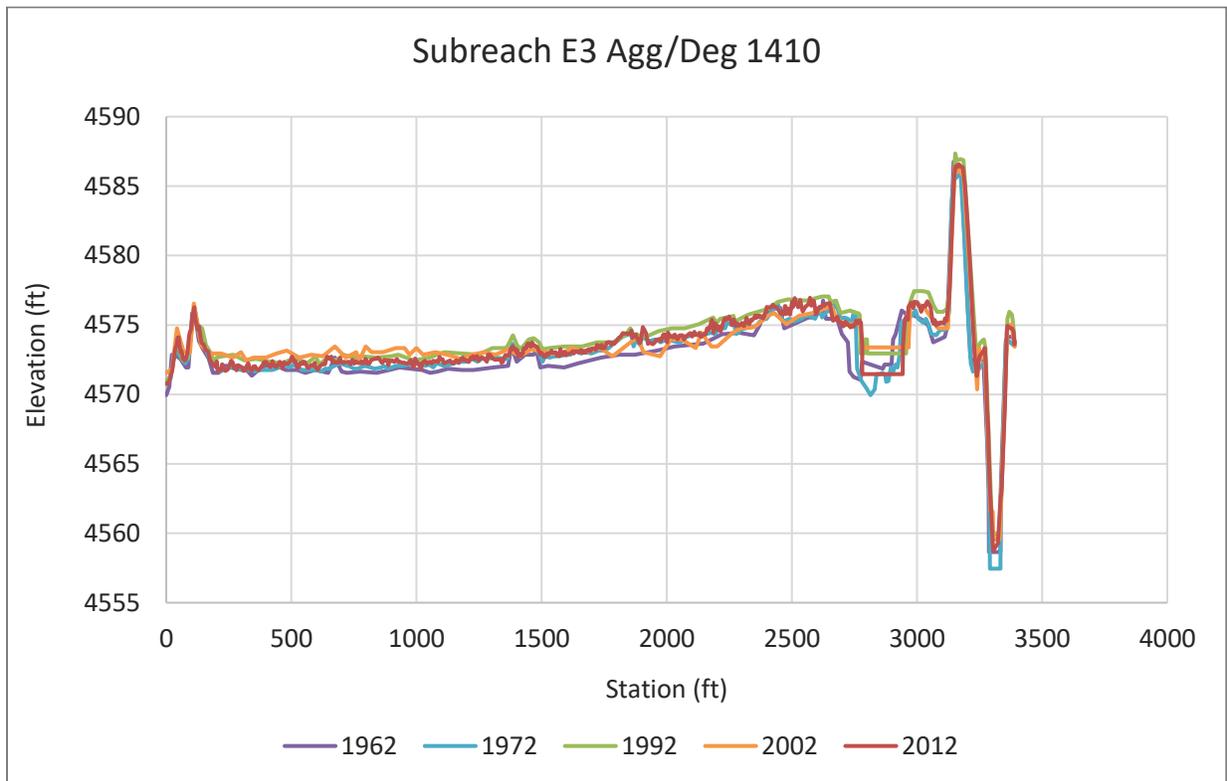
Figure 44 Channel evolution of a representative cross section from subreach E3

Subreach E3 appears to be in the M5 stage. Based on the evolution of the cross-section profile throughout the available years (Figure 44), the channel has not changed significantly between 1962 and 2012. There was aggradation that occurred leading up to 1992, but the channel has since degraded to a level like 1962. The channel remains single-threaded and the sinuosity has remained relatively constant between 1918 and 2016 based off of the GIS analysis performed, further indicating that the subreach may be in the M5 stage. Although the channel may be in the migrating stages now, the perched cross sections within subreach E3 indicate that the channel was aggrading at one point. This highlights that the subreach can transition between migrating and aggrading stages depending on the hydrology and sediment trends. Figure 45 shows the cross-section profile for the various years along with a corresponding aerial image of the river.

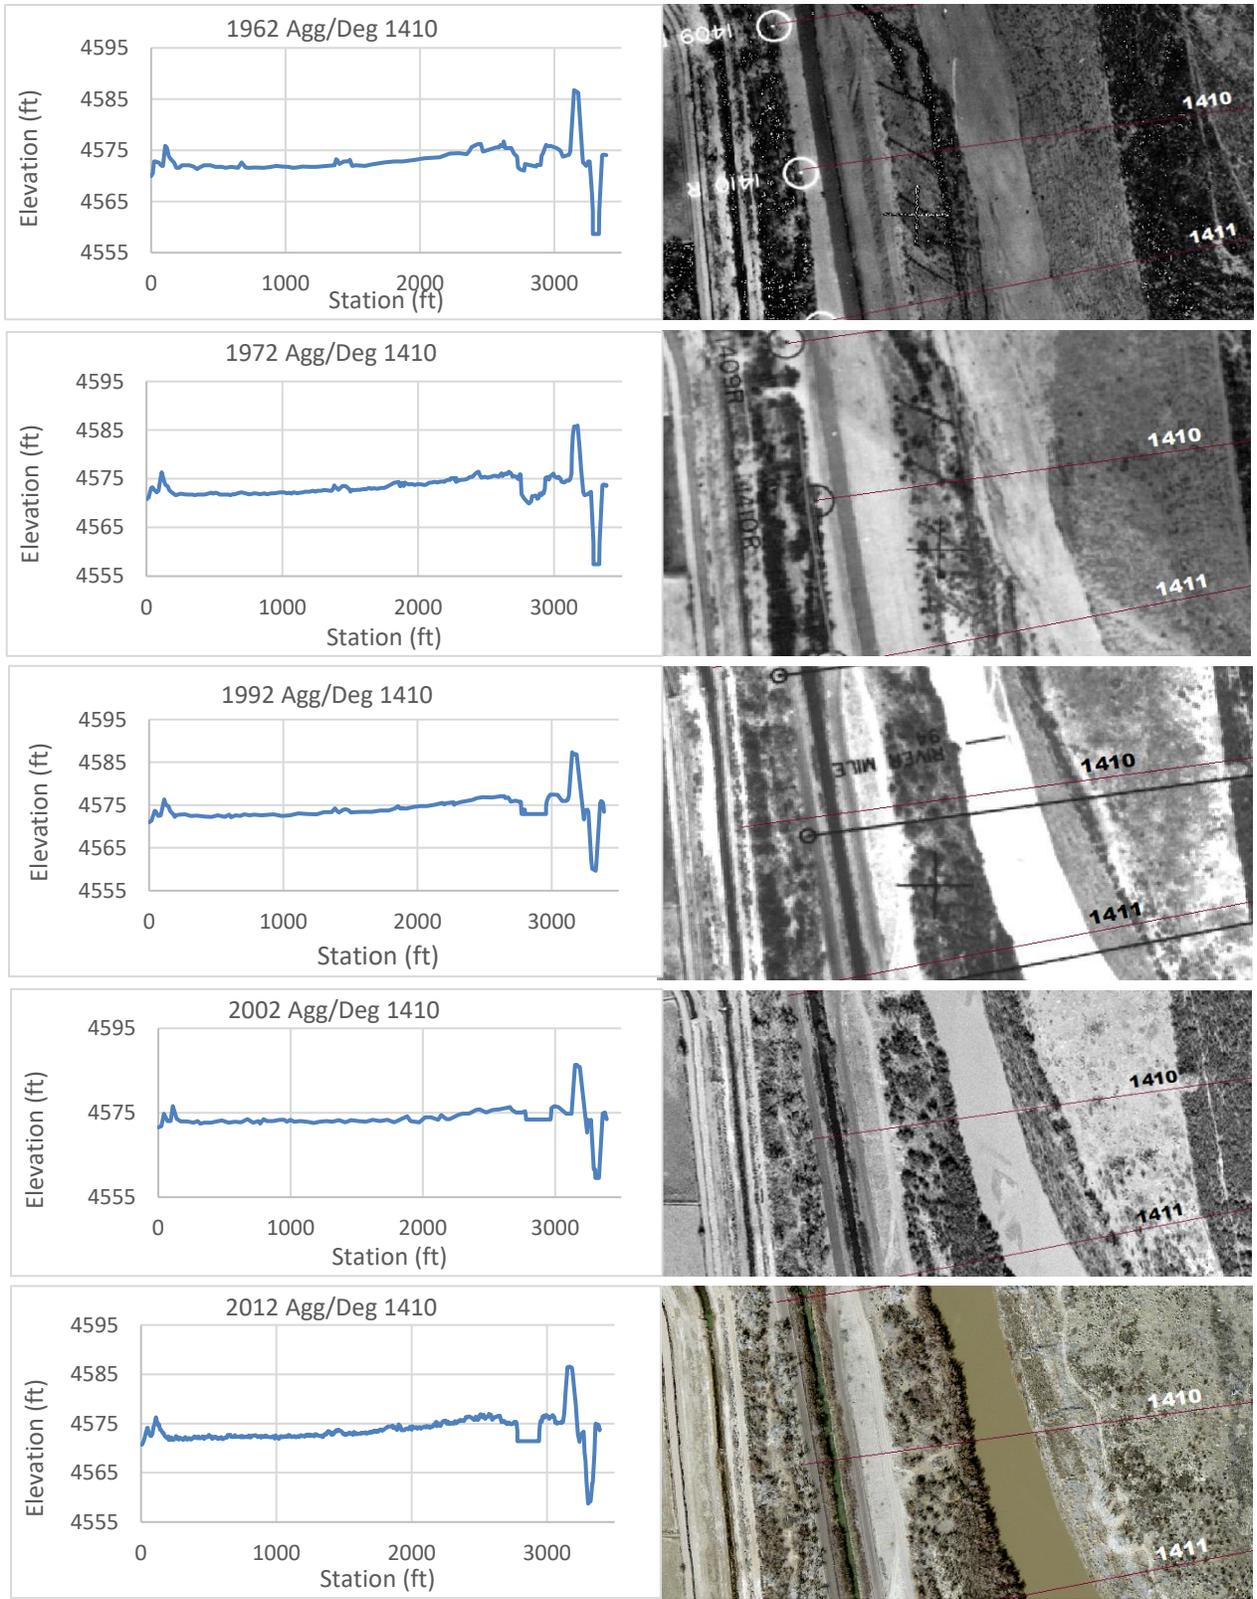
Figure 45 Subreach E3: historical cross section profiles and corresponding aerial images

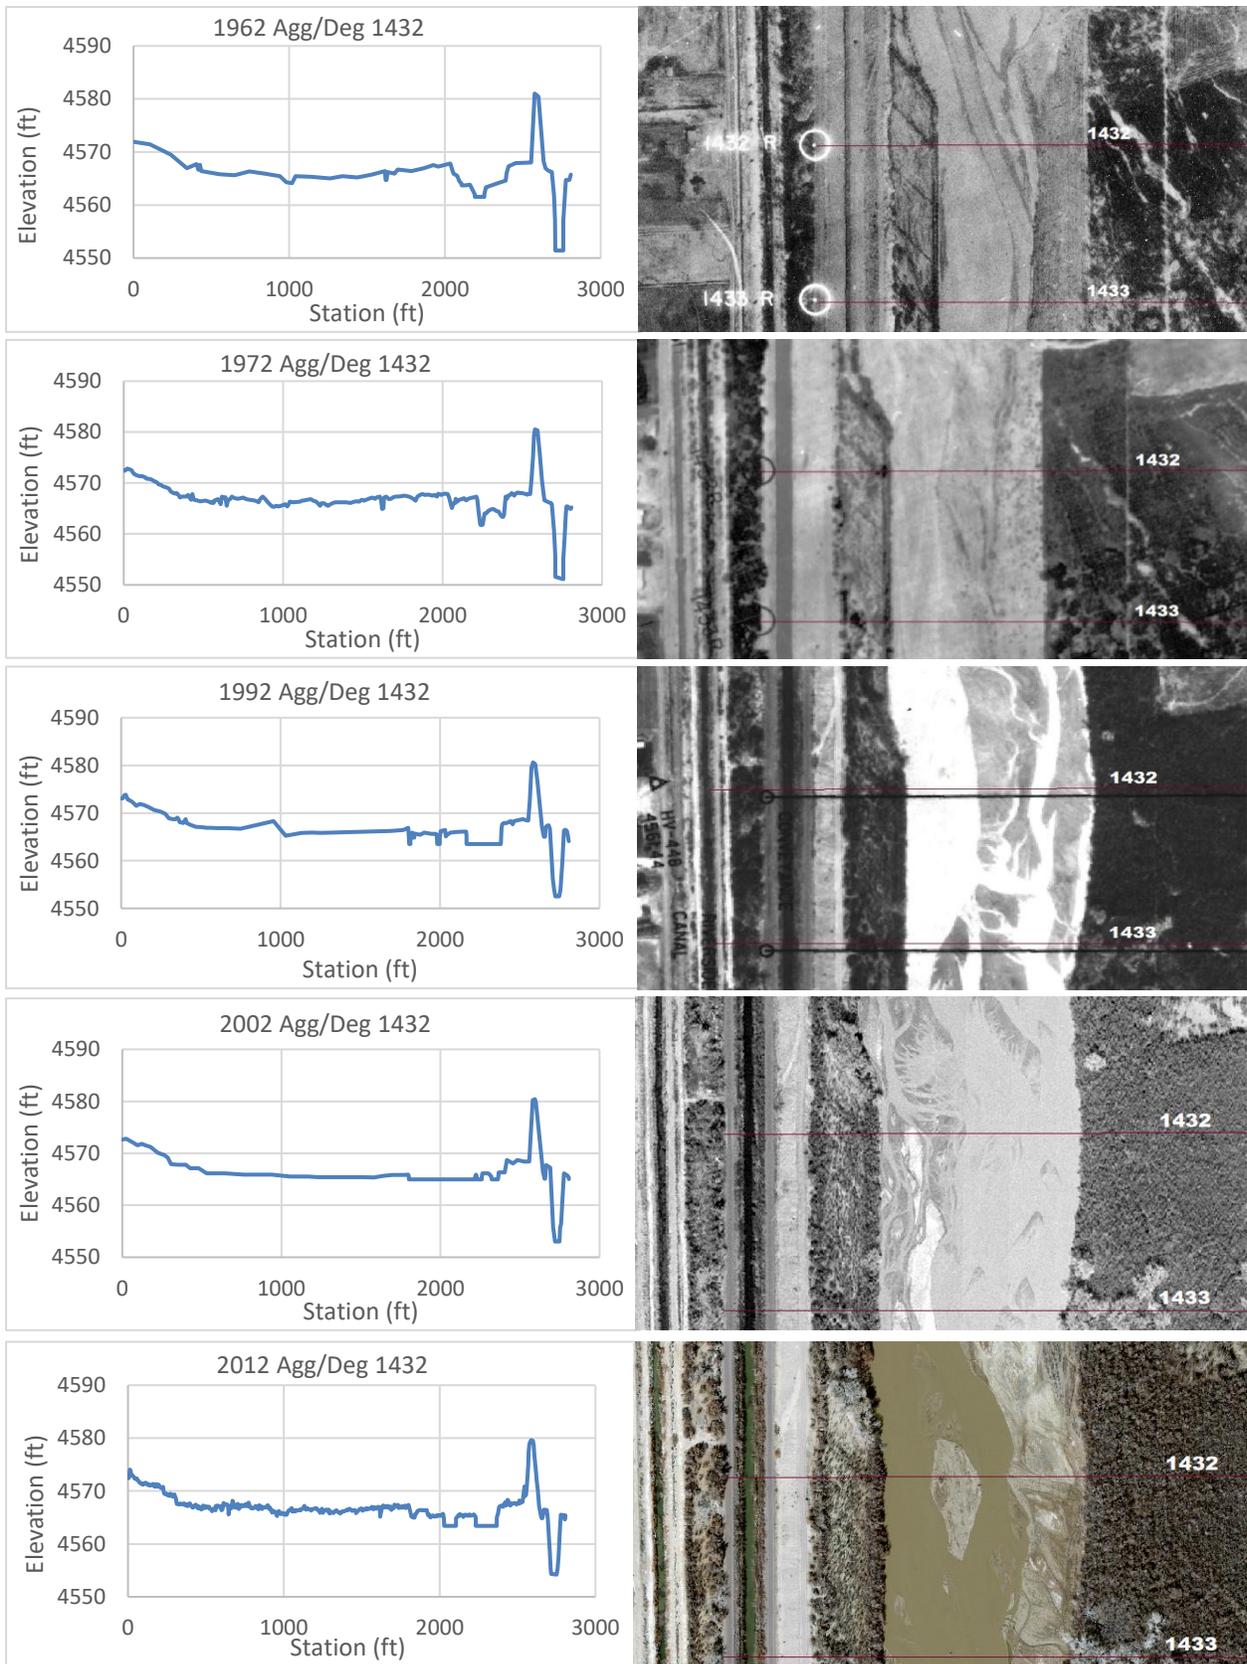
Figure 47 Subreach E4: historical cross section profiles and corresponding aerial images

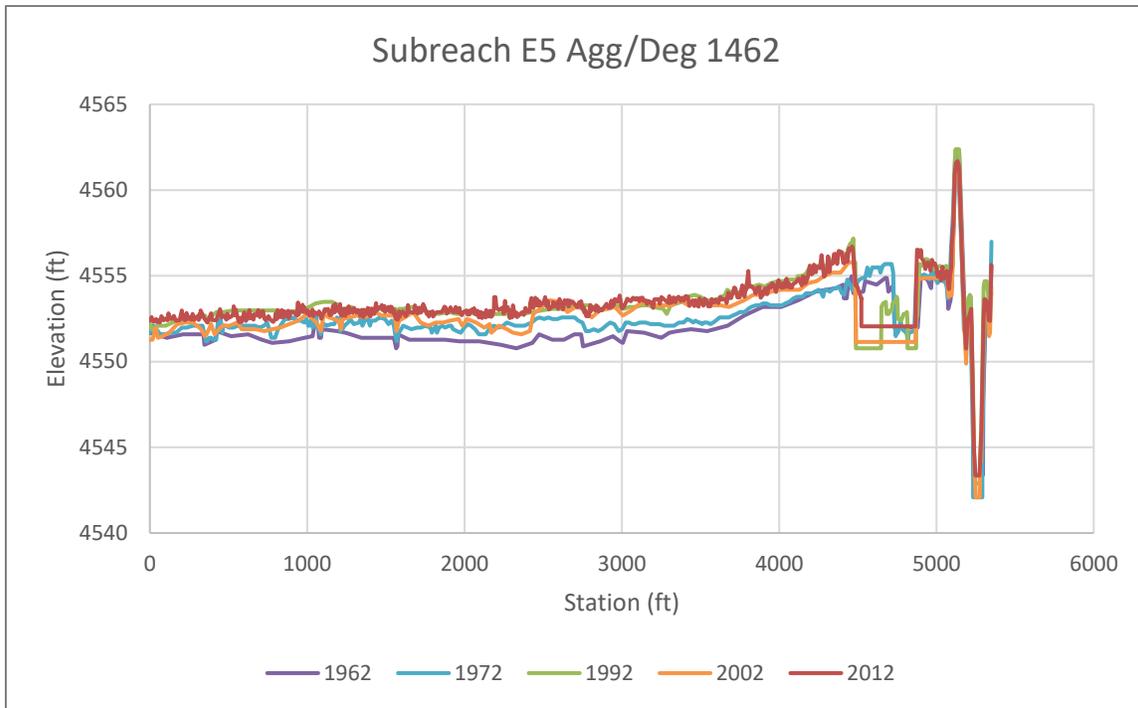
Figure 48 Channel evolution of a representative cross section of subreach E5

Subreach E5 is characteristic of having a perched channel for many of the cross sections. This subreach is at the downstream end of the reach, past the “pivot point” of degradation and aggradation. As seen in Figure 48 and Figure 49, the main channel has widened and aggraded from 1962 and 2012. Between 2002 and 2012, the sediment load has exceeded the transport capacity, so sediment is deposited in the channel while the width has remained nearly constant leading to a decrease in channel area. This subreach would be classified as an aggrading reach, A4. At a moderate flow, the water would overtop the banks and spill into the floodplains. While the subreach is aggrading, the aggradation rate has not increased enough to result in a sediment plug.

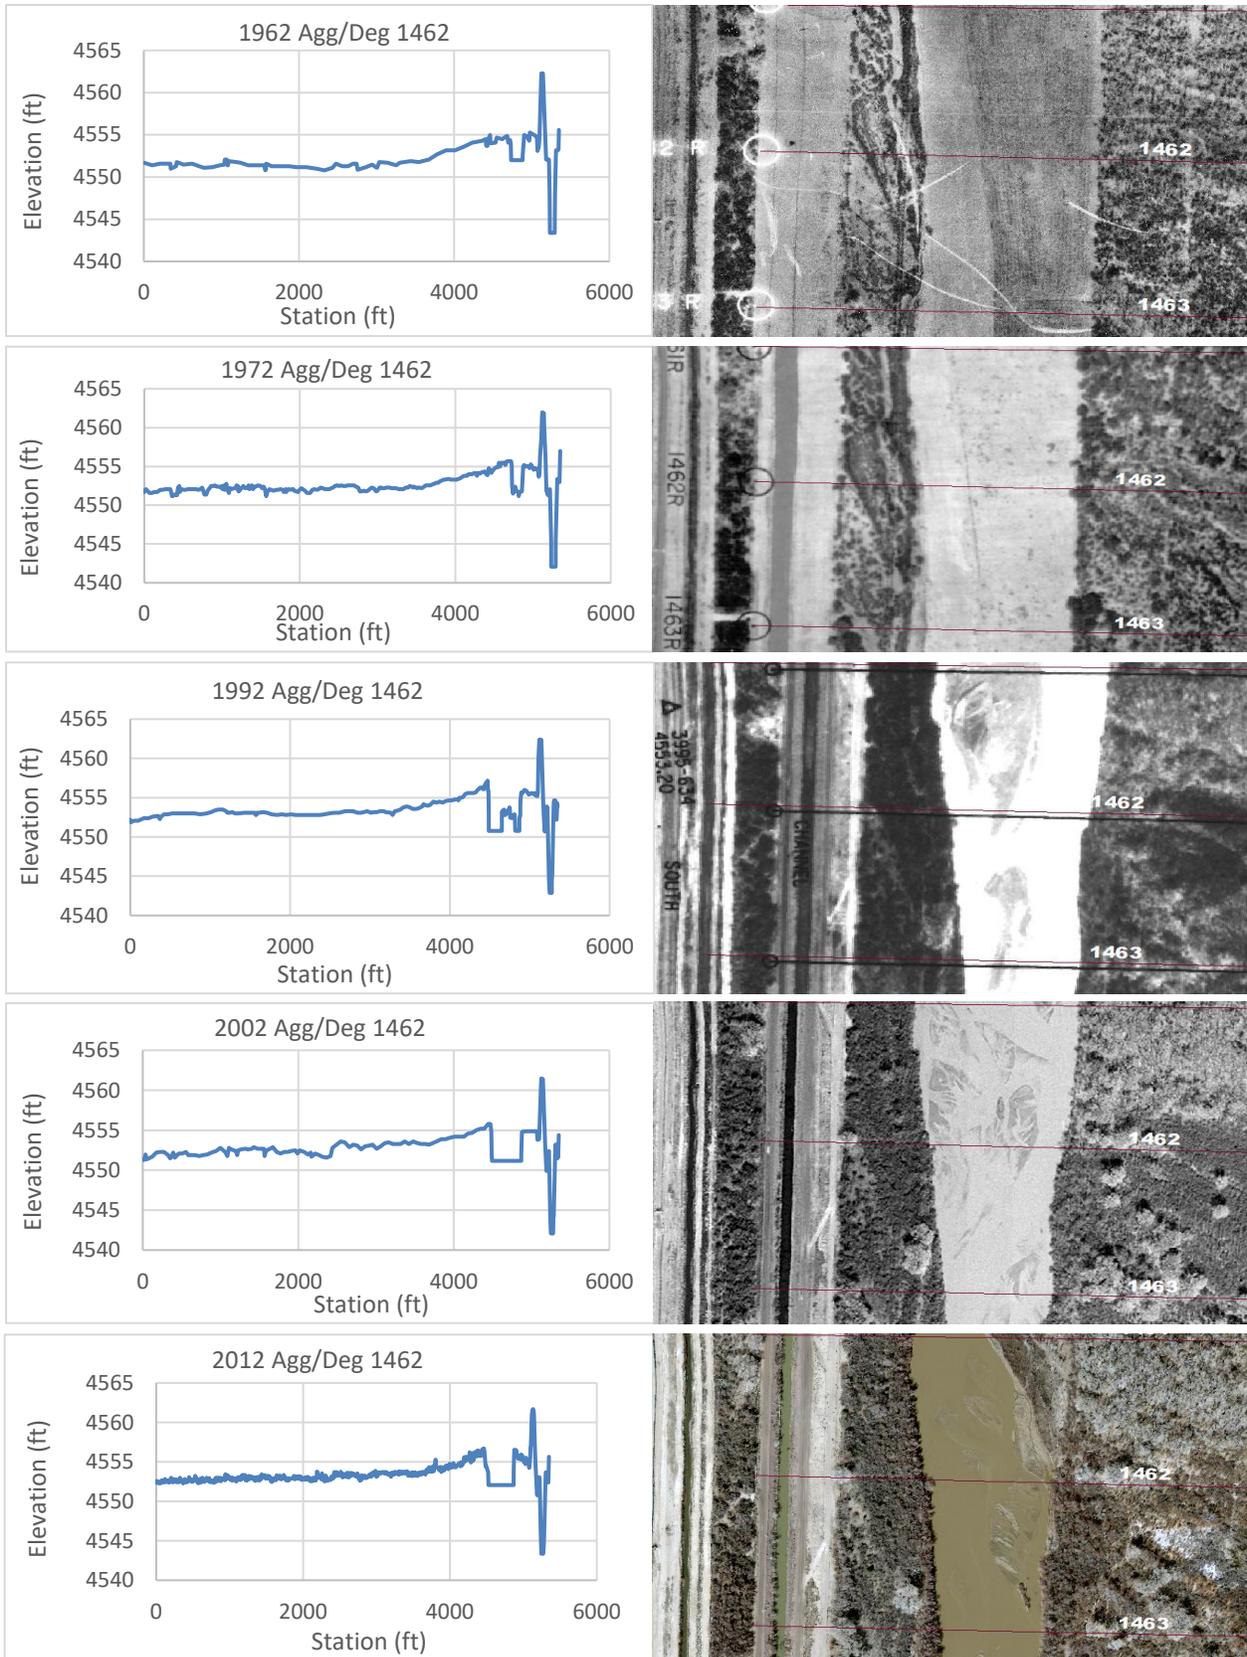
Figure 49 Subreach E5: historical cross section profiles and corresponding aerial images

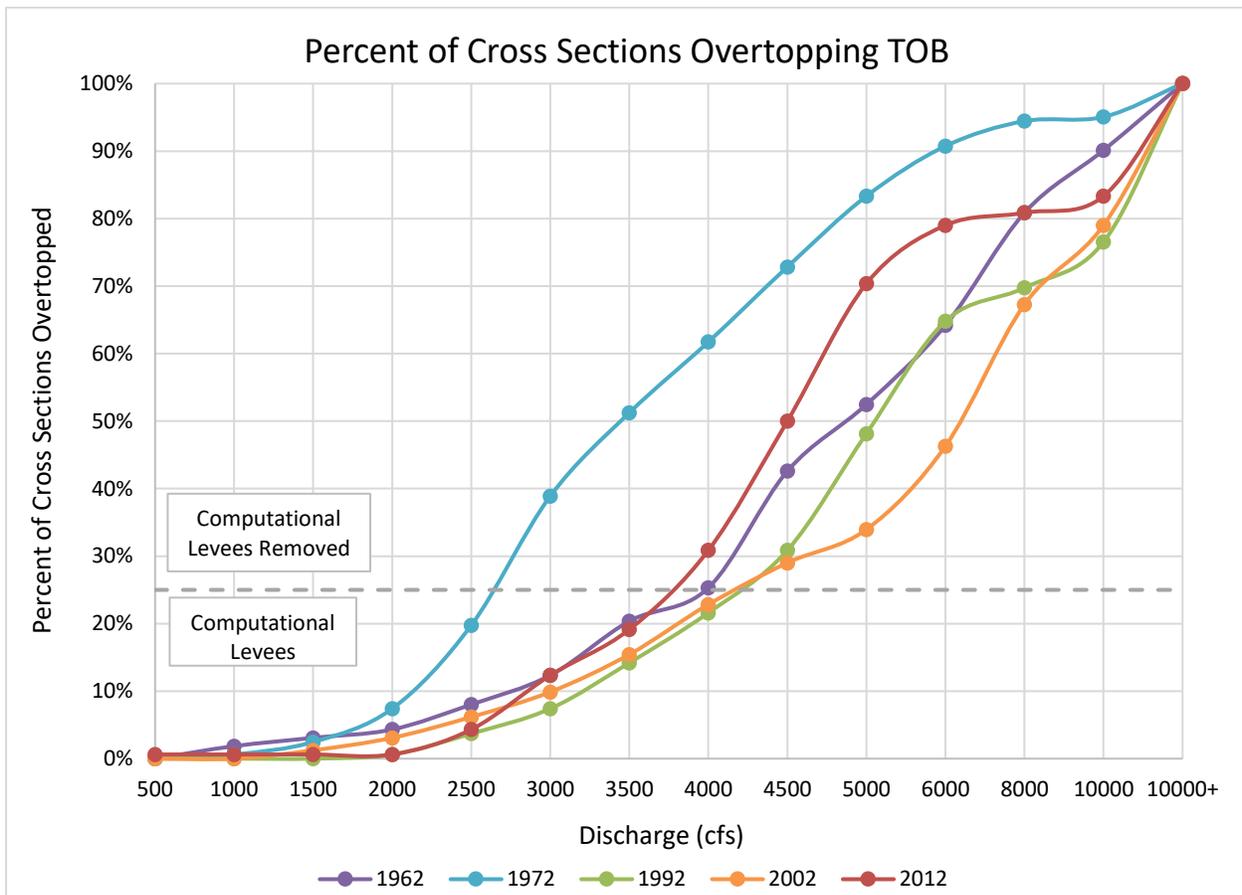
Figure 50 Comparing the overbanking discharge values at various years. The dashed line (indicating 25% of cross sections in a reach experiencing overbanking) determines the discharge at which computational levees are removed for habitat analysis.

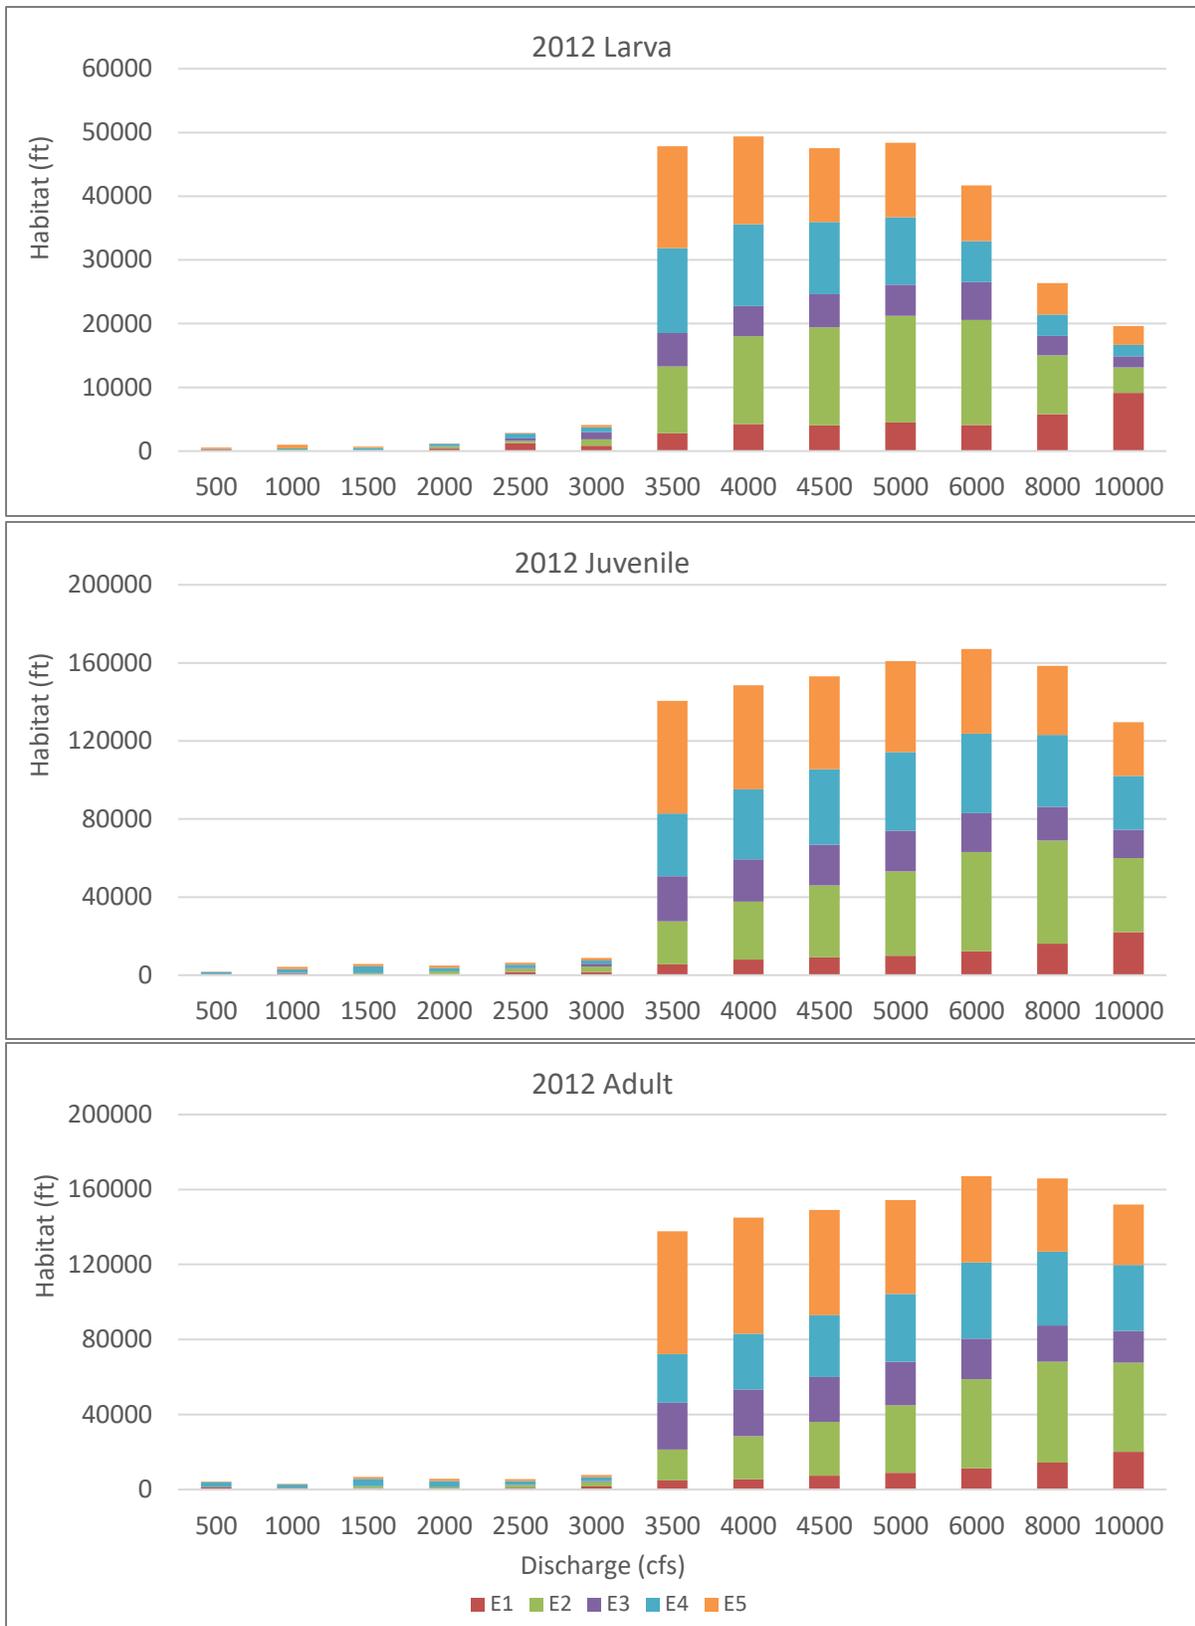
Figure 56 Stacked habitat charts to display spatial variations of habitat throughout the Escondida reach in 2012

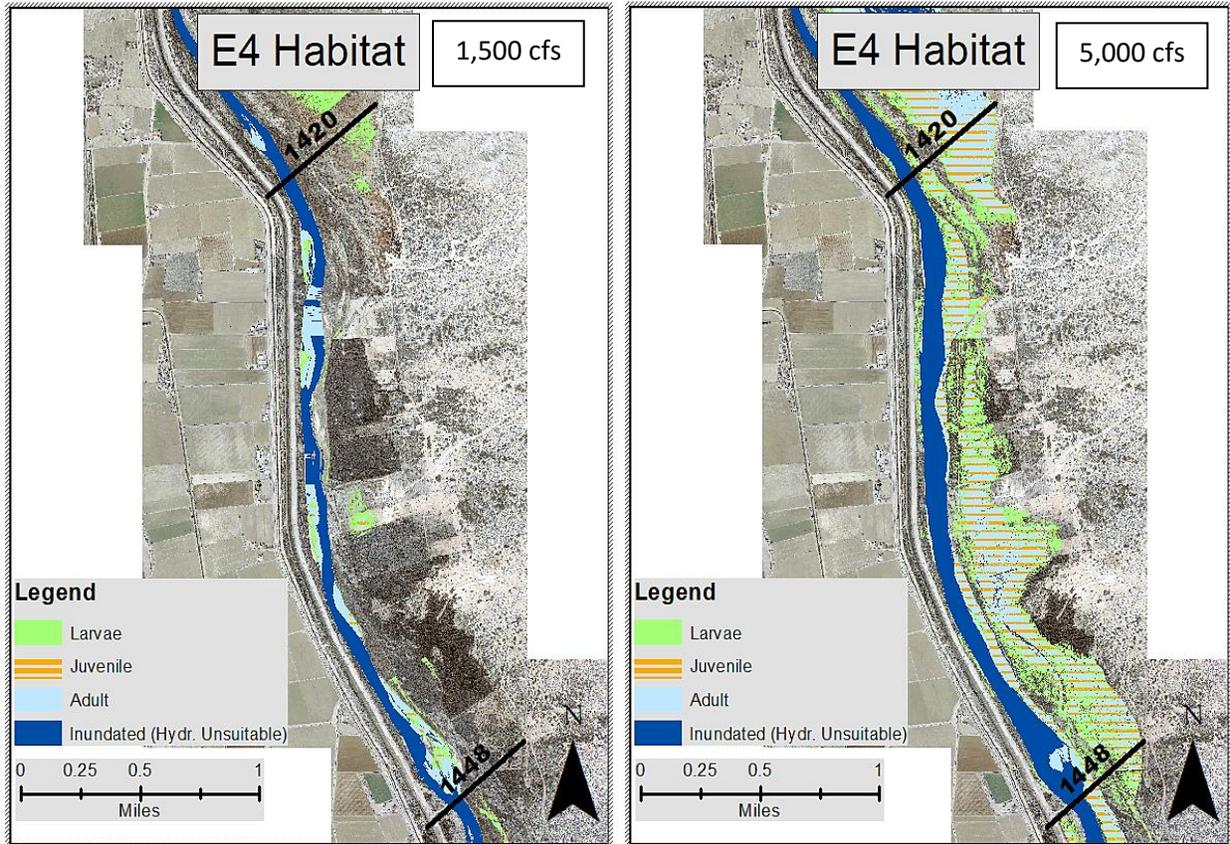
Figure 57 Hydraulically suitable habitat for each life stage in subreach E4 at 1,500 cfs (left) and 5,000 cfs (right)

According to the RAS-Mapper results, there is very little Silvery Minnow habitat in the upper portion of the Escondida reach at 1,500 cfs and 3,000 cfs. At a discharge of 5,000 cfs, the amount of hydraulically suitable habitat increases greatly. An example of the habitat maps for subreach E4 at discharges of 1,500 cfs and 5,000 cfs is shown in Figure 57. The habitat maps for the remainder of the subreaches at each discharge can be found in Appendix E.

Although a discharge of 5,000 cfs may not be commonly seen throughout the Escondida reach, maps at this discharge still provide the opportunity to examine possible areas that are more likely to meet the velocity and depth criteria for the RGSM. This can help in identifying which areas may have hydraulically suitable habitat that are connected to the main channel due to backwater or natural formation of pools and which subreaches contain habitat that may be found suitable but are not connected to the main channel. Both instances may be beneficial for the future of the RGSM, but different approaches may be needed in planning restoration efforts.

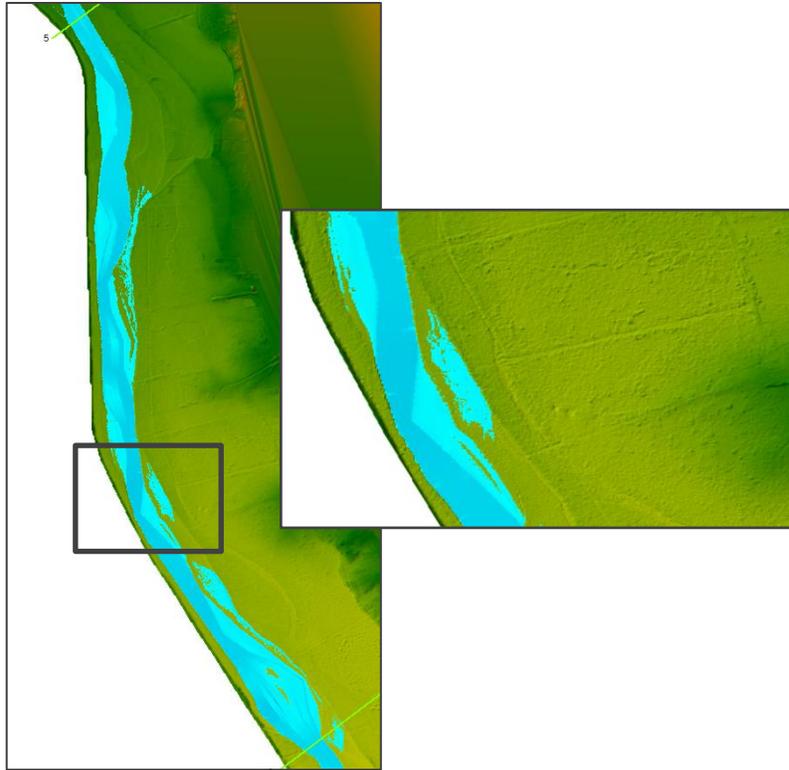
Figure 58 Example of a disconnected area that contains water, but no access to or from the main channel

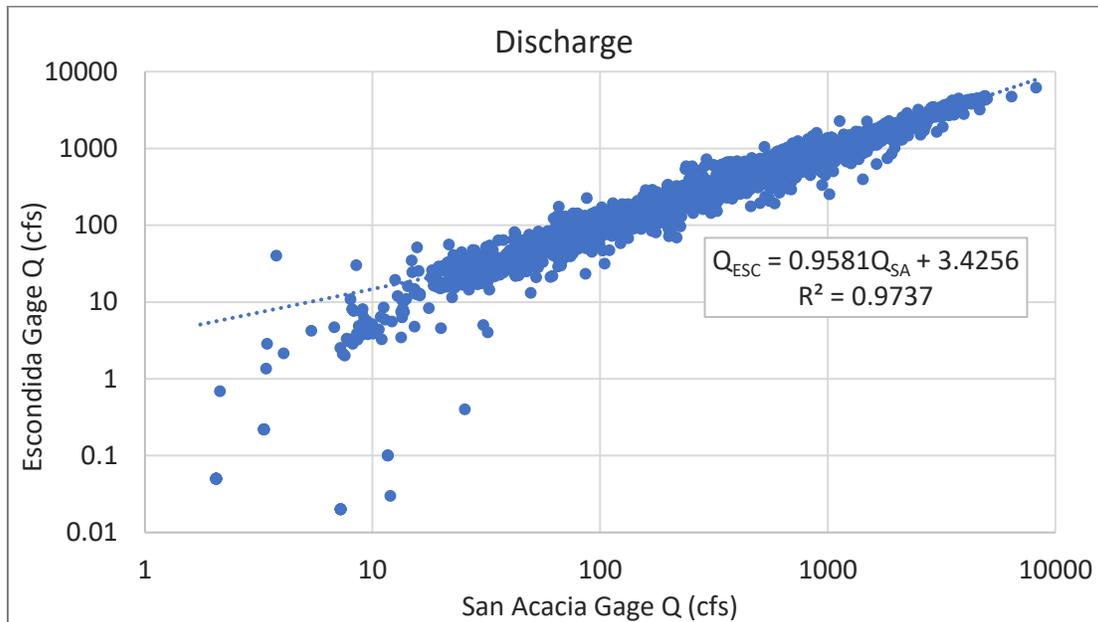
Figure 60 Correlating the discharge values at the San Acacia (Q_{SA}) and Escondida (Q_{ESC}) gages to create a model to estimate the unknown values at the Escondida gage.

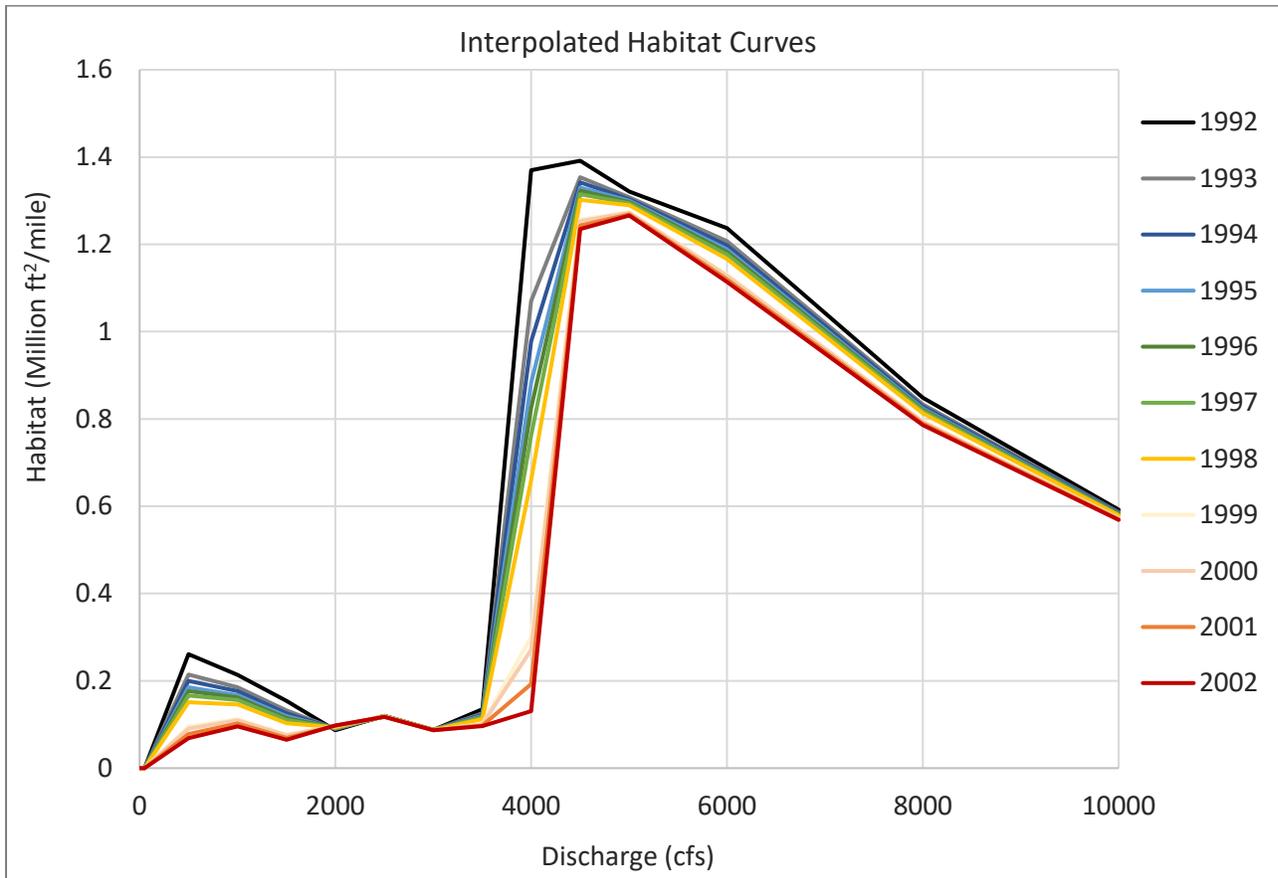
Figure 61 Habitat curves at 1992 and 2002 from the width slice method, with remaining curves being interpolated from the sediment rating curve.

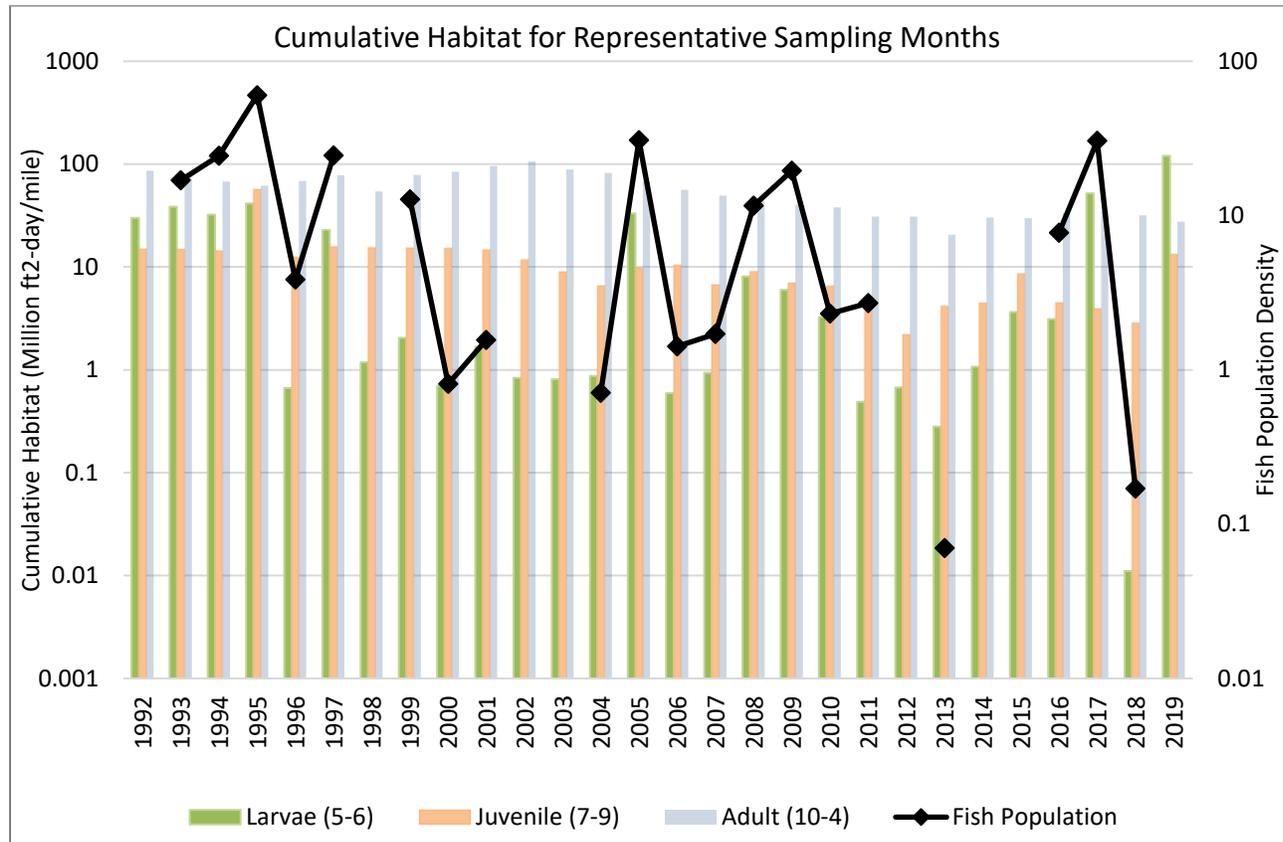
Figure 62 TIHMs for the Escondida reach. In the legend, the numbers in the parentheses indicate the months for which the habitat is accumulated over based on the life stage cycle of the RGSM. For example, months 5 and 6 (May and June) are the months when the new RGSM enter the larval stage. They enter the juvenile stage around month 7 (July) and the adult stage around month 10 (October).
