Middle Rio Grande Escondida Reach:

Morpho-dynamic Processes and Silvery Minnow Habitat
from Escondida Bridge to US-380 Bridge
(1918-2018)

August 2020
Master of Science
Plan B Technical Report

Prepared by:
Tori Beckwith

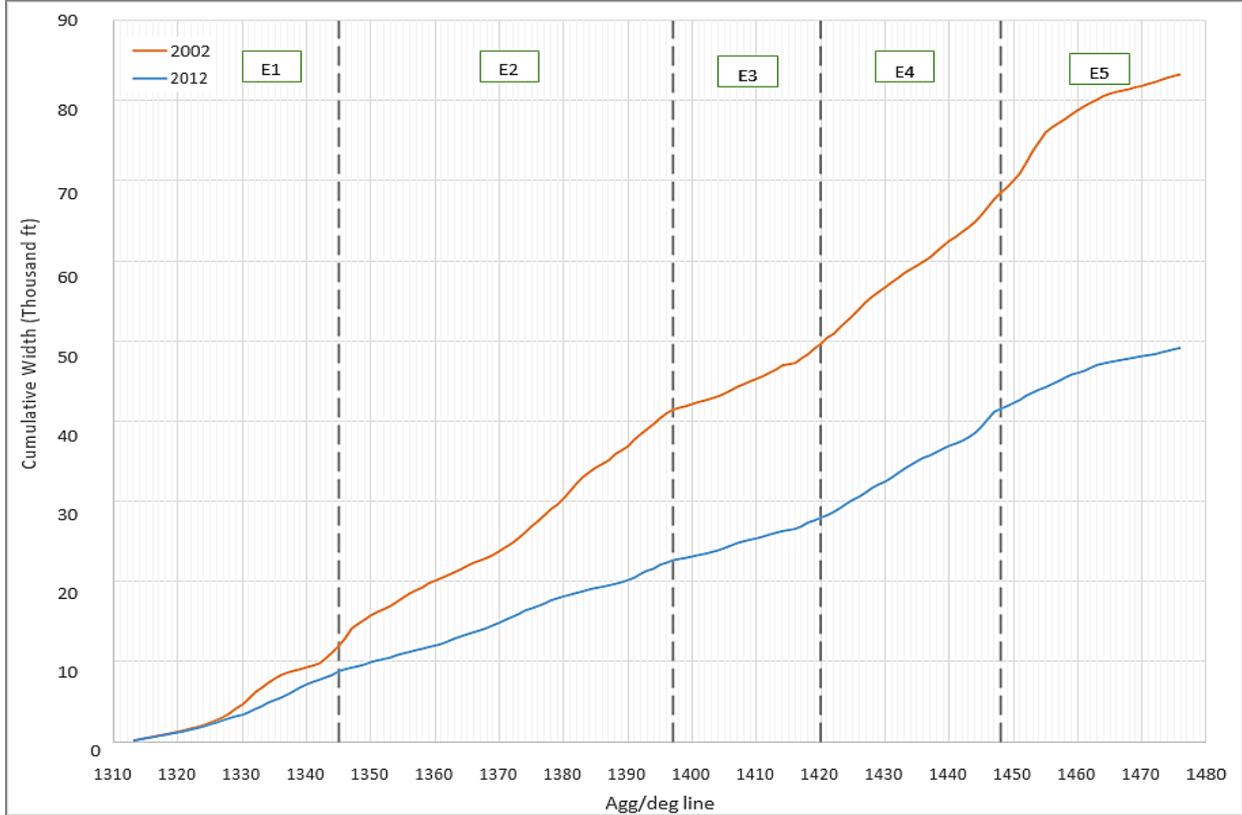
Figure A- 1 Width (top) and cumulative width (bottom) throughout the Escondida reach for the years 2002 (orange) and 2012 (blue).

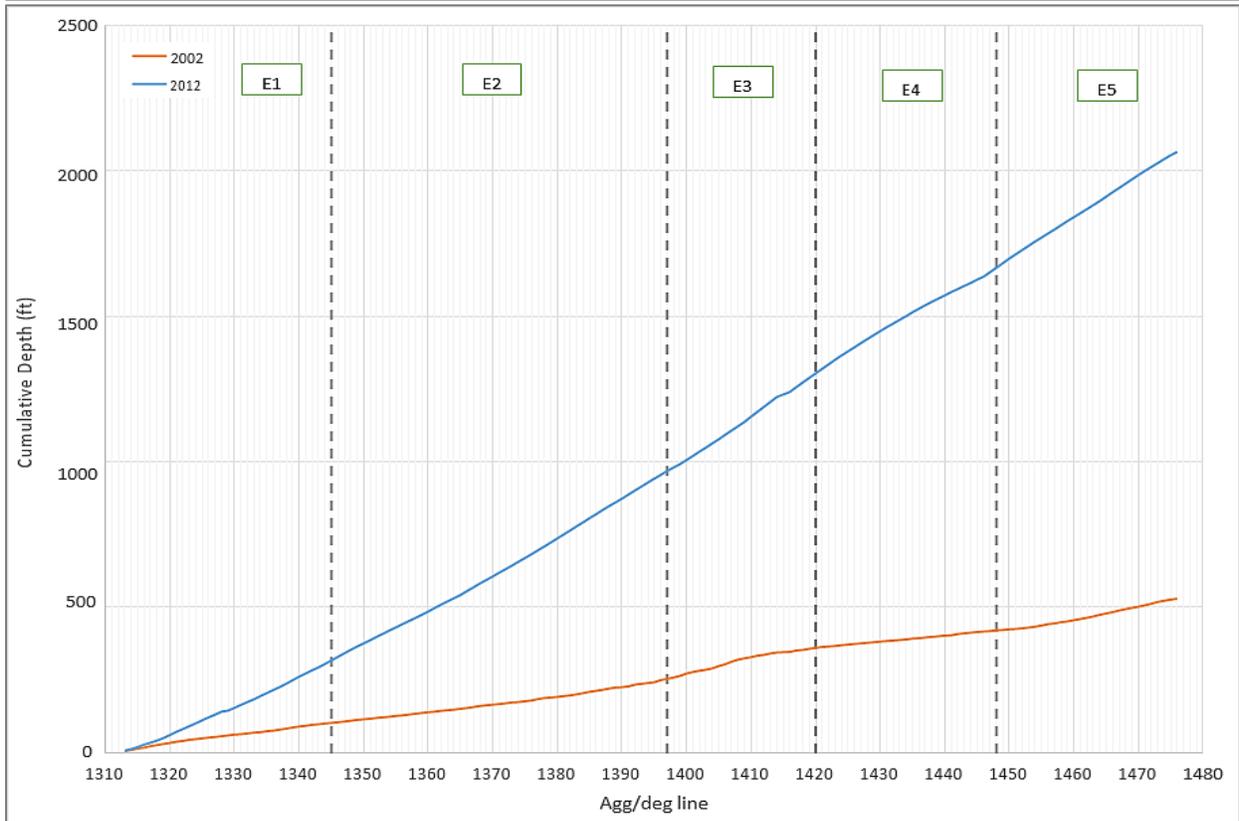
Figure A- 4 Depth (top) and cumulative depth (bottom) throughout the Escondida reach for the years 2002 (orange) and 2012 (blue).

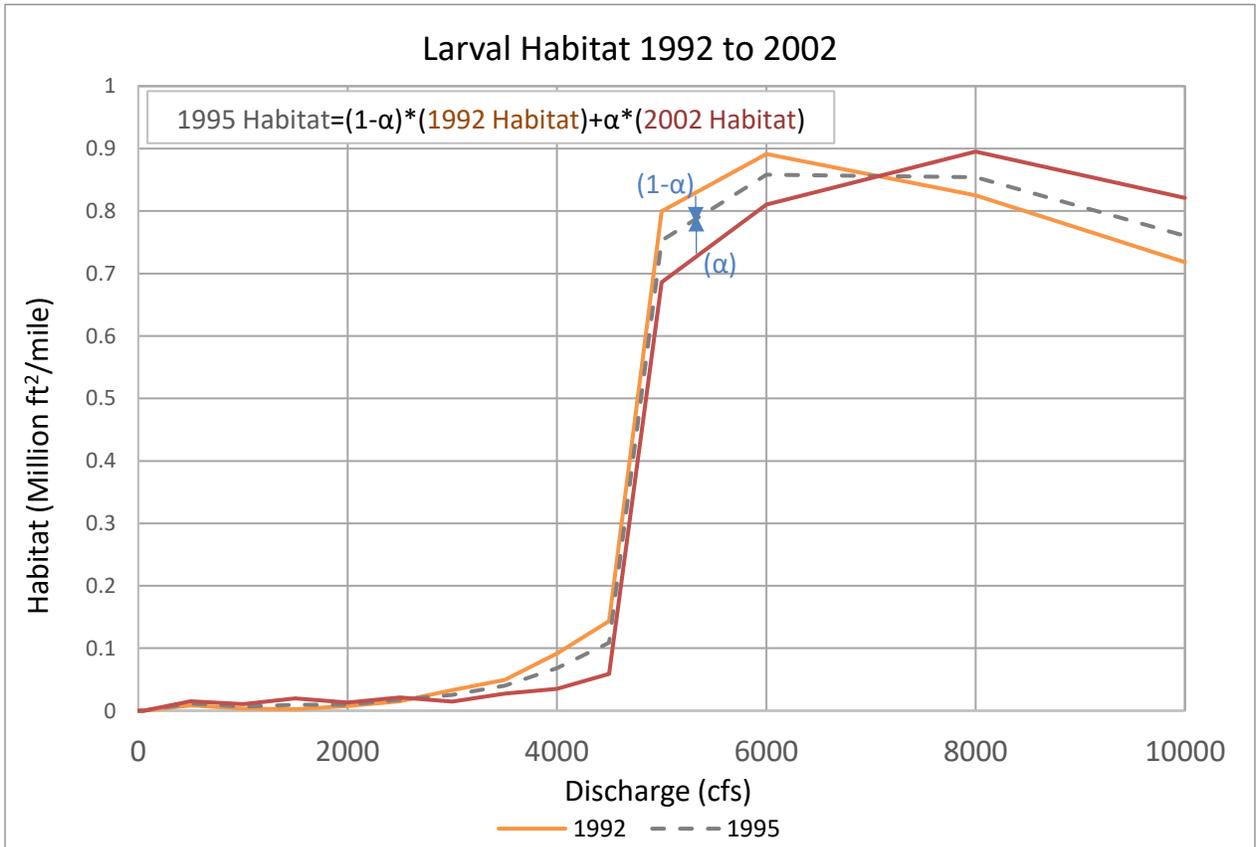
Figure C-3 Example of annual habitat interpolating using the sediment rating curve and alpha technique.

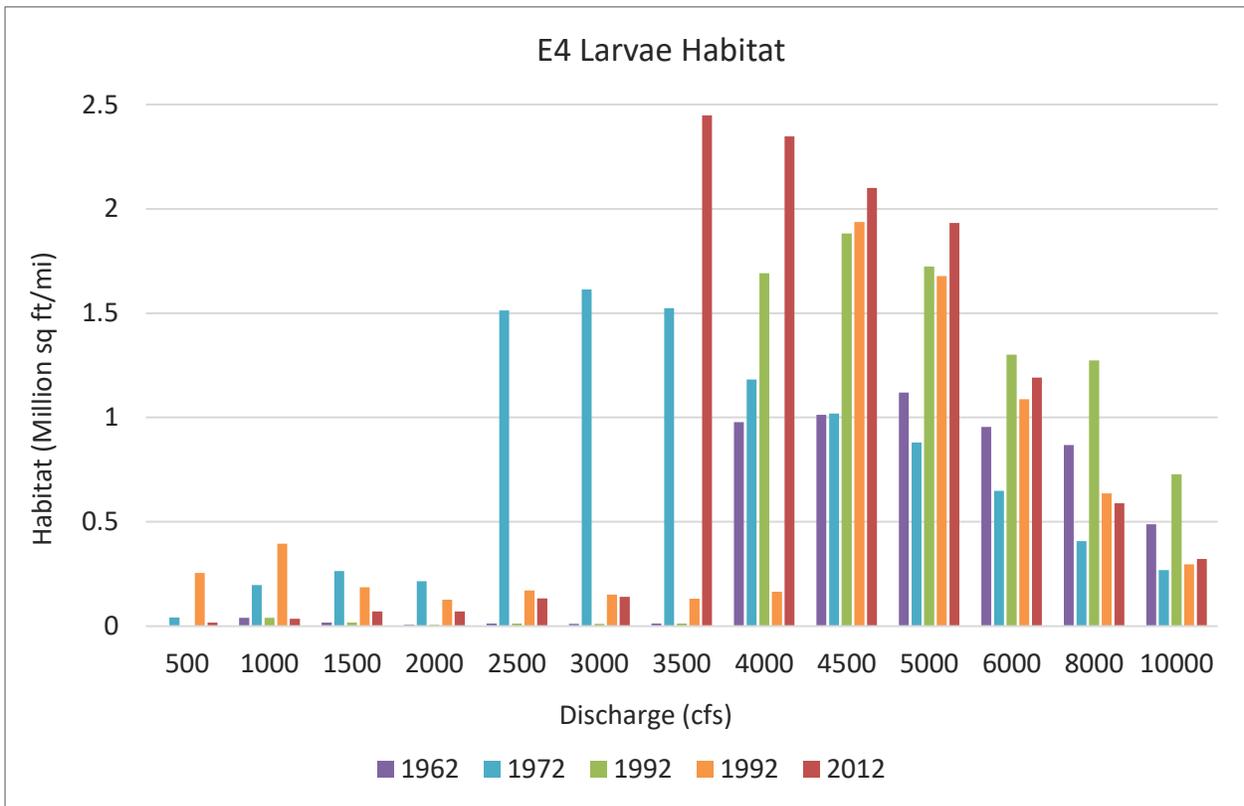
Figure D- 10 Subreach E4 Larva Habitat

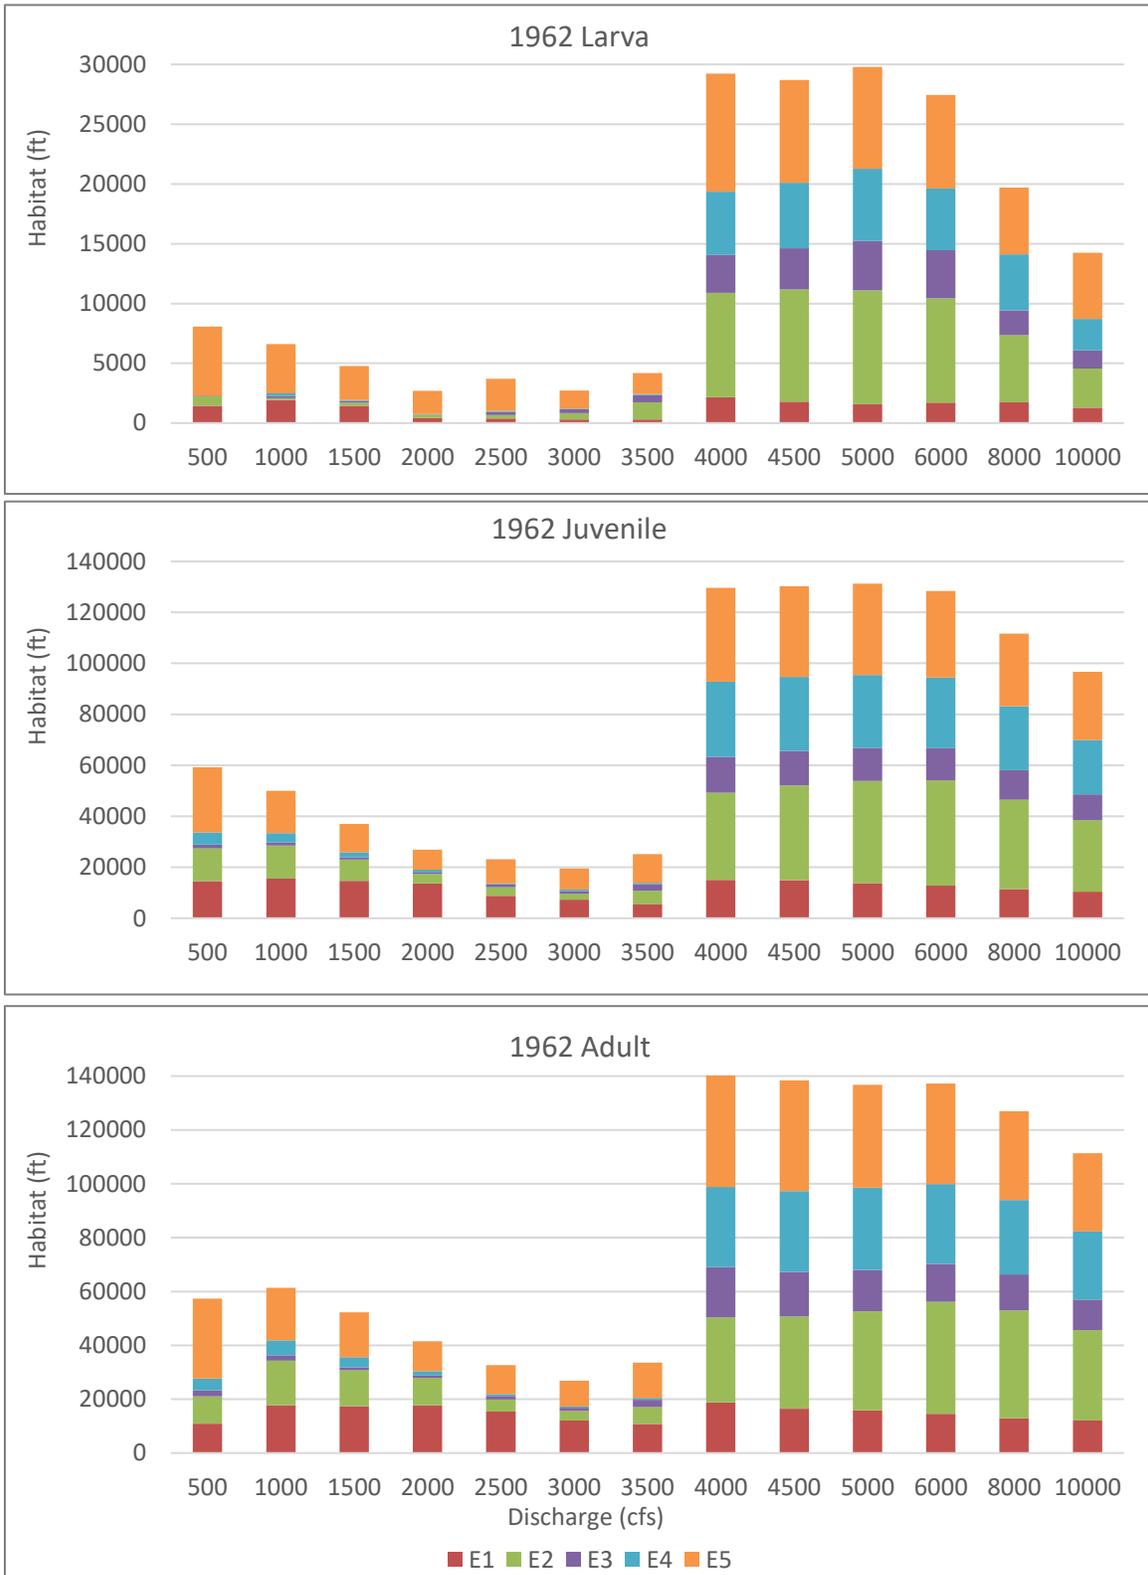
Figure D- 16 Stacked habitat charts to display spatial variations of habitat throughout the Escondida reach in 1962

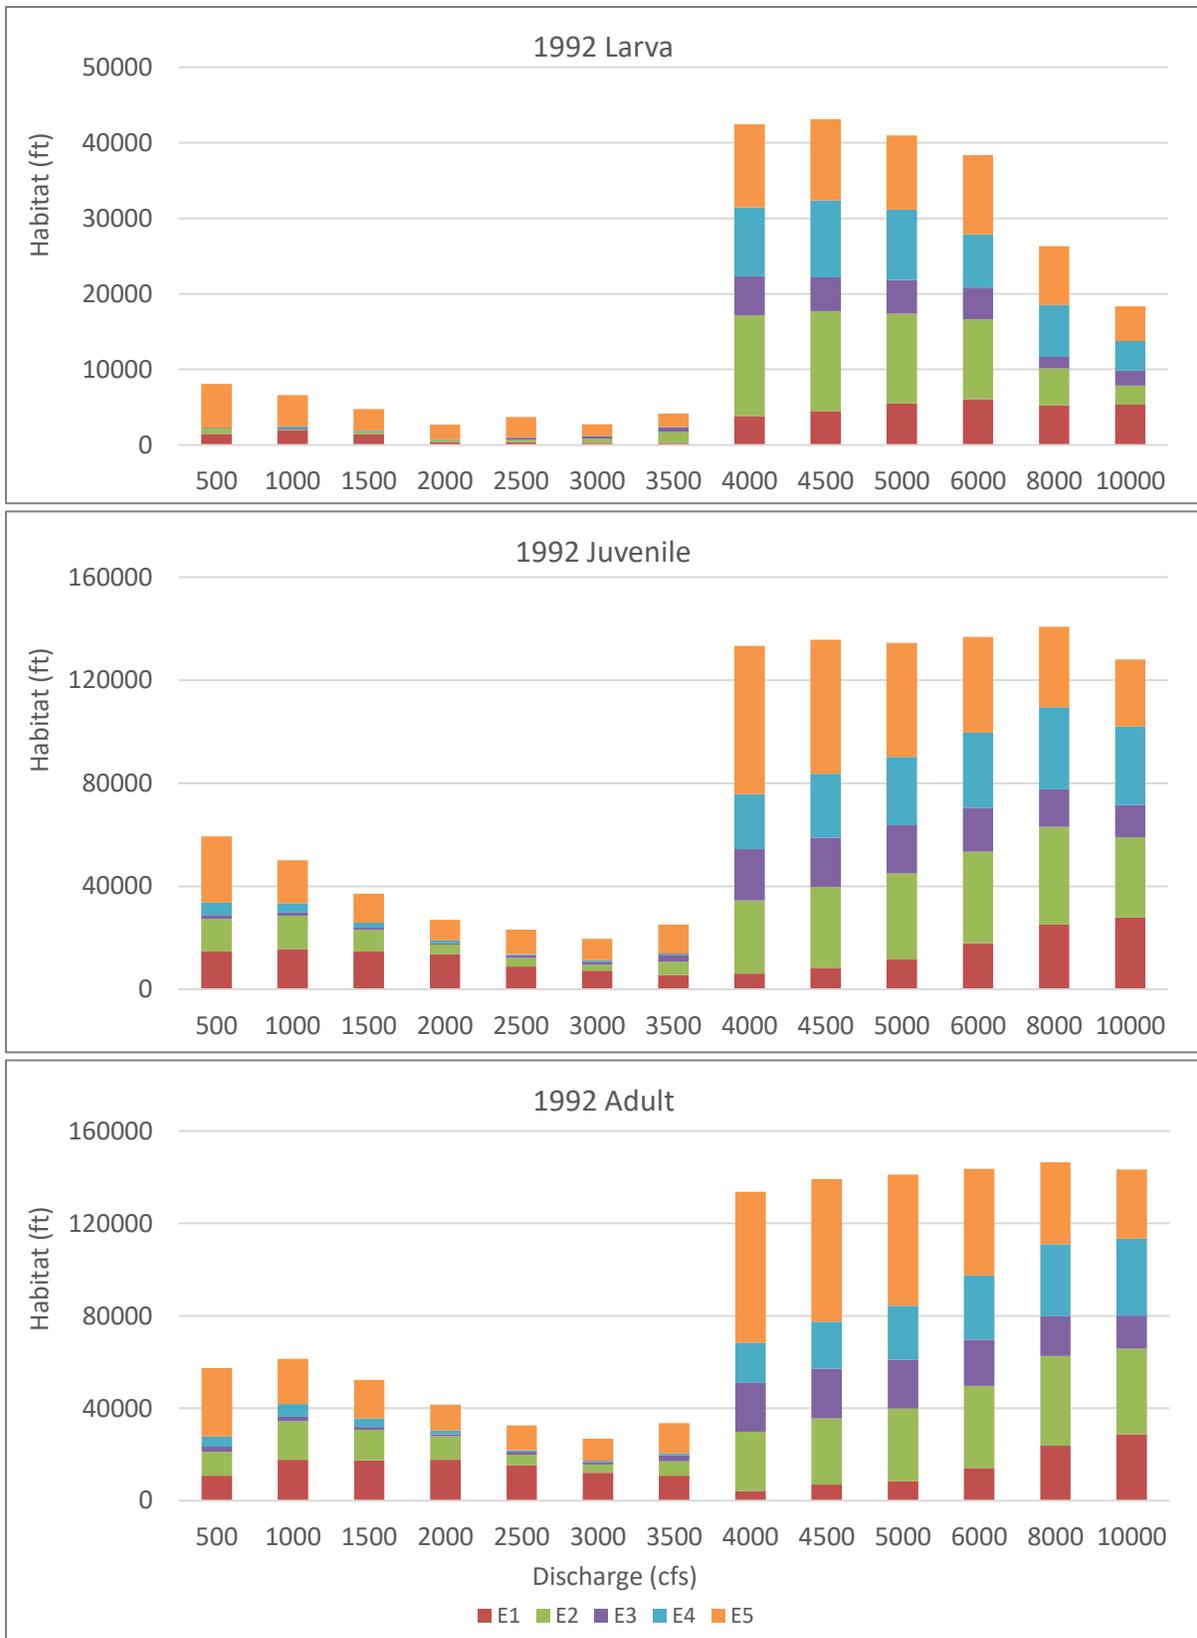
Figure D- 18 Stacked habitat charts to display spatial variations of habitat throughout the Escondida reach in 1992

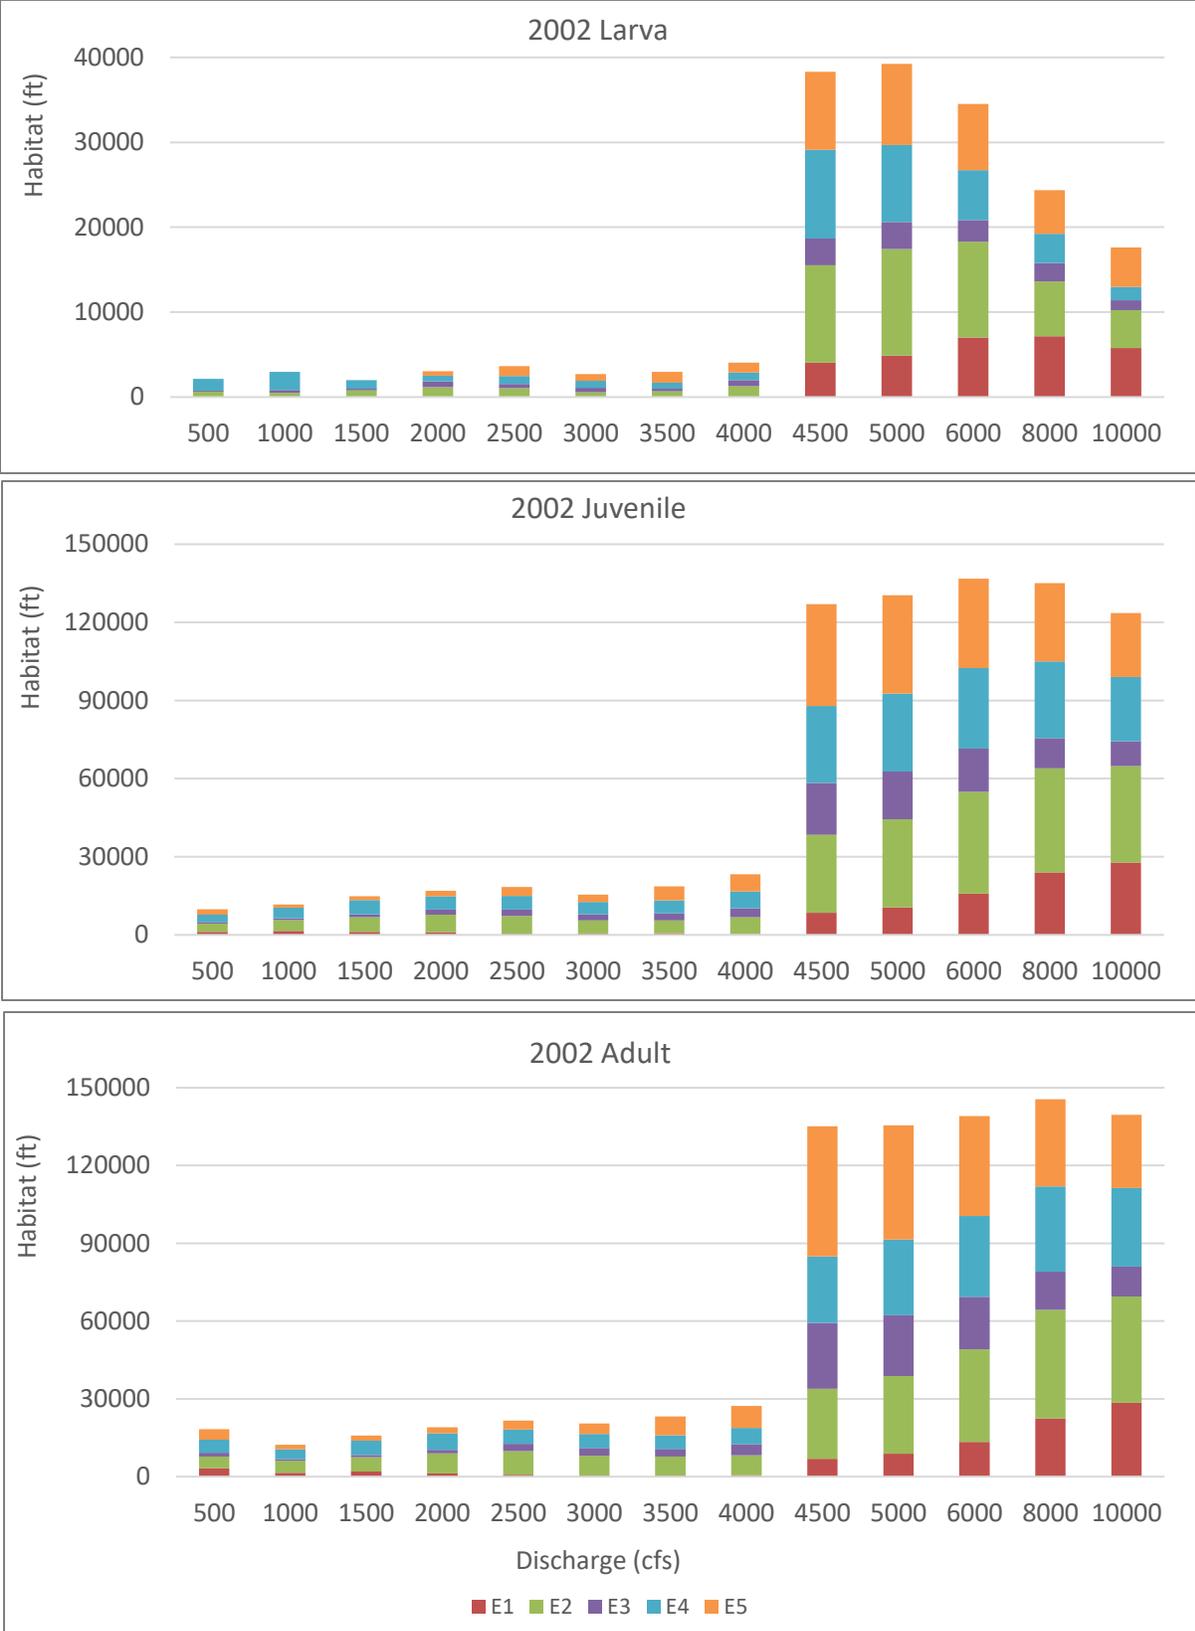
Figure D- 19 Stacked habitat charts to display spatial variations of habitat throughout the Escondida reach in 2002

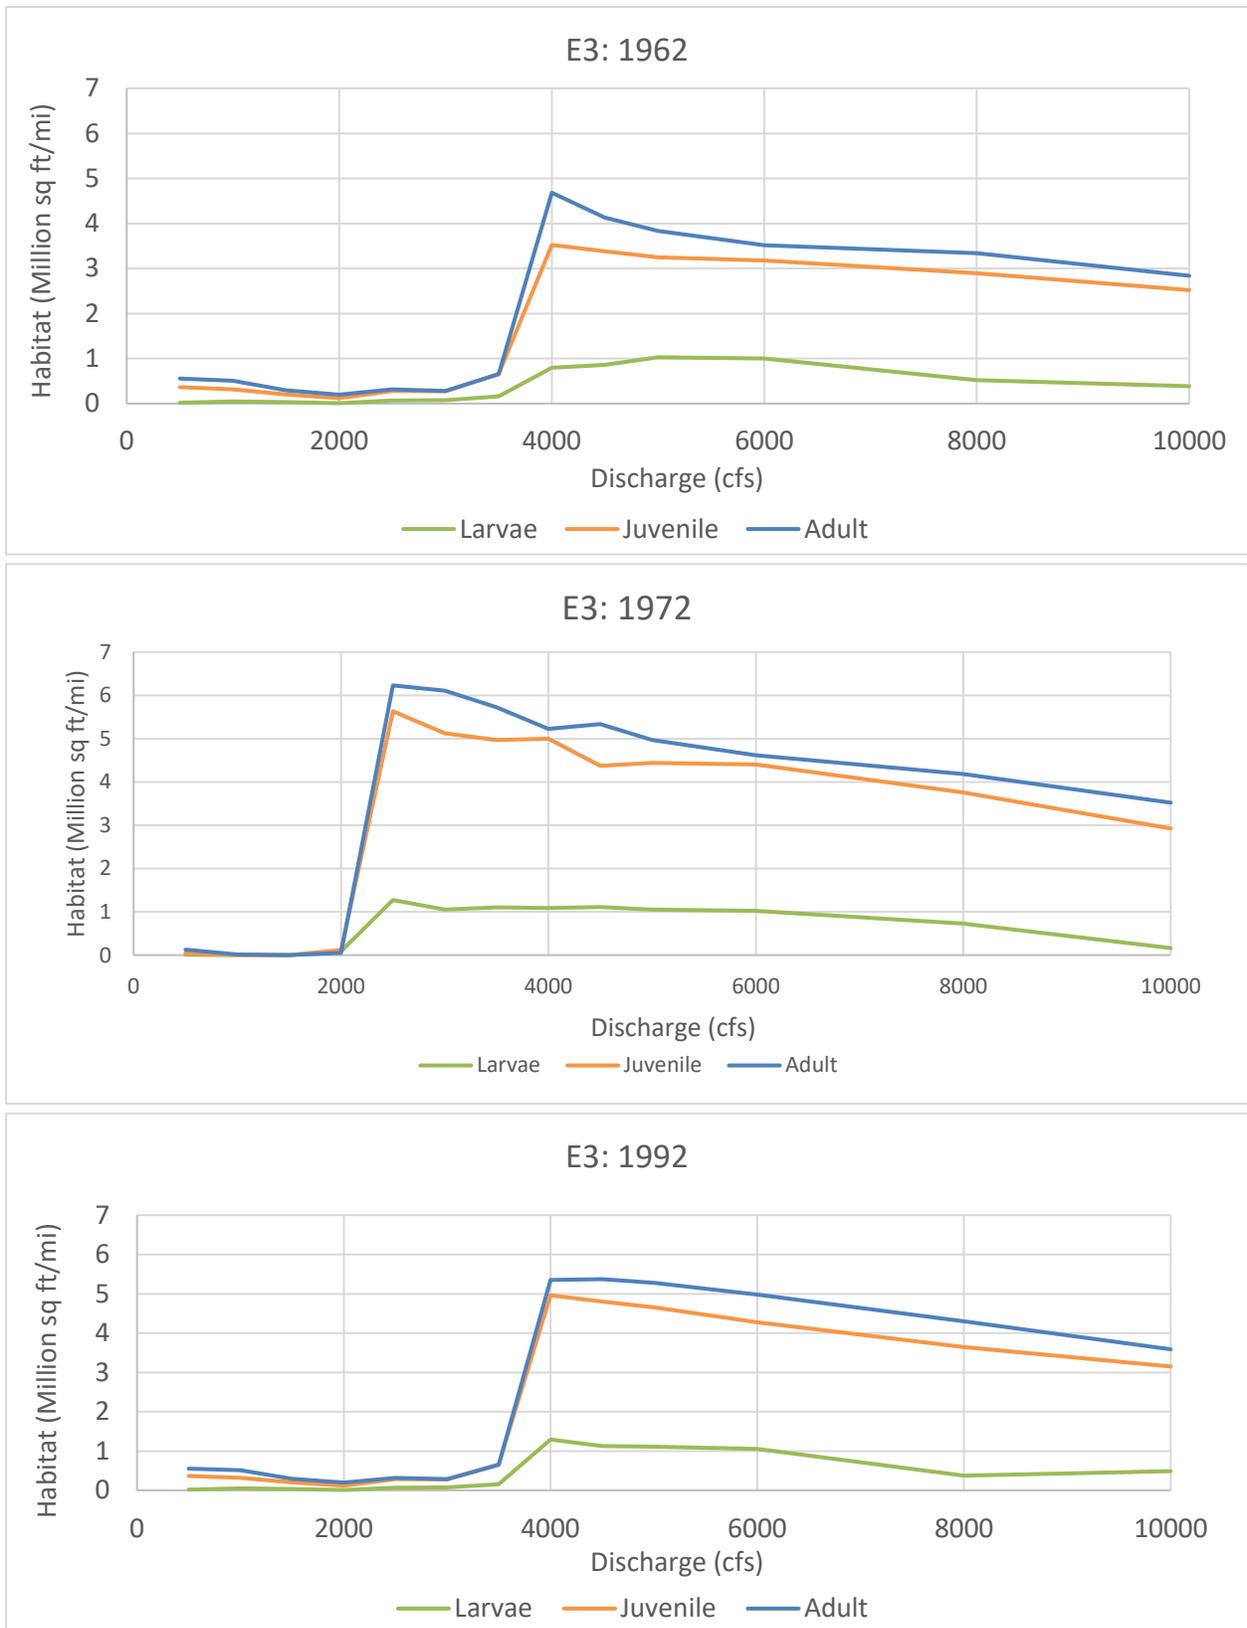
Figure D- 24 Life stage habitat curves for subreach E3 at the years 1962 (top), 1972 (middle), and 1992 (bottom)

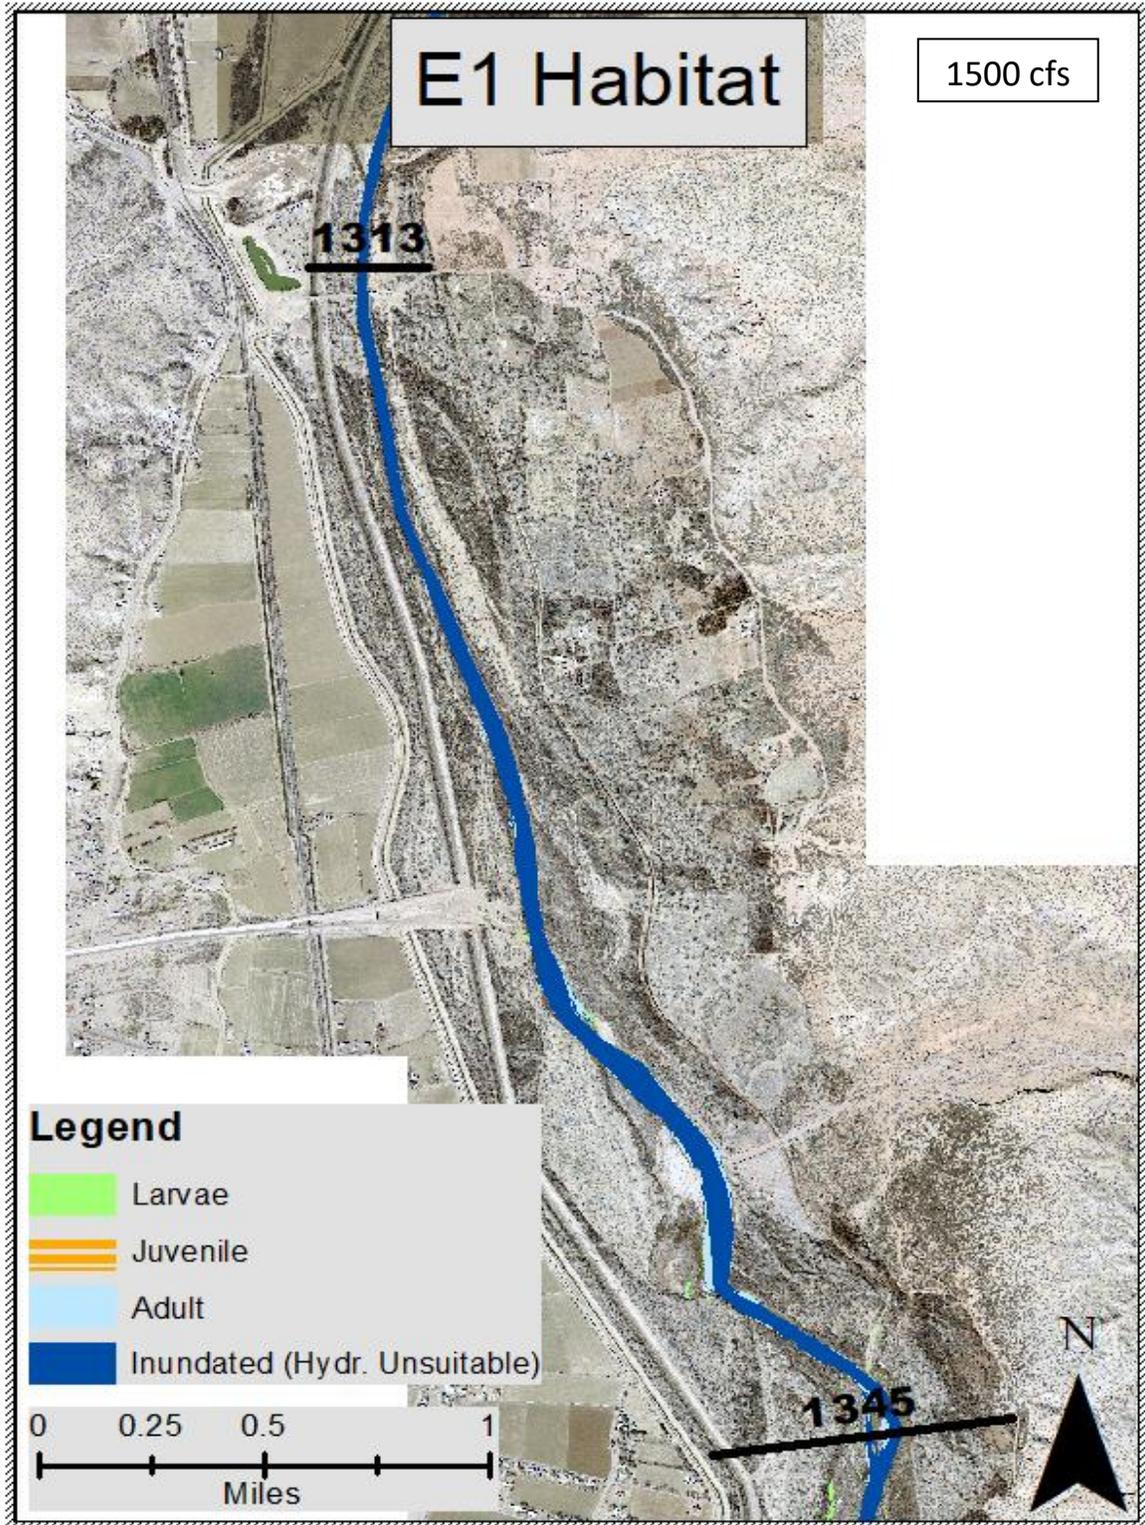
Figure E- 1 RGSM Habitat in subreach E1 at 1500 cfs with hydraulically suitable areas labeled for larvae (green), juvenile (orange), and adult (light blue) and unsuitable inundated areas in dark blue.

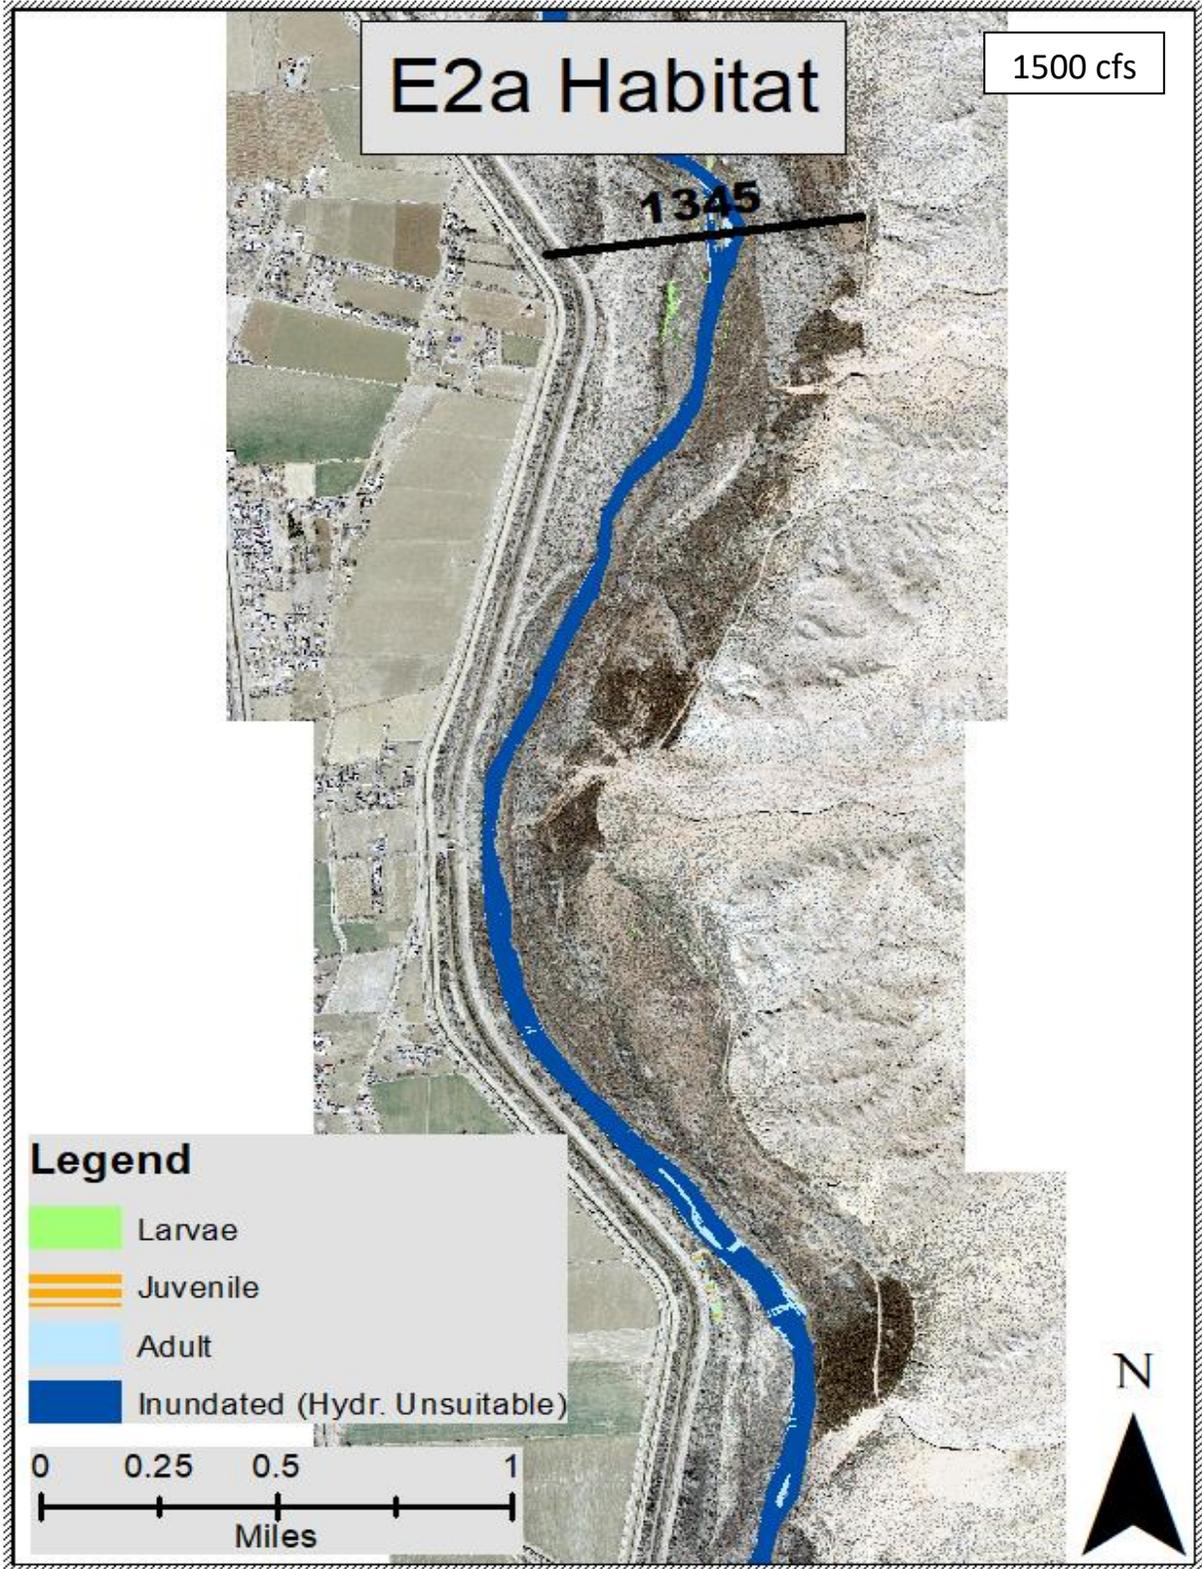
Figure E- 2 RGSM Habitat in subreach E2 (upstream portion part a) at 1500 cfs with hydraulically suitable areas labeled for larvae (green), juvenile (orange), and adult (light blue) and unsuitable inundated areas in dark blue.

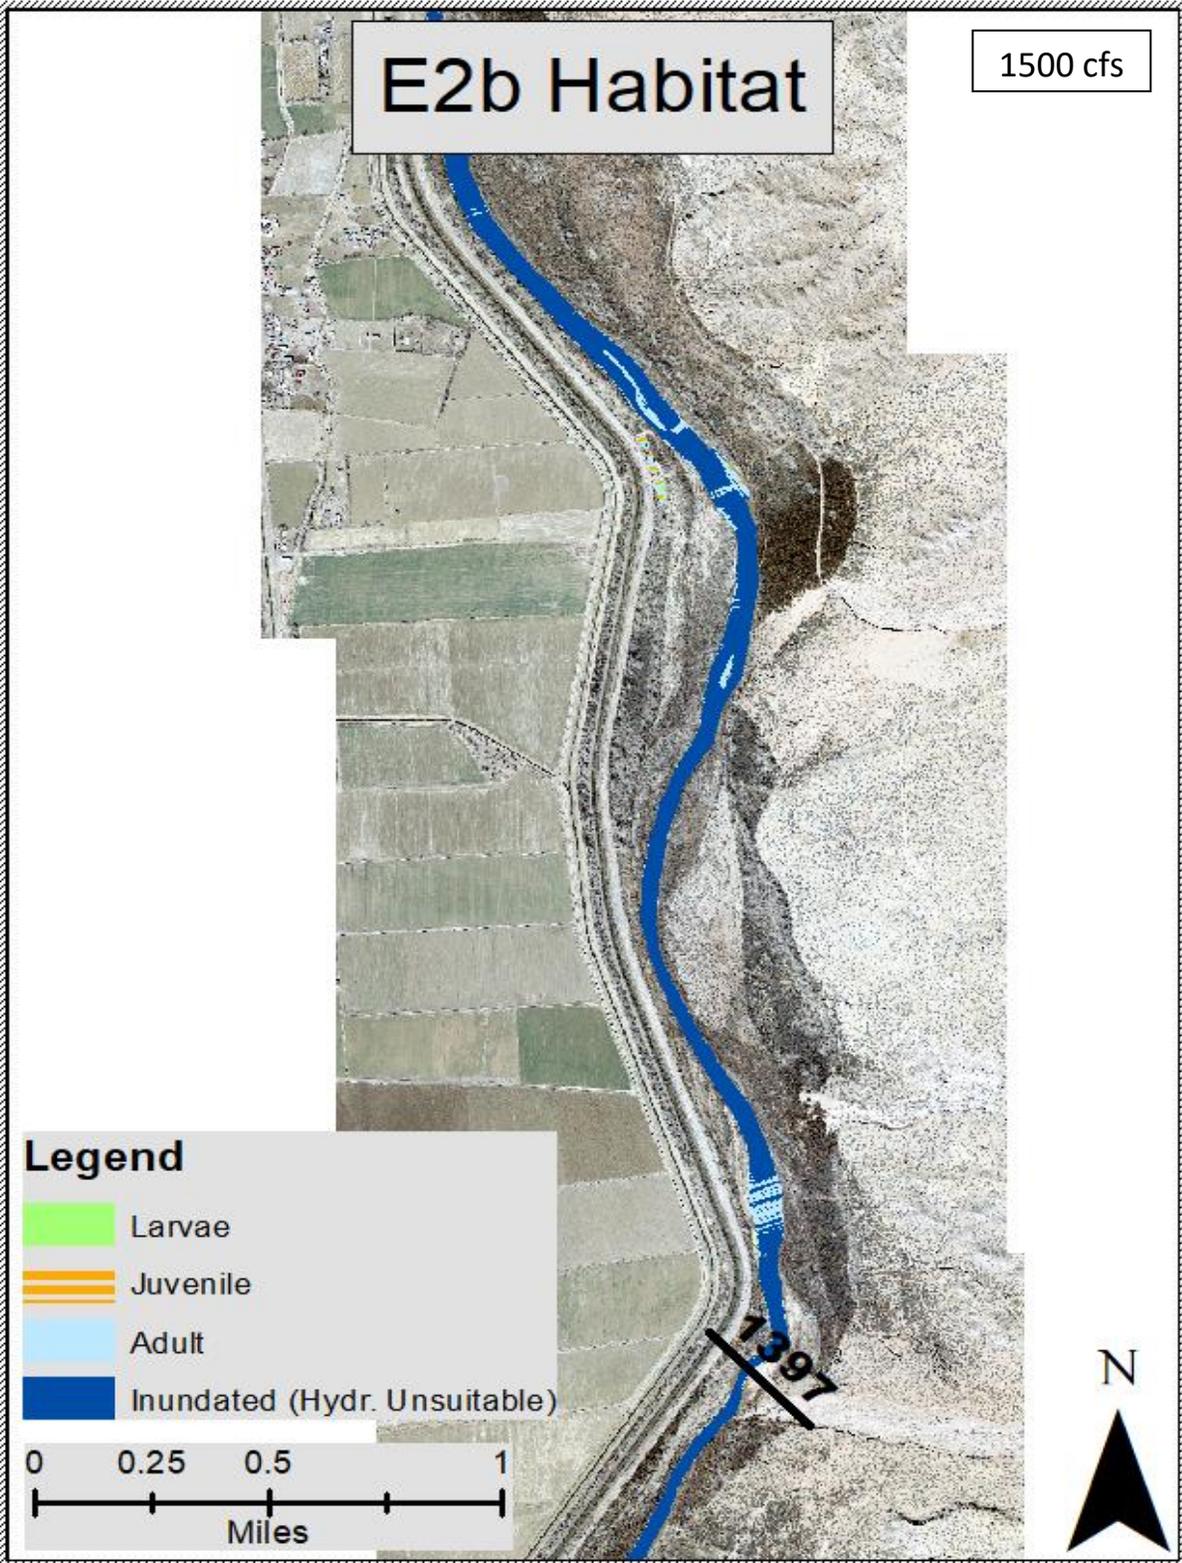
Figure E-3 RGSM Habitat in subreach E2 (downstream portion part b) at 1500 cfs with hydraulically suitable areas labeled for larvae (green), juvenile (orange), and adult (light blue) and unsuitable inundated areas in dark blue.

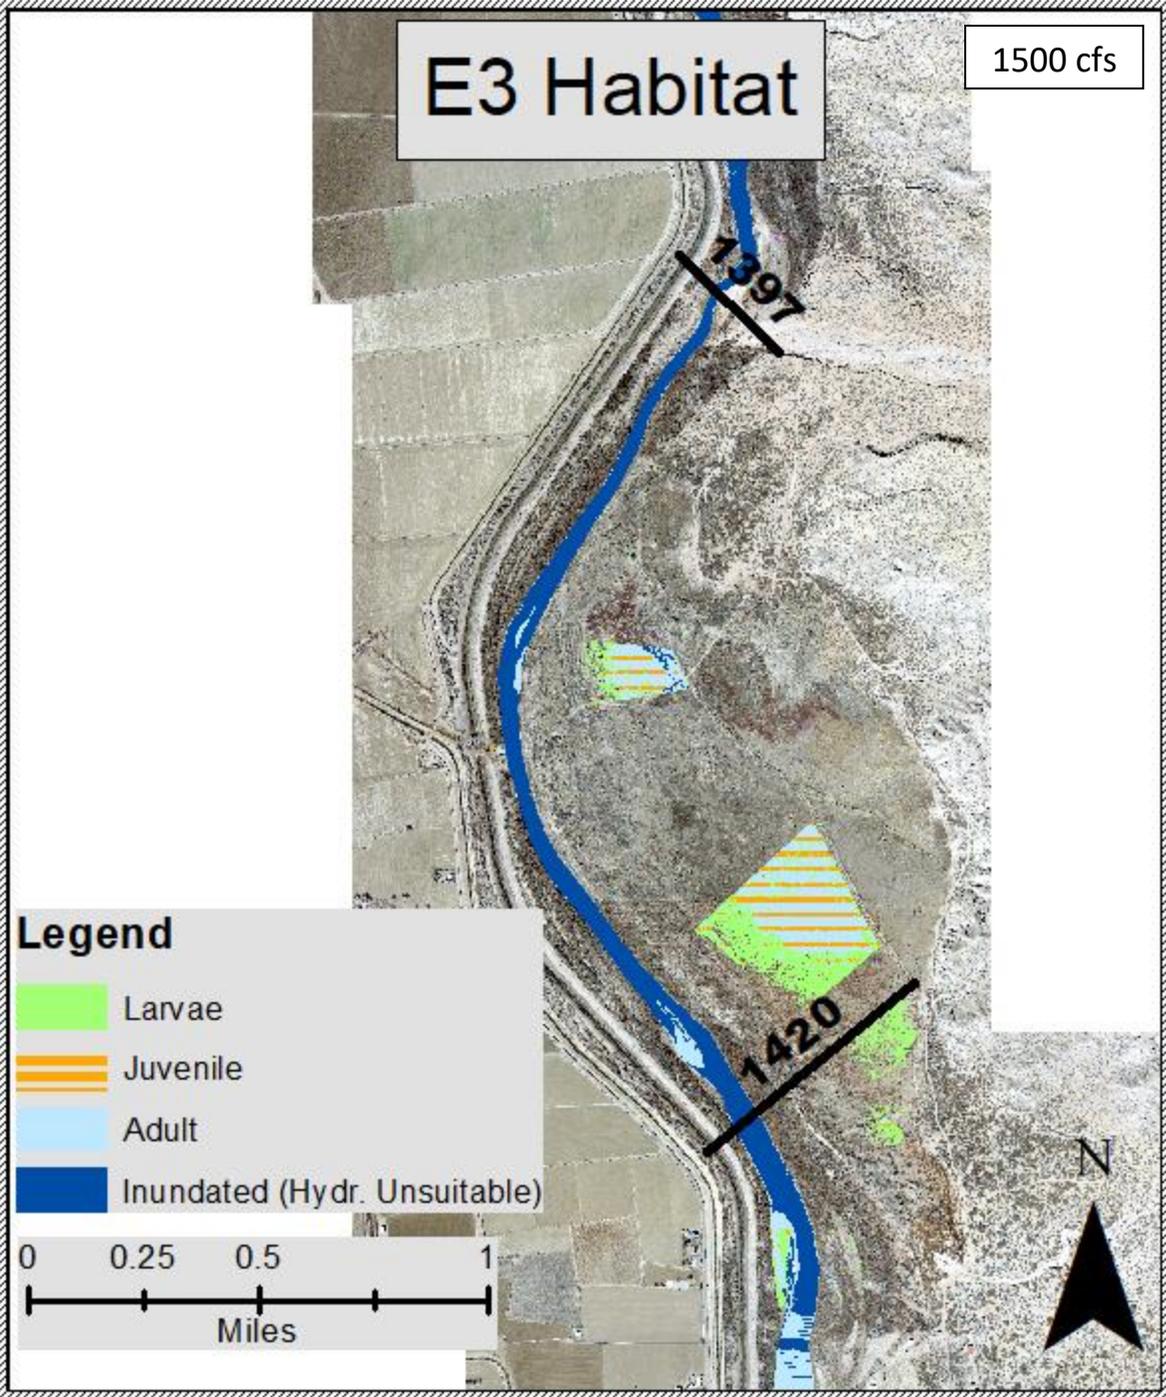
Figure E- 4 RGSM Habitat in subreach E3 at 1500 cfs with hydraulically suitable areas labeled for larvae (green), juvenile (orange), and adult (light blue) and unsuitable inundated areas in dark blue. There should be very little overtopping of the computational levees at 1,500 cfs, which means water inundation is not expected in the floodplains. This may be an issue of the pseudo 2-D model that arises when working with perched channels.

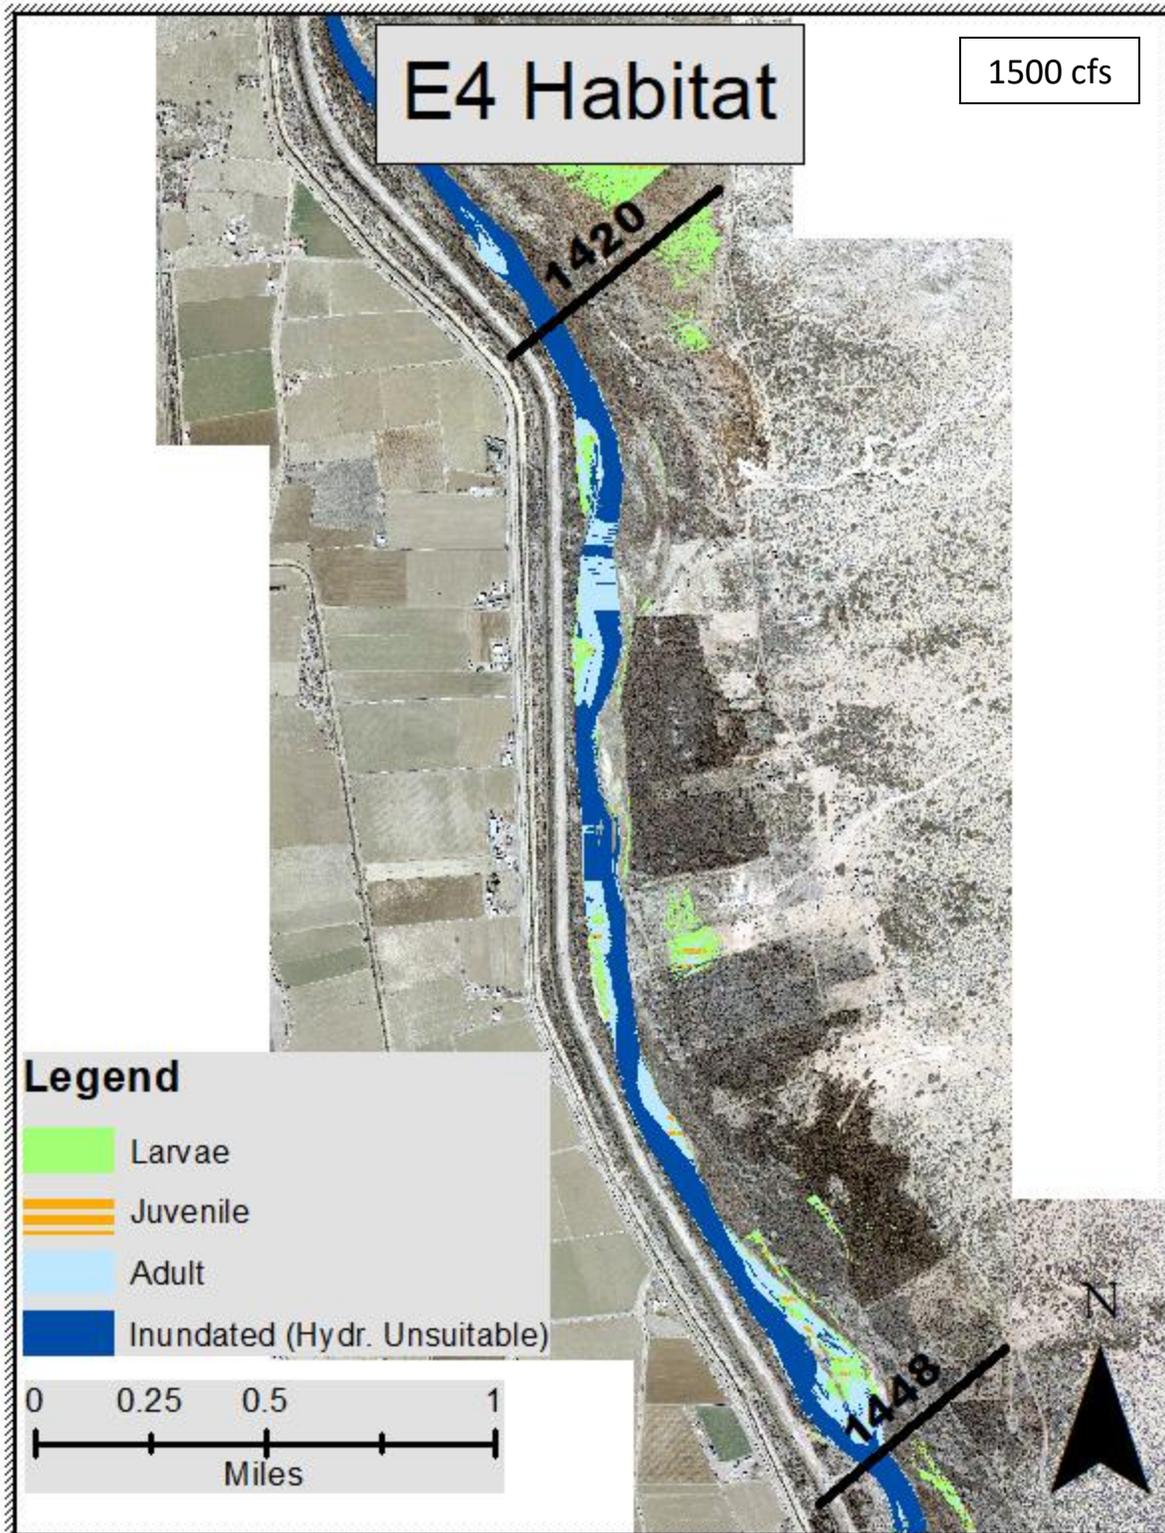
Figure E- 5 RGSM Habitat in subreach E4 at 1500 cfs with hydraulically suitable areas labeled for larvae (green), juvenile (orange), and adult (light blue) and unsuitable inundated areas in dark blue.

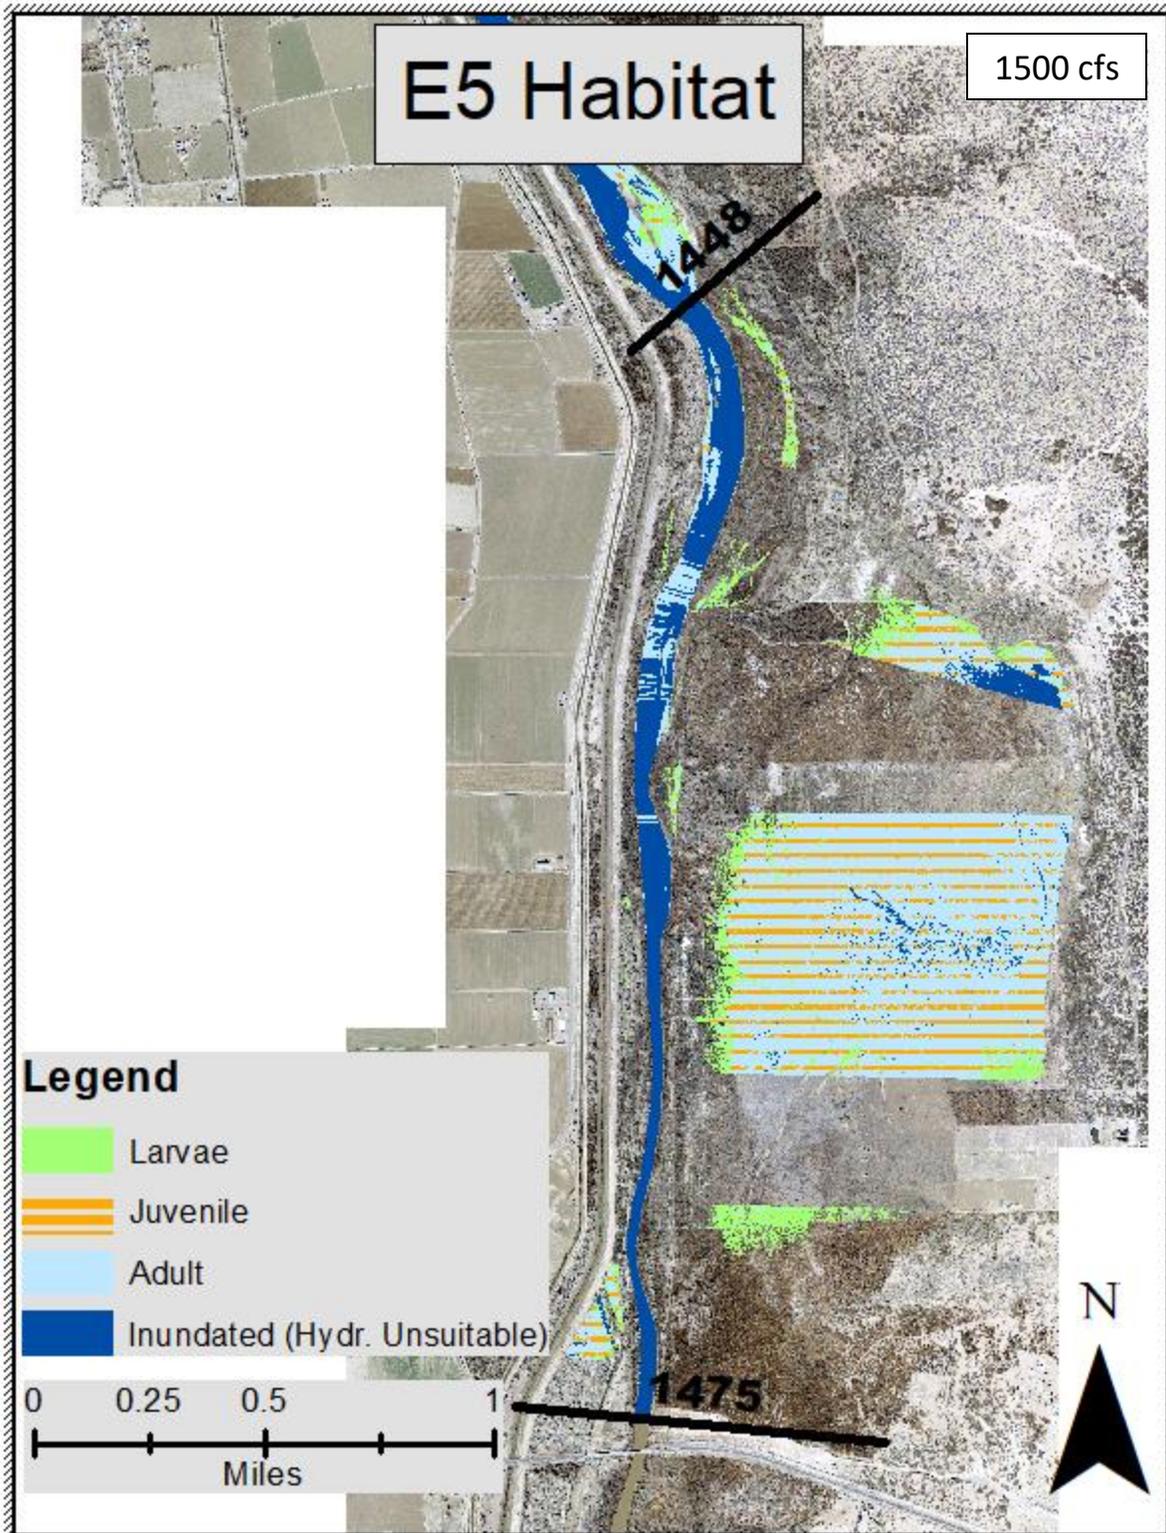
Figure E- 6 RGSM Habitat in subreach E5 at 1500 cfs with hydraulically suitable areas labeled for larvae (green), juvenile (orange), and adult (light blue) and unsuitable inundated areas in dark blue. There should be very little overtopping of the computational levees at 1,500 cfs, which means water inundation is not expected in the floodplains. This may be an issue of the pseudo 2-D model that arises when working with perched channels.
