Middle Rio Grande Escondida Reach:

Morpho-dynamic Processes and Silvery Minnow Habitat
from Escondida Bridge to US-380 Bridge
(1918-2018)

August 2020
Master of Science
Plan B Technical Report

Prepared by:
Tori Beckwith

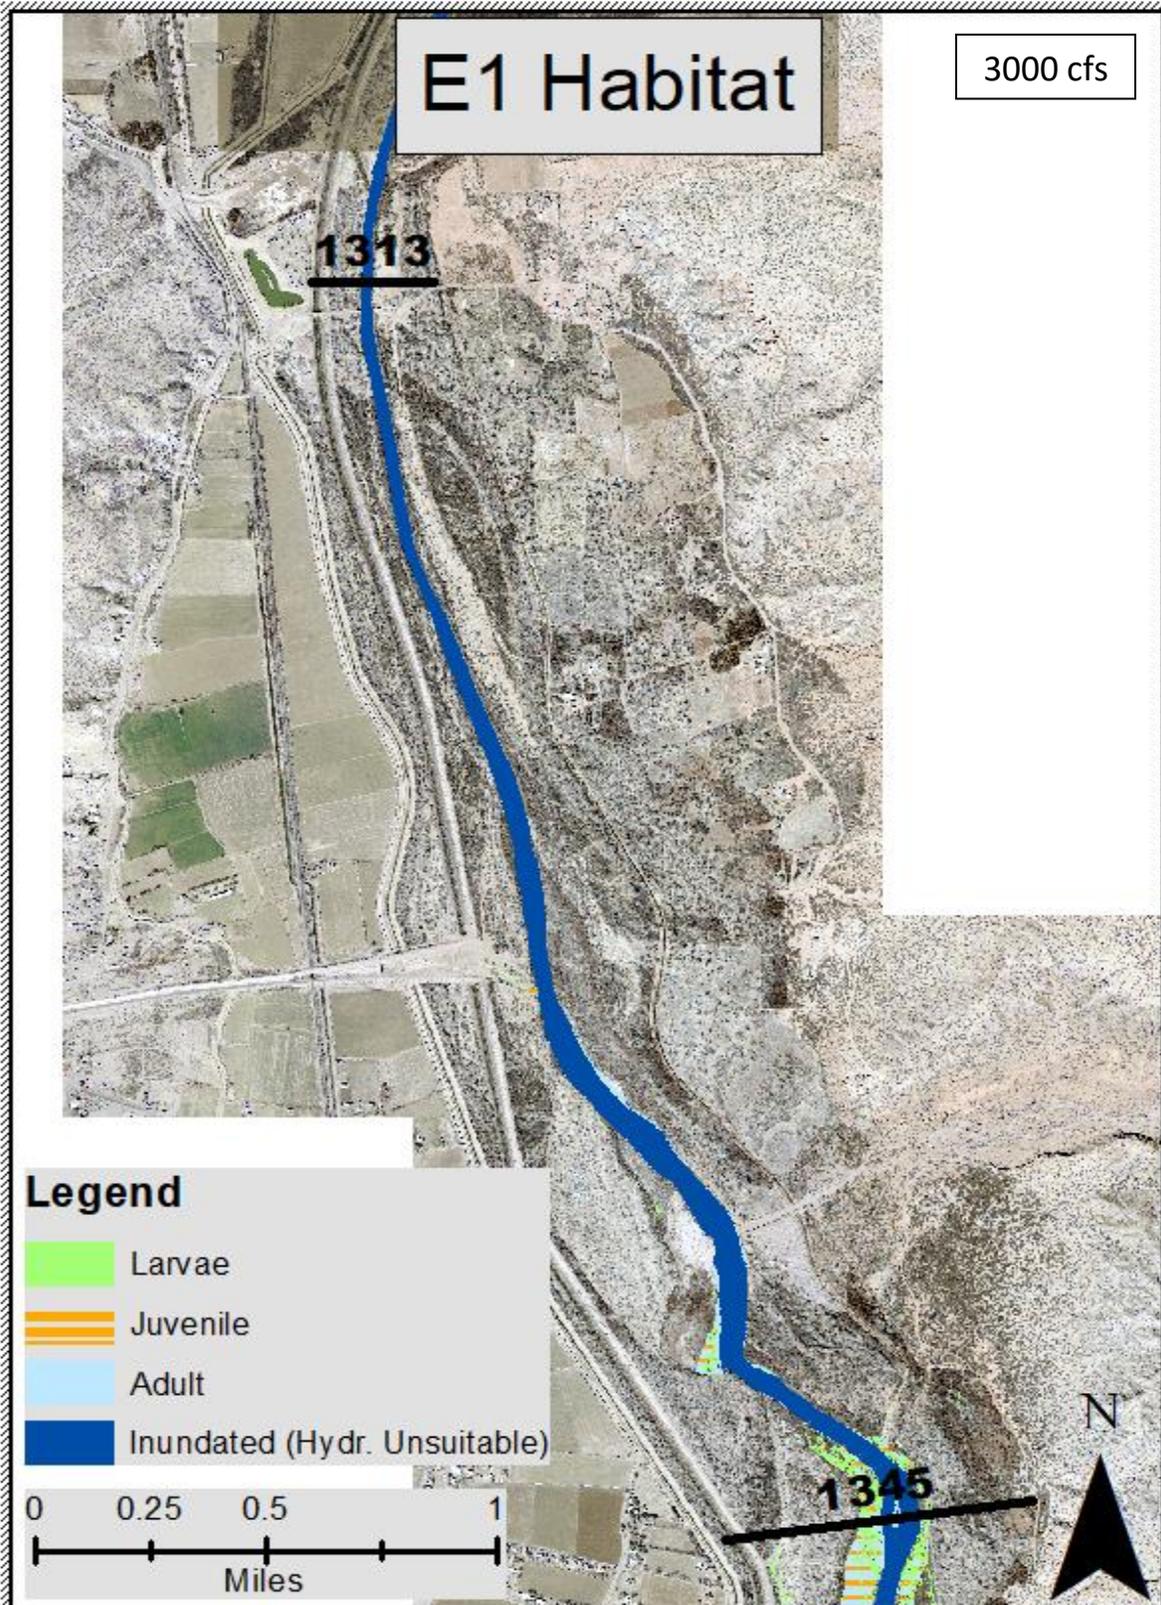
Figure E- 7 RGSM Habitat in subreach E1 at 3000 cfs with hydraulically suitable areas labeled for larvae (green), juvenile (orange), and adult (light blue) and unsuitable inundated areas in dark blue.

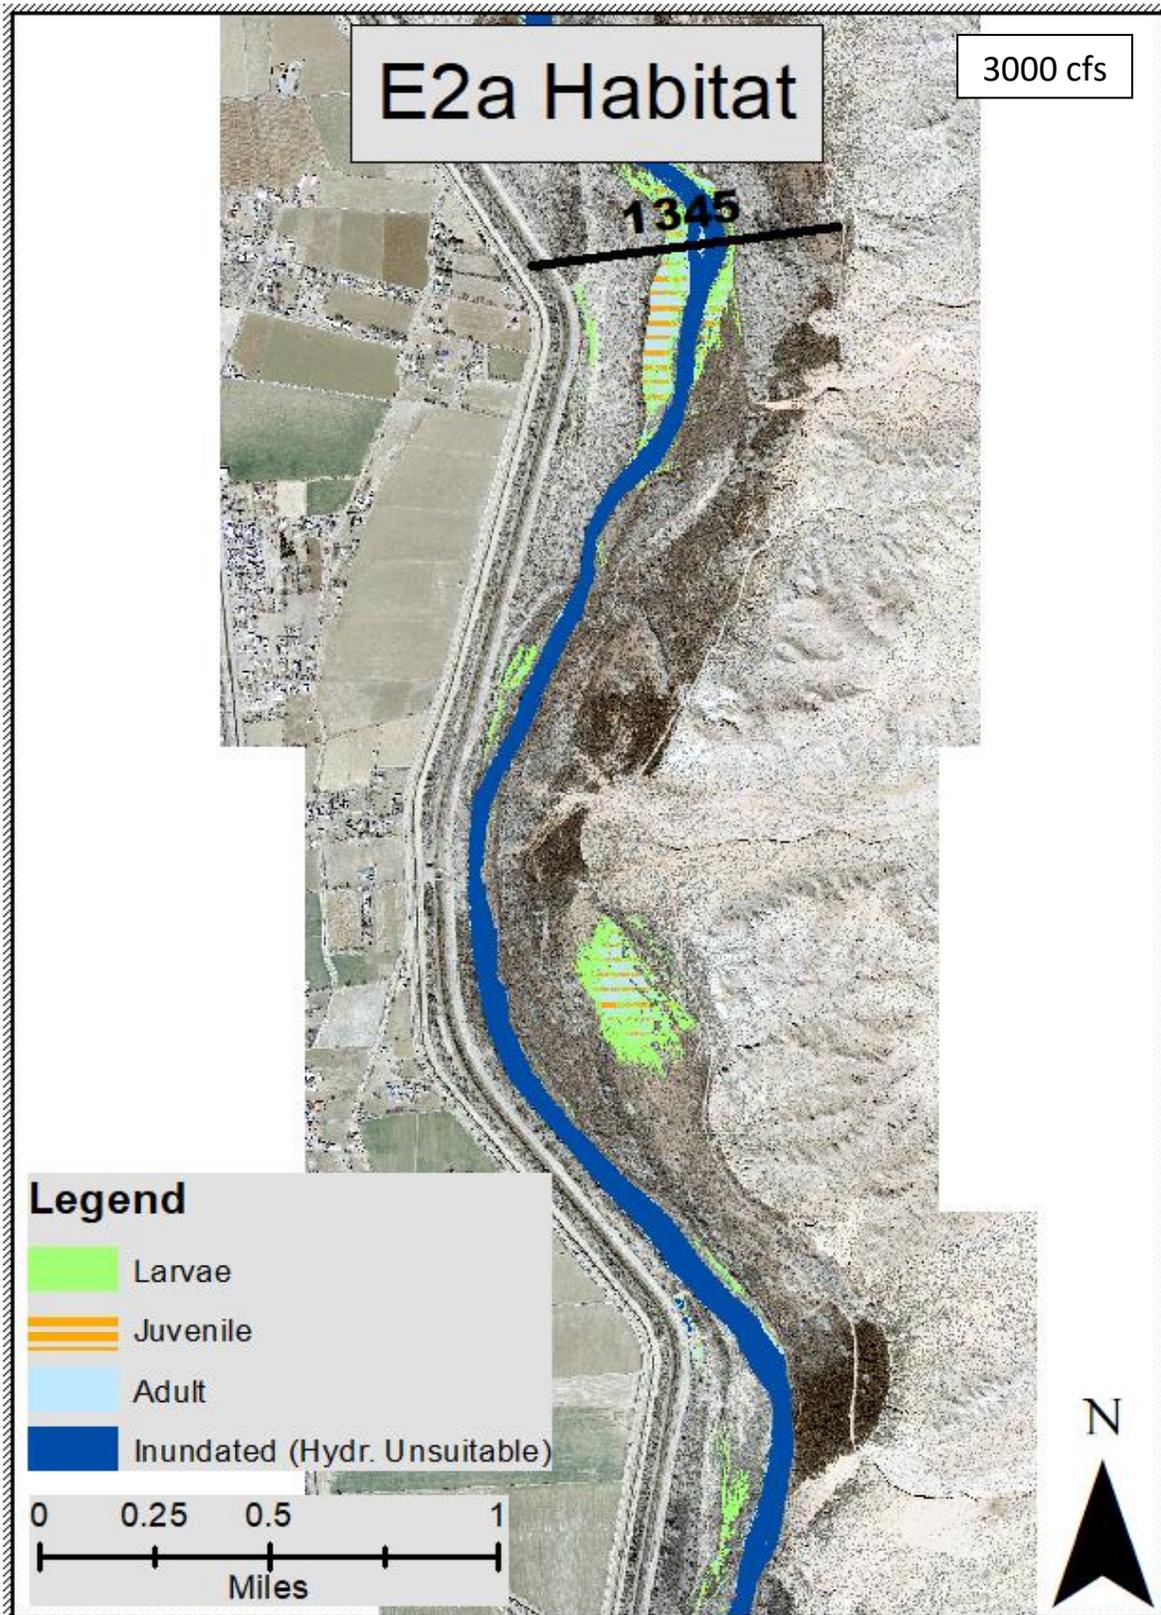
Figure E- 8 RGSM Habitat in subreach E2 (upstream portion part a) at 3000 cfs with hydraulically suitable areas labeled for larvae (green), juvenile (orange), and adult (light blue) and unsuitable inundated areas in dark blue.

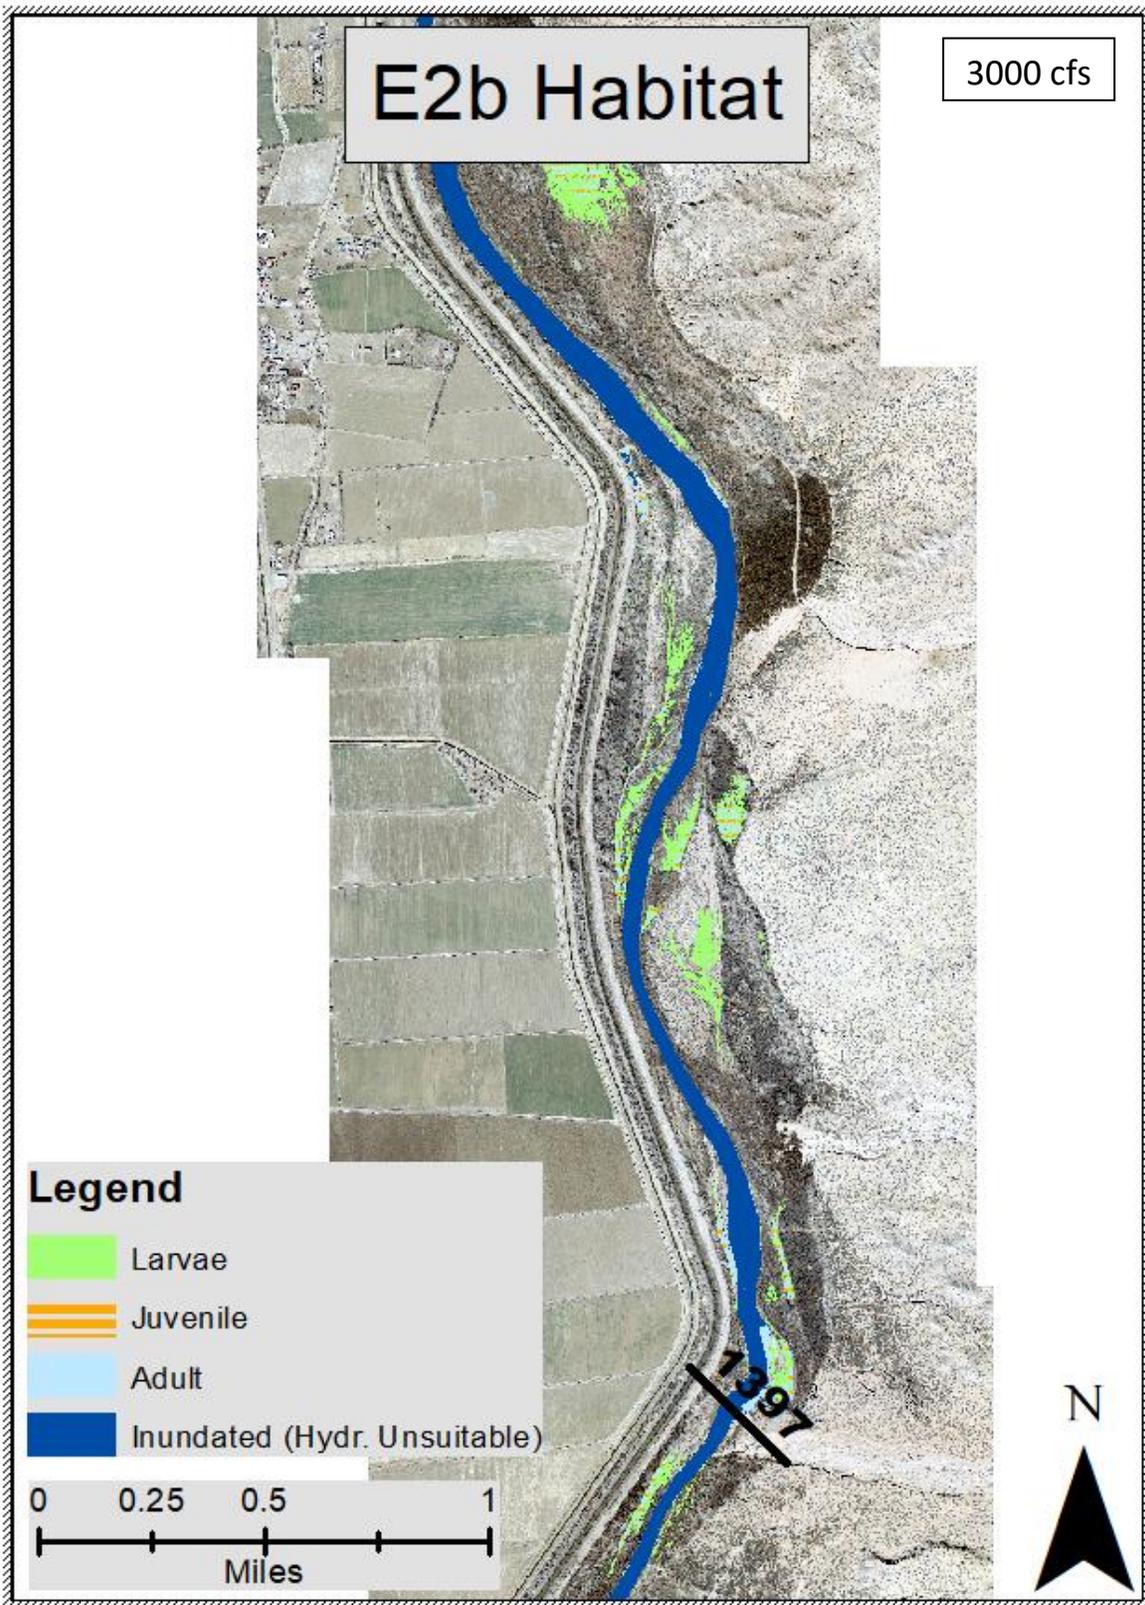
Figure E-9 RGSM Habitat in subreach E2 (downstream portion part b) at 3000 cfs with hydraulically suitable areas labeled for larvae (green), juvenile (orange), and adult (light blue) and unsuitable inundated areas in dark blue.

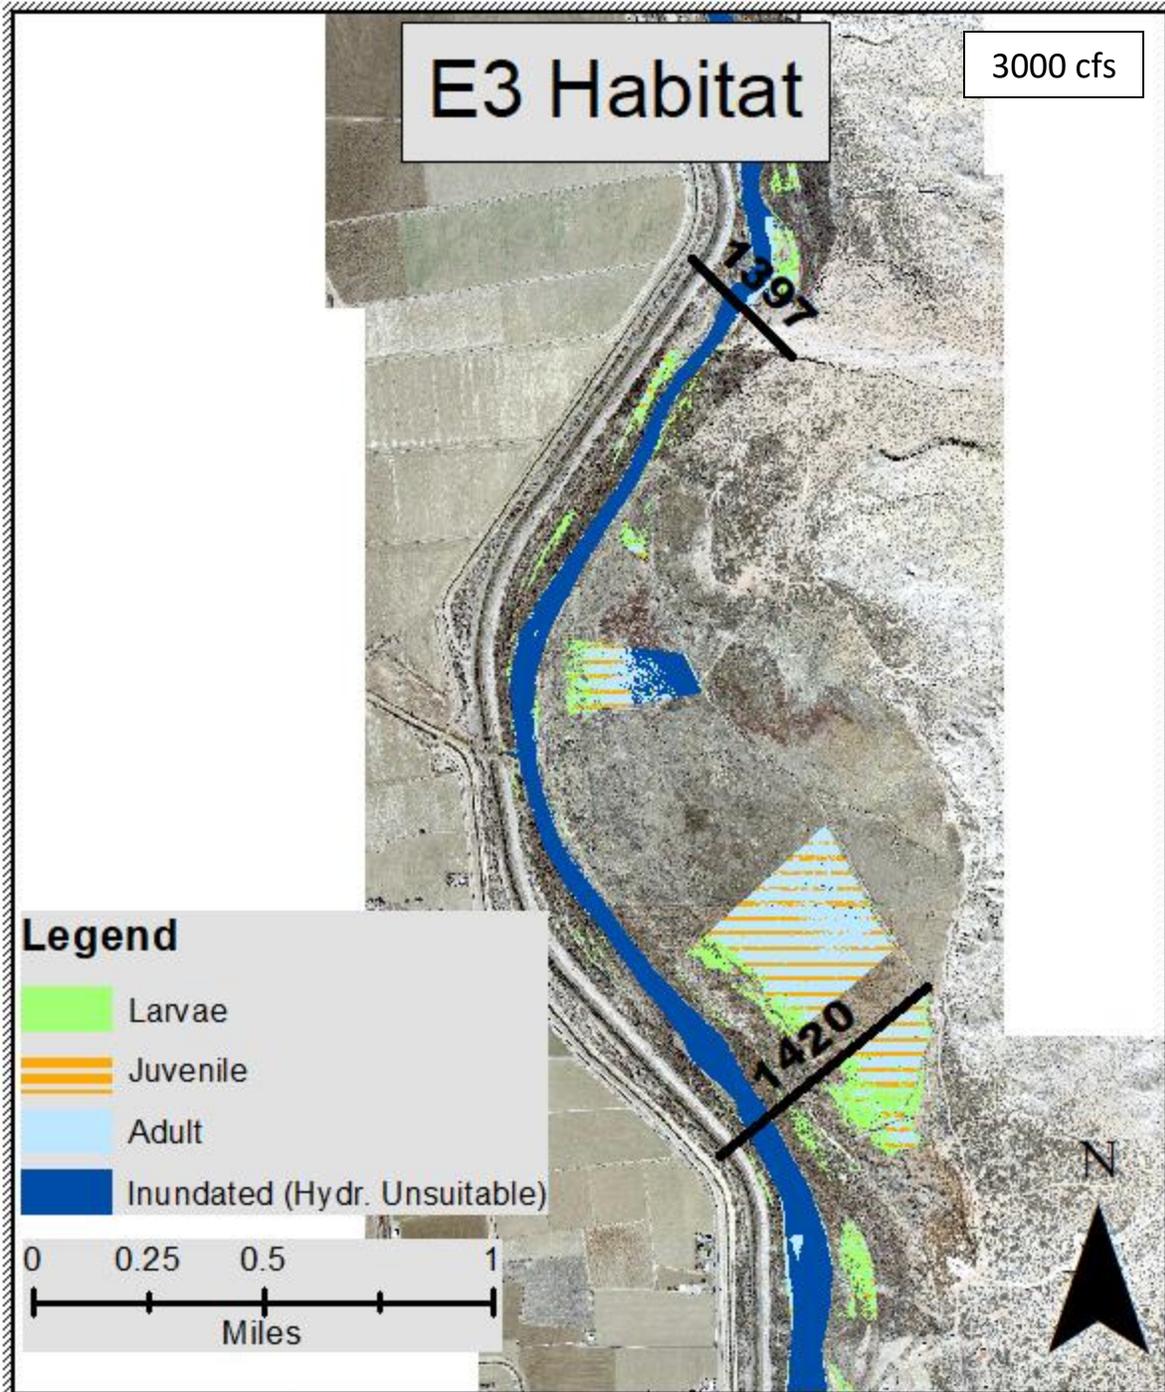
Figure E- 10 RGSM Habitat in subreach E3 at 3000 cfs with hydraulically suitable areas labeled for larvae (green), juvenile (orange), and adult (light blue) and unsuitable inundated areas in dark blue. At 3,000 cfs, computational levees have not been removed from the model, so some cross sections are experiencing overtopping while others are not.

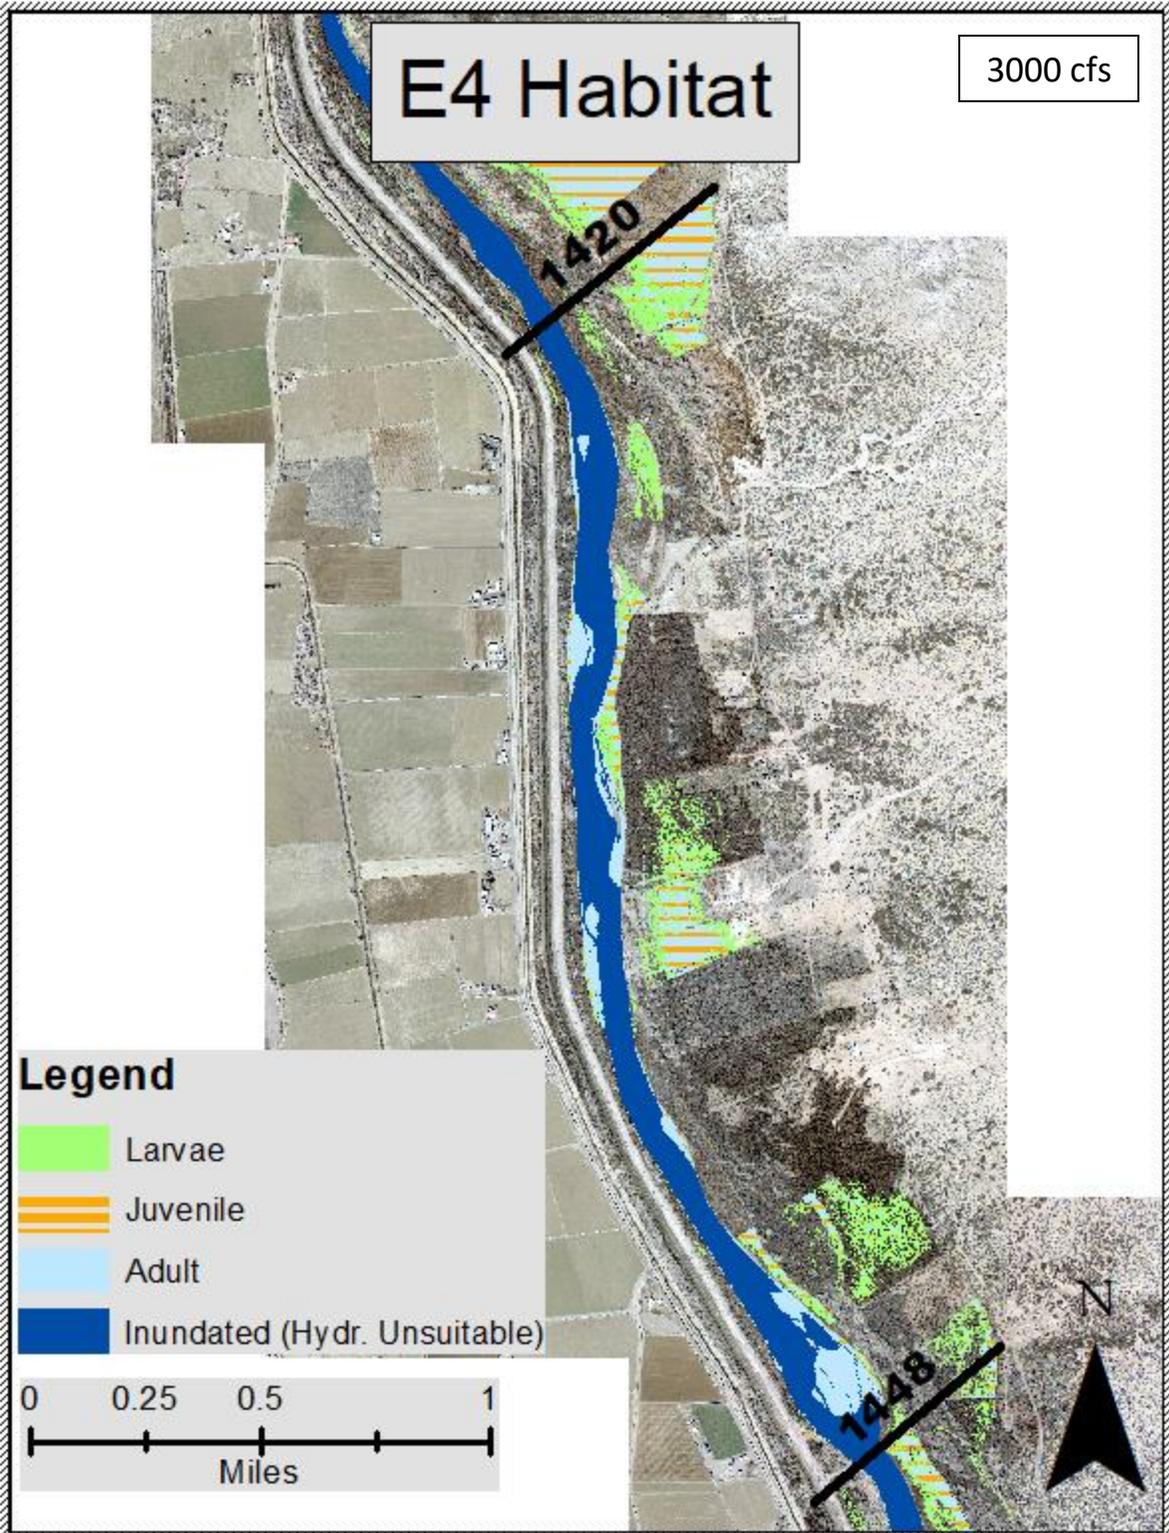
Figure E- 11 RGSM Habitat in subreach E4 at 3000 cfs with hydraulically suitable areas labeled for larvae (green), juvenile (orange), and adult (light blue) and unsuitable inundated areas in dark blue.

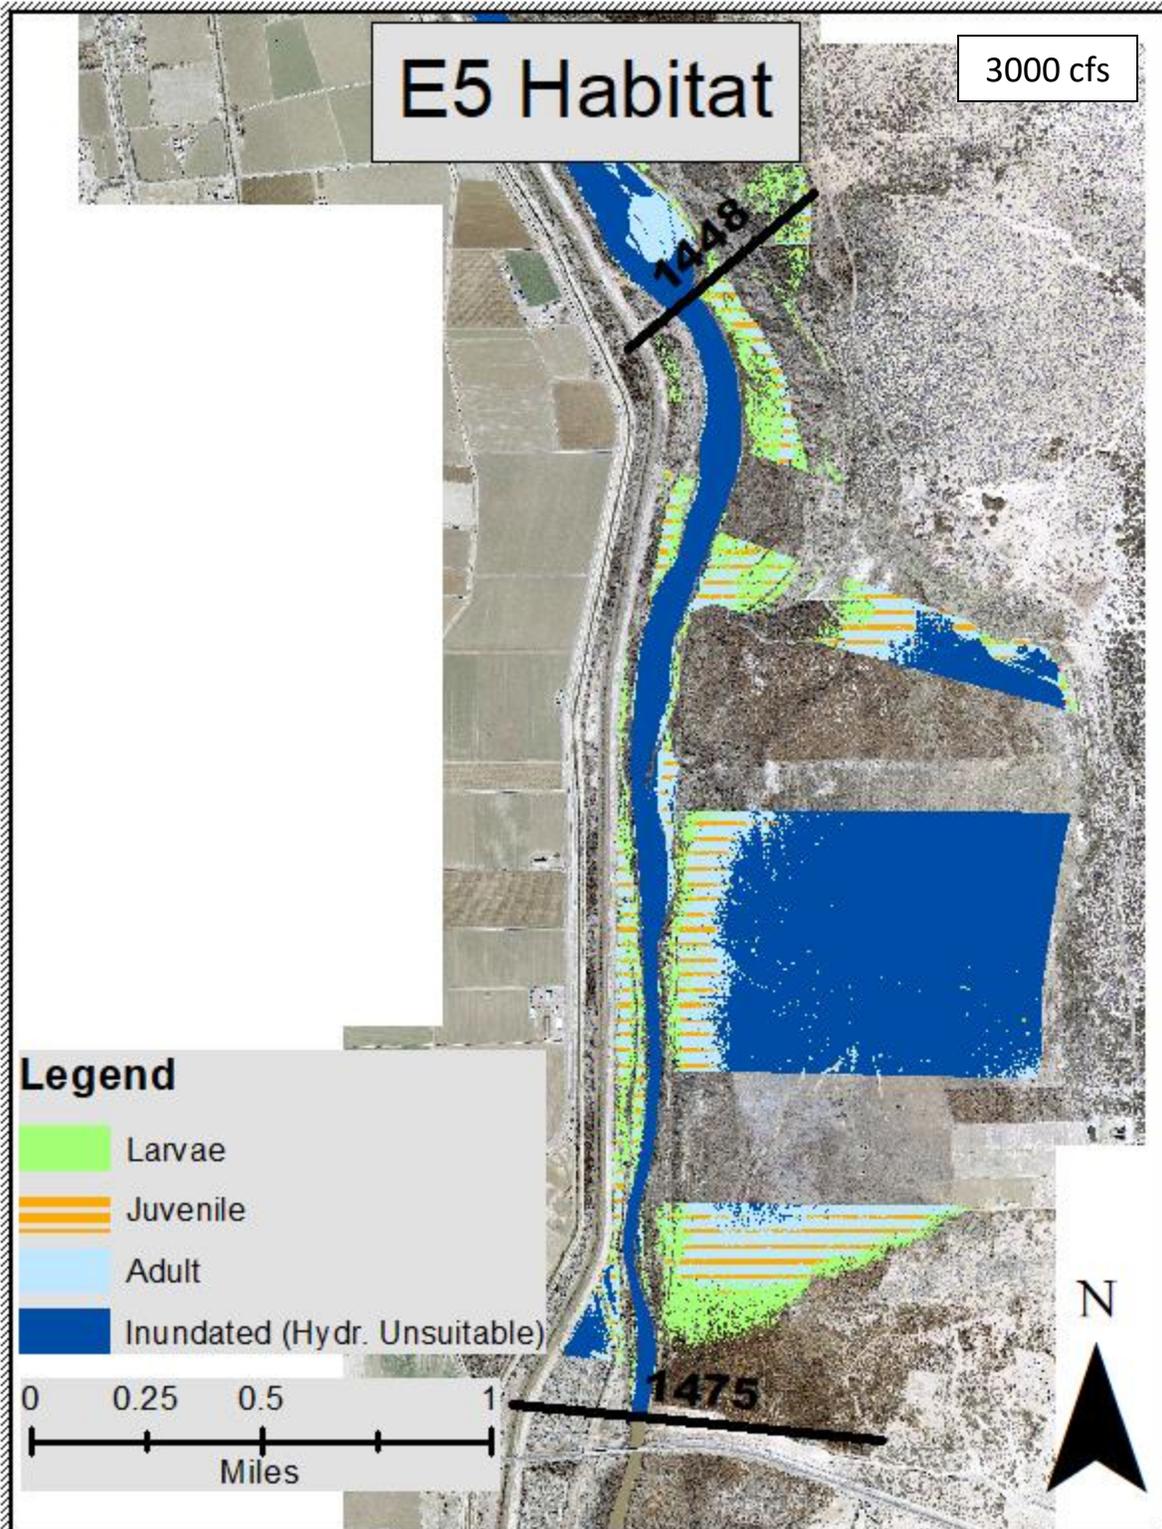
Figure E- 12 RGSM Habitat in subreach E5 at 3000 cfs with hydraulically suitable areas labeled for larvae (green), juvenile (orange), and adult (light blue) and unsuitable inundated areas in dark blue.

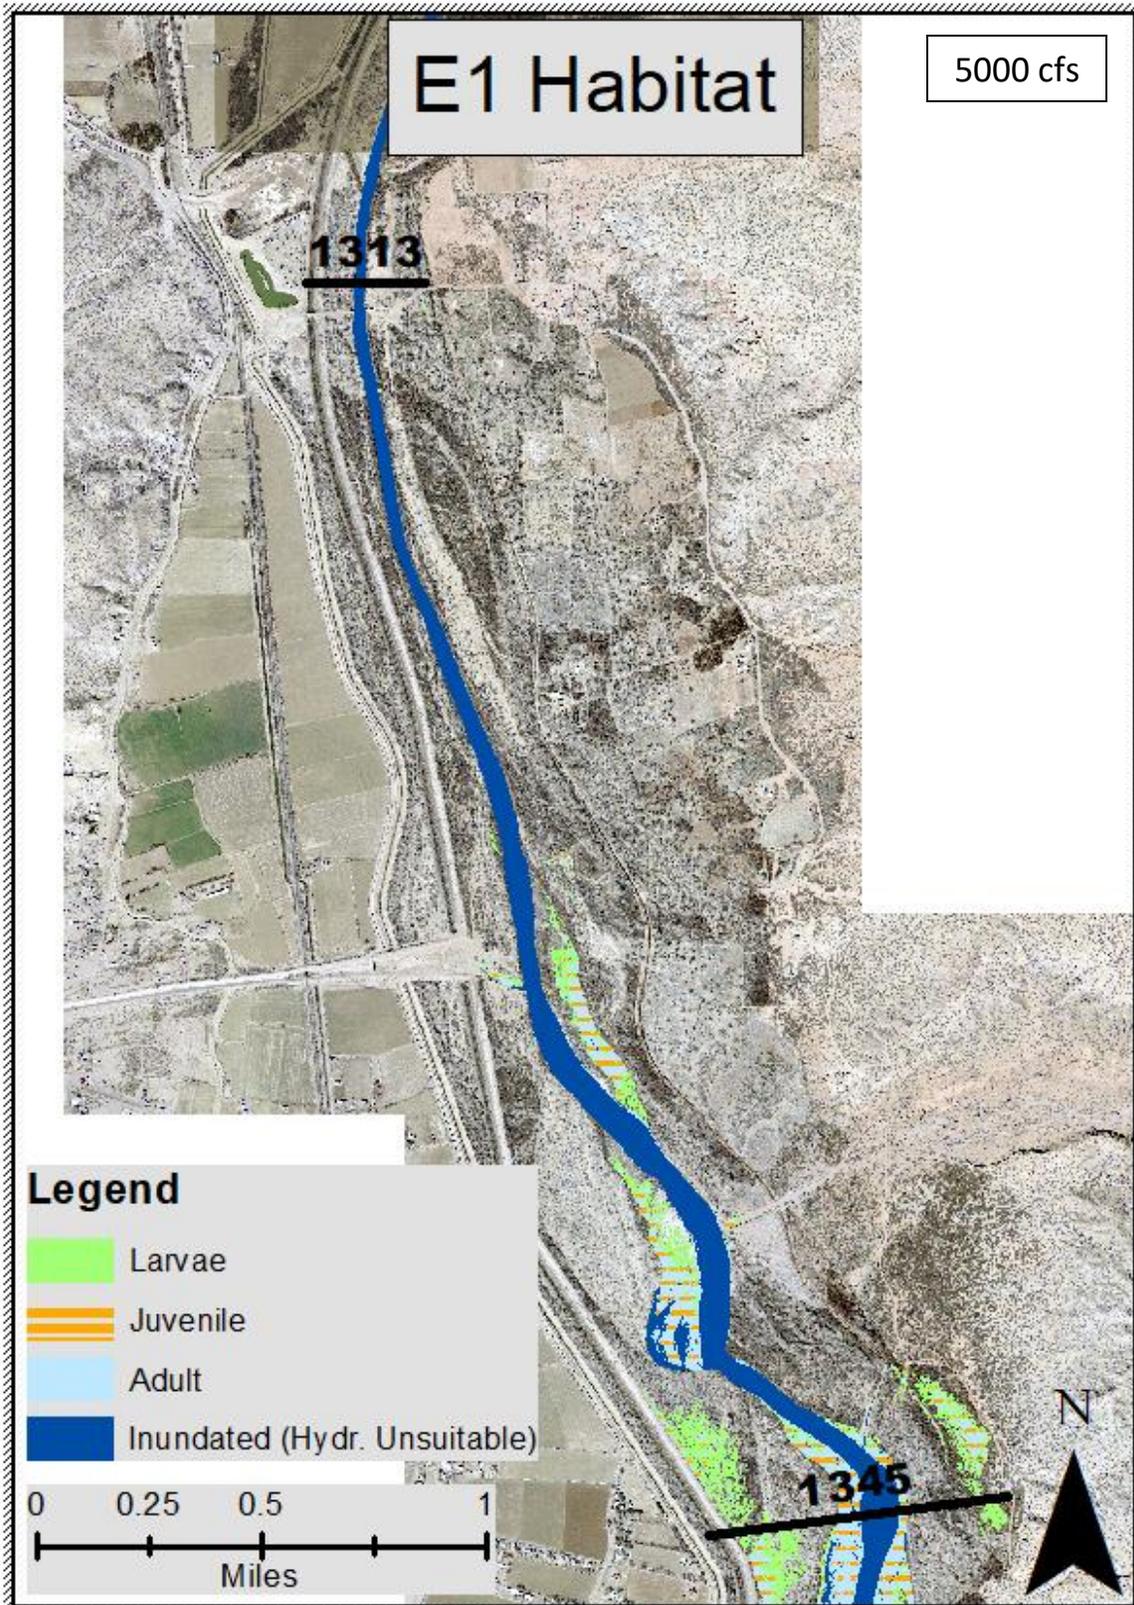
Figure E- 13 RGSM Habitat in subreach E1 at 5000 cfs with hydraulically suitable areas labeled for larvae (green), juvenile (orange), and adult (light blue) and unsuitable inundated areas in dark blue.

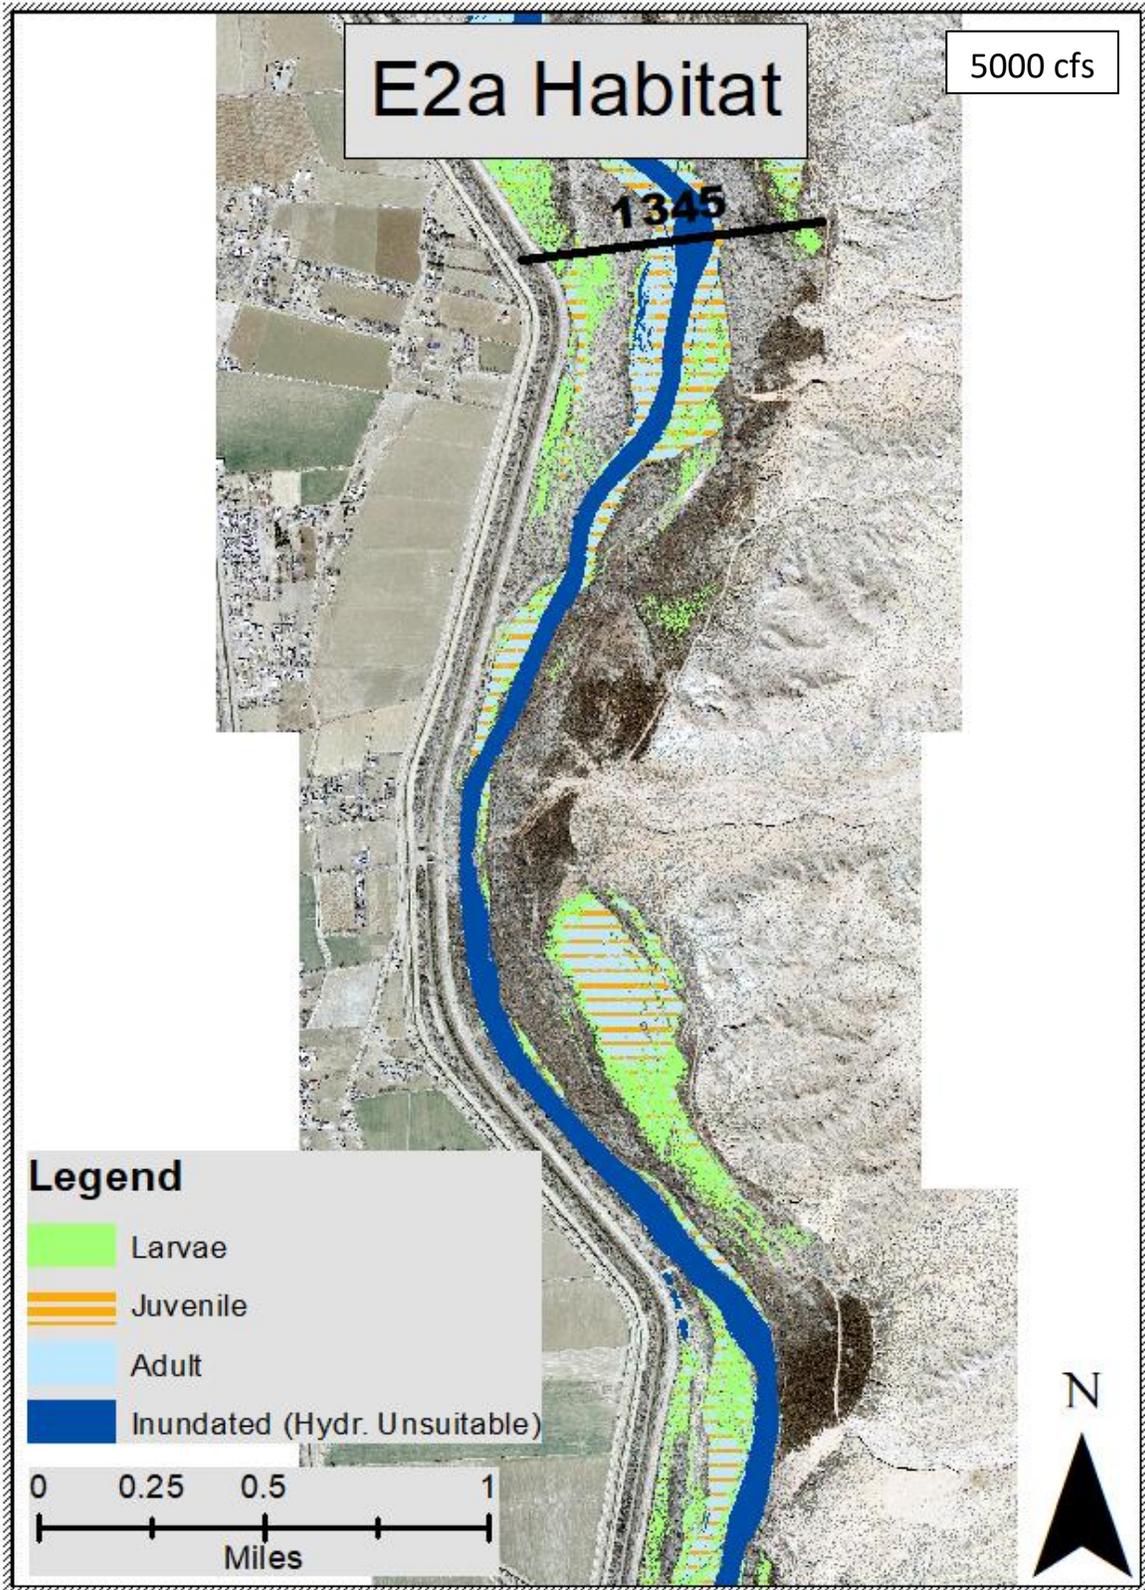
Figure E- 14 RGSM Habitat in subreach E2 (upstream portion part a) at 5000 cfs with hydraulically suitable areas labeled for larvae (green), juvenile (orange), and adult (light blue) and unsuitable inundated areas in dark blue.

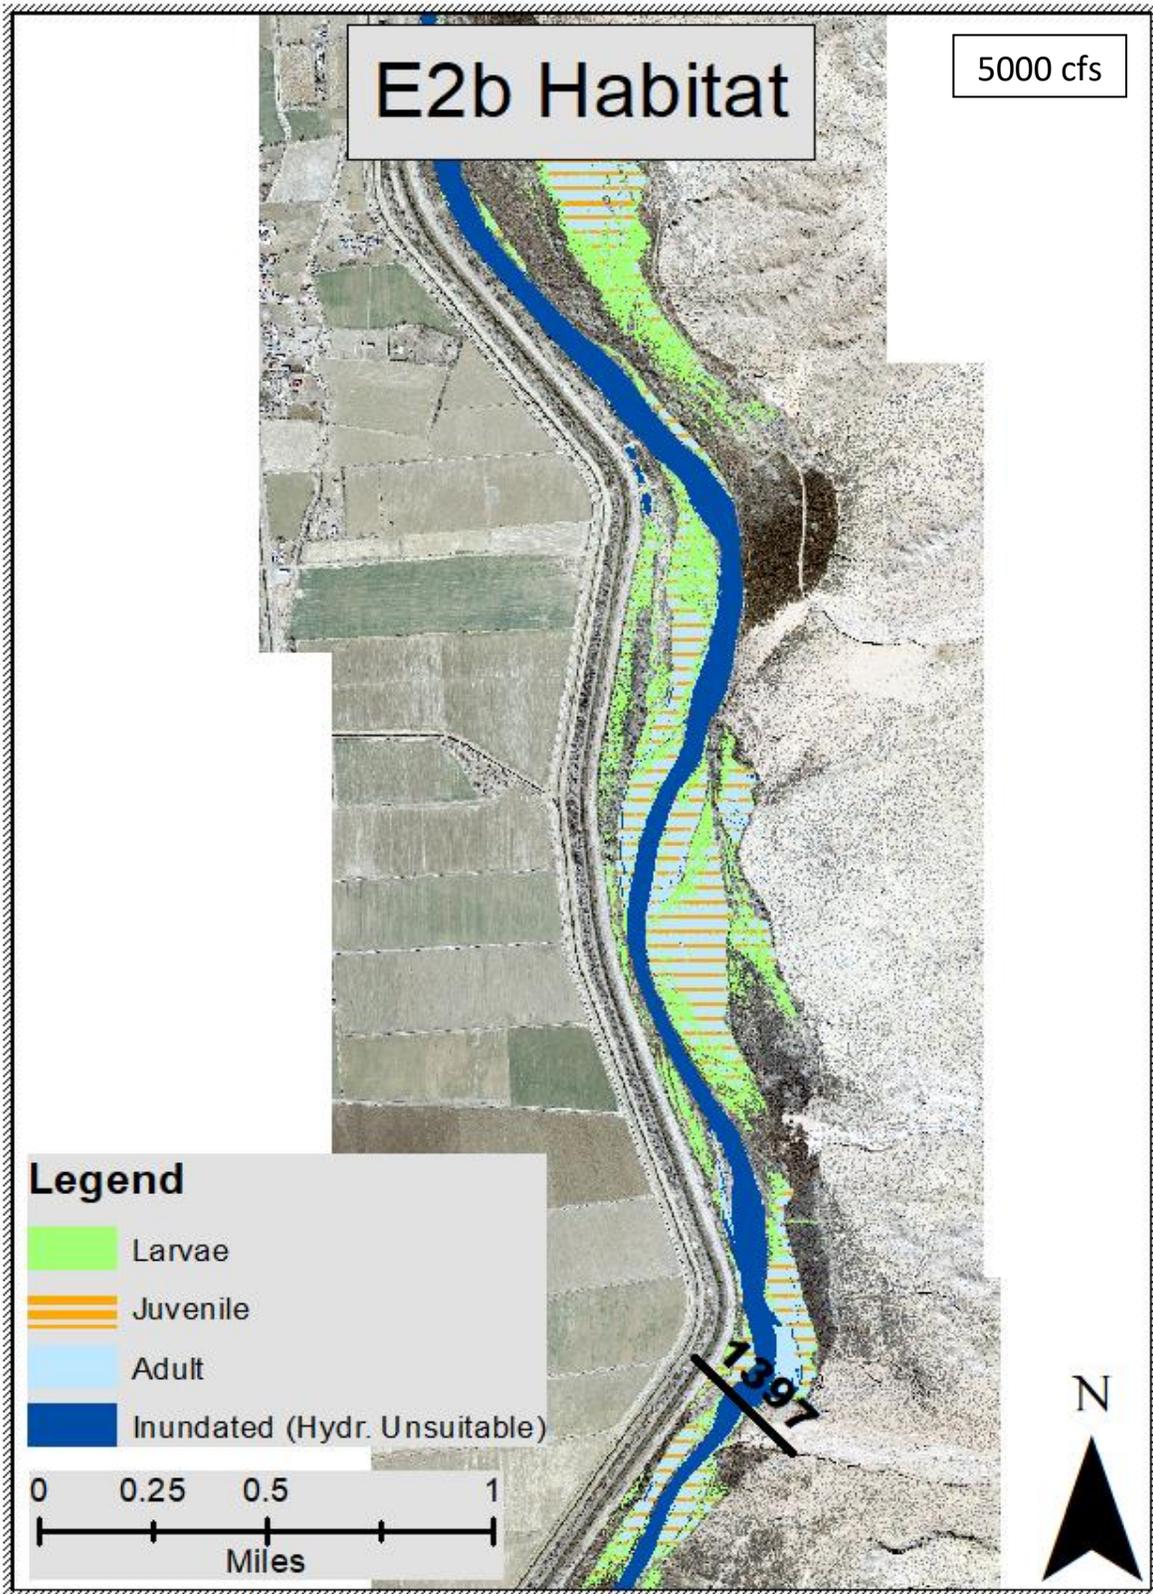
Figure E- 15 RGSM Habitat in subreach E2 (downstream portion part b) at 5000 cfs with hydraulically suitable areas labeled for larvae (green), juvenile (orange), and adult (light blue) and unsuitable inundated areas in dark blue.

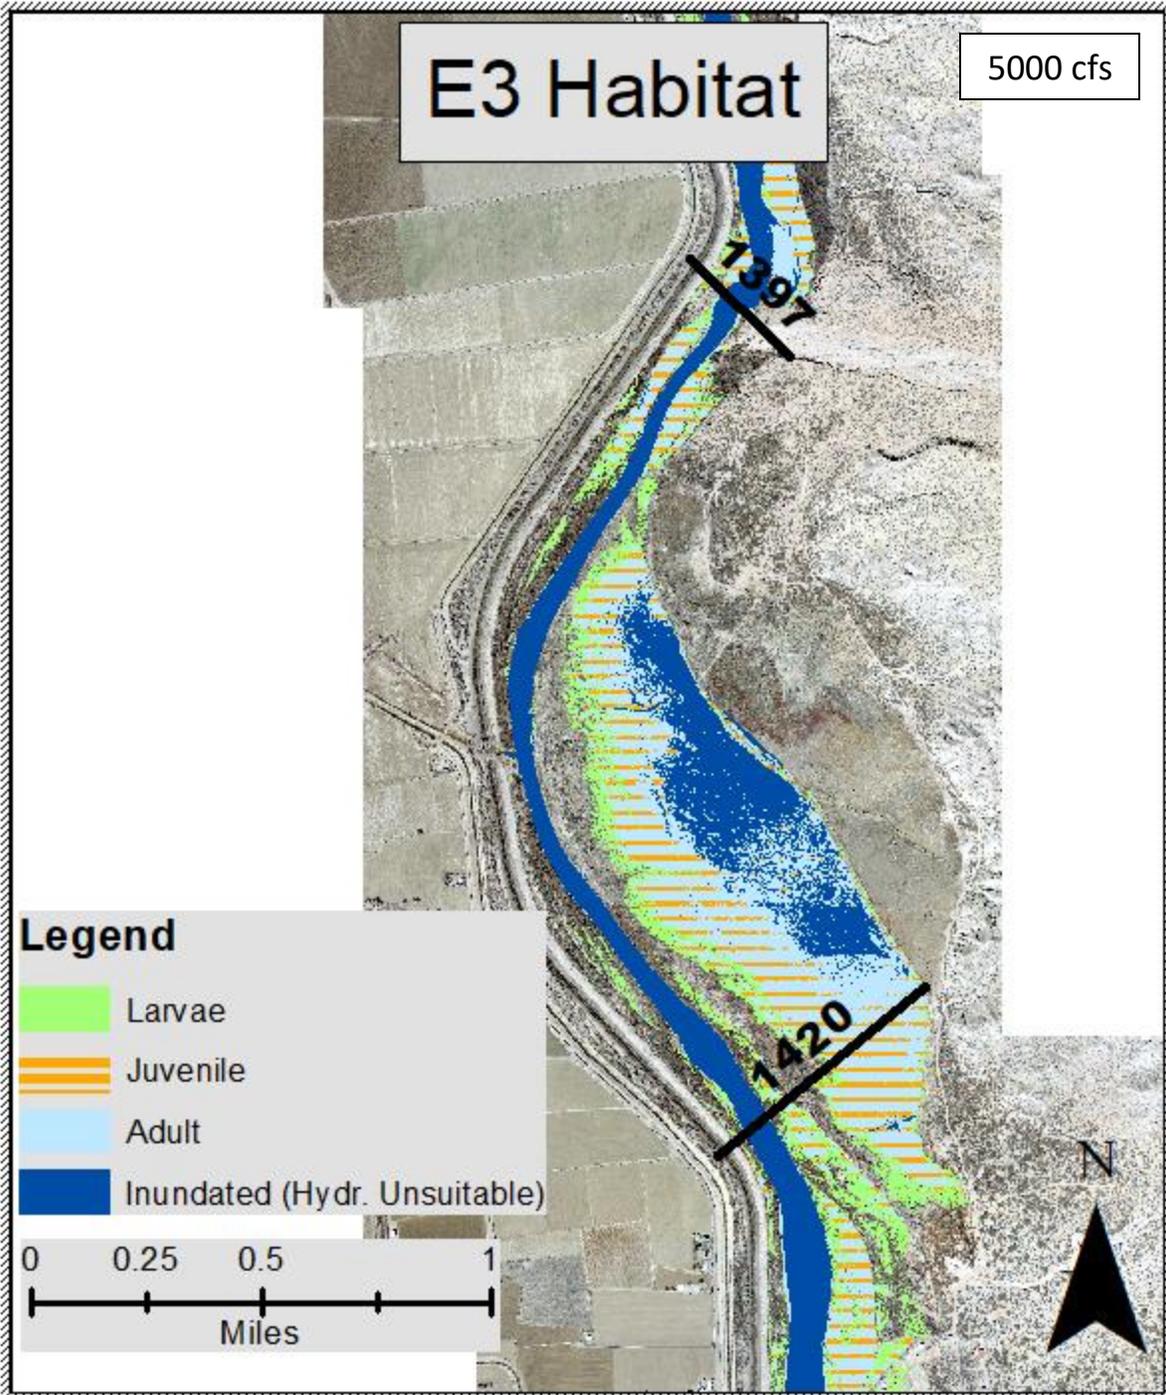
Figure E- 16 RGSM Habitat in subreach E3 at 5000 cfs with hydraulically suitable areas labeled for larvae (green), juvenile (orange), and adult (light blue) and unsuitable inundated areas in dark blue.

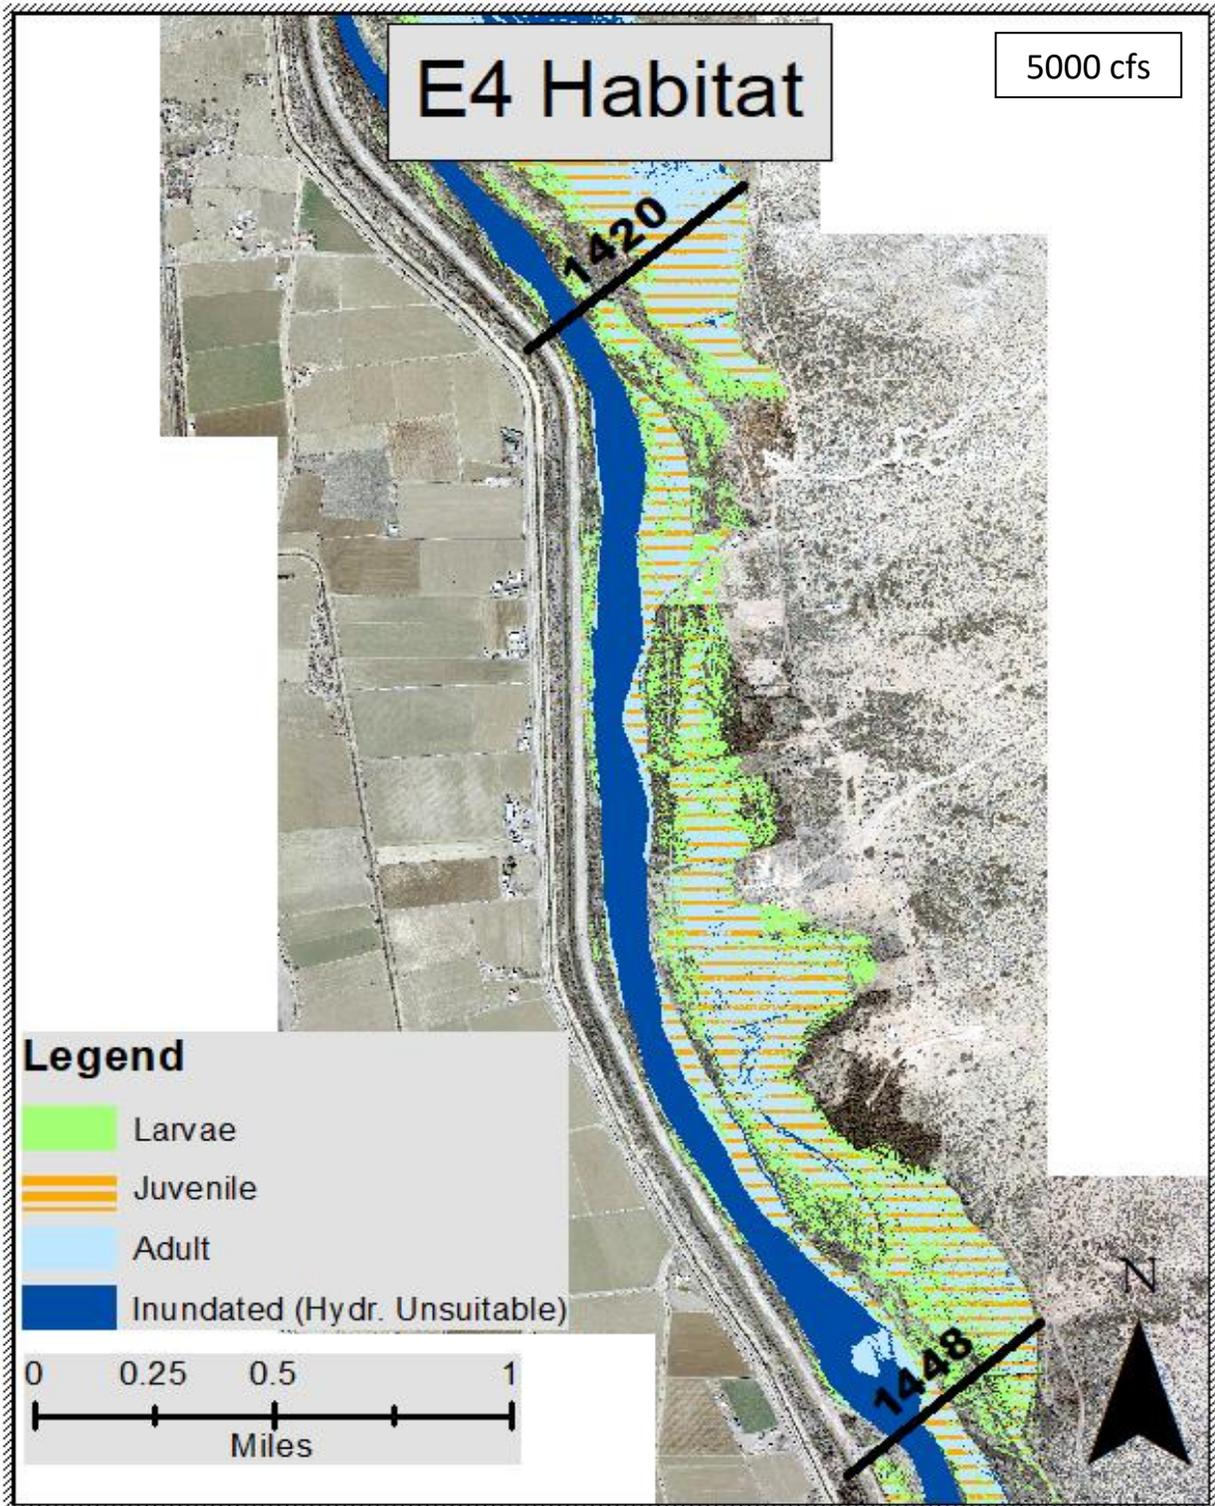
Figure E- 17 RGSM Habitat in subreach E4 at 5000 cfs with hydraulically suitable areas labeled for larvae (green), juvenile (orange), and adult (light blue) and unsuitable inundated areas in dark blue

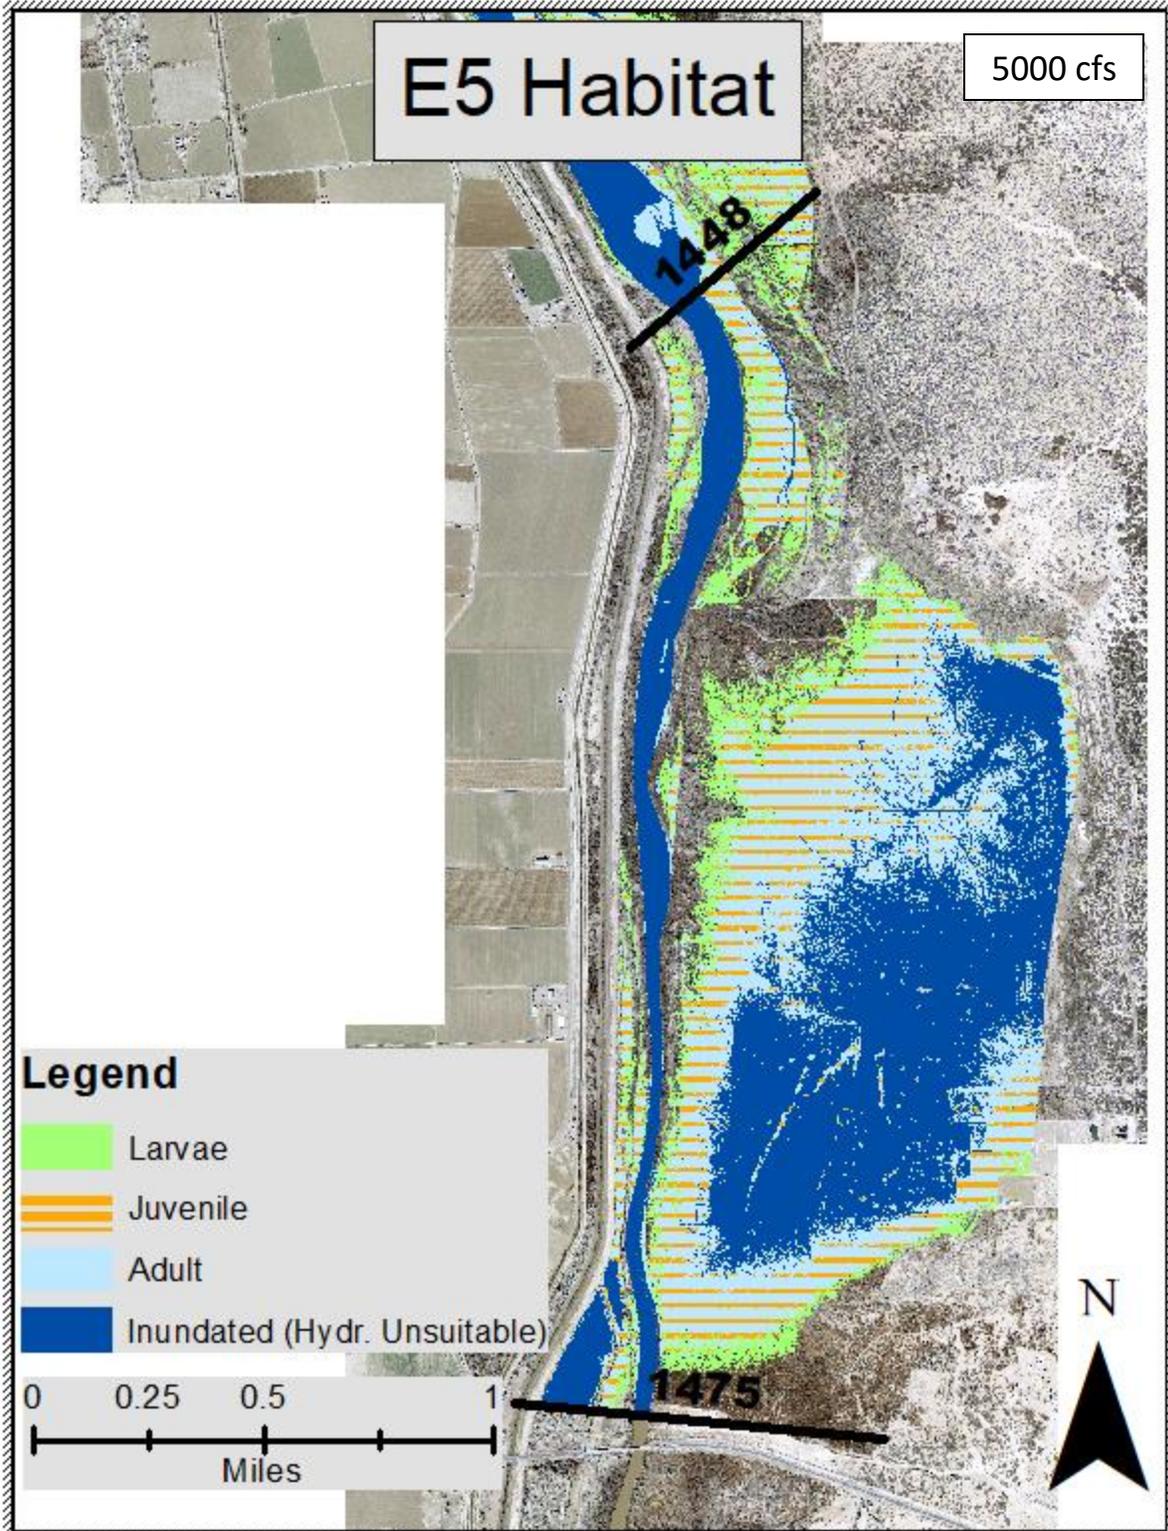
Figure E- 18 RGSM Habitat in subreach E5 at 5000 cfs with hydraulically suitable areas labeled for larvae (green), juvenile (orange), and adult (light blue) and unsuitable inundated areas in dark blue.
