Middle Rio Grande Escondida Reach:

Morpho-dynamic Processes and Silvery Minnow Habitat
from Escondida Bridge to US-380 Bridge
(1918-2018)

August 2020
Master of Science
Plan B Technical Report

Prepared by:
Tori Beckwith

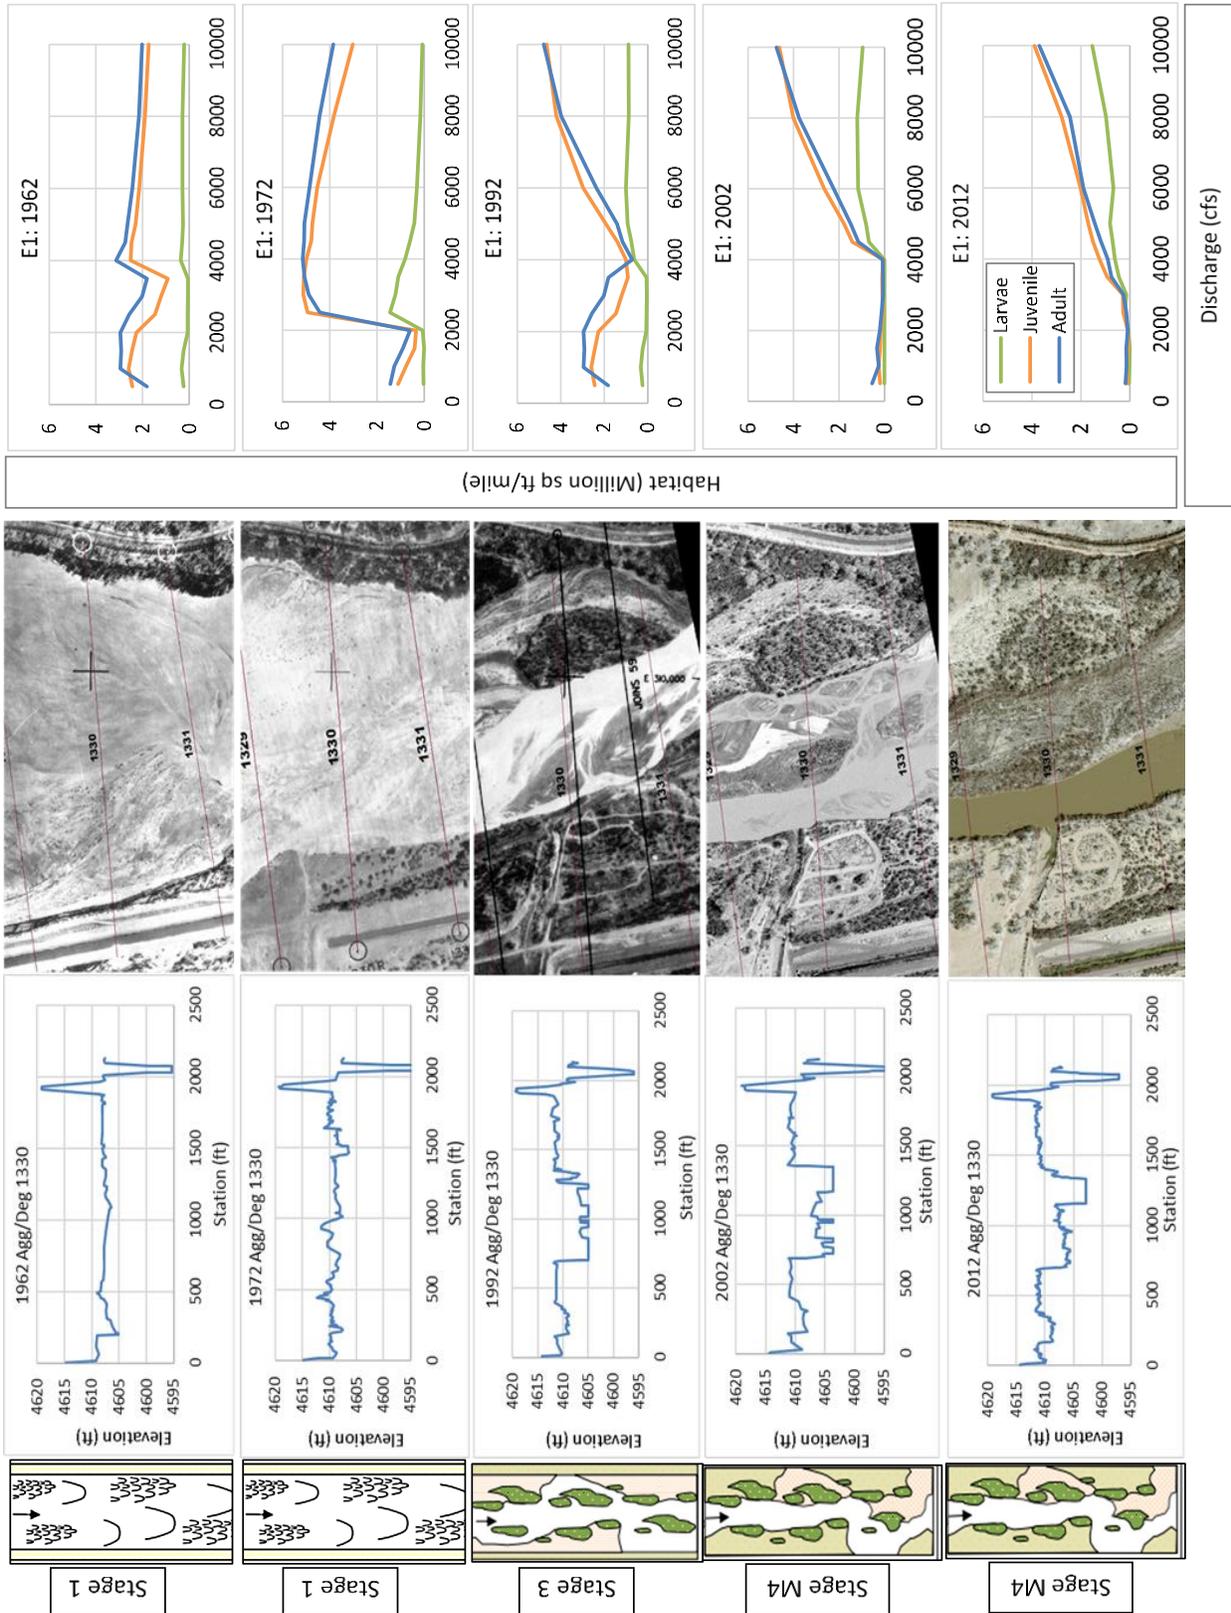
Figure F- 1 Geomorphology and habitat connections collage for subreach E1

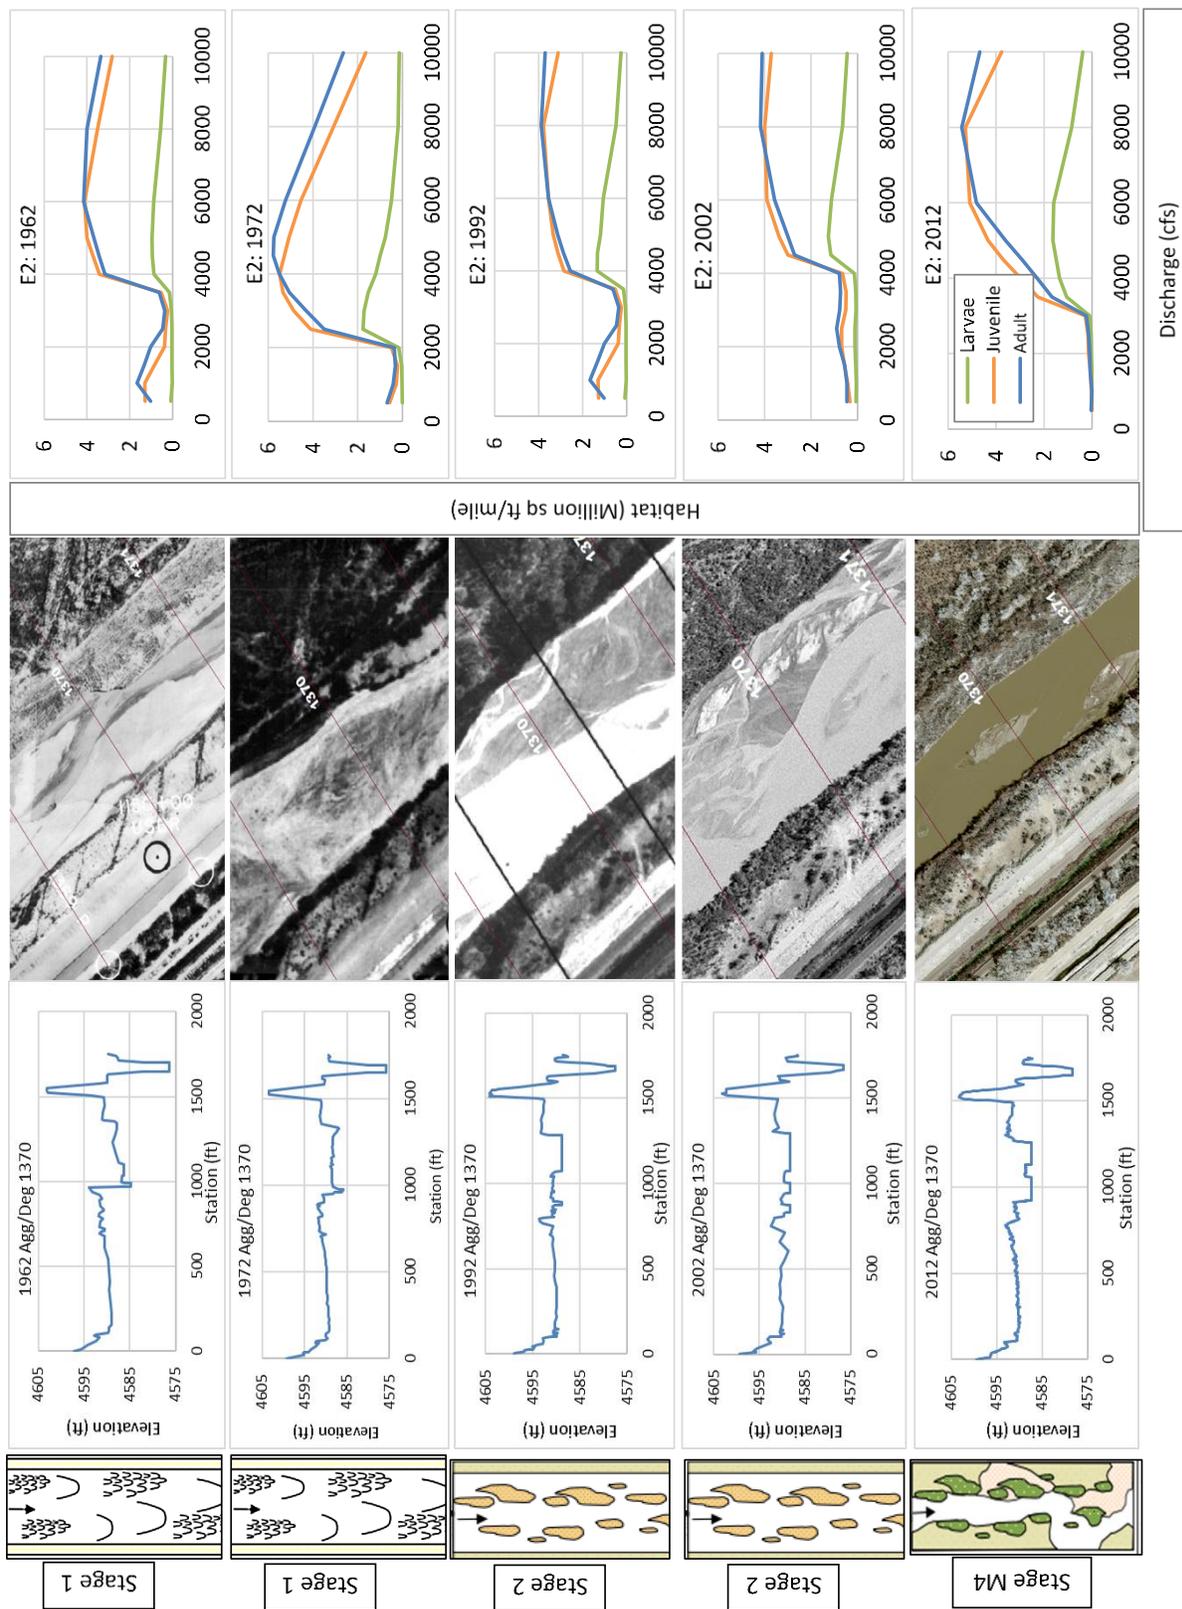
Figure F- 2 Geomorphology and habitat connections collage for subreach E2

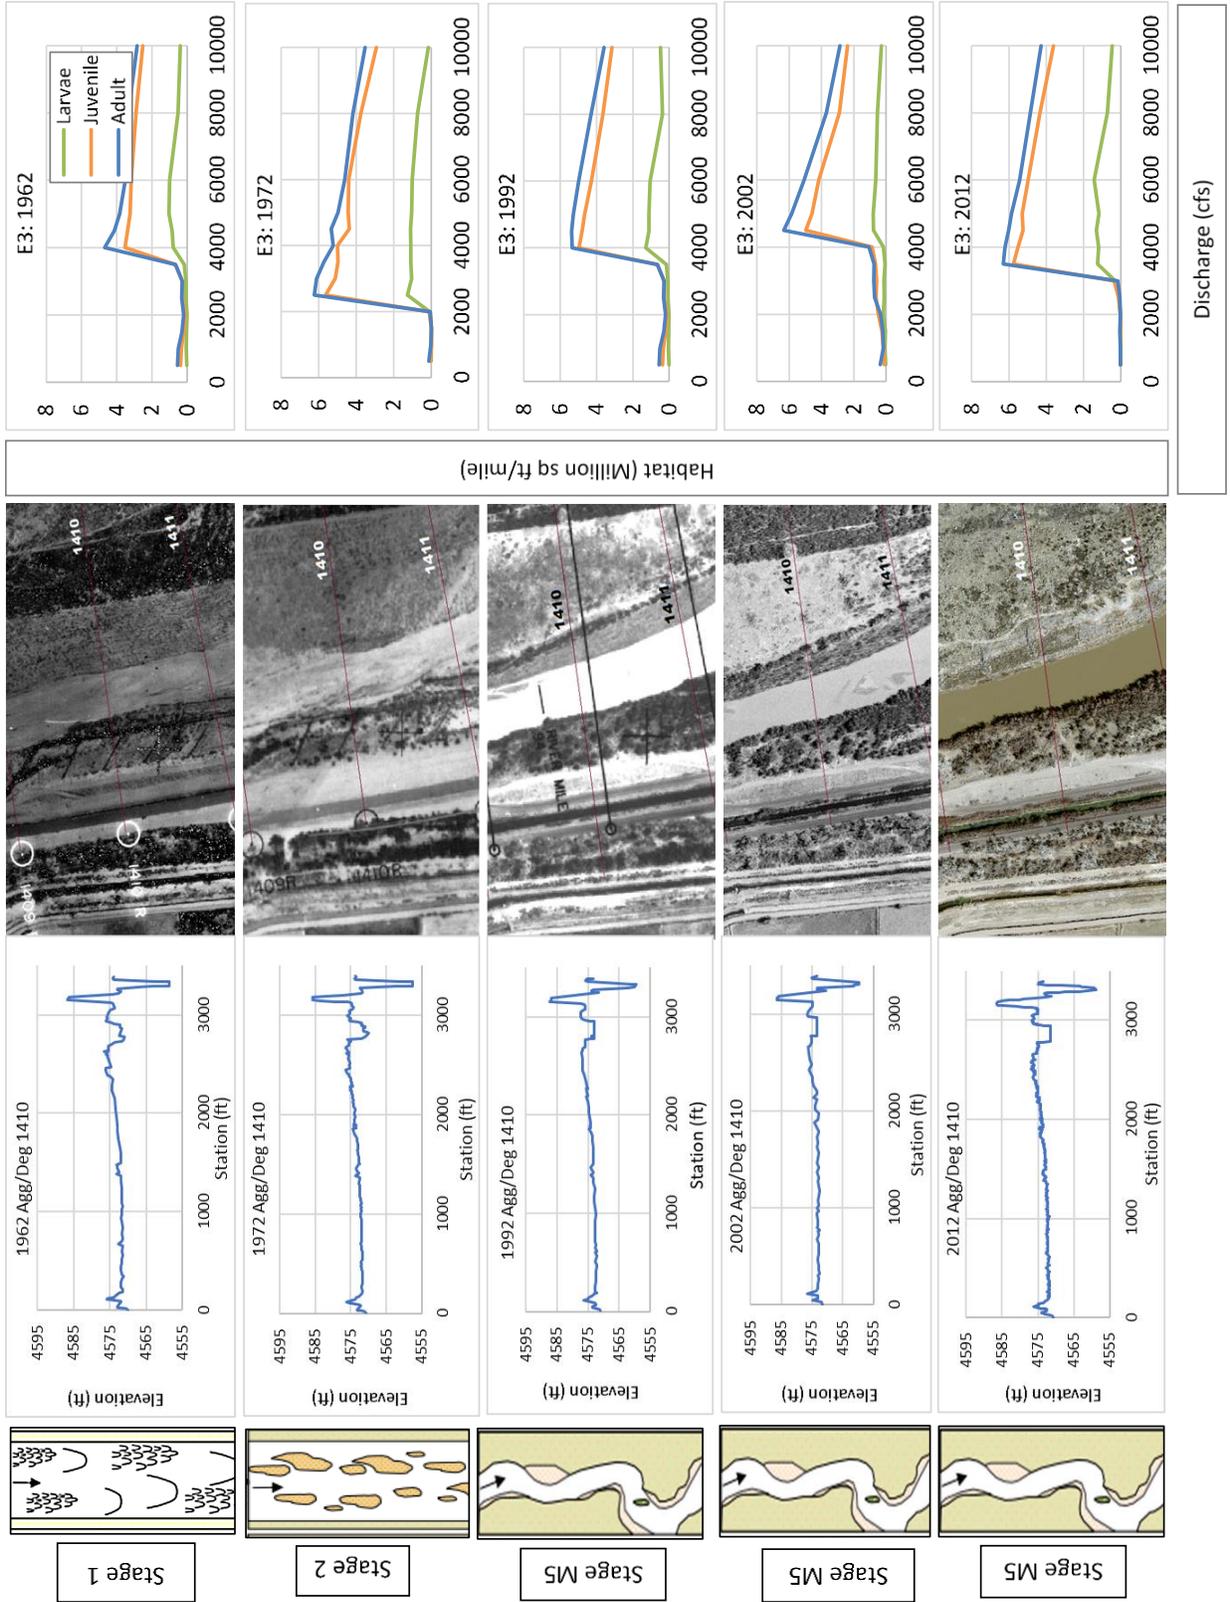
Figure F- 3 Geomorphology and habitat connections collage for subreach E3

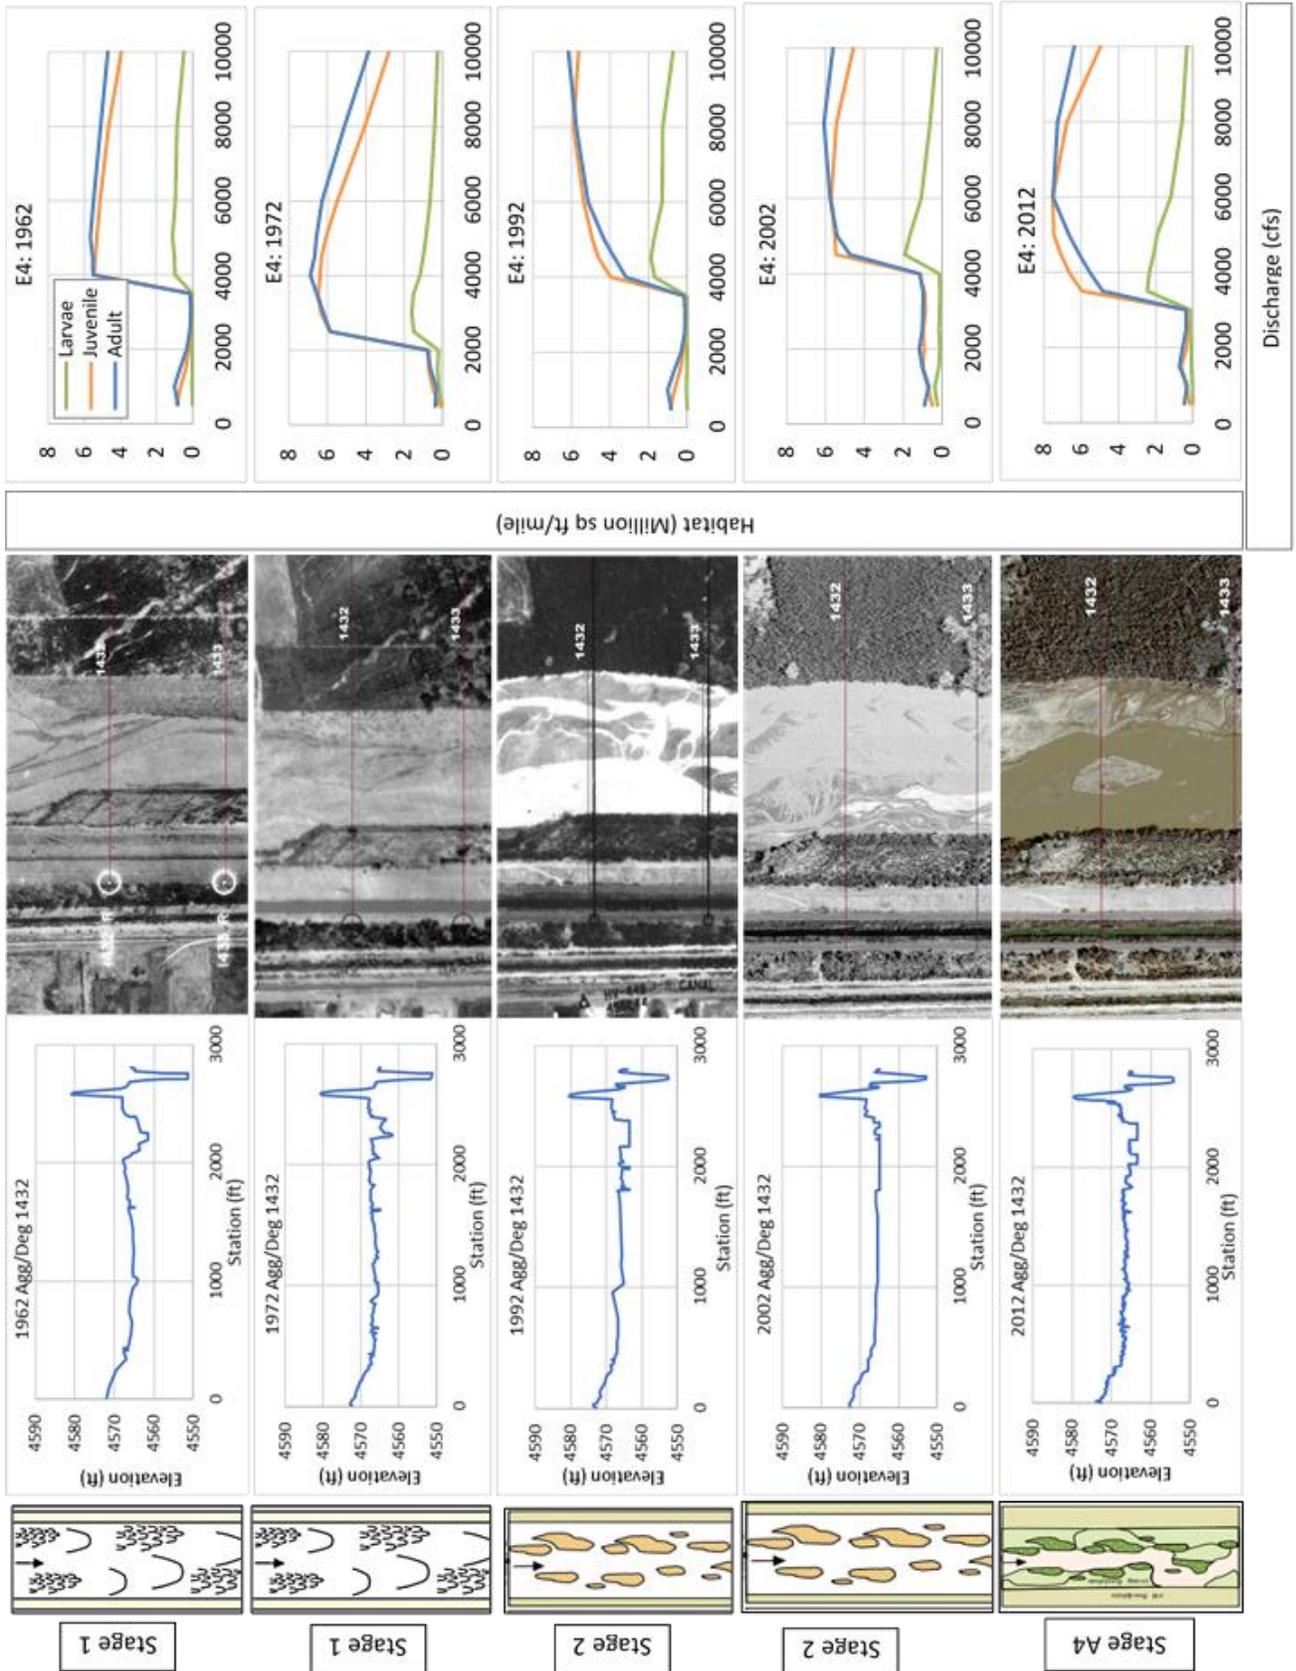
Figure F- 4 Geomorphology and habitat connections collage for subreach E4

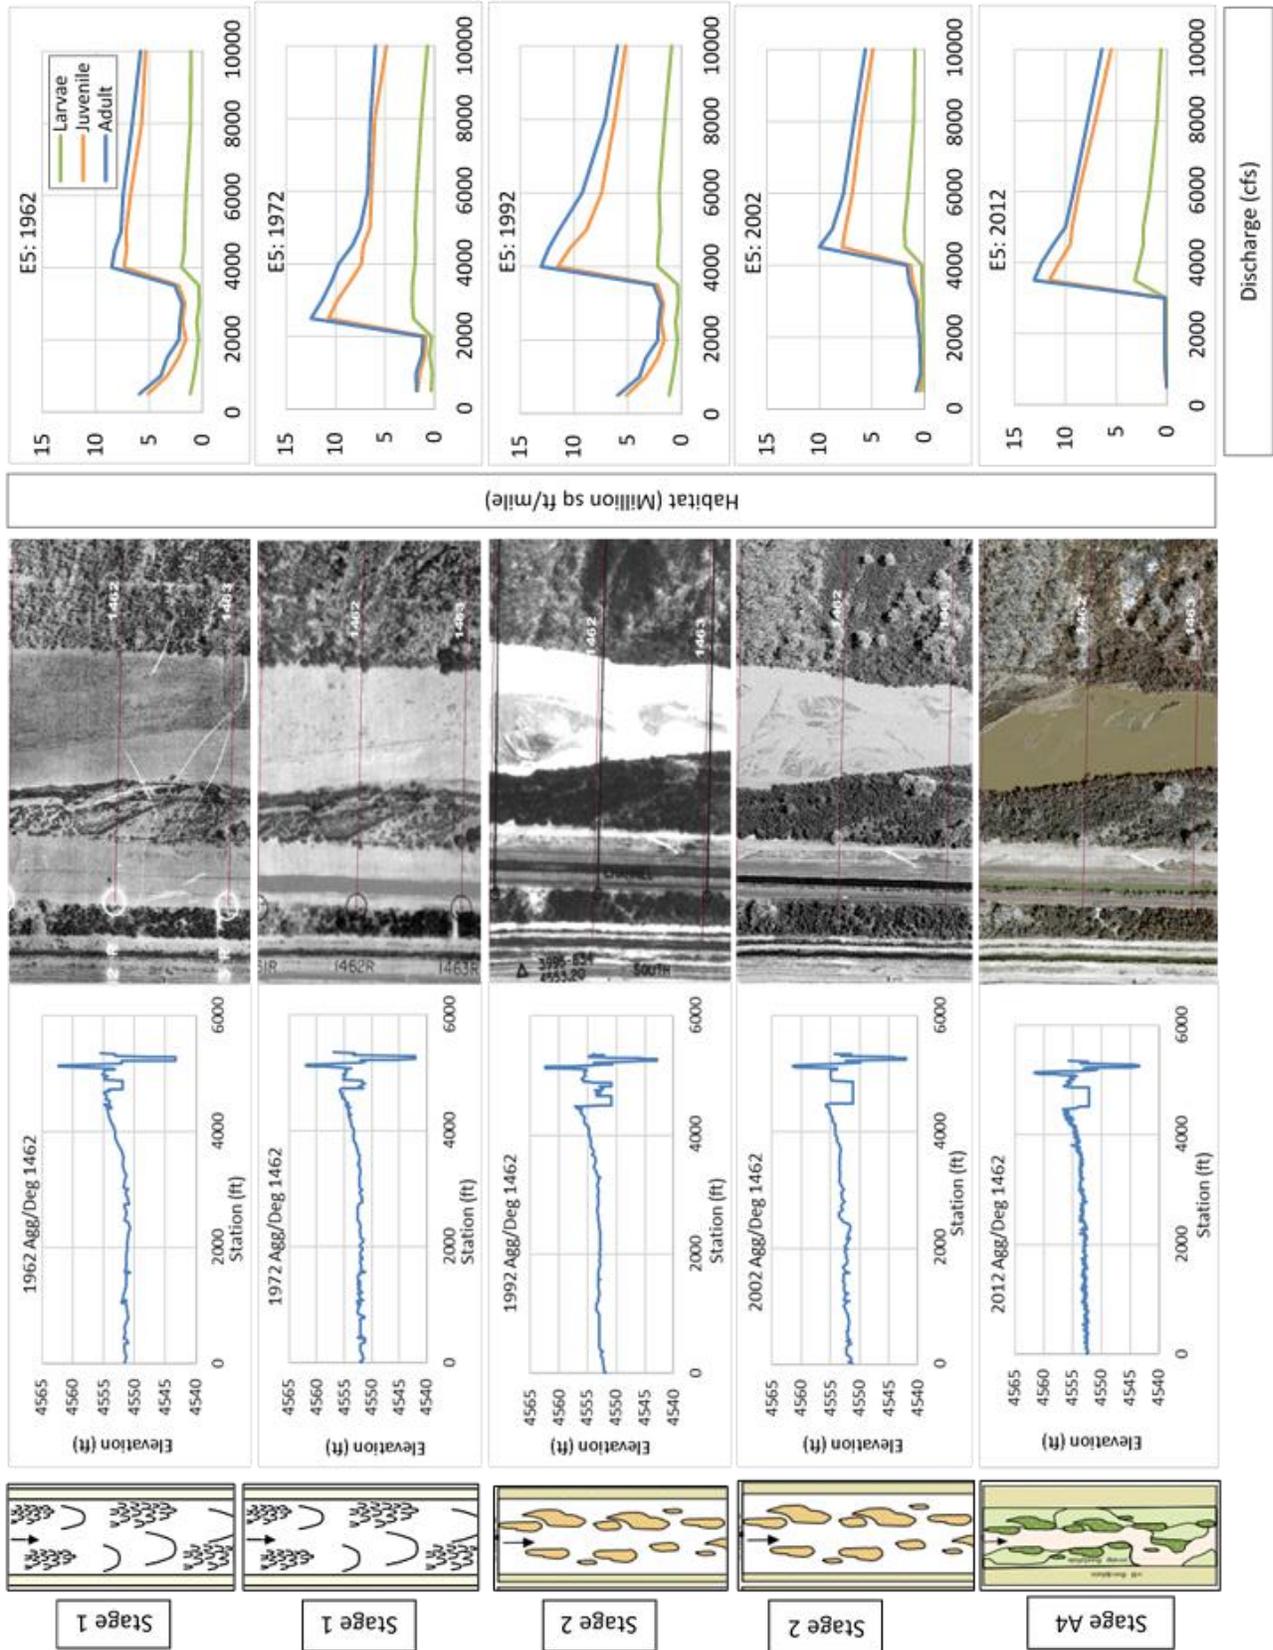
Figure F- 5 Geomorphology and habitat connections collage for subreach E5
