Middle Rio Grande Isleta Reach: Isleta Diversion Dam to Rio Puerco Hydraulic Modeling and Silvery Minnow Habitat Analysis 1918-2016

The Isleta Reach spans about 42 miles of the Middle Rio Grande, from the Isleta Diversion Dam to the confluence with the Rio Puerco, in central New Mexico. This reach report for the U.S. Bureau of Reclamation aims to better understand the morphodynamic processes of the reach and how this links to Rio Grande silvery minnow habitat. The reach is split into six subreaches (I1, I2, I3, I4, I5 and I6) to facilitate the analysis of spatial and temporal trends in channel geometry, morphology and habitat quality.

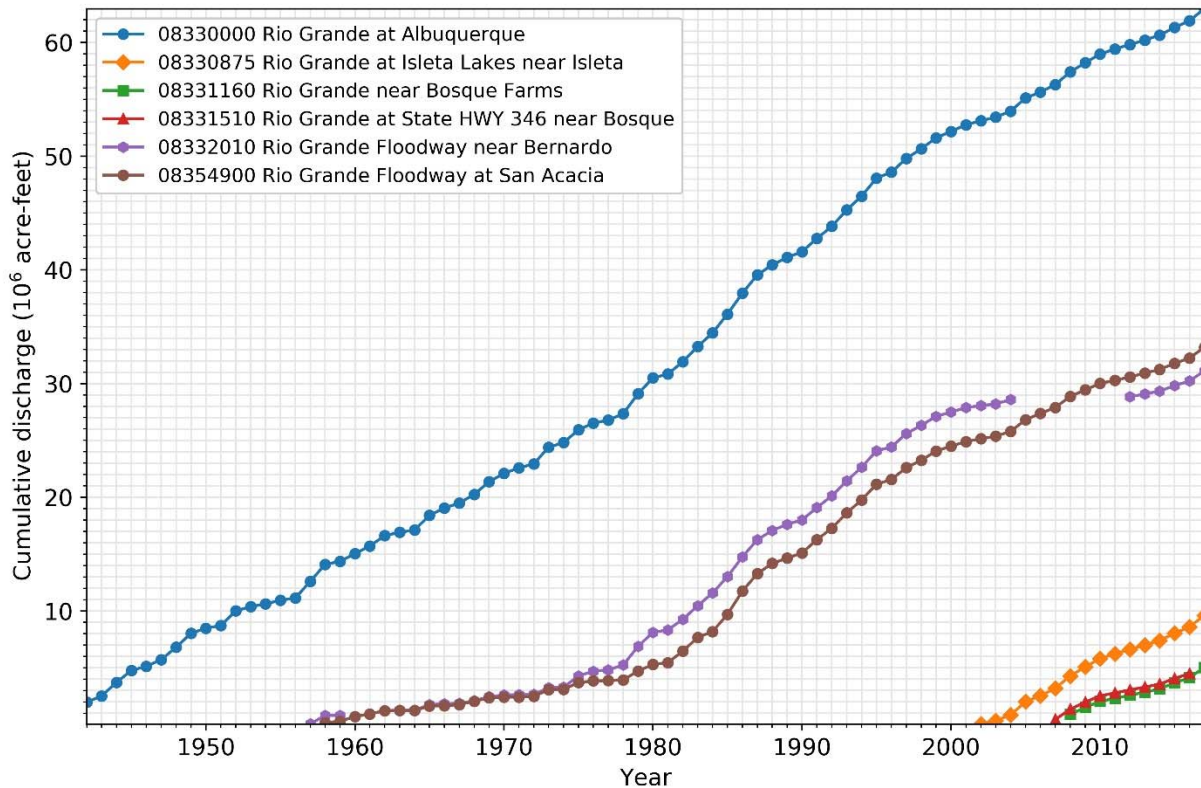
Single mass curves are used to show changes in annual flow volume over time. The cumulative discharge is presented as a function of time in years. The slope of the line gives the mean annual discharge. Breaks in slope show changes in the flow volume. Figure 5 shows the flow mass curves of gages at Albuquerque, Isleta, Bosque Farms, Bosque, Bernardo, and San Acacia. The annual flow volume shows slight reduction in the downstream direction. The discharge mass curves are divided by the time periods 1942 to 1978, 1978 to 1980, 1980 to 1981, 1981 to 1987, 1987 to 1990, 1990 to 1995, 1995 to 2001, 2001 to 2004, 2004 to 2010, 2010 to 2014, 2014 to 2017. The average discharge of each period is listed in Table 2. For the Albuquerque gage (08330000), the annual flow increases from 0.74 million acre-feet to 1.21 million acre-feet after 1978. A decrease in discharge between 1995 and 2010 and another decrease in discharge is found after 2010. Similar trends are found in the other stations as well.

Figure 5: Single mass curves with the cumulative water discharge on the y-axis and the year is on the x-axis.

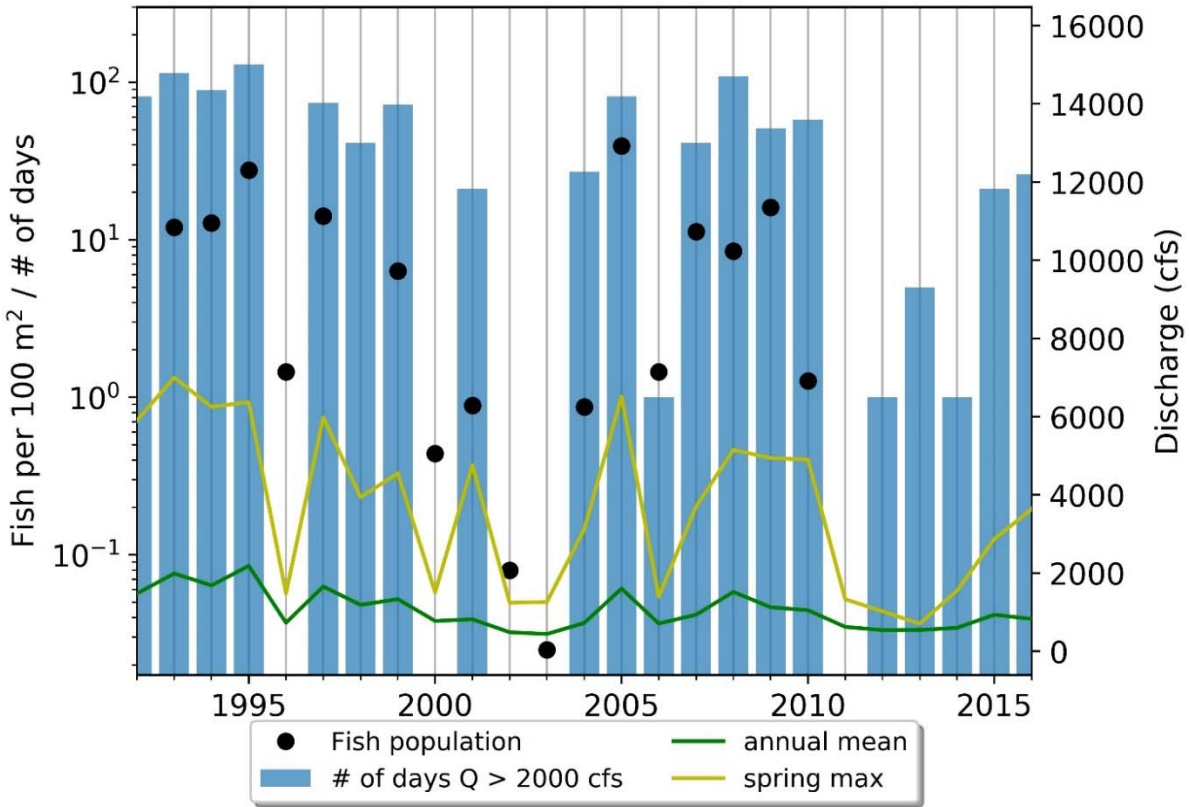
According to Dudley et al., the population of RGSM is “closely related to the timing, magnitude, and duration of flows in spring and summer” (Dudley et al. 2016). Figure 9 shows the relation between the population density of RGSM, spring peak discharge, annual mean discharge, and occurrence of flow higher than 2000 cfs at Albuquerque. The change of fish population generally follows the magnitude of spring peak flow and the occurrence of high flow. Figure 10 shows the scatter plots of fish population vs spring peak discharge and fish population vs number of days that discharge is higher than 2000 cfs. This suggests the fish population is positively related to these two variables.

Figure 9: Population of silvery minnow vs annual mean discharge vs spring peak flow vs number of days that discharge is greater than 2000 cfs.

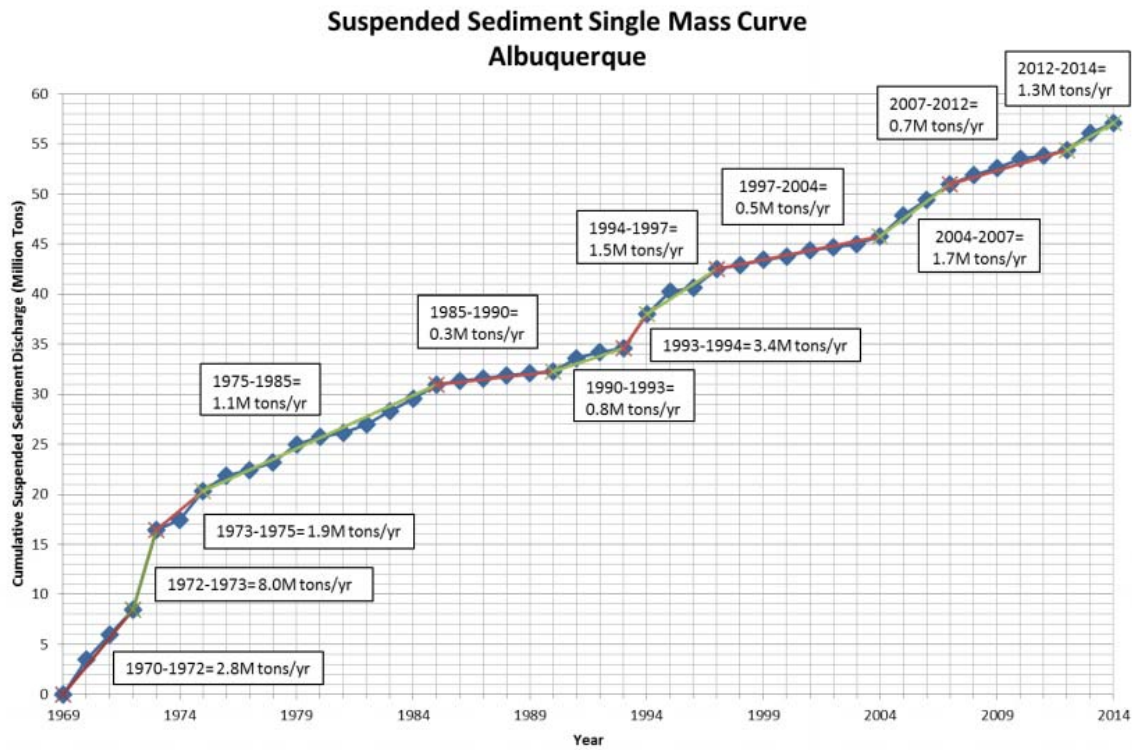
Figure 13: Single mass curve at Albuquerque (08330000) for suspended sediment (Klein et al., 2018a).

For both the Albuquerque and Bernardo gages, there is a significant decrease in suspended sediment being transport starting around the 1970's. Also, from 1991 to 1995 there was a large increase in suspended sediment which then decreased and became constant after 1995. The Bernardo and Albuquerque gage have switched back and forth in terms of which one transports more suspended sediment. From the 1970's to the mid 1980's and from the mid 2000's through 2014 the Albuquerque gage showed more sediment yield. In-between those two time periods, the Bernardo gage recorded more suspended sediment transport.

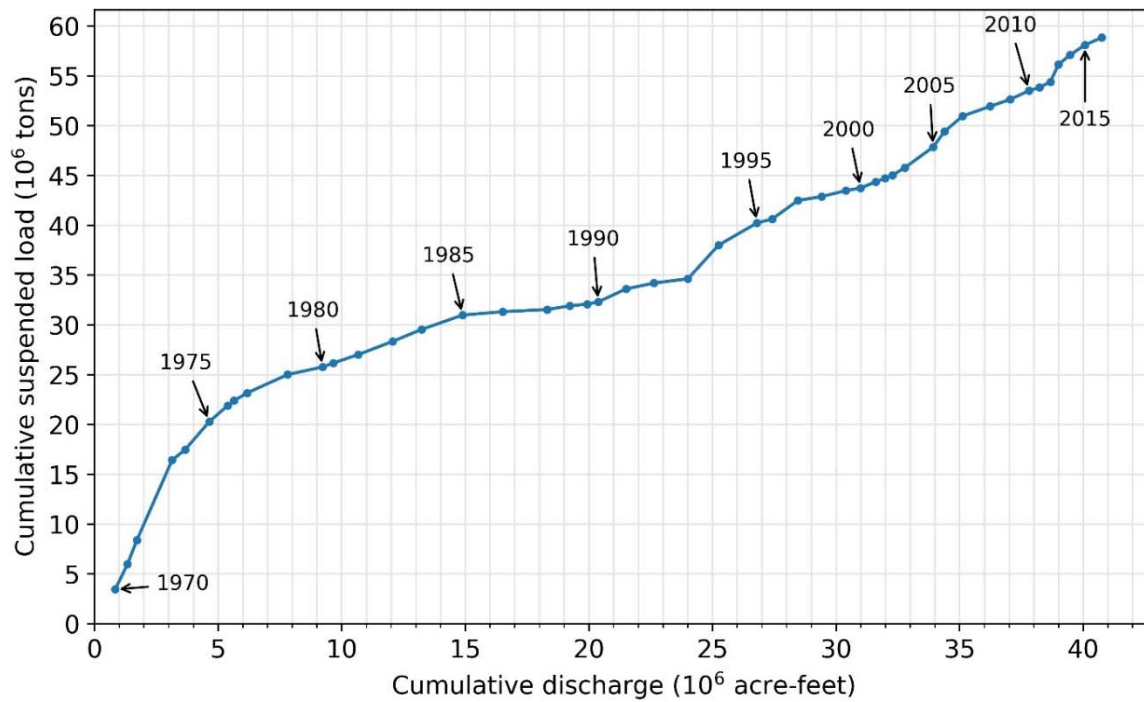
Figure 16: Double mass curve at Albuquerque gage (08330000) from 1970 to 2016.

The highest concentration occurred prior to 1975 at this gage. It decreased from 1985 to the 1990's and then increased again.

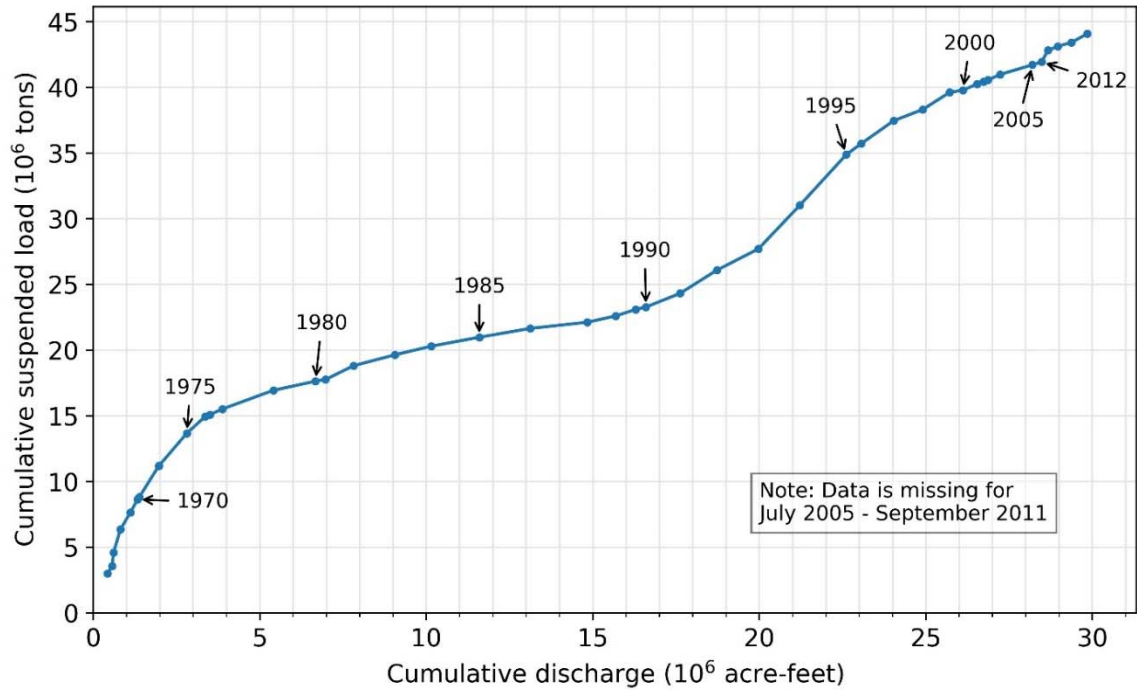
Figure 17: Double mass curve at Bernardo gage (08332010) from 1965 to 2016.

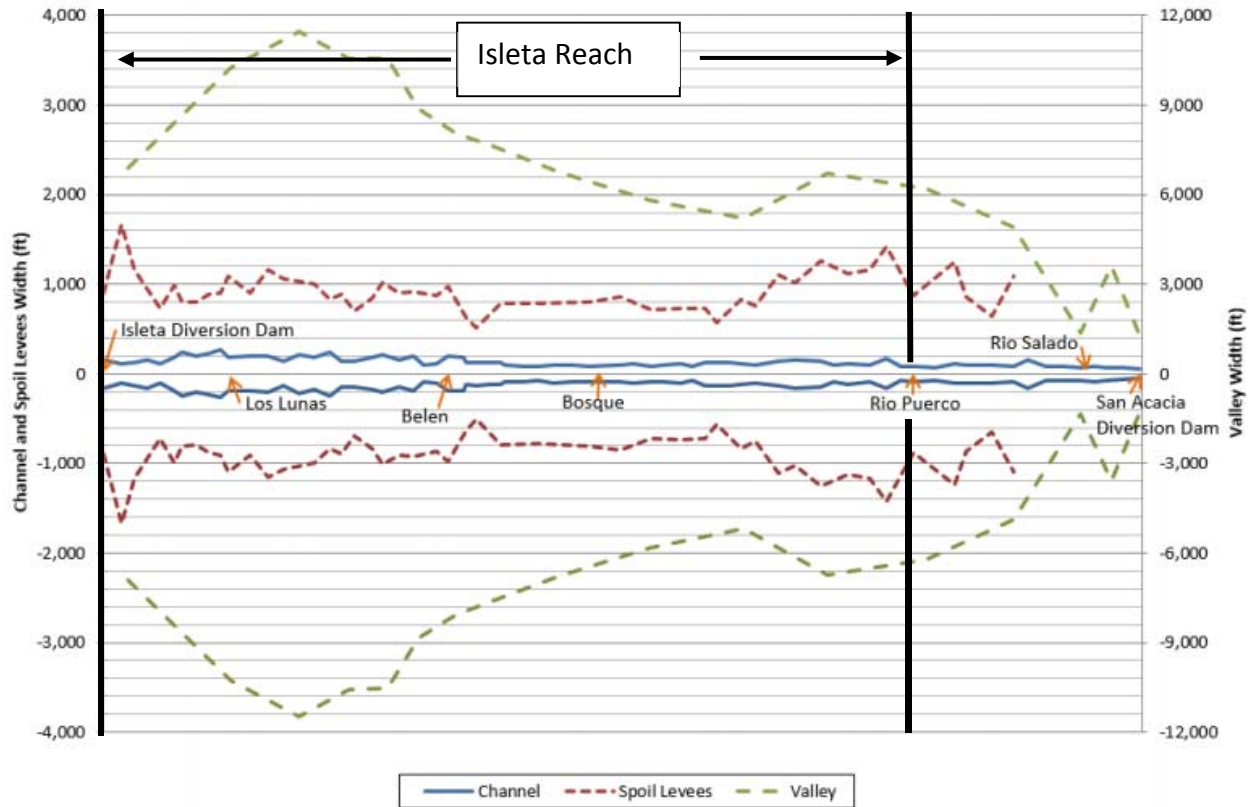
A schematic outlining basin morphology of the valley, levee and channel widths from 2007 and 2008 data helps present an overall reach perspective in Figure 23. The schematic is not to scale and provides an arbitrary centerline of the reach that doesn't account for sinuosity. It is used to get a perspective on the width of the active channel, levees and basin.

Figure 23: Channel, spoil levees, and valley widths from the Isleta Diversion Dam to the San Acacia Diversion Dam. The figure is not to scale and just depicts relative widths. The Isleta reach is shown on the first $\frac{3}{4}$ of the graph going left to right from Isleta diversion Dam to Rio Puerco (Klein et al. 2018a).

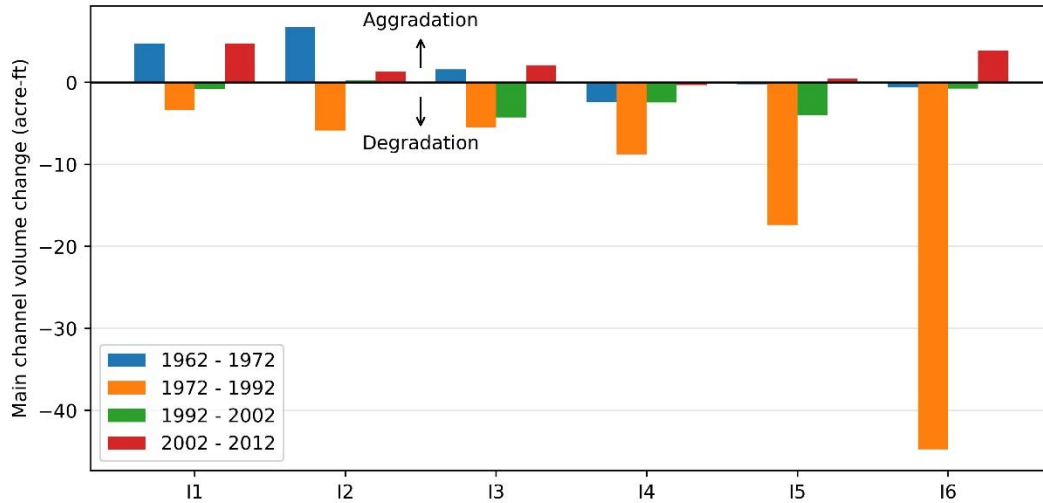
Figure 28: Main channel volume change.

Notice that from 2002 to 2012, most of the reaches show aggradation based on volume change but degradation based on the elevation change. It suggests that the channel is narrowing and incising.

Figure 28 presents the main channel volume change of each subreach. The change generally follows the trend in mean channel bed elevation.

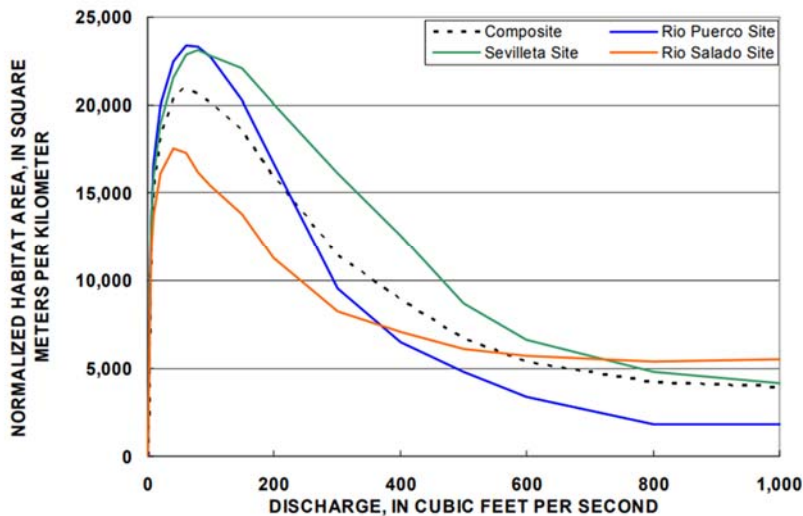
The scores may be low in July of 2008 due to the flow of 1630 cfs. This flow is suboptimum for silvery minnow as suggested by a study done on silvery minnow by Bovee et al. (2008). The study was done in 2008 in a few small reaches (1-2 km each) downstream of the Rio Puerco and upstream of the San Acacia Diversion dam. They mapped out adult and juvenile hydraulic habitat in the study areas at flows up to 1000 cfs. Looking at connectivity, woody debris, depths and velocities, they found that habitat areas were reduced when flows exceeded 150 cfs mainly because of flow depth and velocity as shown in Figure 48. In stream habitat such as connectivity and woody debris decreased over time as well for flows exceeding 150 cfs (Bovee et al. 2008).

Figure 48: Habitat area for silvery minnows (*H. amarus*) from Bovee et al (2008).
