# Performance review of Jamuna Bridge River Training Works 1997-2009

**ABSTRACT:** Recently a review was made of the performance of the Jamuna Bridge River Training Works, (RTW) crossing the braided Brahmaputra River in Bangladesh. The RTW are functioning since 1997. The review was carried out to identify any improvements which could possibly be made both in the design proper and in the supporting studies for forthcoming bridge projects. In the review period of 13 years, the RTW were not fully tested, as during none of the years was the design discharge approached or was the upstream channel pattern characterized by extreme outflanking. Although the yearly maintenance required until 2009 is on the average only 0.13% of the capital costs of the RTW, still some unexpected phenomena were observed. The design scour depths were exceeded substantially, and scour holes of almost 45 m below average flood levels were observed. The scour occurs during outflanking and additional studies are needed to understand the cause and possible remedies. Locally substantial shifting of the rock of the slope protection is observed, leaving the underlying geotextile exposed. Regular inspection and mainte

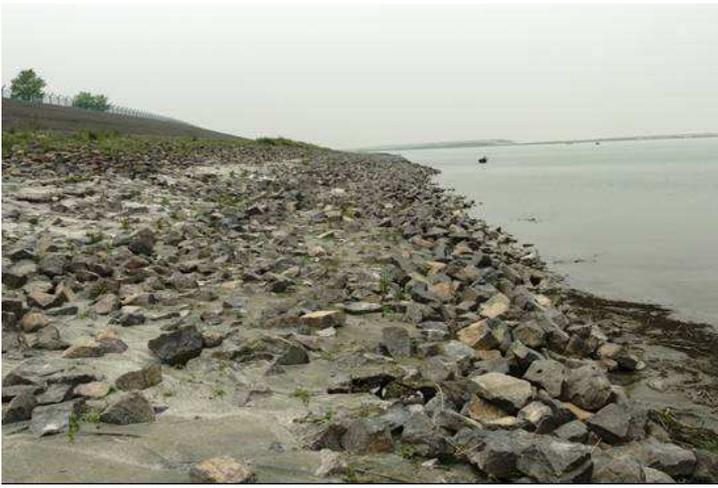
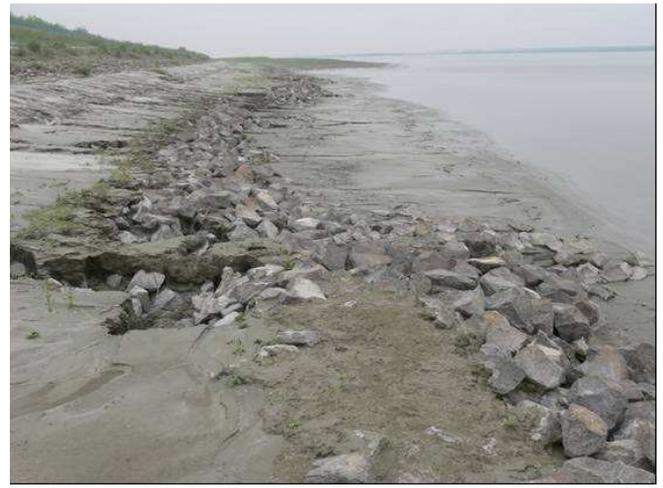
Figure 13: Original and damaged section of slope protection (SP) of WGB

With regard to the SP from 2006 onwards two different problems have occurred which may or may not be linked. It concerns the shifting of rock in downward direction exposing at some places the geotextile filter and the formation of one localized hole in the lower part of the slope protection. The shifting of the rock on the guide bunds slope is shown in the two photographs in Figure 13. The cause of the shifting was studied on the basis of the limited information available. The most plausible explanation is the occurrence of flow slides of the sand deposits on the guide bunds during receding flows.

(a) Slope SP WGB below berm without damage

(b) Damaged section with shifted rock with exposed geotextile and some sand deposits

- The cause of the shifting of the protective layer on the guide bunds, leaving the geotextile filter exposed at some places, is not fully understood and requires further studies. For the time being only timely maintenance can prevent subsequent damage which ultimately might result in the failure of the guide bunds.
