Middle Rio Grande Montaño Reach Report:

Morphodynamic Processes and
Silvery Minnow Habitat from the
Montaño Road Bridge Crossing to
the Isleta Diversion Dam

February 2023
Master of Science
Plan B Technical Report

Prepared by:
Tristen Anderson

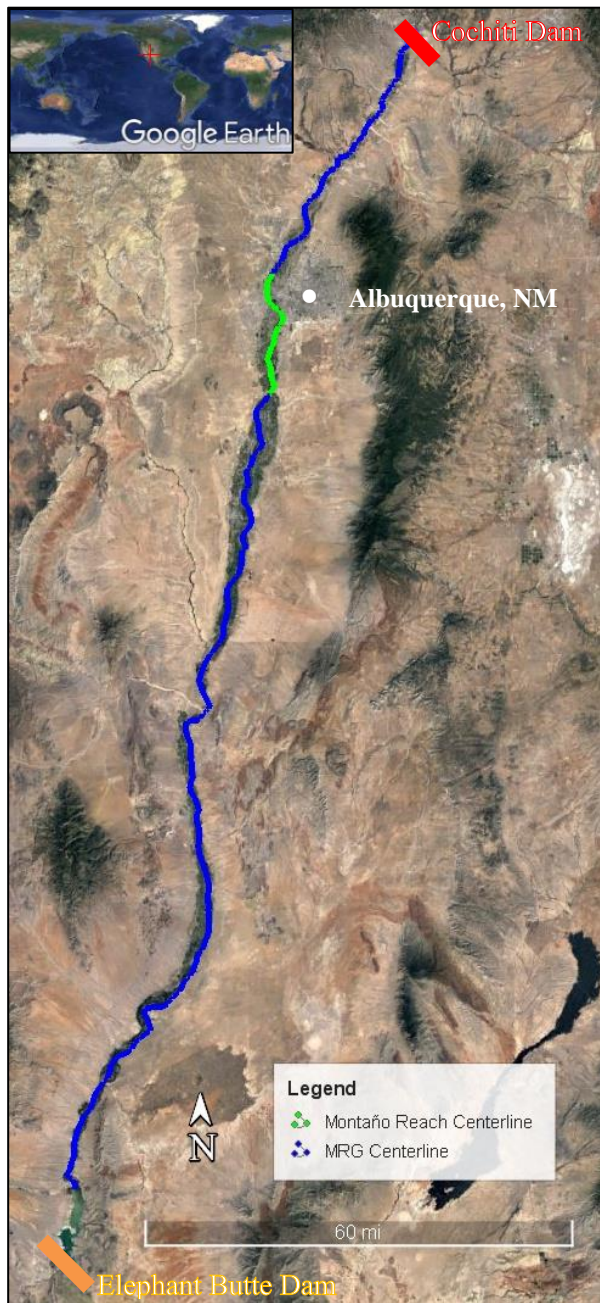
outlined in blue. It begins at Cochiti Dam (Red line) and continues downstream to the narrows just upstream of Elephant Butte Reservoir (Orange line). The green line highlights the Montañero Reach.

This reach report aims to evaluate the morphodynamic conditions and quantify the Rio Grande Silvery Minnow (RSGM) habitat within the Montañero Reach of the Middle Rio Grande (MRG). The MRG extends from Cochiti Dam to the narrows upstream of the Elephant Butte Reservoir. The Montañero Reach begins at the Montañero Road Bridge crossing in Albuquerque, New Mexico, and ends at the Isleta Diversion Dam (**Figure 1-1**).

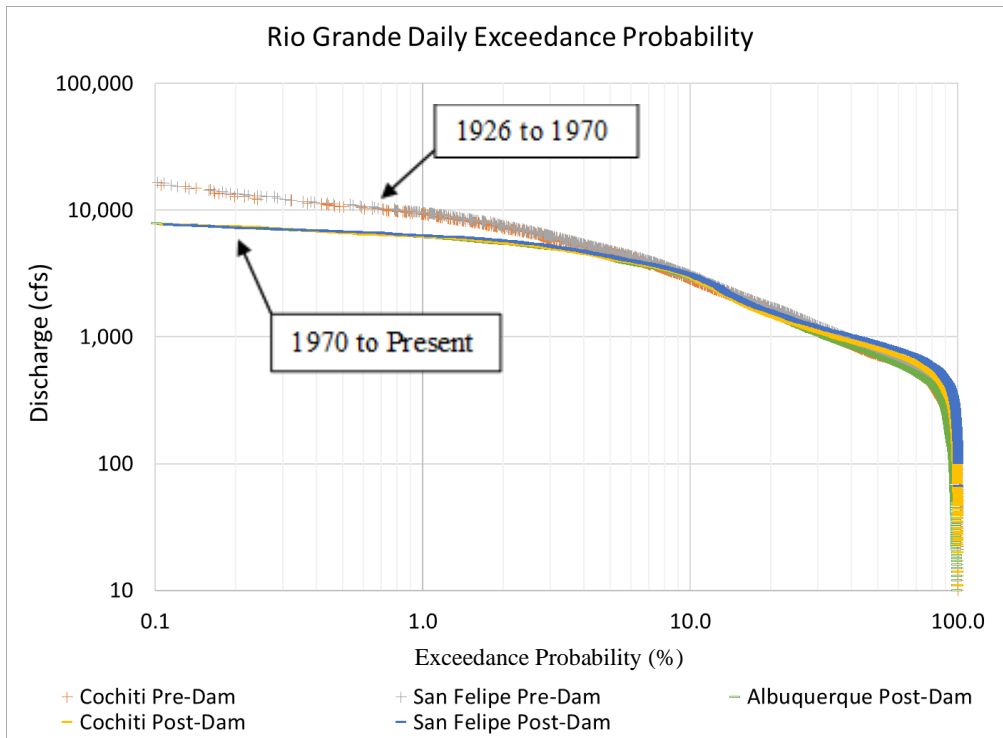
Figure 2-17 Flow duration curves for the Rio Grande gages before and after dam construction in 1970.

Flow duration curves were developed using the mean daily flow discharge values for the Cochiti, San Felipe, Albuquerque, and Jemez River gages. **Table 2-2** shows the probabilities of daily exceedance values calculated from the flow duration curves for a range of exceedance probabilities. The gage records were split between pre- and post- construction of the Cochiti Dam for the Rio Grande gages. Gage records were similarly split for the Jemez River gages to account for any differences in flow conditions before and after the completion of the Jemez Dam. The curves for the Rio Grande gages are shown in **Figure 2-17**, and the curves for the Jemez River gages are shown in **Figure 2-18**.

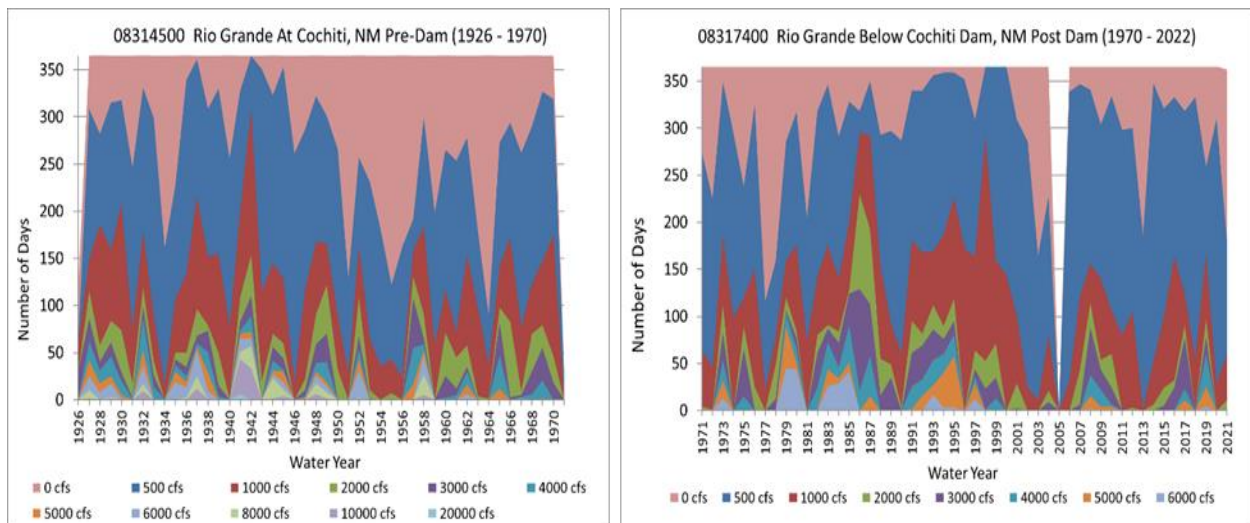
Figure 2-19 Number of days greater than an identified discharge at the Cochiti gages before (left) and after (right) dam construction.

The Cochiti graphs have a very similar pattern to the San Felipe graphs, which is an indication that these two gages see very similar magnitude of flows. The most notable difference between the Cochiti and San Felipe graphs before and after Cochiti Dam construction is that pre-dam flow conditions saw a greater number of days above 6,000 cfs. The graphs also seem to indicate that the years between 1979 and 1999 show a greater number of days (around half of the year, on average) above 1,000 cfs. These graphs also give a good indication of dry years. For example, between 2003 and 2006, fewer than 50 days of the year saw flows greater than 1000 cfs. In general, the larger flows become less frequent after 2001.

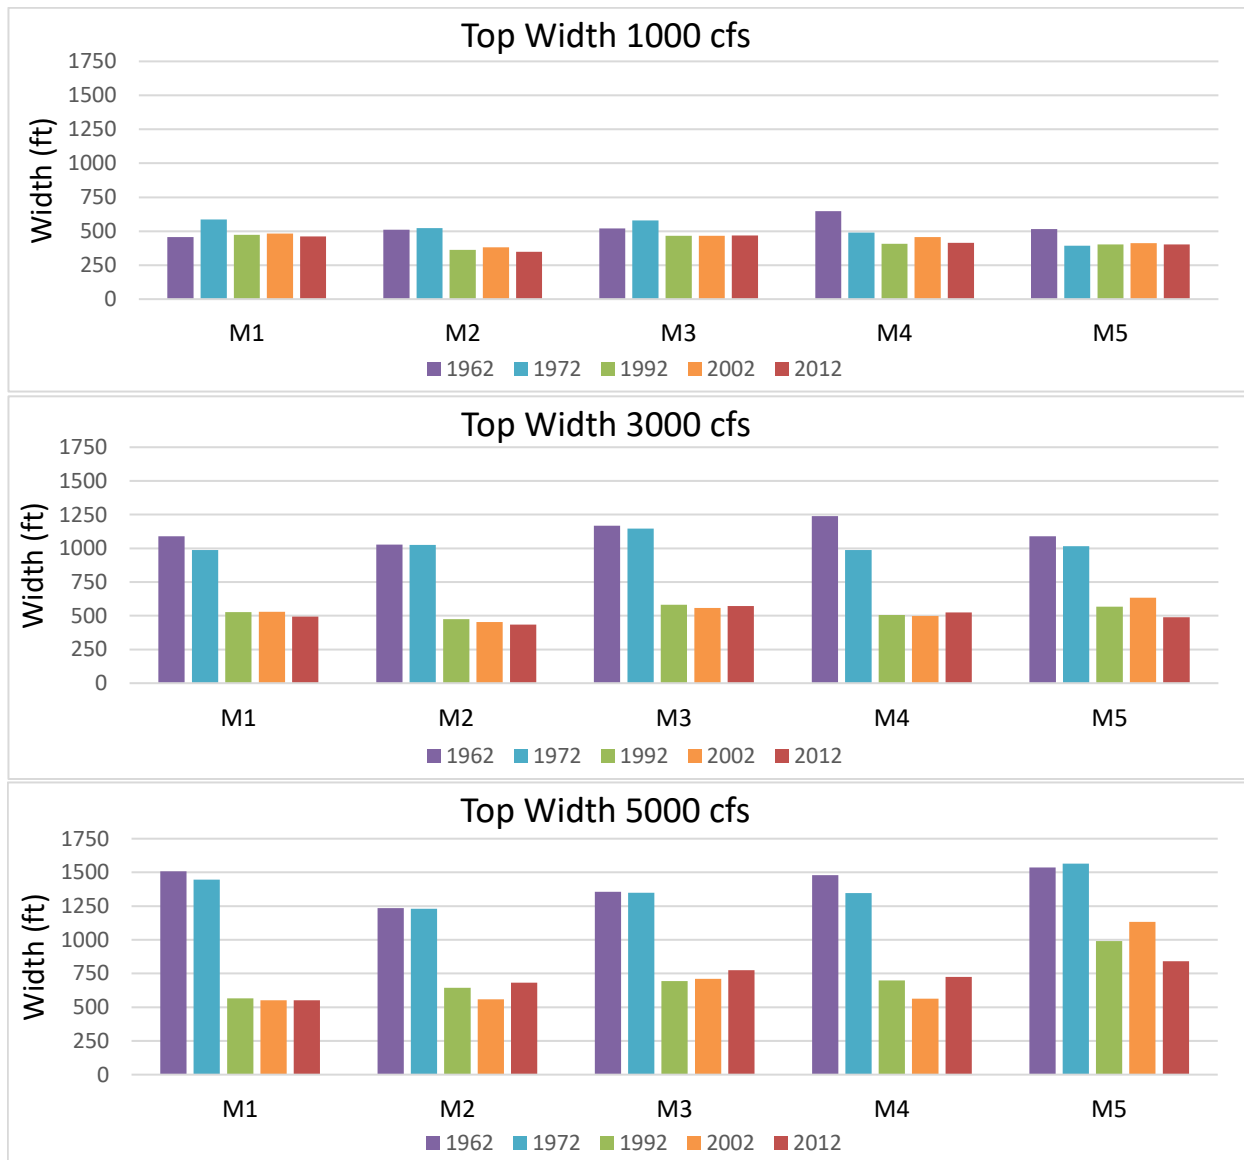
Figure 3-14 HEC-RAS wetted top width of Montañó Subreaches at 1,000 cfs (top), 3,000 cfs (middle), and 5,000 cfs (bottom).

The HEC-RAS results of top width (**Figure 3-14**) confirm general trends that matches shown in **Section 3.1** and **3.2**. At 1,000 cfs, the top width is similar throughout all the subreaches. M1 – M3 show an increase in top width from 1962 to 1972, while M4 and M5 show a decrease. For years 1992-2012, the top width has remained consisted, although there is some variation between the subreaches; M2 has the smallest average top width. At 3,000 cfs, pre-Cochiti dam years display a sharp increase in top width (roughly doubled) while post-Cochiti dam years show a very slight increase. This emphasizes that 3,000 cfs exceeds the bankfull condition for the pre-Cochiti dam years and does not exceed the bankfull condition for the post-Cochiti dam years. At 5,000 cfs, all the years' experience an increase in top width around 300 feet. The most notable increase occurs in M5, and the least amount of top width change occurs in M1.

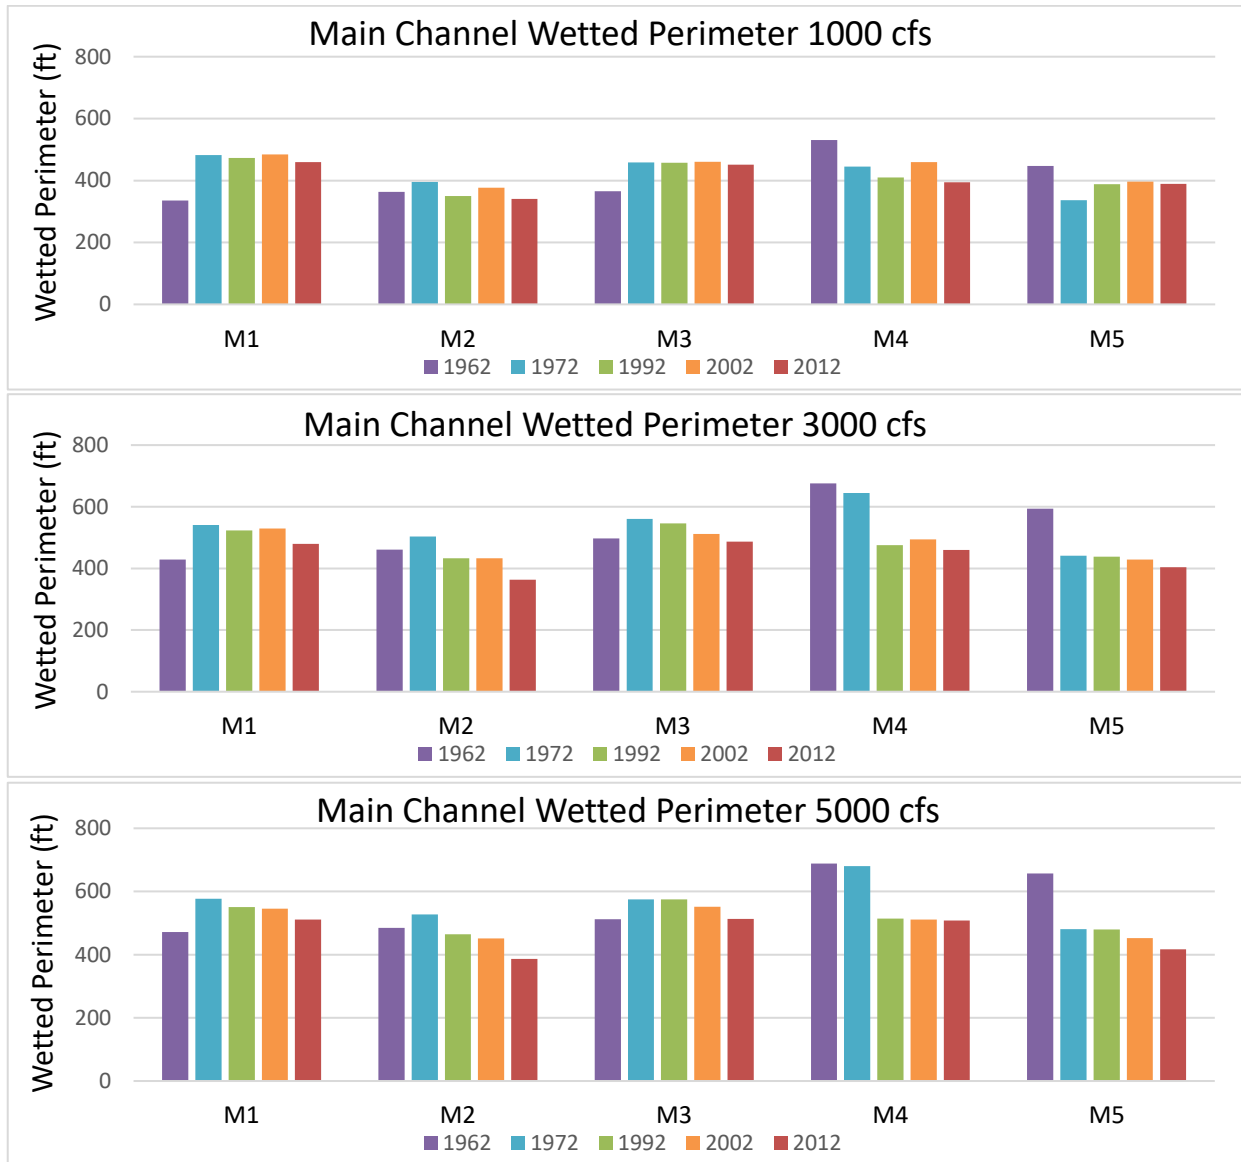
Figure 3-16 HEC-RAS main channel wetted perimeter at 1,000 cfs (top), 3,000 cfs (middle), 5,000 cfs (bottom).

The wetted perimeter of the main channel was also obtained from HEC-RAS for each of the years analyzed, as shown in **Figure 3-16**. In general, for all the analyzed flow rates, the wetted perimeter increases from 1962 to 1972 for subreaches M1-M3 but decreases for M4 and M5. From 1972 to 2012 the wetted perimeter slightly decreases. It is important to note that the wetted perimeter is confined to the main channel and shows how the main channel has changed over time.
