Middle Rio Grande Bernalillo Report:

Morpho-dynamic Processes and
Hydraulic Modeling to Assess
Silvery Minnow Habitat from
Hwy 550 Bridge to
Montaño Road Bridge

March 2023
Master of Science
Plan B Technical Report

Colorado State University
Engineering Research Center
Department of Civil and
Environmental Engineering
Fort Collins, Colorado 80523

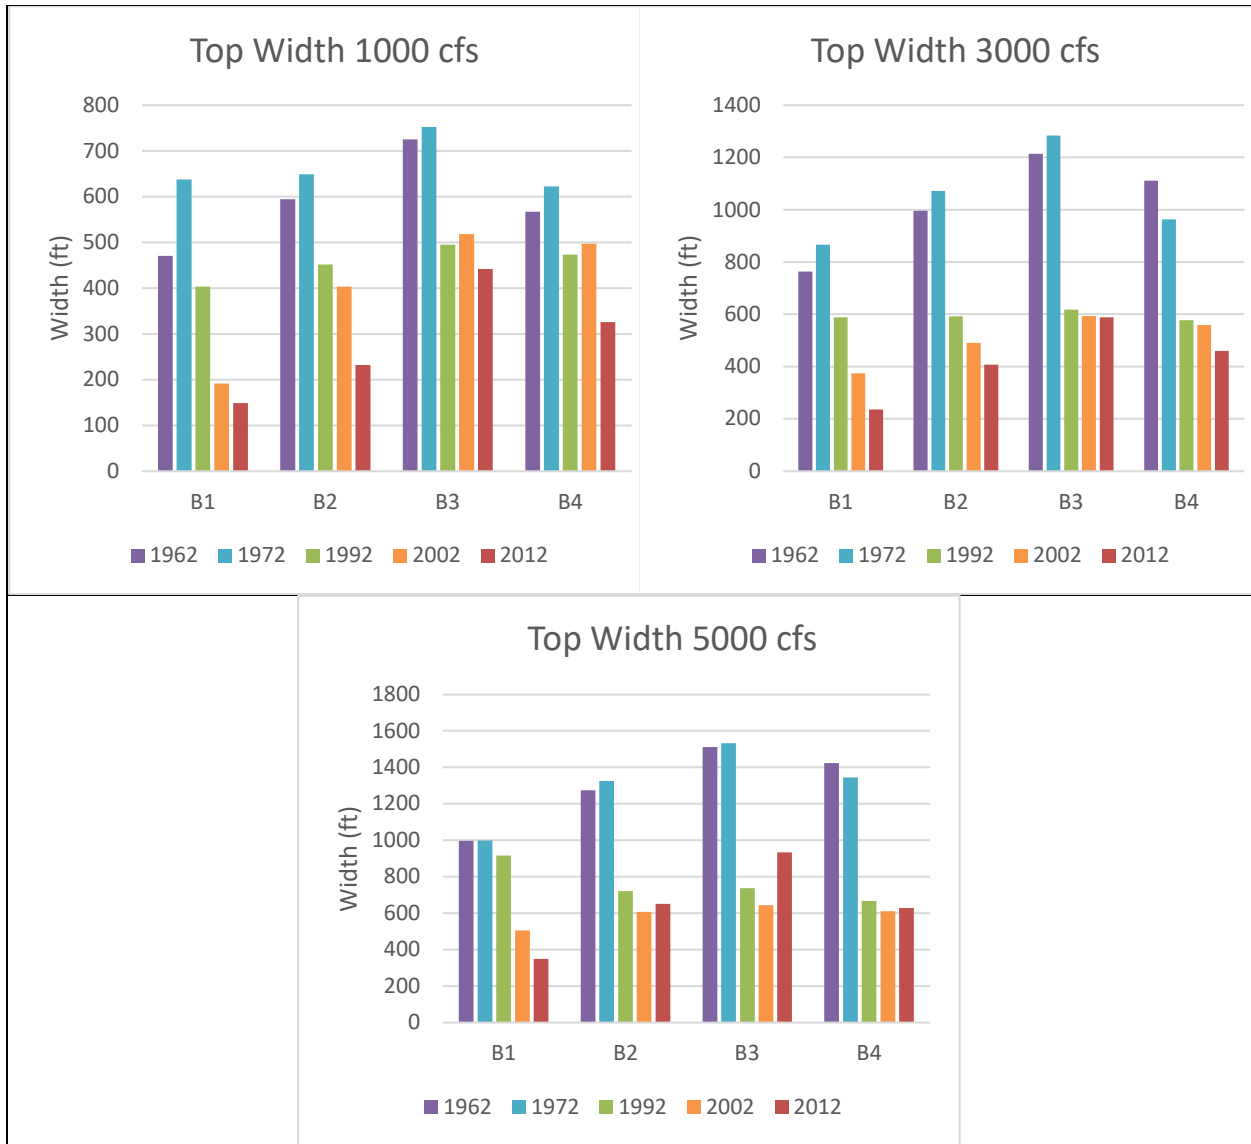
Figure 3-16 HEC-RAS Wetted top width of channel at 1,000 cfs (top left), 3,000 cfs (top right), and 5,000 cfs (bottom middle)

The HEC-RAS results shown in **Figure 3-16** show a general trend that matches the trend seen in **Sections 3.1 and 1.1**. For all flows, there is generally an increase in wetted top width from 1962 to 1972, except in subreach B4 at 3,000 cfs and 5,000 cfs. From 1972 to 1992, there is a large decrease in wetted top width. From 1992 to 2012, there is generally a decrease in top width, except at 5,000 cfs. The fluctuation between 1962 to 1972 and 1972 to 2012 are a result of the aggradation and degradation trends that the Bernalillo Reach experienced during those time periods. The aggradation was most likely a result of large sediment discharge events between 1962 and 1972, as seen in **Section 2.3**.
