## Rehabilitation of an Incised Stream Using Plant Materials: the Dominance of Geomorphic Processes

*F. Douglas Shields, Jr.*<sup>1</sup>, *S. Reza Pezeshki*<sup>2</sup>, *Glen V. Wilson*<sup>1</sup>, *Weiming Wu*<sup>3</sup>, and *Seth M. Dabney*<sup>1</sup>

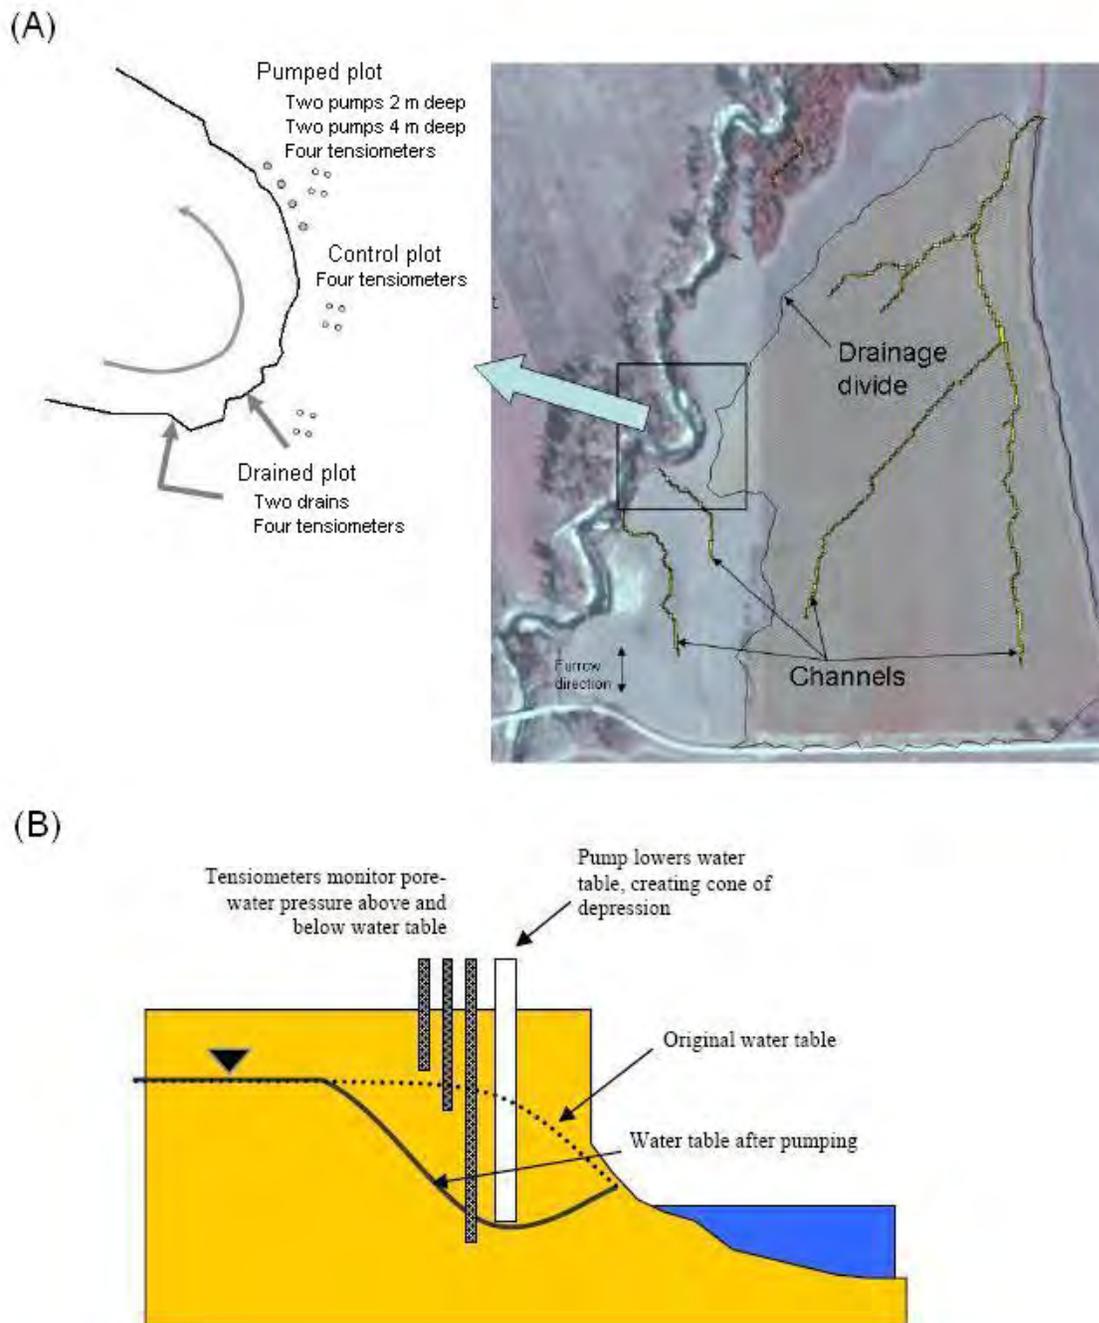
**Fig. 7.** Bank dewatering using pumps and drains. (A) Plan of the dewatering plots. (B) Schematic profile of the pumped plot.

Streambank instability as a result increasing soil-water pressure (Simon and Curini 1998, Casagli et al. 1999, Simon et al. 2000, Rinaldi et al. 2004) and seepage erosion (Fox et al. 2007a, Chu-Agor et al. 2008) were addressed by dewatering the soil profile that composed parts of a 6 m high eroding bank (Shields et al. *unpublished manuscript*; Figs. 3A and 7A). The outside bank of a bend was divided into three study plots separated from each other by approximately 25 m. At the first plot, two pairs of 5 cm diameter boreholes were installed 15 m apart to depths of 2 and 4 m (Fig. 7B), and a solar-powered peristaltic pump was installed in each borehole. Pumps discharged into the creek. The pumps were activated by float switches controlled by tensiometers. The second plot was an untreated control equipped with a nest of tensiometers to monitor the soil-water pressure profile. The third plot was treated by installing two 10 cm diameter perforated plastic drain tile lines ~1.5 m deep perpendicular to the bank and extending ~10 m into the field. The drain lines were placed approximately 20 m apart. One of the lines had an additional 10 m of tile that turned 90 degrees and ran an additional 10 m parallel to the top bank (Fig. 7A).

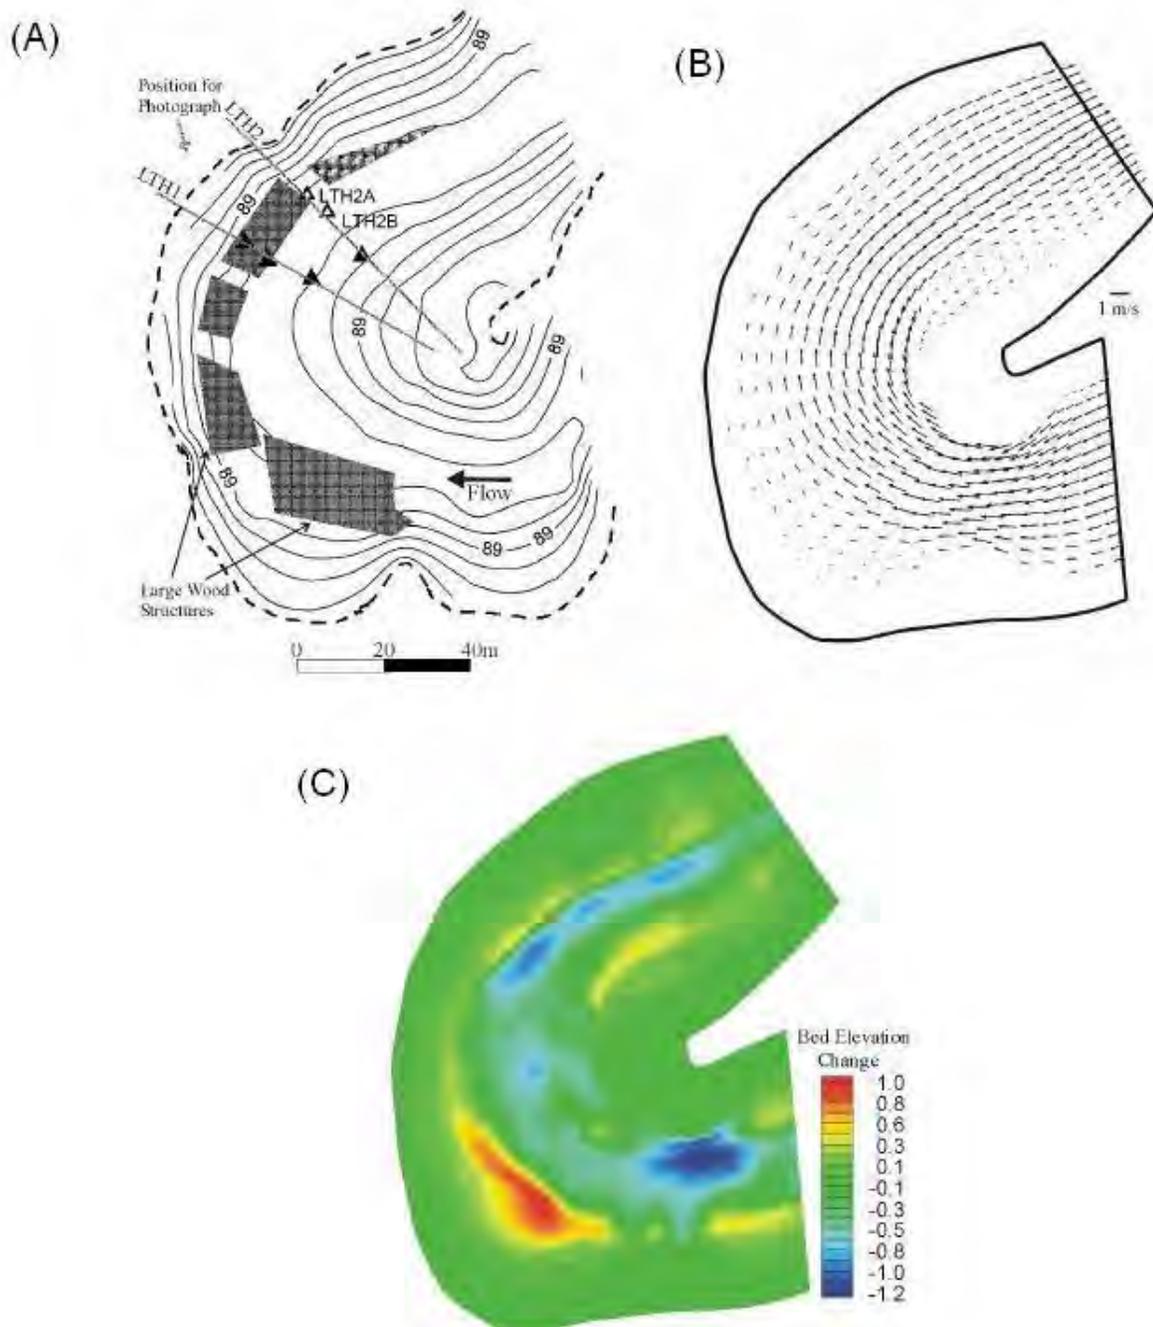
LW also exerted an important influence on habitats during high flow events (Shields et al. 2003, 2006). Acoustic Doppler loggers were used to record high flow current velocity magnitudes at the bank toe and at the channel centerline adjacent to the structures in a tight bend. Prior to the placement of LW structures, the highest velocities within bends occurred at the bank toe, but an LW structure placed at the bank toe created a velocity shelter. Velocities within the LW structure were usually < 0.10 m/s, even during events that were large enough to produce flow depths > 3 m. Such low velocities are well within the preferred ranges for centrarchid and ictalurid fishes (McMahon and Terrell 1982, Stuber et al. 1982). Velocities measured in the channel adjacent to the structure were approximately three times greater than those within the LW matrix. The measured velocities were used to calibrate a two-dimensional model of flow and sediment transport for the entire meander bend. The model incorporated the effects of the LW structures and secondary currents typical of bends (Fig. 8; Wu et al. 2005). The model output showed significant regions of velocity shelter and sediment deposition associated with LW structures (Fig. 8C).

**Fig. 8.** Numerical simulation of the effects of large wood (LW) structures on a meander bend on Little Topashaw Creek. (A) Topography and LW locations. (B) Simulated flow field at a discharge of  $43 \text{ m}^3/\text{s}$ . (C) Simulated bed change after 1 yr due to erosion and deposition.

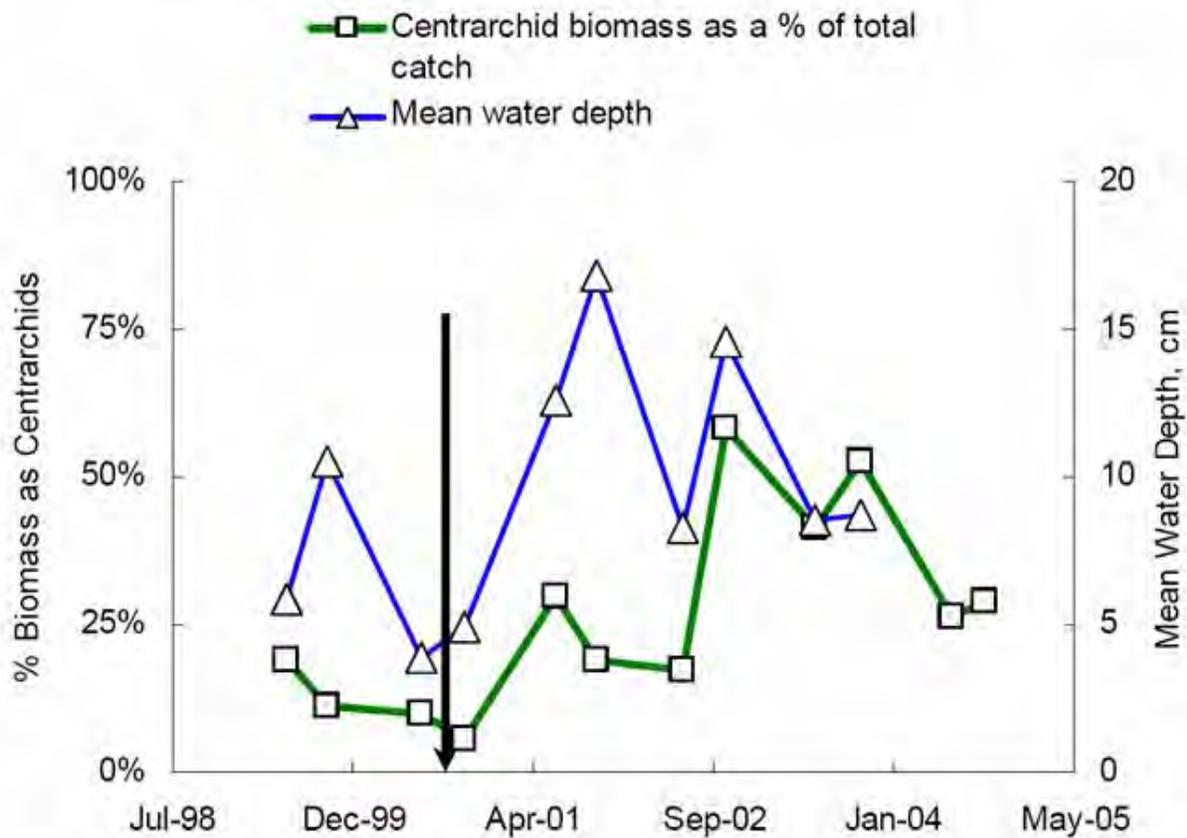
**Fig. 10.** Response of base-flow mean water depth and fish community composition (% of catch biomass that was centrarchids) to the rehabilitation of Little Topashaw Creek. The vertical arrow indicates the date of rehabilitation.

The longer-term failure of the LW structures was accompanied by a reversion to shallow base flow water depths, and the dominance of centrarchids declined to levels typical of the downstream untreated reach during the fourth year following rehabilitation (Fig. 10). By 3 yr after rehabilitation, streambed carbon levels were not significantly
