Mississippi River Levee Failures: June 2008 Flood

ABSTRACT: *During the spring and summer of 2008, record rainfall in the Midwest United States led to severe flooding as water overtopped the levees bordering the Mississippi River and its tributaries. The erosion associated with the overtopping resulted in levee breaches in many places. After the flooding, a field reconnaissance team was sent to collect time-sensitive data and provide a comprehensive overview of the performance of the levees during the flooding.*

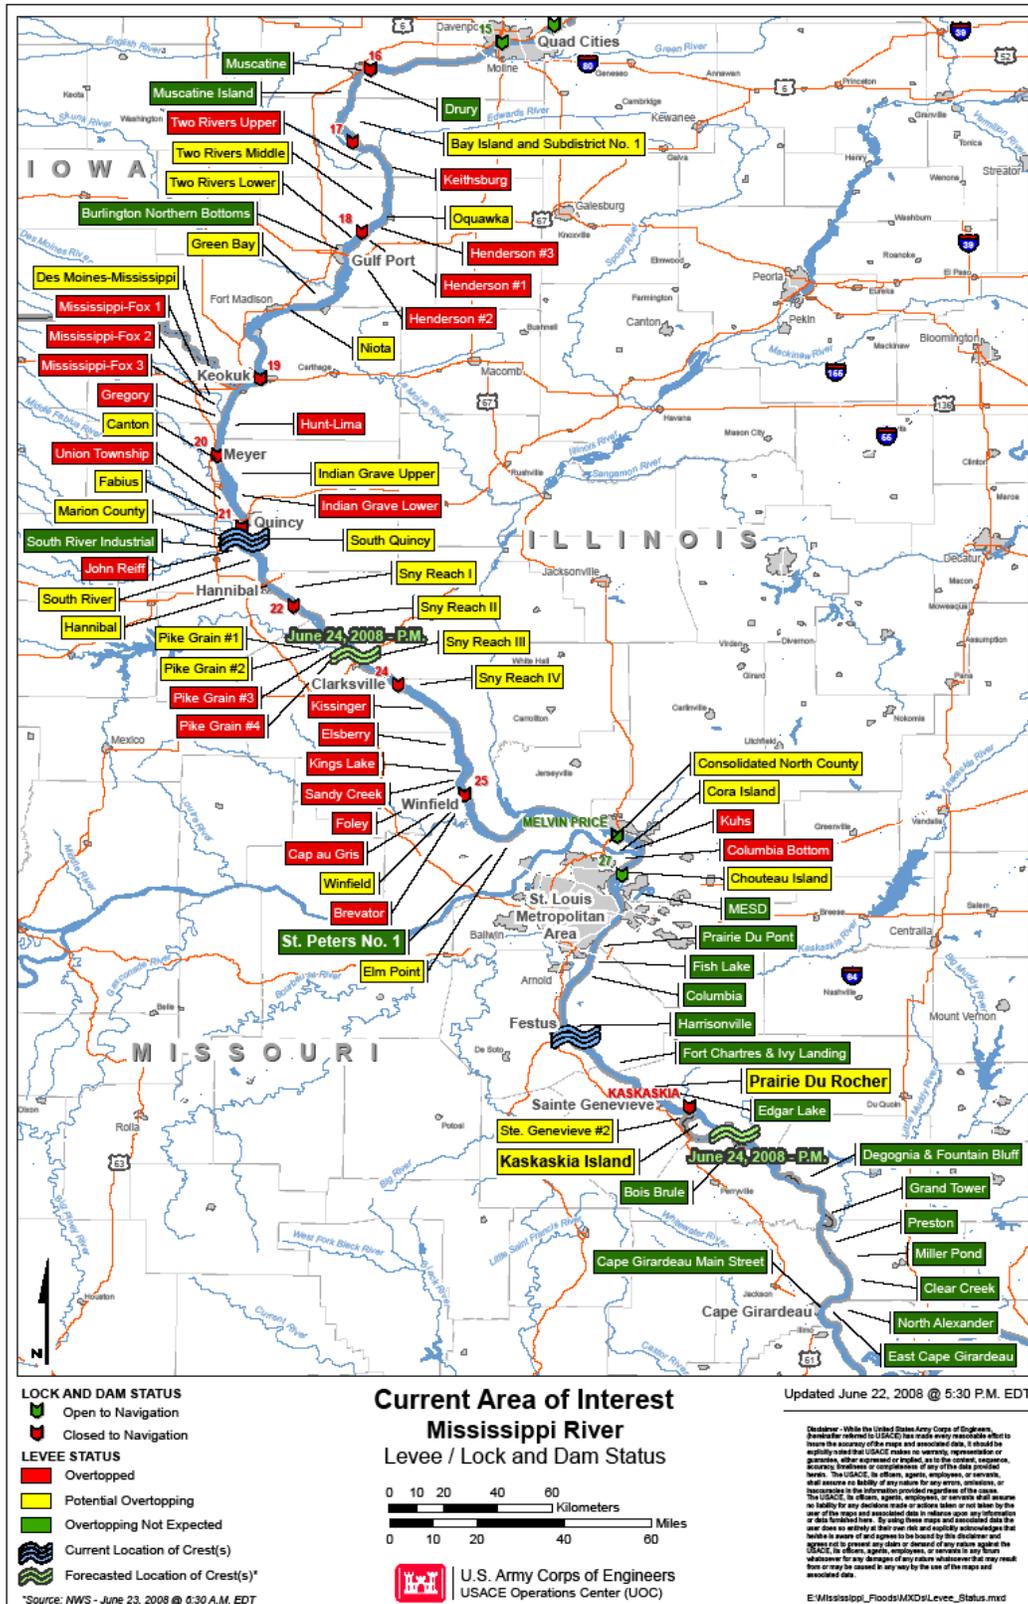
Figure 10. Overtopping status of Upper Mississippi River System (USACE 2008).

Figure 10 shows the US Army Corps of Engineers map of each particular levee system along the Upper Mississippi River System and the corresponding overtopping status during the flooding events as reported on 22 June 2008. The areas tagged in red had already been overtopped while the areas tagged in yellow show levee sections that were still in danger of being overtopped at that date.

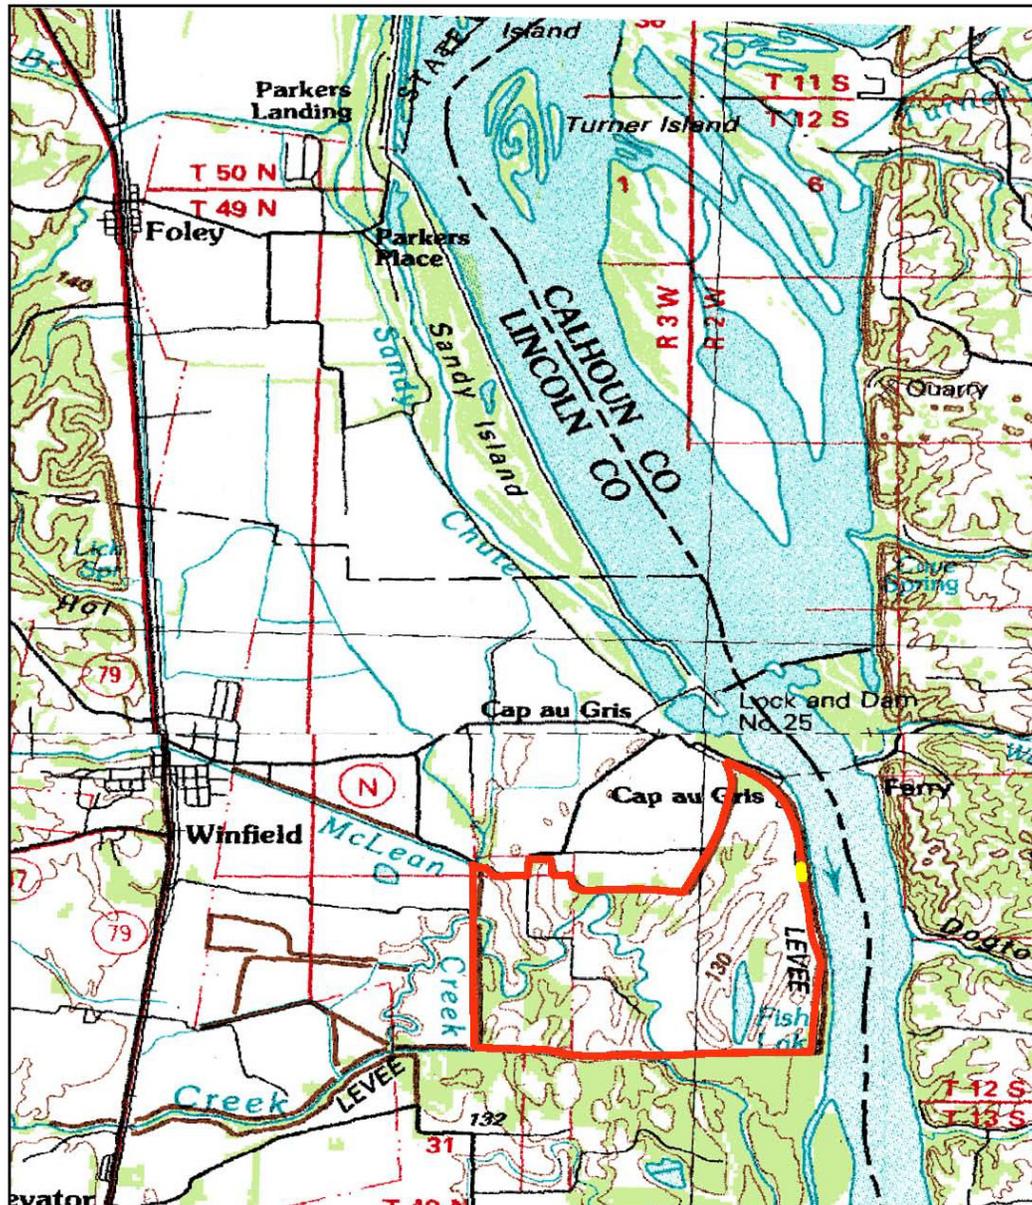
Figure 14. Winfield-Pin Oak levee system and levee breach (Storesund 2009).

The Winfield-Pin Oak levee is maintained by the Cap Au Gris Drainage and Levee District. This levee system is estimated to reduce the risk of flooding of approximately 493 ha up to a 14-year return period flood event on the Mississippi River (Figure 14). This area failed during the 1993 floods, however, the specific location of the breach (or breaches) was not documented (USGS 2006). This site was overtopped for an extended period beginning on June 18th, 2008.

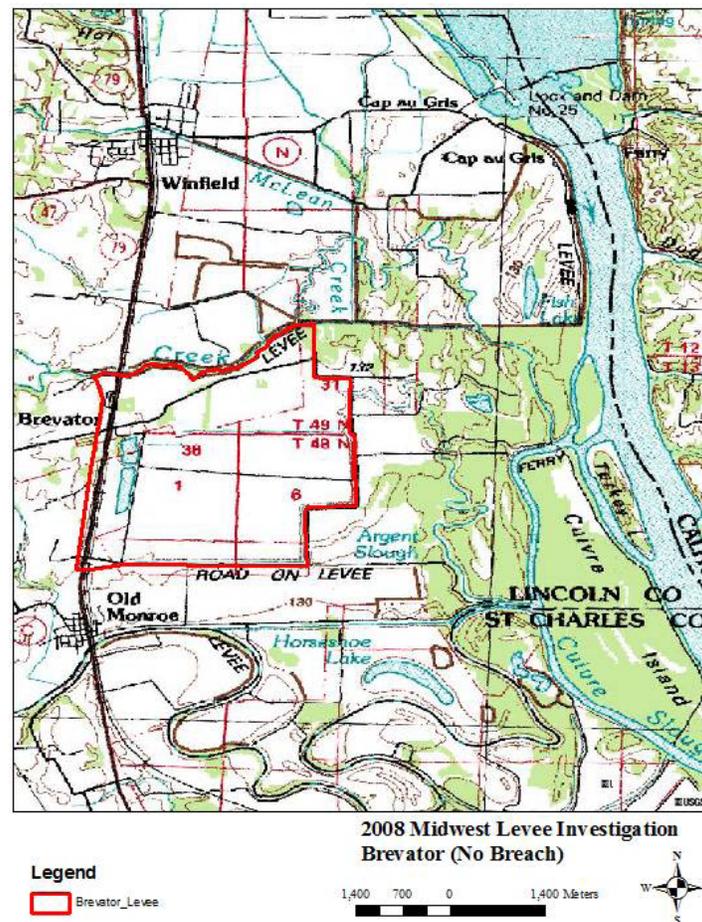
Figure 19. Brevator levee system (Storesund 2009).

This site was unique in the fact that there was no breach in 2008. The only sign of erosion was at a box culvert that was cracked allowing water and soil to seep through. A local resident (Mr. James Pieper) informed the team that the levee was overtopped by nearly 1 m of water for three days and never failed. Four samples were collected from various locations along the levee. Because there was no actual breach, only surficial samples were taken. These samples were much harder to obtain and the soil seemed to be much stiffer than at the previous sites as can be seen by the higher Pocket Penetrometer values (Table 6) obtained at this site compared to the Winfield site. Figure 20 shows the boring locations and Table 6 presents the sample logs for this site.

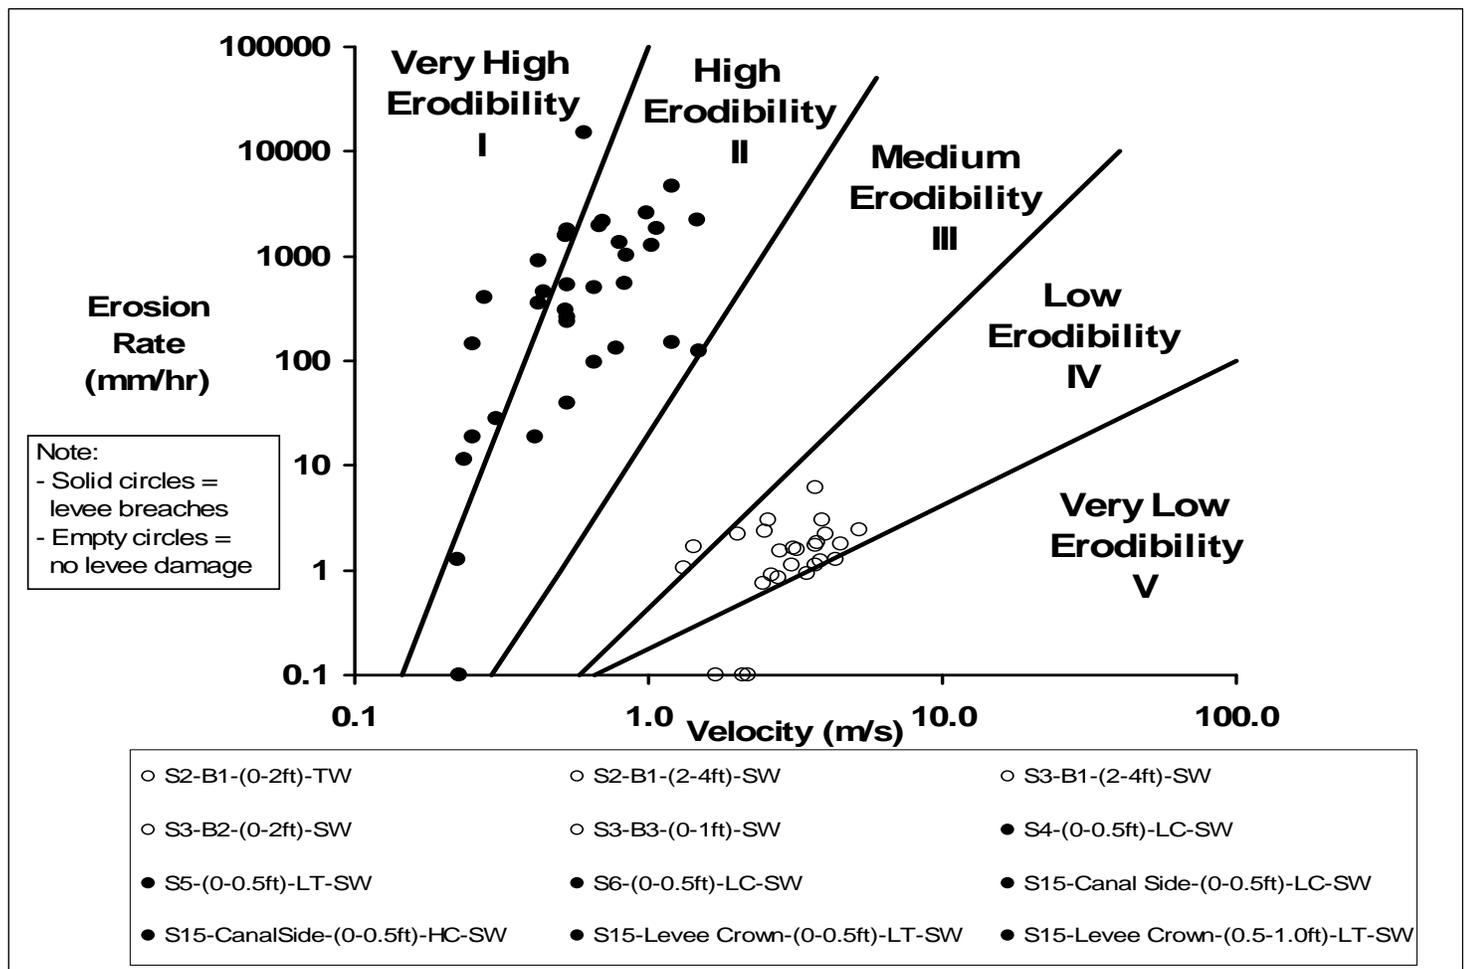
Overall there is no clear division between the two sets of points like what was seen in the Katrina data (Figure 35) given in Briaud et al. (2008). The soils from the Brevator site are among some of the more resistant soils tested; however, there are several sites where the samples are just as resistant yet the sites failed. Comparing the sites that failed to the sites that did not fail based on the plotted points is somewhat deceptive because the EFA tests were limited to the bare soil and did not

Figure 35. Overtopping comparison - pass vs. fail for Katrina data (Briaud et al. 2008).

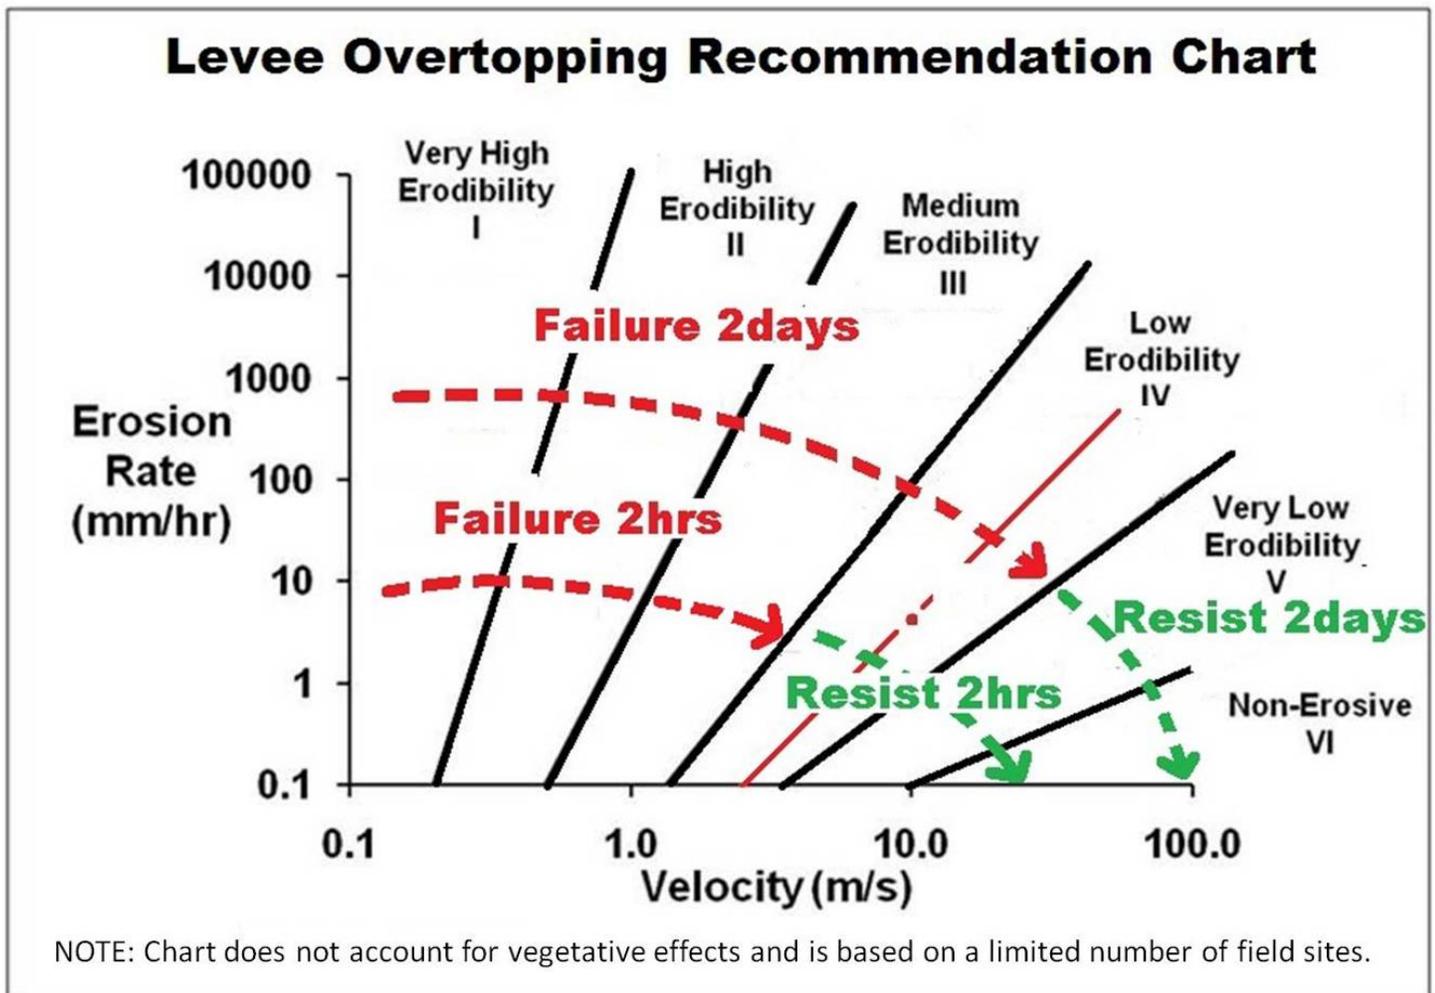
The overtopping recommendation chart given in Briaud et al. (2008) was developed for overtopping periods of less than two hours associated with hurricane events. Based on the findings from this study, the chart was expanded to include the longer overtopping periods of 2 days experienced in flood events (Figure 36). The boundary was determined by considering the data of Figure 34 and setting an erosion limit of 0.3 m over two days for a velocity of 10 m/s. This velocity represents an average value for levees at the bottom of the dry side of the levee. To satisfy this criterion, the erosion rate has to be less than 6 mm/hr (red dot and thin red line shown on Figure 36). It is important to note that the EFA tests used to develop this chart were conducted on barren soil and therefore the chart does not account for vegetation present at a site. Also, this chart is based on a limited number of field sites and may not be representative of every field case.

Figure 36. Recommendation chart for overtopping events.

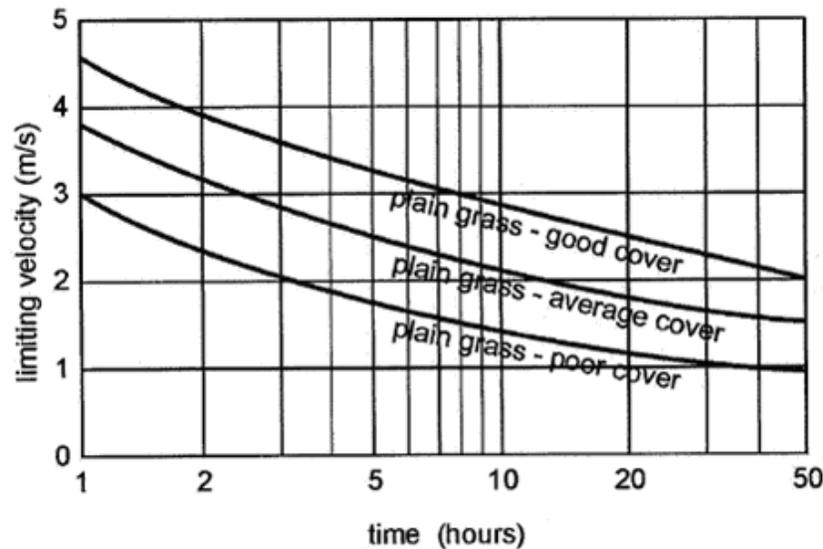
Levee performance under wave action and overtopping has been a major area of interest in the Netherlands after the disaster of 1953 in which many levees failed from inner slope shearing following overtopping. The primary purpose of the vegetation is to prevent erosion caused by hydraulic forces (Seijffert and Verheij 1998). Normal grass cover can resist velocities up to 2 m/s with little or no erosion; however, higher velocities can become problematic (Figure 37). This chart shows the importance of the duration of the overtopping. As the number of hours of overtopping increases, the benefit gained from having increased vegetative cover decreases. For normal flooding events like those experienced in the Midwest it is not unreasonable to assume that the overtopping lasts 20 hours or more. Velocities at the toe of a levee can reach 10 m/s depending on the levee height. This point (20 hours at 10 m/s) plots much higher than the limiting cases shown in Figure 37. Since the Brevator site survived at least 2 days of overtopping, it is likely that Figure 37 is conservative.

Figure 37. Limiting velocities for plain grass (Seiffert and Verheij 1998).

The grasses found at the Brevator site seemed to satisfy all of these criteria. The recommended grasses for the Midwest include: Switchgrass, Tall Fescue, Smooth Brome and Reed Canarygrass. A percent coverage of at least 90 percent is desirable. It is also recommended that the grasses on the levee be allowed to grow to taller heights during the flood season (0.5 to 1 m). While most of the erosion prevention depends on the root system, it is not always adequate for the magnitude and duration of flows experienced during overtopping flood events.
