Elephant Butte Reach Middle Rio Grande

Prepared For:
The US Bureau of Reclamation
Albuquerque Area Office
December 1st, 2021

Colorado
State
University

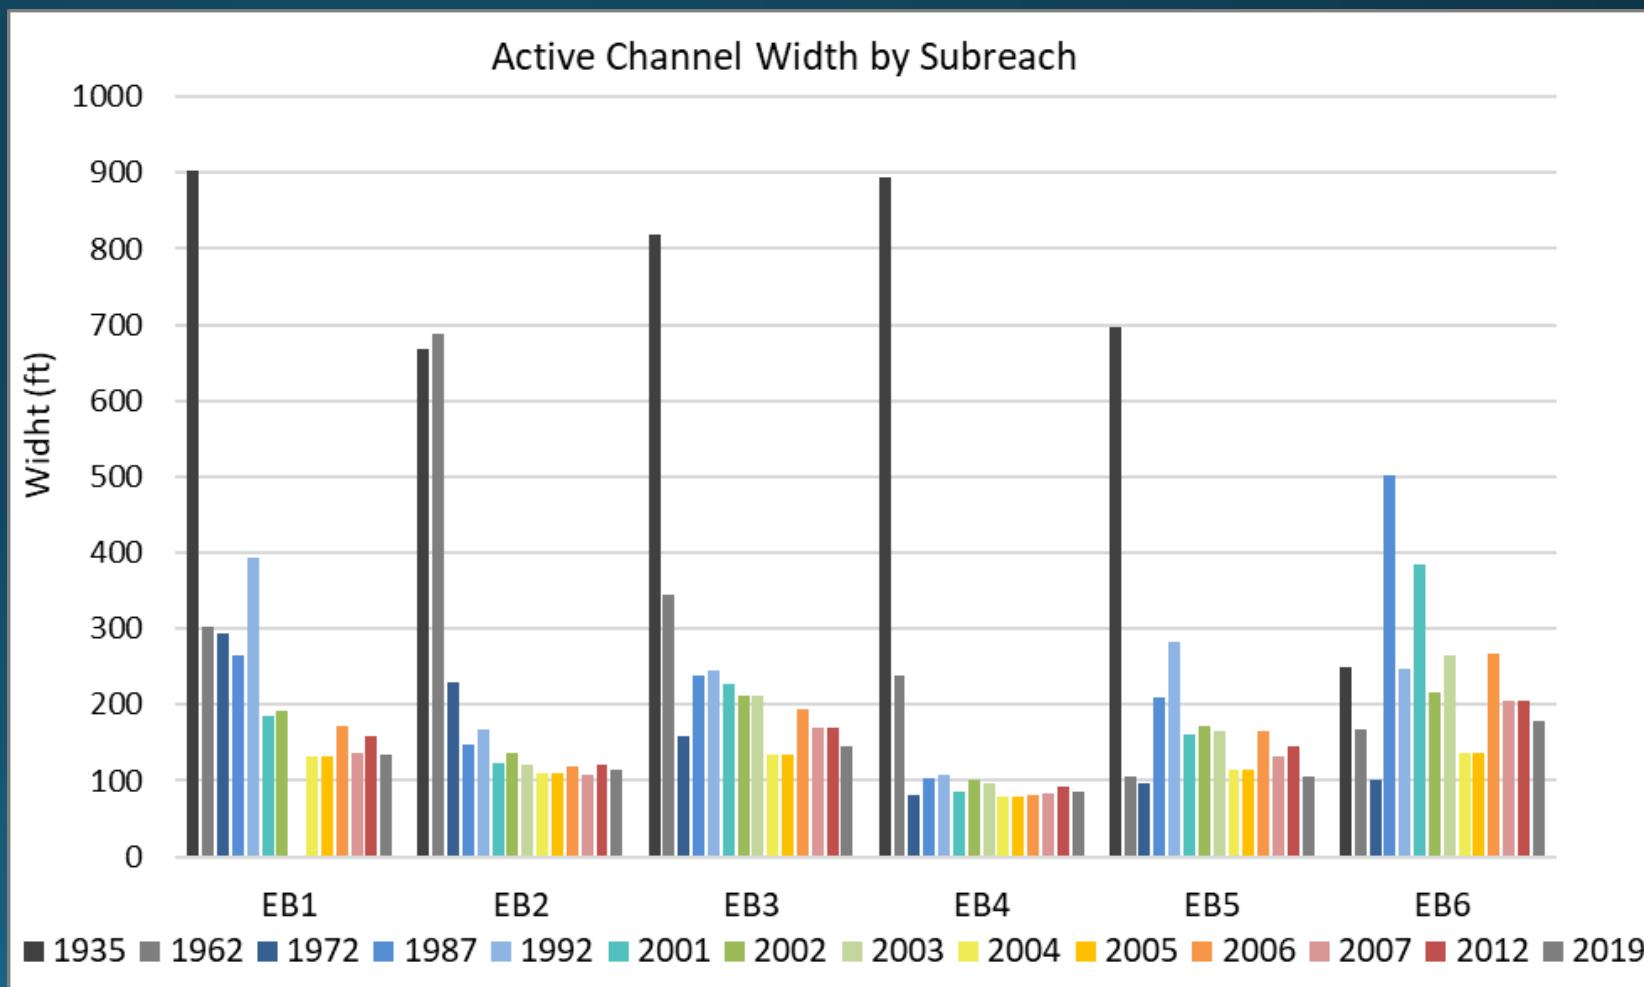
Active Channel Widths

- Generally, has decreases and stabilized around 100 to 200 feet.
- Subreach EB5 and EB6 has fluctuated potentially due to reservoir effects .

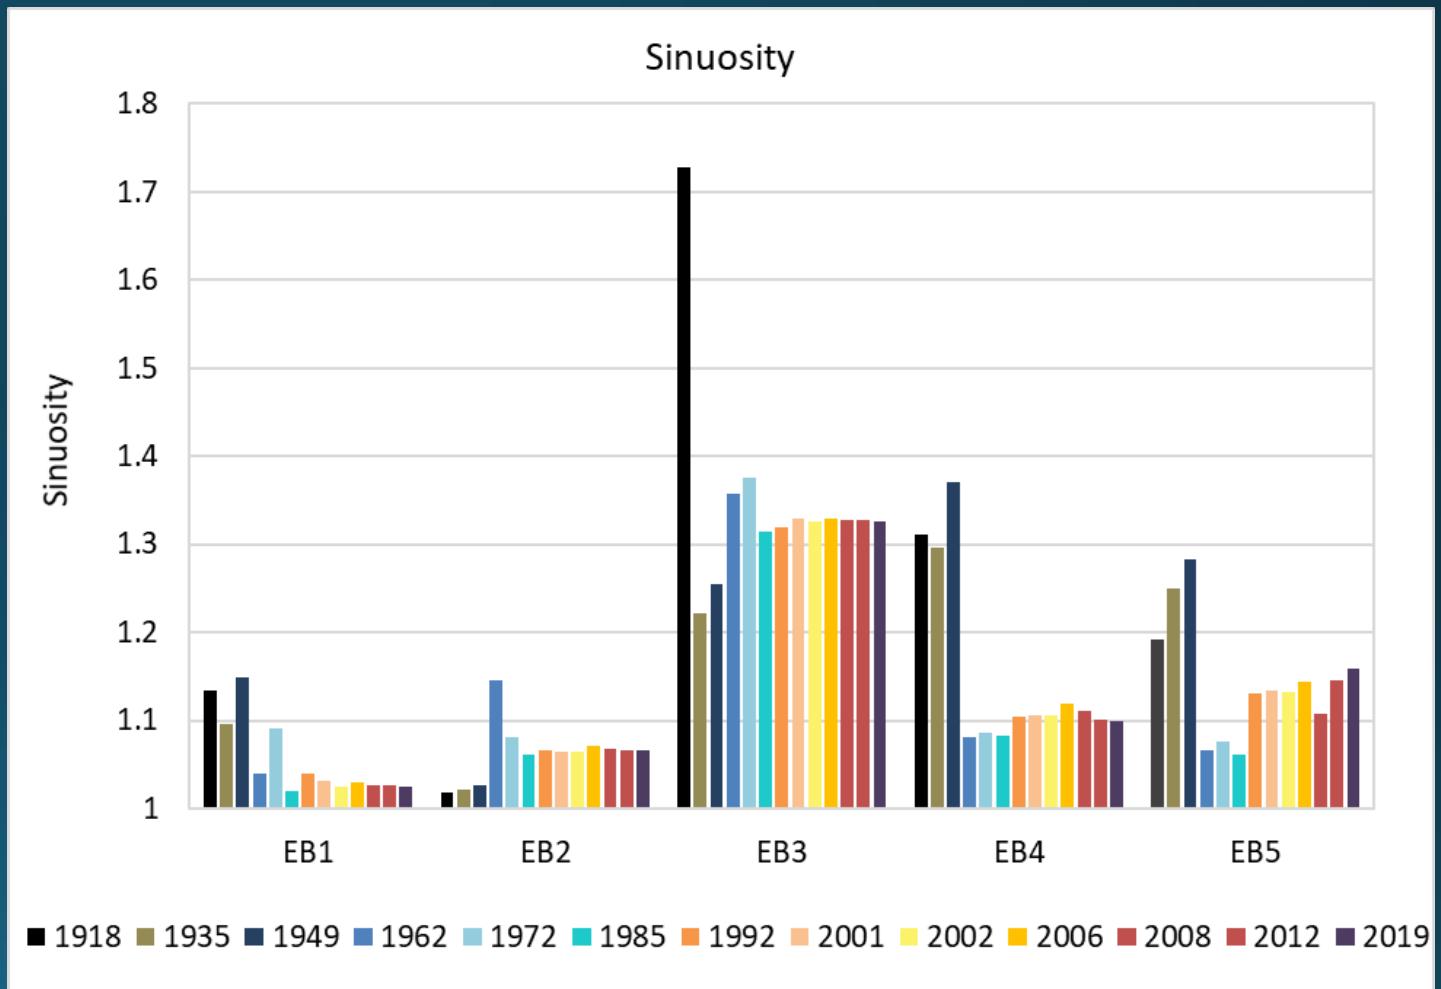
Sinuosity

- Generally, has decreases and stabilized
 - Subreach EB3 has become more sinuous since 1935

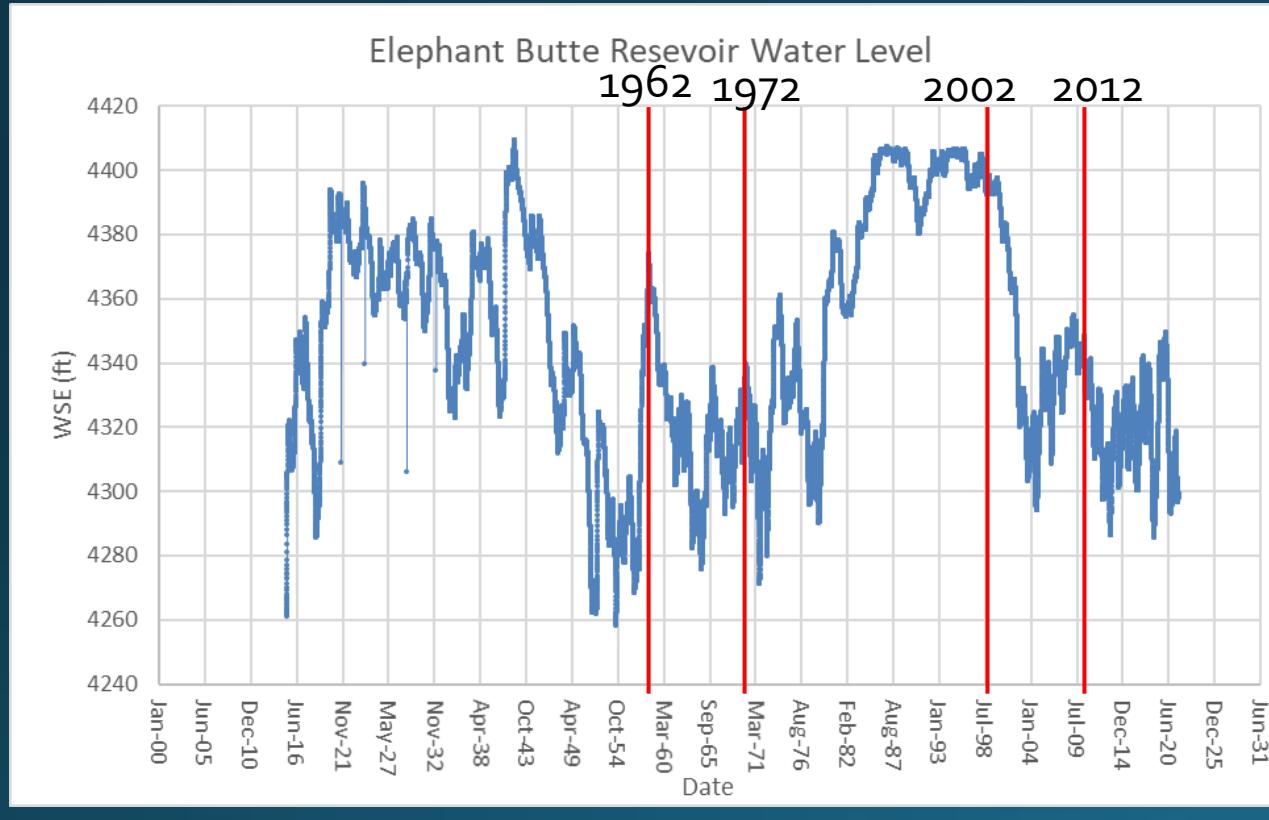
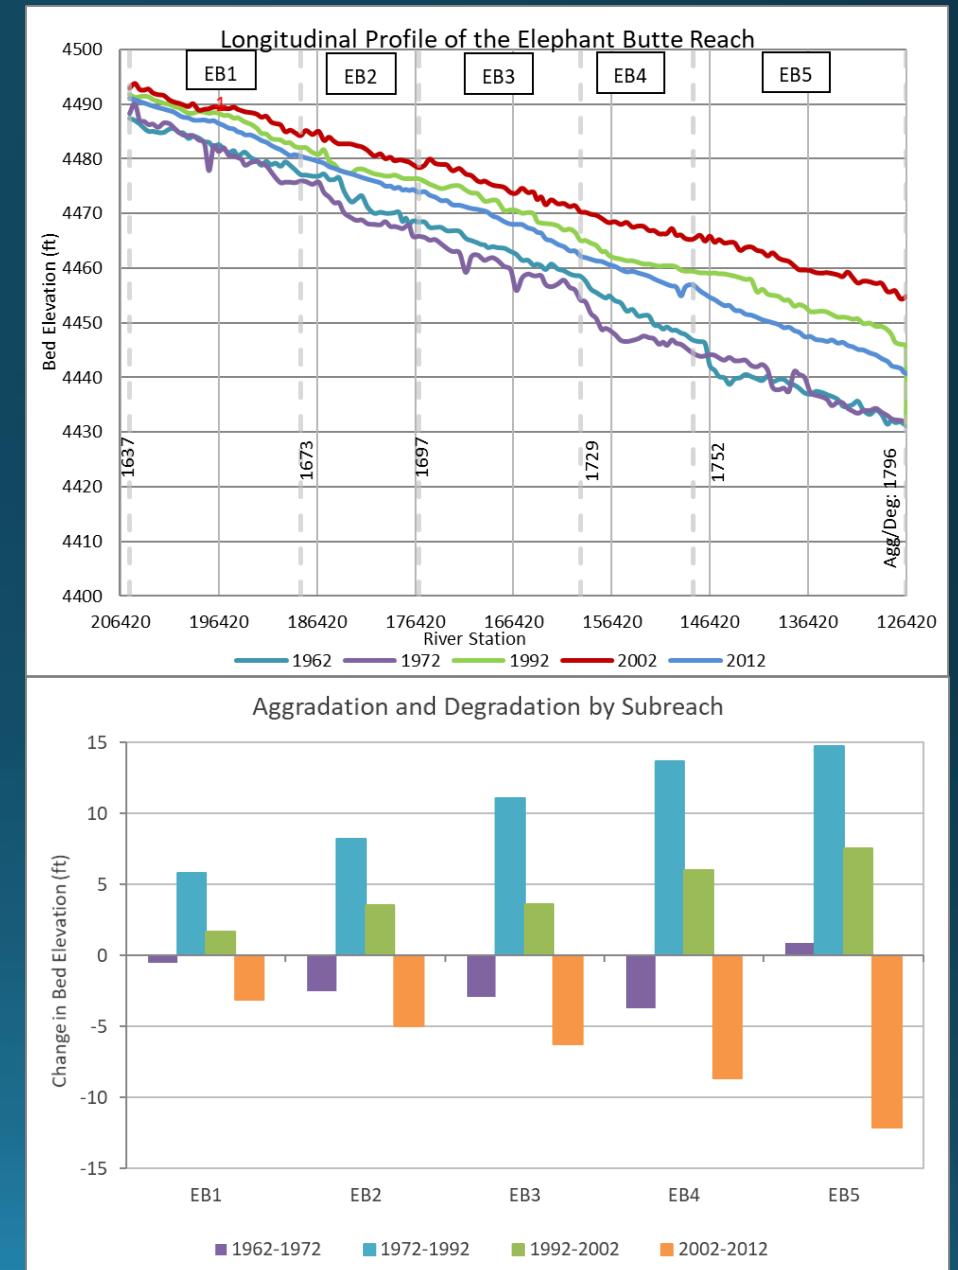
Aggradation & Degradation

- How has the river reacted and changed over time?

- Main inflow of water is during snowmelt, where main input of sediment is due to monsoons.
- Cycle of aggradation, degradation through the reach as a whole. Farther downstream these trends get more extreme potentially due to reservoir effects.
- History of aggradation and perching of the main channel.
- Currently there needs to be flows of around 4,750 cfs to have 25% levee overtopping.
- Perching has caused severe disconnection between floodplain and main channel.

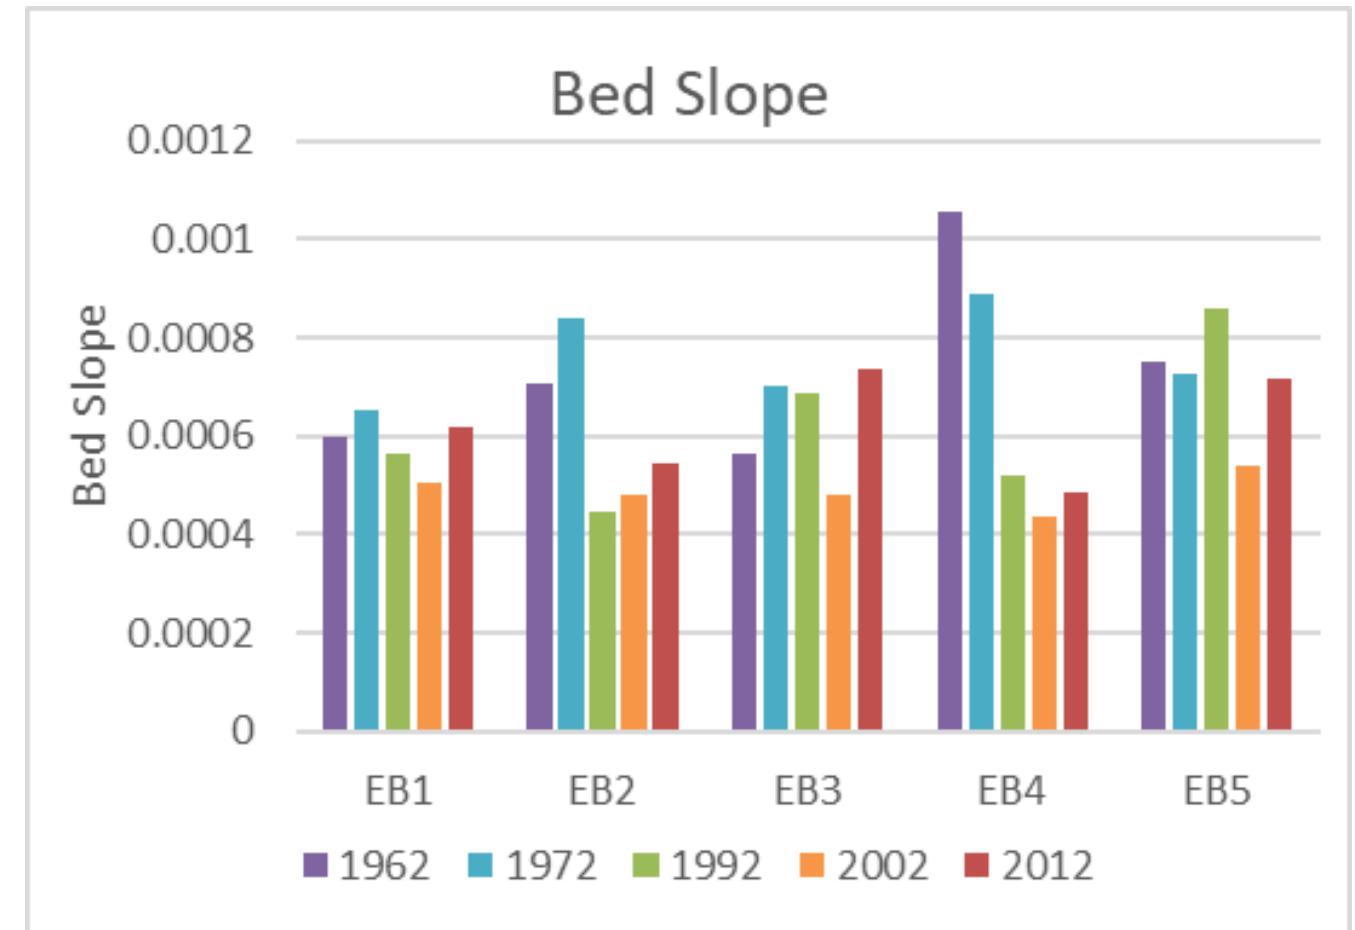
Bed Slope

- Slope has stayed relatively the same.
- In general, aggradation has a decrease in slope.
Degradation has an increase in slope.

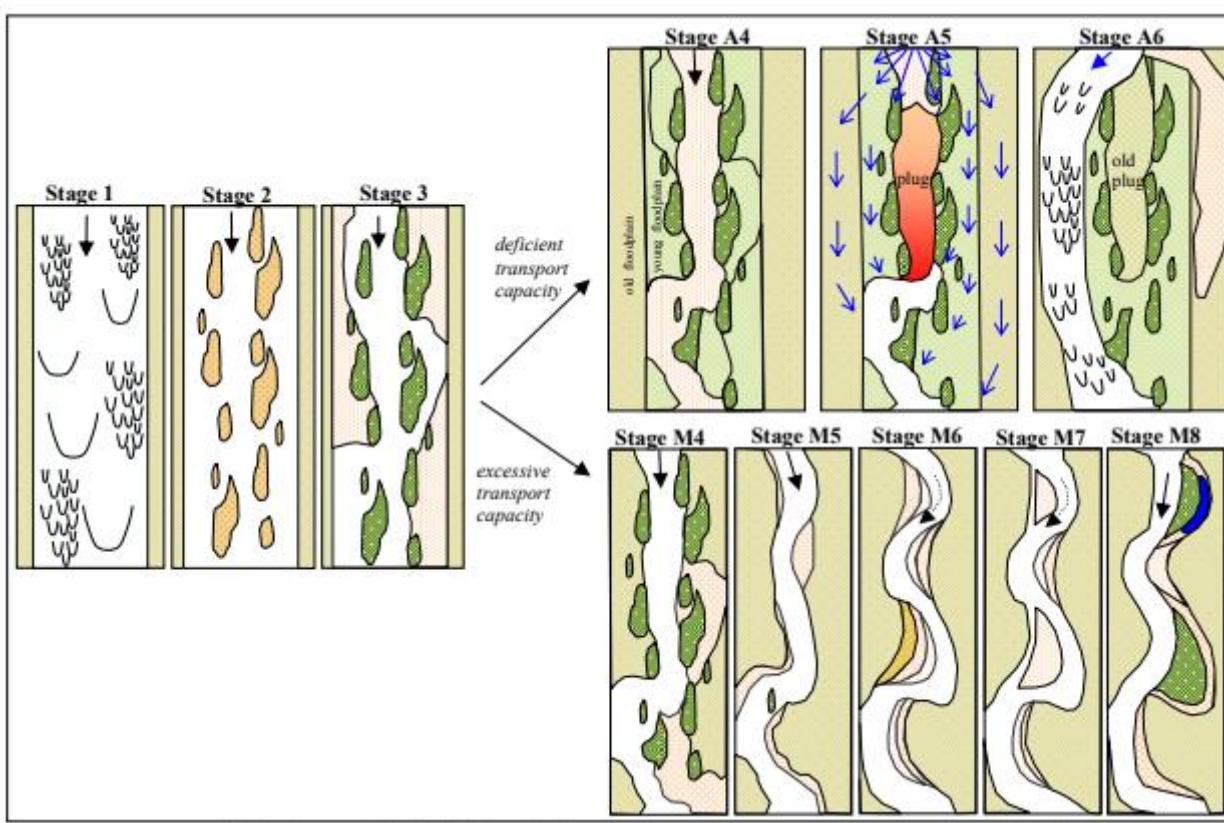
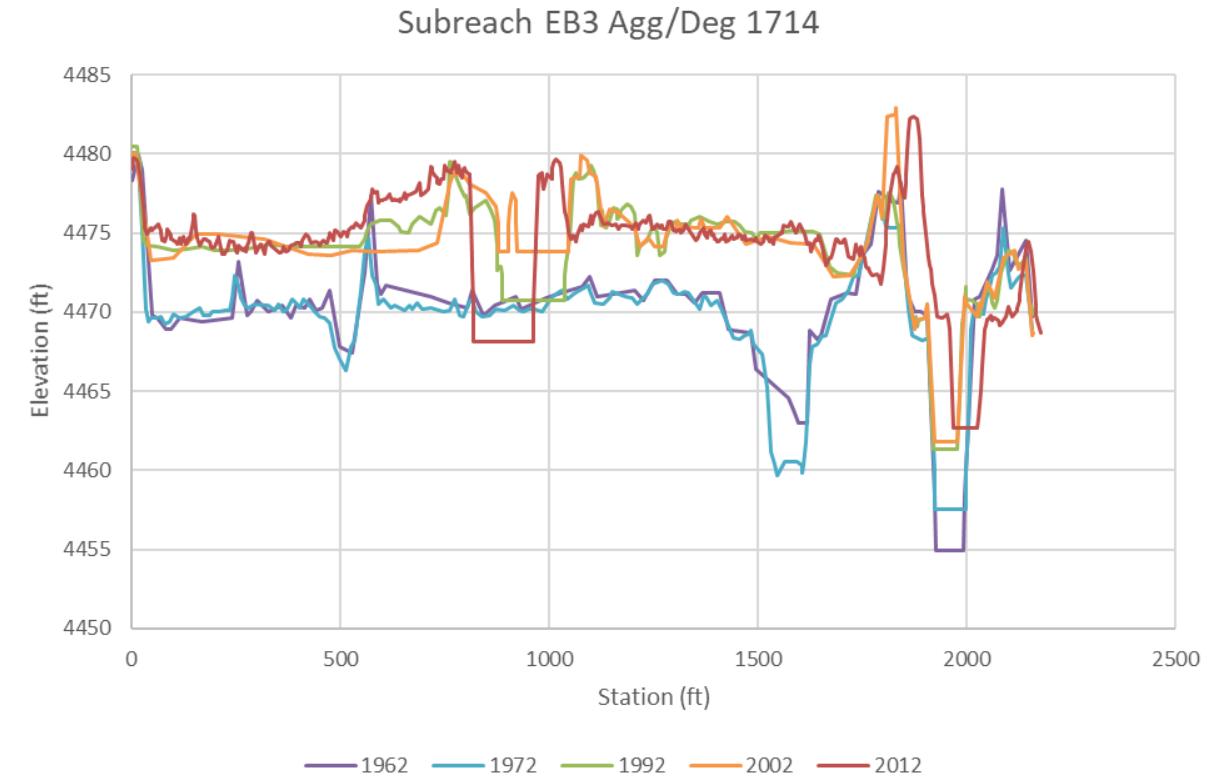
Conceptual Planform Model

Planform evolution model from Massong et al. (2010). The river undergoes stages 1-3 first and then continues to stages A4-A6 or stages M4-M8 depending on the sediment transport capacity.

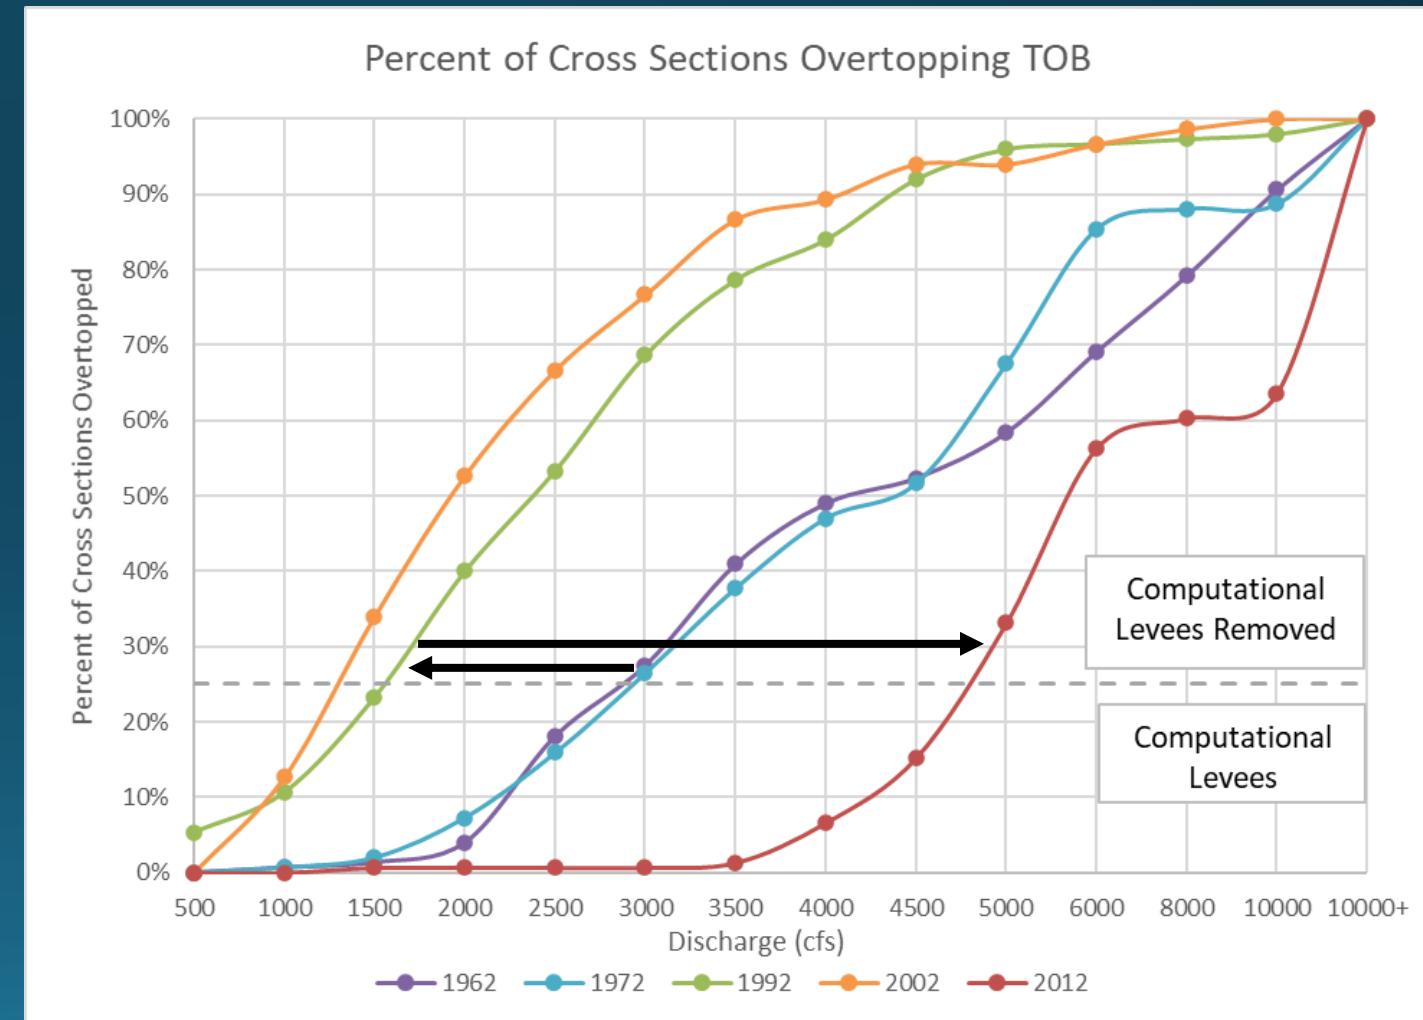
Percent Overtopping

- Due to aggradation degradation cycles over topping has required different cfs
- Potentially takes 4,750 cfs or more for overtopping

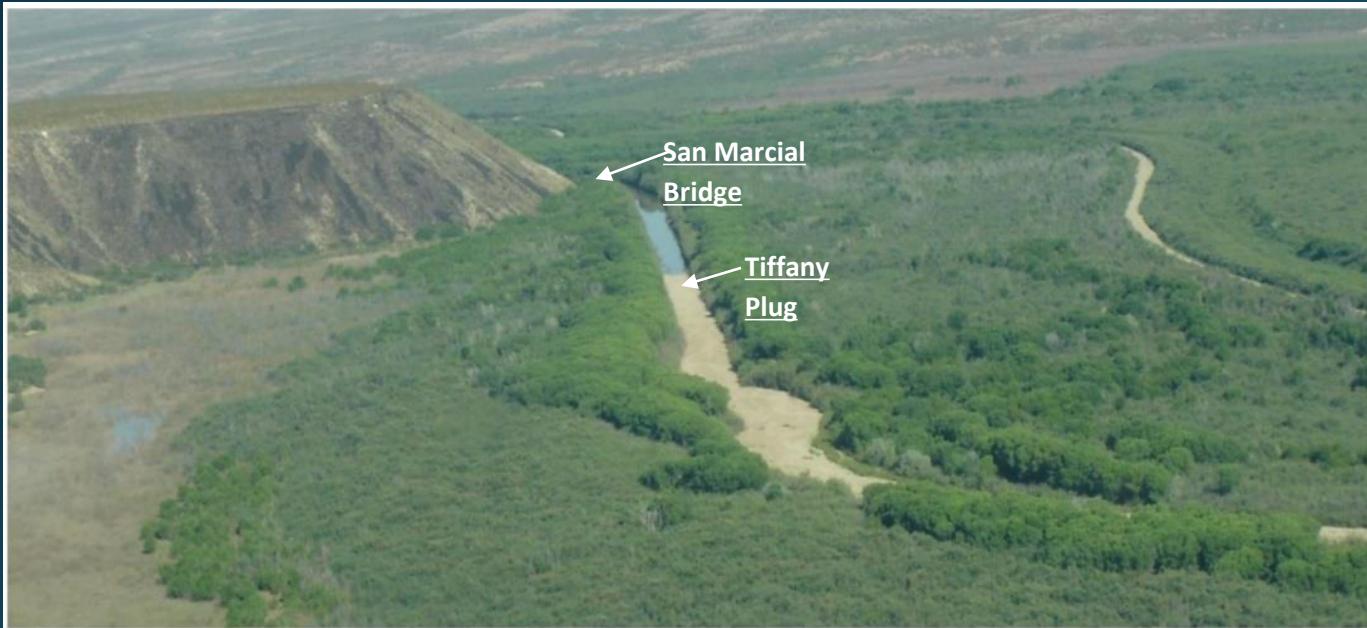
Sediment Plugging

Downstream view of the 2005 Tiffany Plug (Owen et al., 2011)

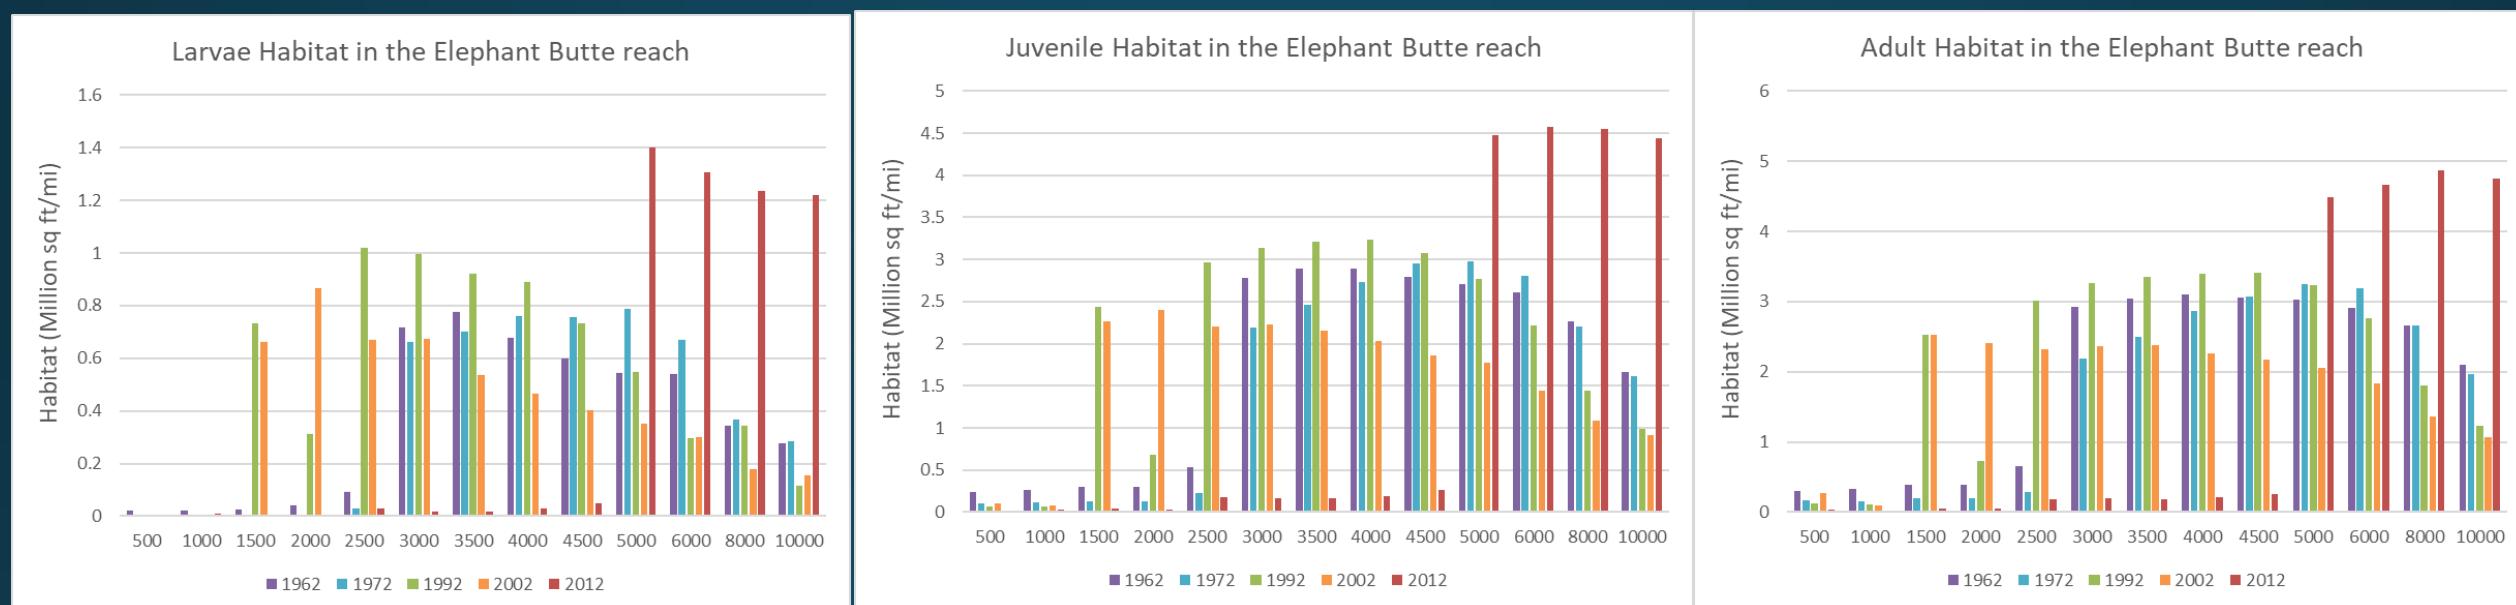
Habitat Availability

- Takes up to 4,750 cfs to over top in some locations (Subreach EB5)
- 2012 includes subreach EB6

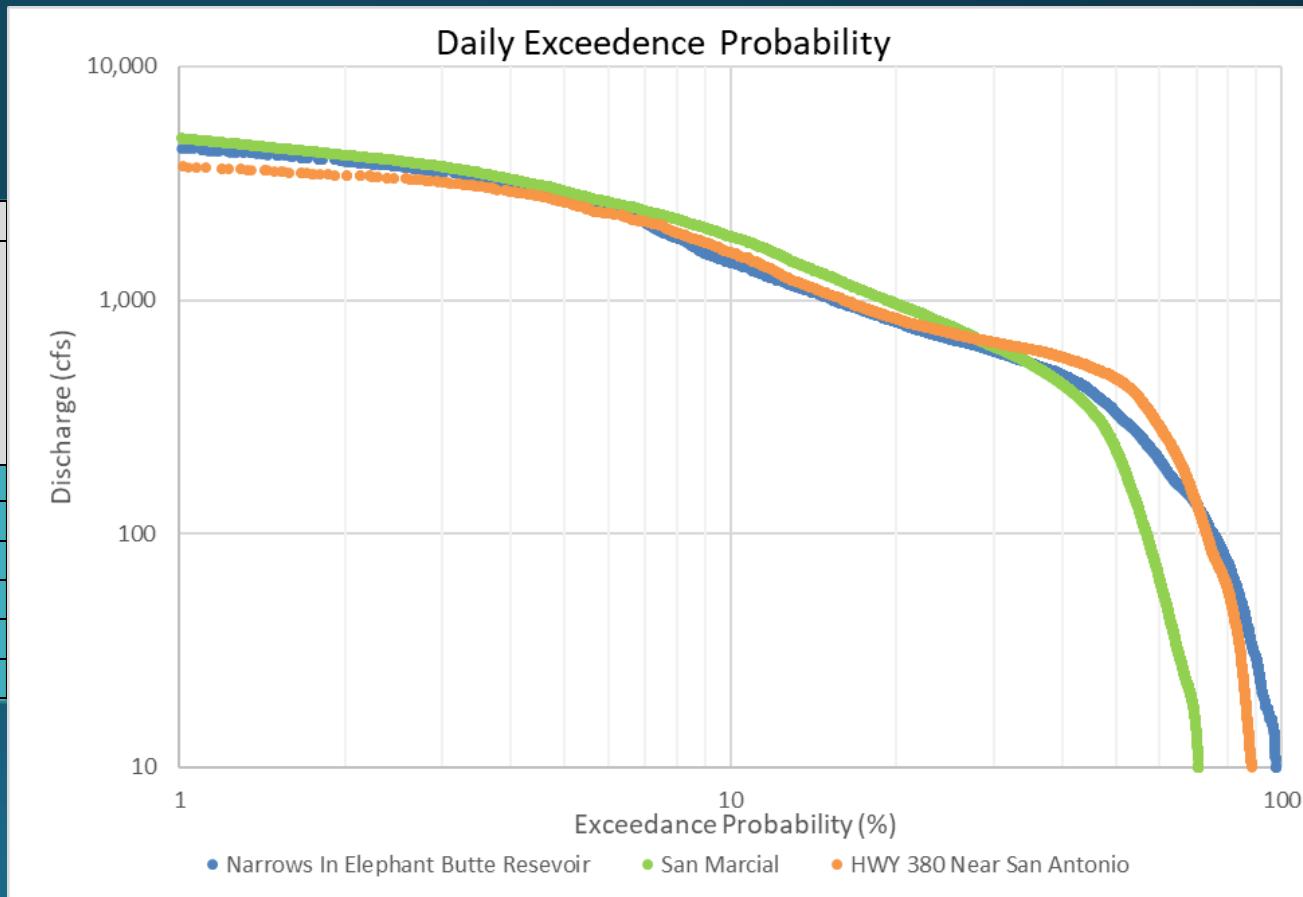
Flow Exceedance

Probability of Exceedance	Discharge (cfs)		
	08358400 Rio Grande Floodway at San Marcial, NM (October 1, 1949 – May 25, 2021)	08359500 Rio Grande at Narrows in Elephant Butte Reservoir, NM (April 1, 1951 – May 25, 2021)	08355490 Rio Grande Above US HWY 380 NR San Antonio, NM (September 30, 2005 – May 25, 2021)
1%	4926	4483	3739
10%	1870	1449	1602
25%	775	681	723
50%	232	330	461
75%	0.009	100	82
90%	0.004	29	4

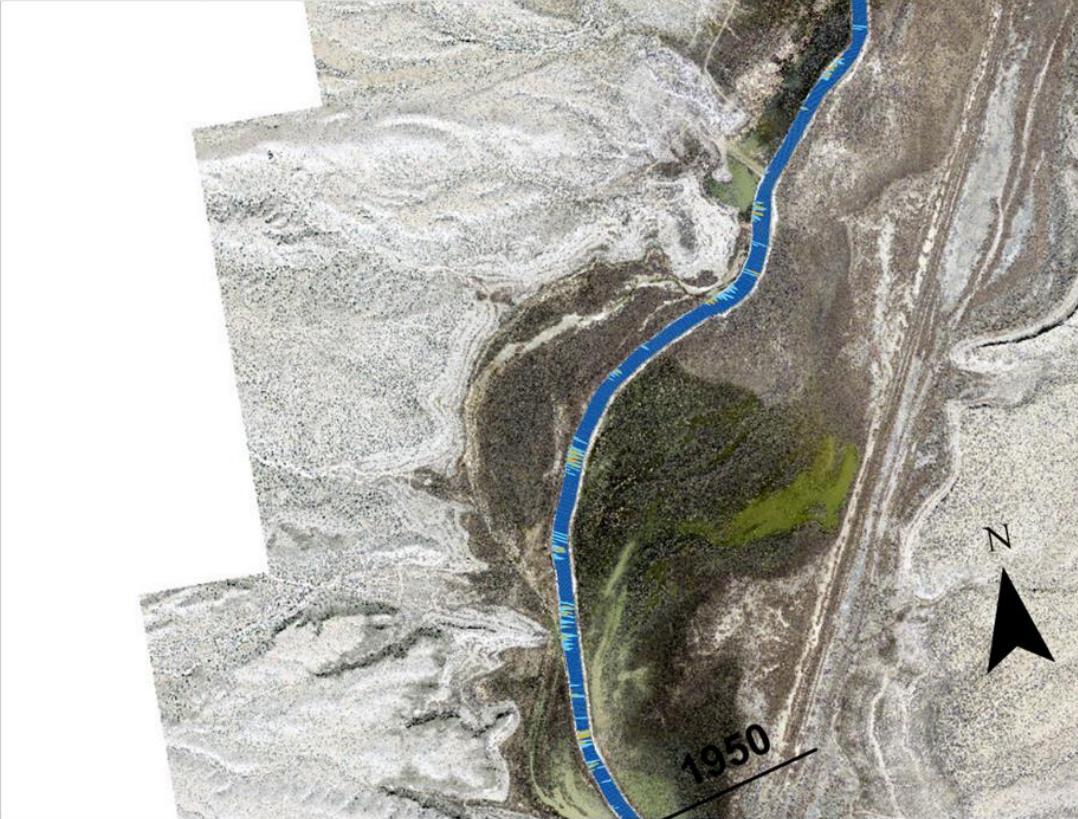
EB6.5 Habitat

1,500 cfs

- Larvae
- Juvenile
- Adult
- Inundated (Hydr. Unsuitable)

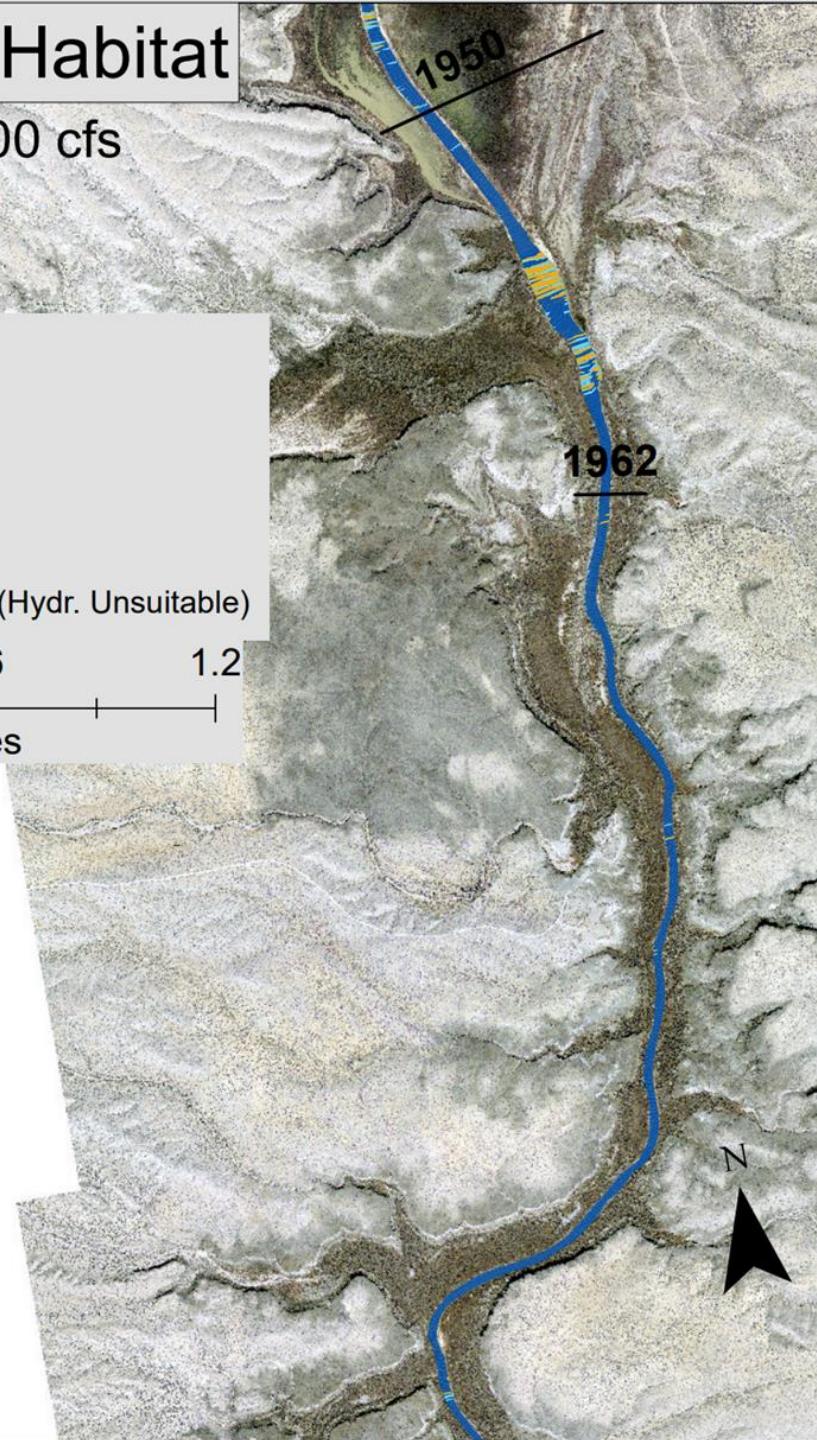
EB6.6 Habitat

1,500 cfs

- Larvae
- Juvenile
- Adult
- Inundated (Hydr. Unsuitable)

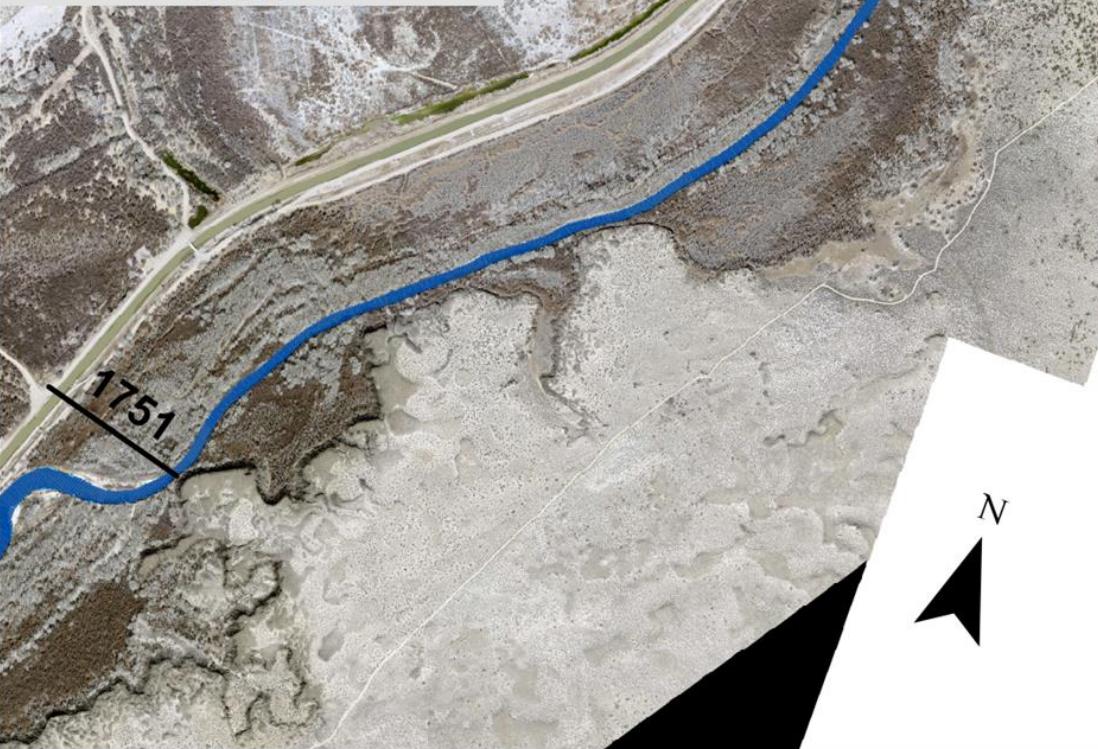
EB5 Habitat

3,000 cfs

- Larvae
- Juvenile
- Adult
- Inundated (Hydr. Unsuitable)

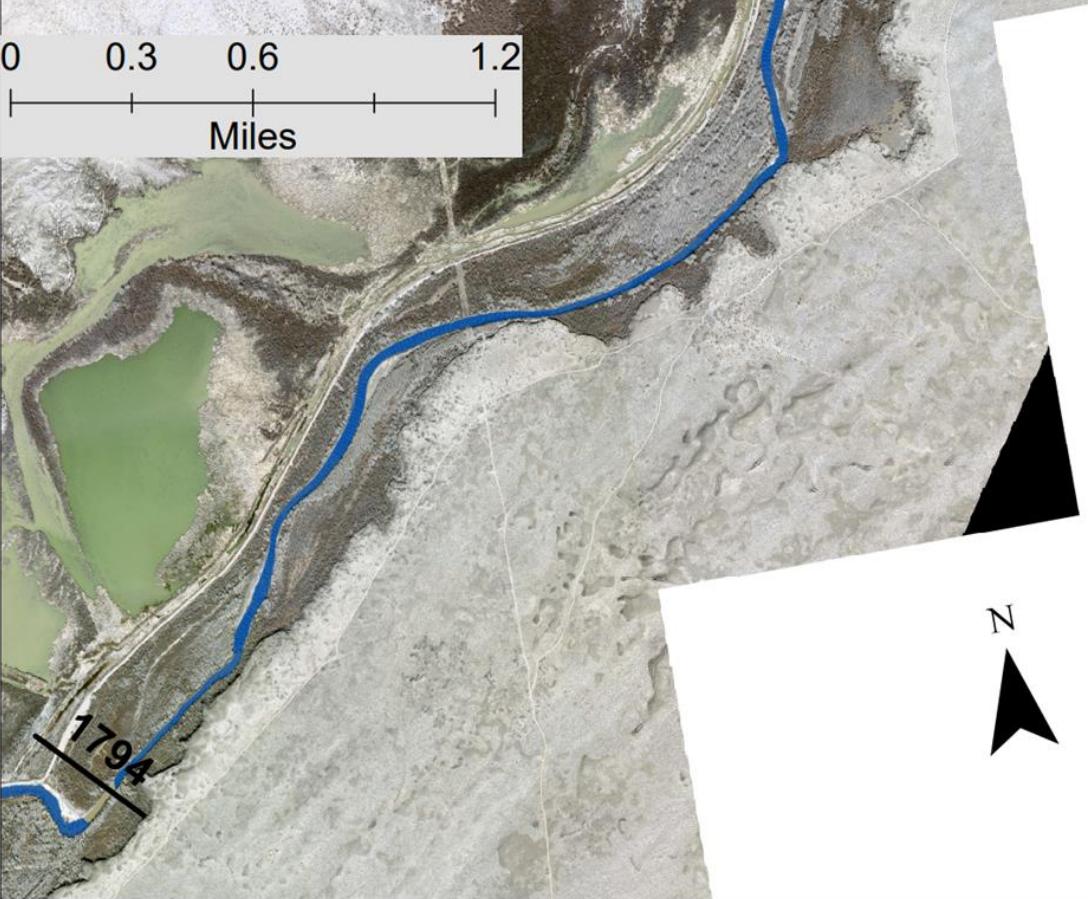
EB6.1 Habitat

3,000 cfs

- Larvae
- Juvenile
- Adult
- Inundated (Hydr. Unsuitable)

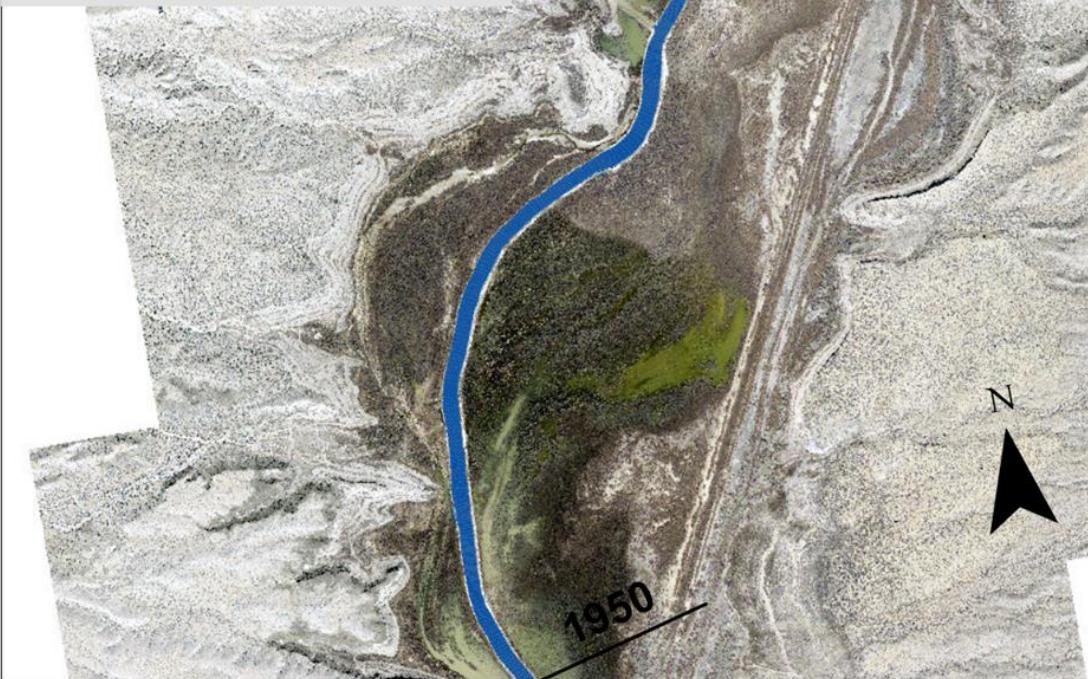
EB6.5 Habitat

3,000 cfs

- Larvae
- Juvenile
- Adult
- Inundated (Hydr. Unsuitable)

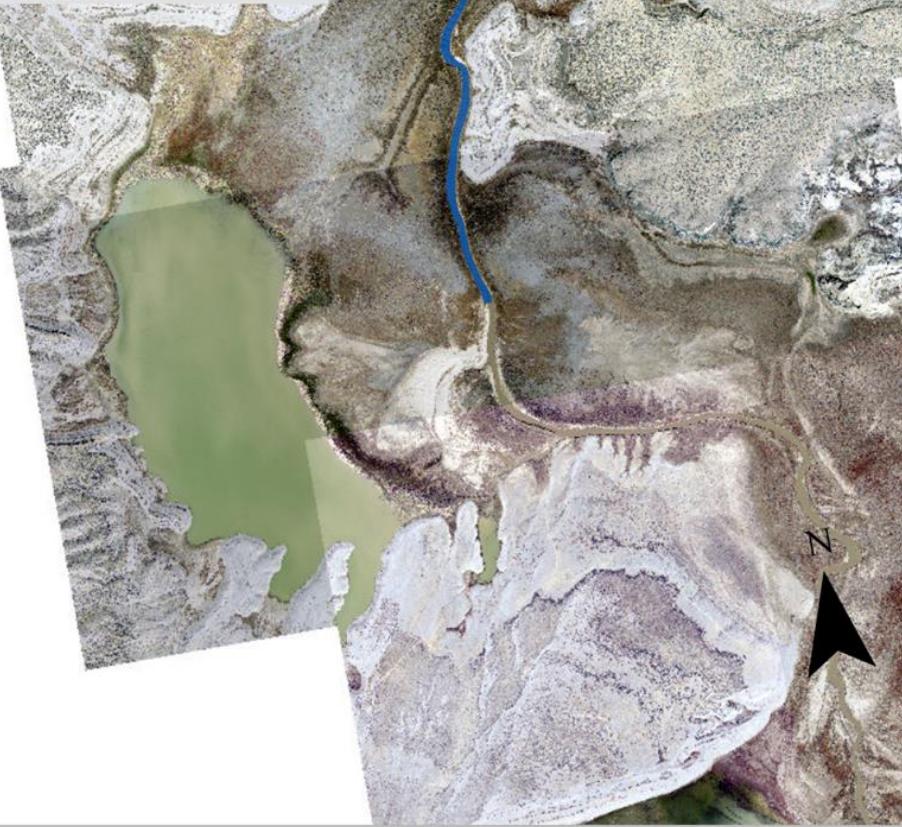
EB1 Habitat

5,000 cfs

- Larvae
- Juvenile
- Adult
- Inundated (Hydr.Unsuitable)

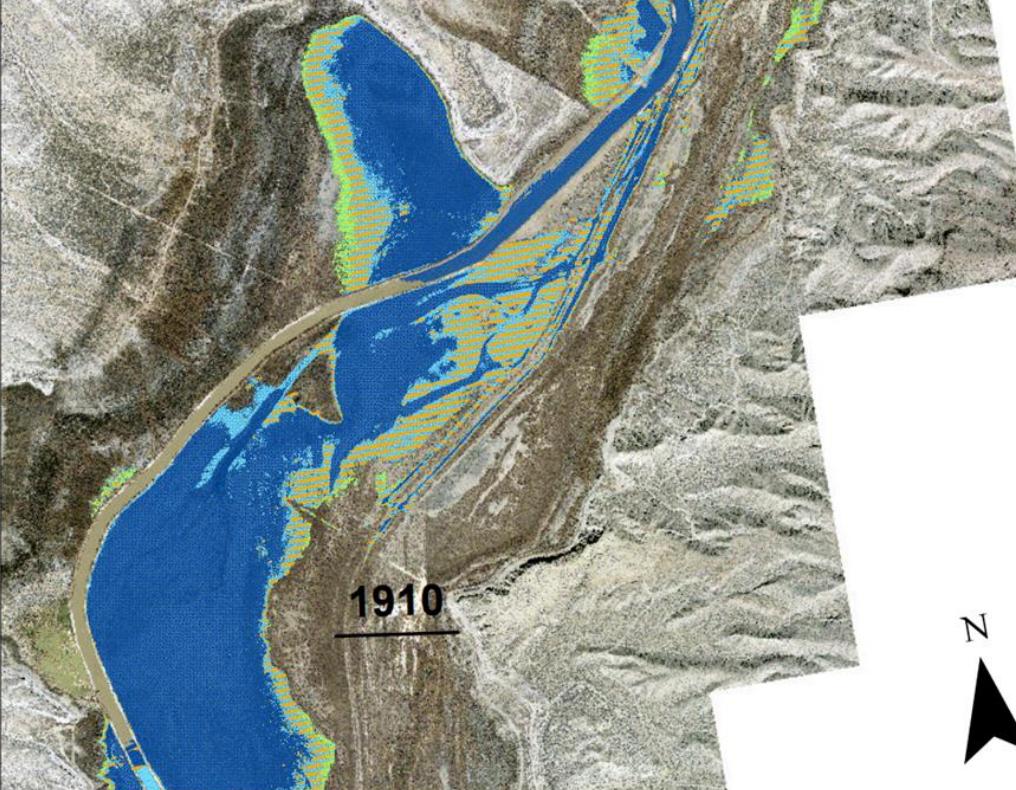
EB6.4 Habitat

5,000 cfs

- Larvae
- Juvenile
- Adult
- Inundated (Hydr.Unsuitable)

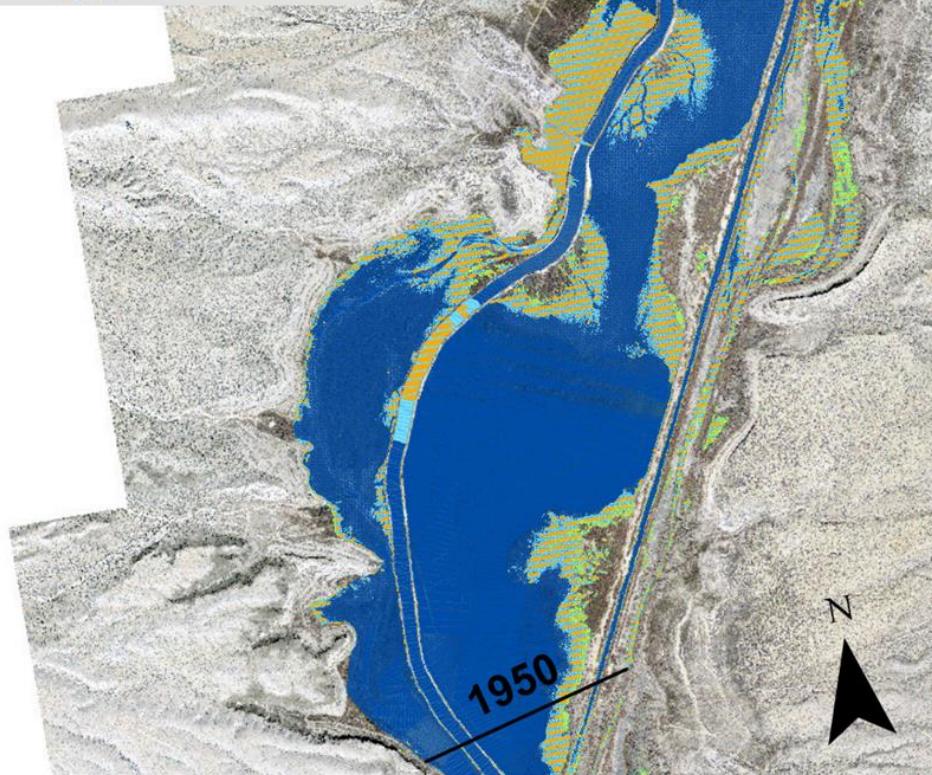
EB6.5 Habitat

5,000 cfs

- Larvae
- Juvenile
- Adult
- Inundated (Hydr.Unsuitable)
