Restoration of Abandoned Channels

Report prepared for the:

Korea Institute of Construction Technology (KICT), South Korea

Colorado State University

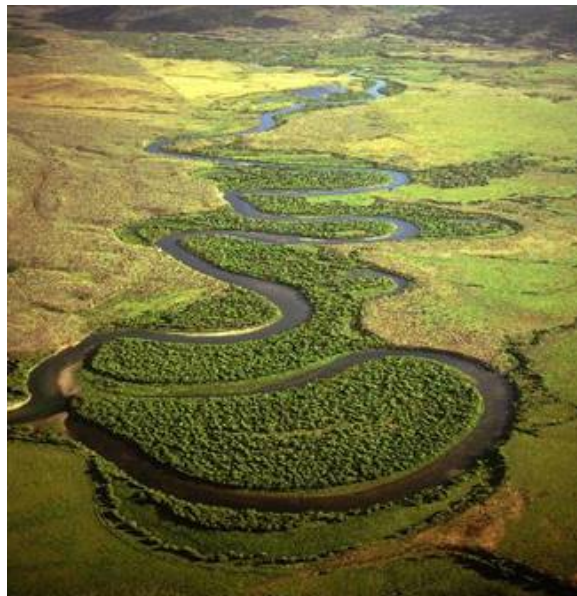
Figure 2.1 – Natural Neck Cutoff

Rivers have a tendency to meander within their floodplains to balance the transport of water and sediment. There are two types of natural cutoffs that occur. The first natural cutoff is a neck cutoff. It is formed when river sediment is deposited continuously on the convex bank and sediment is eroded from the concave bend. This causes the sinuosity of the meander to increase and the formation of a narrow neck of land. Eventually the neck disappears and a straight channel is formed, thus creating an abandoned channel or cutoff. When the cutoff is sealed from the main channel by sediment deposition an oxbow lake is formed. Refer to Figure 2.1 for a schematic of a neck cutoff and an example of a neck cutoff located along Green River in Wyoming.

a. Neck Cutoff Process

b. Example of Neck Cutoff on Green River in Wyoming

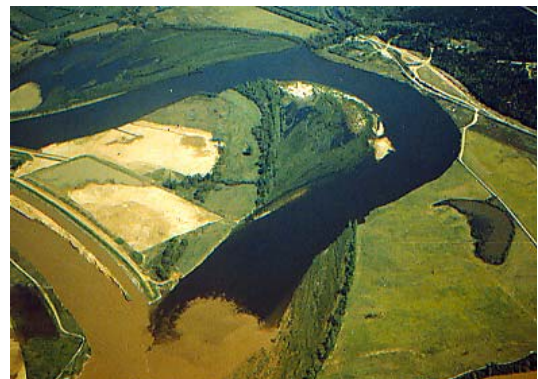
Figure 2.3 – Engineered Abandoned Channel (Julien 2002)

Abandoned channels have also been formed by engineering a straight channel. Rivers are straightened to aid with navigation and flood control. It is important to provide bank stabilization when straightening a channel, if this is not provided the channel will have a tendency to meander. Figure 2.3 provides an illustration how a channel is engineered and an example of an abandoned channel along the Red River.

a. Engineered Cutoff

b. Example of an Engineered Cutoff on the Red River

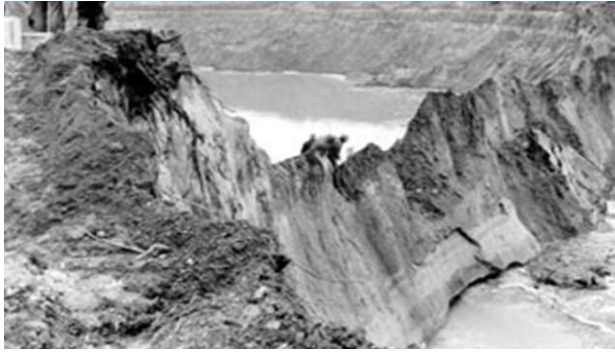
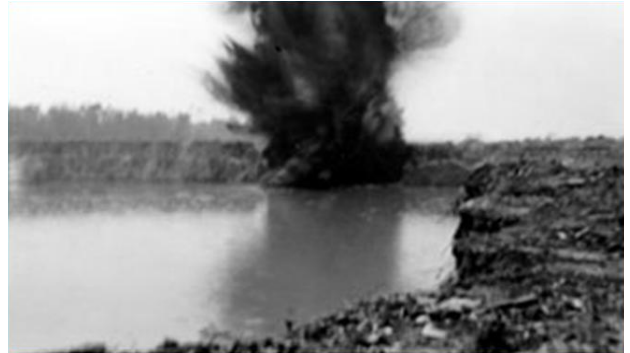
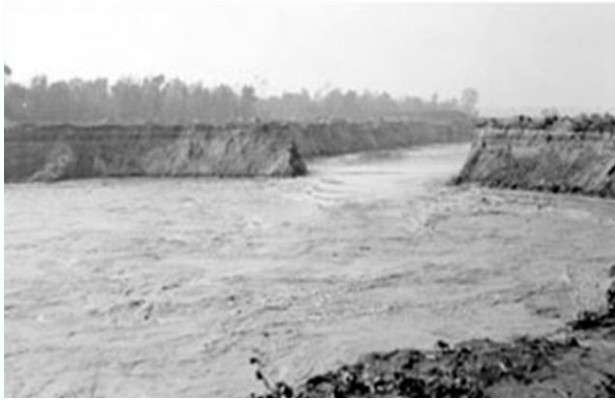
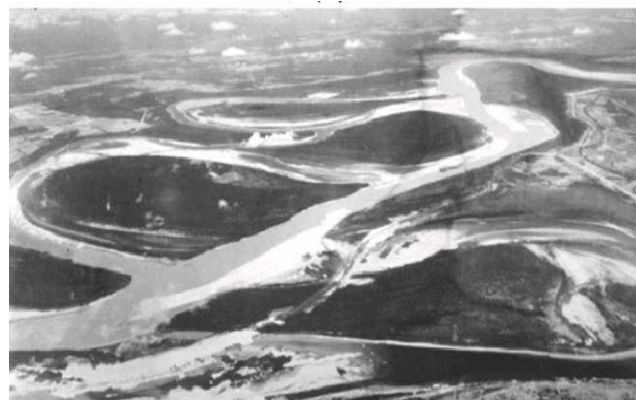
Figure 2.4 – Construction and Aerial View of Engineered Cutoffs

When engineering a cutoff, it is important to construct revetments upstream and downstream of the concave side of the meander. In addition, a small revetment trench is needed along the cut prior to the construction of the pilot channel. The excavation of the pilot channel should be from downstream to upstream with a minimum of 3 to 1 side slope, 15 to 60 meters wide and 2 to 4 meters below the low water reference plane (Julien 2002). This will allow for a straight channel that will be able to pass the flow without impairing navigation or flood control. Figure 2.4 shows the process of an engineered cutoff on the Mississippi River.

a. Earth Plug Separating Pilot Channel

b. Dynamite Blasting Earth Plug

c. One Hour opening cutoff

d. Ashbrook, Tarpley and Leland Cutoffs.

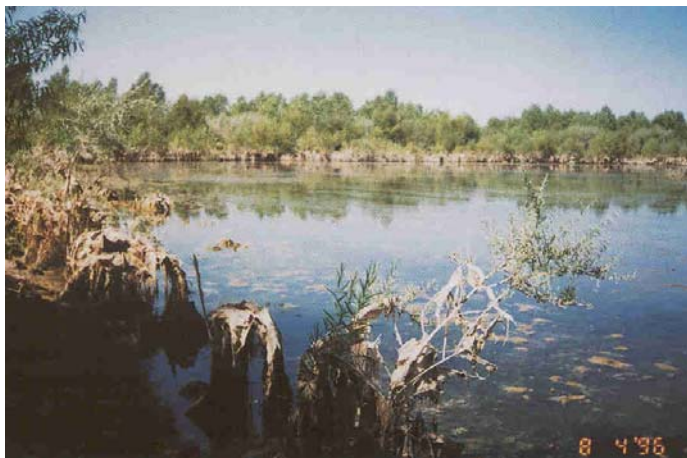
Figure 2.6 – Kachituli Oxbow along Sacramento River (Hey and Philippi 1999)

Kachituli Oxbow is the only constructed oxbow lake along the Sacramento River in Northern California. Constructed in 1991 to mitigate the destruction of wetlands, this oxbow is located outside of the flood control levees. The characteristics of this oxbow were determined by performing detailed field surveys of six naturally formed oxbows along the Sacramento and Feather Rivers. A sinuous meander channel was specified with a deep pool of approximately 5 feet at the southern end. Analysis of the site revealed groundwater, which would provide sustainable water supply. In addition, irrigation was provided to establish the diverse plant community. Though management is needed to insure the survival of this mitigation site from weeds and herbivory (rats) an aggressive action plan has been implemented for site survival (Hey and Philippi 1999). Figure 2.6 show Kachituli Oxbow during the dry season and an aerial view of the site.

a. Dry Season Flow

b. Aerial View

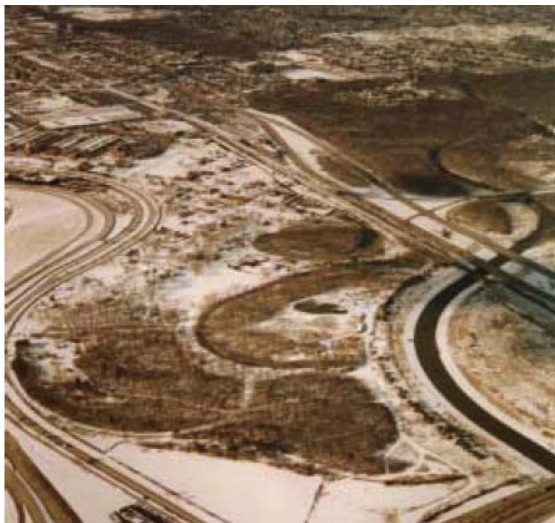
Figure 2.7 – Rouge River Oxbow Lake Restoration

wetlands and improve water quality. This is accomplished by removing existing fill that was placed in the old oxbow. The new oxbow is 2,220 feet long, 15 to 105 feet wide and 3 to 6 feet deep. The area is surrounded by 3 acres of wetlands. Bioengineering techniques were used to stabilize slopes (O'Meara et al. 2002-2003). The project was completed in 2007. Prior to stocking the site with fish over 14 species were identified. The newly constructed oxbow will increase flood storage for the Rouge River. There have been diverse wildlife sightings throughout the area, including coyote, fox, raccoon, deer, raptors, owls, bats, ducks, herons, turtle, frogs, etc. Figure 2.7 provides an aerial views of per and post construction and a typical post construction cross section.

a. Aerial View Pre Construction (O'Meara et al. 2002-2003)

b. Aerial View Post Construction

c. Typical Cross Section Layout (O'Meara et al. 2002-2003)

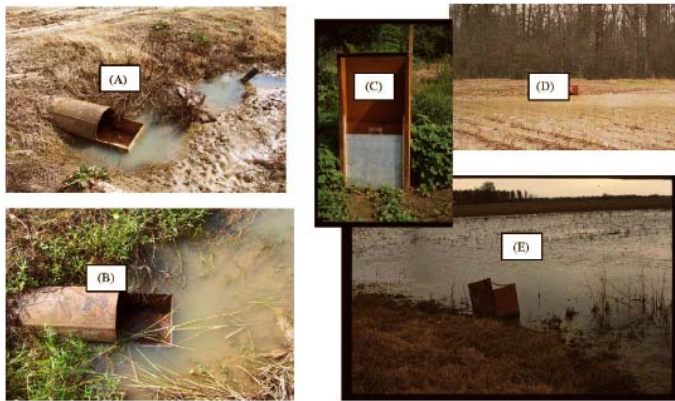
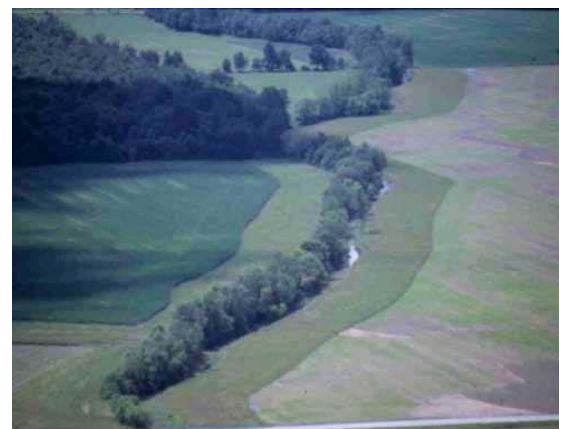
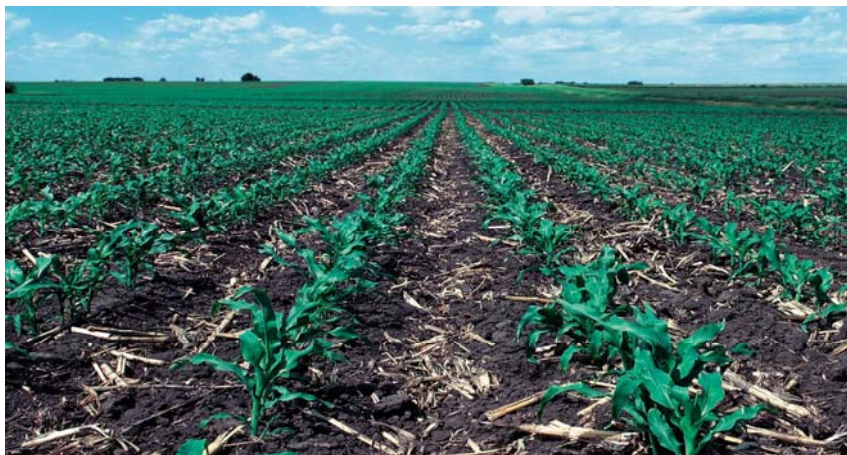
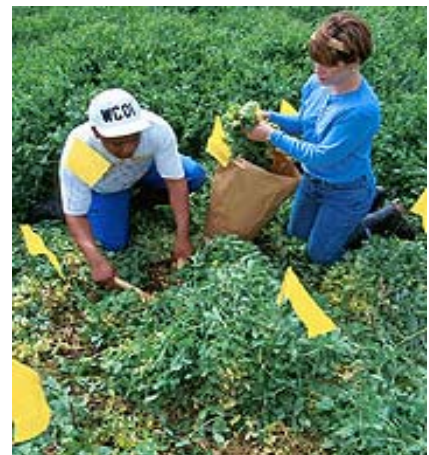
Figure 2.8 – Examples of Best Management Practices

The use of Best Management Practices (BMPs) at sites can significantly improve water quality. A study was performed on three oxbow lakes within Mississippi (Thighman, Beasley and Deep Hollow Lake). The goal of the project was to implement edge-of-field practices (slotted pipes, slotted board inlets, grassed buffers and stiff grass hedges) and agronomic methods (conservation tillage and winter cover crops) to reduce non-point source pollutants from agricultural runoff (Cullum et al. 2006; Knight et al. 2002; Knight and Welch 2004). The Beasley Lake watershed was protected by edge-of-field practices (Refer to Figure 2.8 for examples), Thighman Lake watershed was protected by agronomic methods and Deep Hollow watershed was protected by a combination of the two prescribed BMPs.

a. Edge-of Field BMP (Cullum et al. 2006)

b. Riparian Buffer

c. Conservation tillage

d. Crop Cover to Prevent Erosion

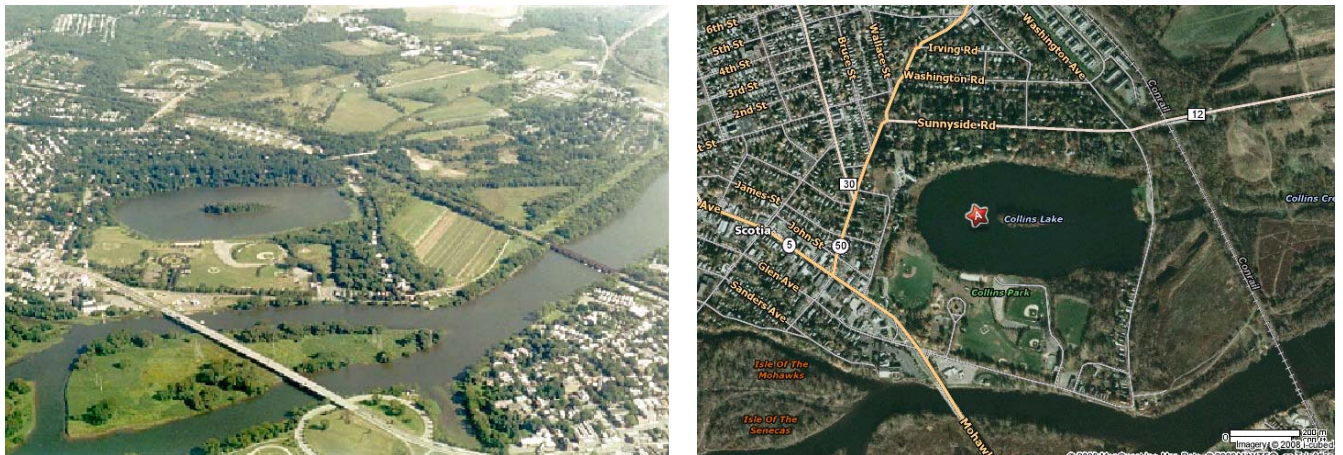
Figure 2.9 – Mohawk River and Collins Lake (<http://engineering.union.edu/~birds/>)

Collins Lake is an oxbow lake created by the Mohawk River in Scotia, New York. This lake is used intensely for swimming, boating, and fishing. The lake is experiencing excessive macrophytes and algae growth, thus restoration strategy has been constructed to remove the organic, nutrient rich sediment and deepen the lake through hydraulic dredging in 1977 and 1978 (Snow et al. 1979). Due to the cost, environmental impacts, and the problem of disposal, dredging should not be performed for aquatic plant management alone. It is best used as a lake remediation technique. Figure 2.9 provides an aerial view of Collins Lake. A long term study has been conducted on the effects of dredging on Collins Lake and is summarized in Section 3.

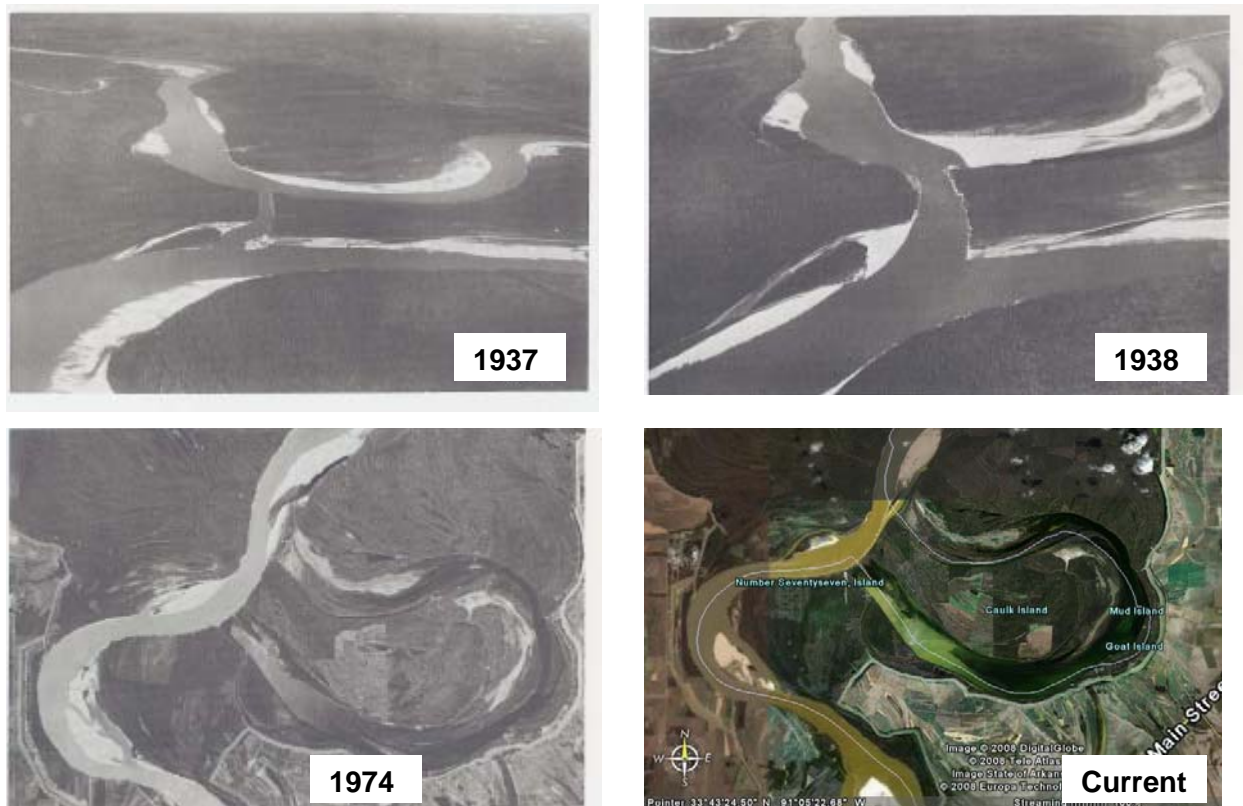
Figure 2.10 – Change of Lake Whittington due to Caulk Island Cutoff, Mississippi River

Additional studies have been conducted on the Mississippi River to look implementing weirs and other water control structures to improve premature or excessive dewatering. Dewatering results in low water for spawning and rearing in the littoral zone, contributes to hypoxia and high temperatures in isolated pools which results in fish kill (Hoover et al. 2000). Lake Whittington is an oxbow lake located along the Mississippi River, refer to Figure 2.10. It was developed in 1937 when the US Army Corps of Engineers completed the Caulk Island Cutoff. The deepest portion of the lake is up to 20 feet deep. During bankfull the surface area of Lake Whittington is 3000 acres, but is reduced to three small pool totaling 1000 acres during the late summer. A weir constructed on Lake Beulah in 1955 helped restore backwater and the sample plan is being proposed on Lake Whittington. This will increase the habitat population.

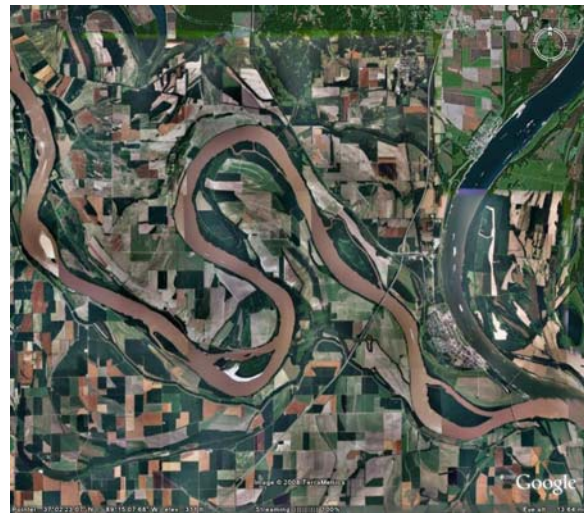
Figure 2.12 – Thompson Bend on the Mississippi River

Thompson Bend on the Mississippi River is above the confluence of the Mississippi and Ohio rivers. Severe erosion has occurred causing the formation of a new channel across the peninsula, which threatens a levee and navigation (Figure 2.12). Costly erosion control methods have been implemented but failed. Thus beginning in 1985 and early 1986 revegetation of the area began. Today solution includes a riparian buffer strip of trees planted between the riverbank and floodplain. Due to the revegetation along 20 miles of shoreline the Great Flood of 1993 resulted in minimal erosion and prevented a neck cutoff from occurring.

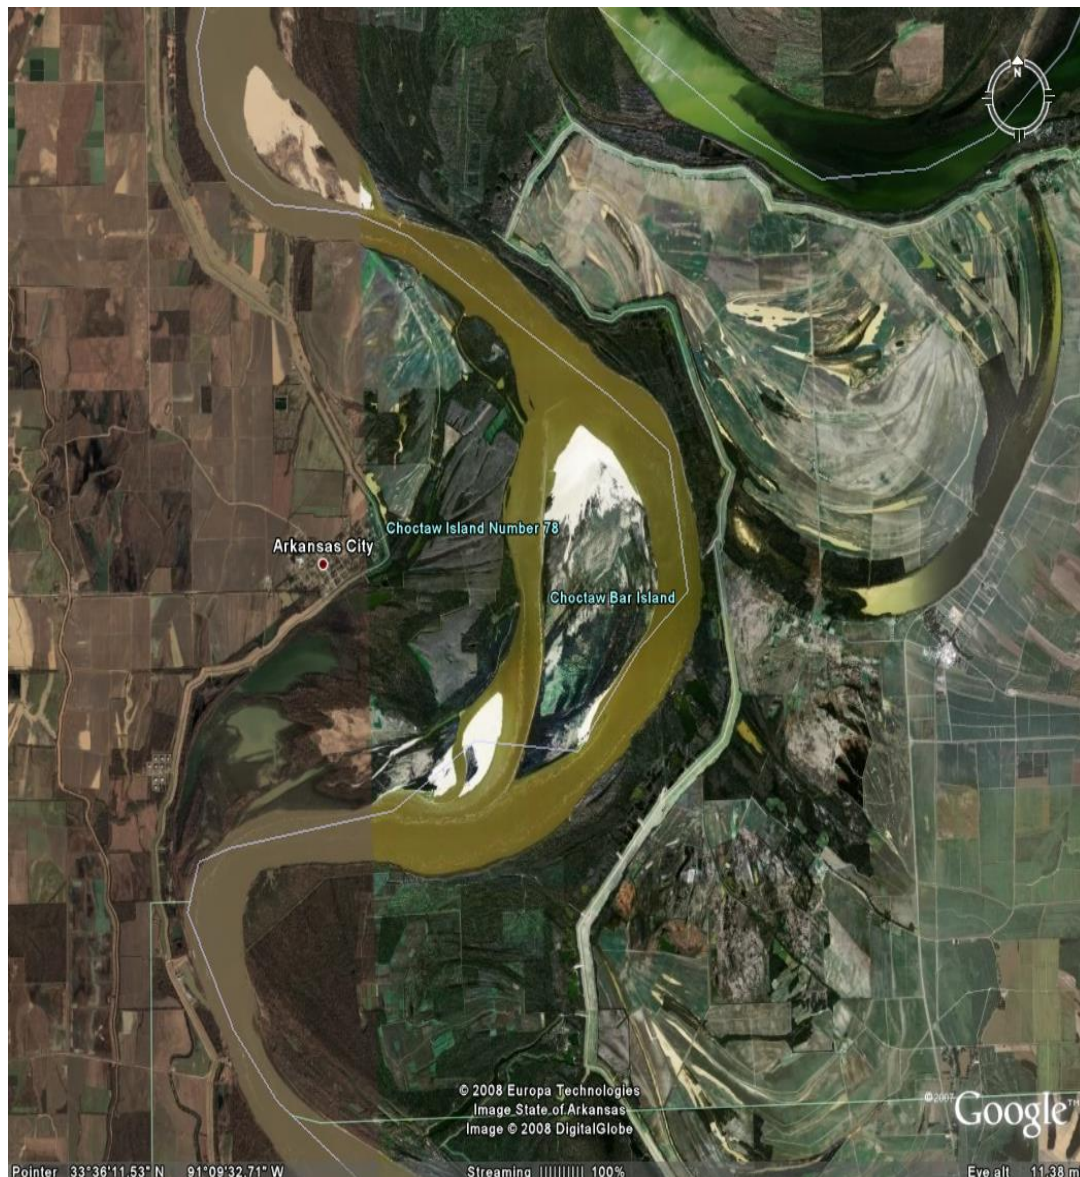
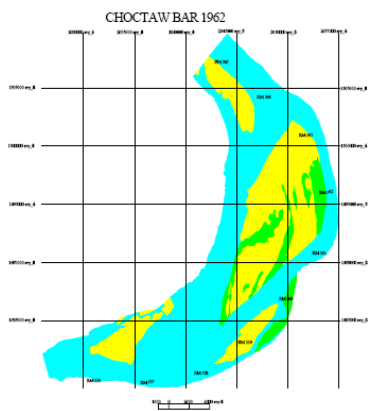
Figure 3.2 – Time Series of Choctaw Bar (USACE 1999)

Engineering efforts have been made at Choctaw Bar to stabilize the river for navigation and flood protection. Flow at the Choctaw Bar is divided with a secondary channel on the right bank and a main channel on the left bank (Figure 3.2). A stone dike system was constructed at the upstream entrance to the secondary channel in 1968 to reduce divided flow conditions and deepen the navigation channel. However during the 1973 flood, a large section of the main closure dike degraded, creating a weir, which allowed significant flow in the secondary channel and caused sedimentation within the main channel requiring dredging. Vegetation on the islands is natural and provides bar stabilization. Appendix A shows the current restoration plan for Choctaw Bar.

(red line = stone dikes, yellow = bare sandbar, blue = water and green = vegetation)

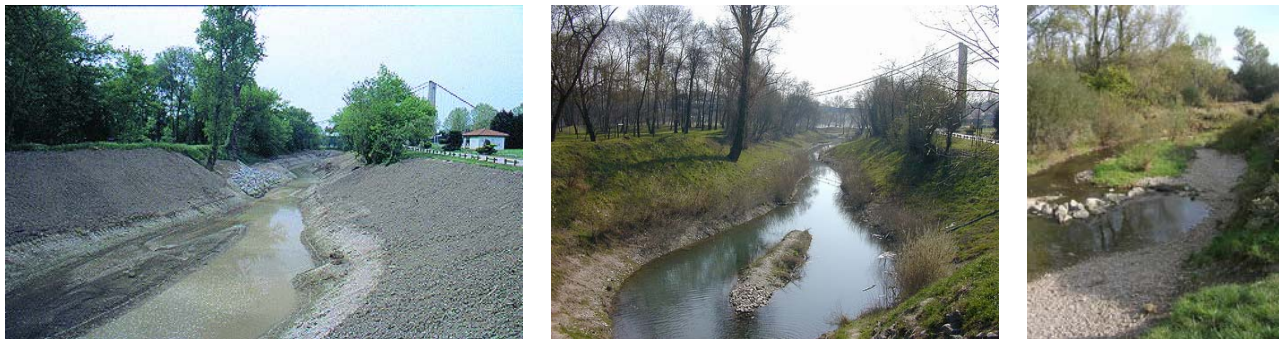
Figure 3.3 – Restored Side Channel along Rhone River downstream of Pierre-Benite Dam
(<http://institutbeaumont.com/field-trips/>)

A restoration effort was carried out on former channels along the Rhone River in France. Long-term monitoring of aquatic vegetation was conducted on two sites for 17 years located in Bregnier-Cordon plain in the Upper Rhone River. One was a reference site and one was a restored ecosystem. A hydroelectric plant was built in 1982 and 1984 and a weir in 1985 was constructed to maintain upstream water levels. This construction destroyed the downstream part of the Rossillon channel. The channel exhibited rapid eutrophication. Thus in 1993 construction began to restore this channel. The following measures were taken to restore the side channels: dredging was conducted, preservation of river banks and riparian forests which bordered the channel, and undamaged shorelines were preserved for rapid re-colonization of vegetation. Figure 3.3 is an example of a restored channel along the Rhone River. By 1997 the restoration was still successful as the channel started to reach a mesotrophic (fertile) state (Henry et al. 2002).

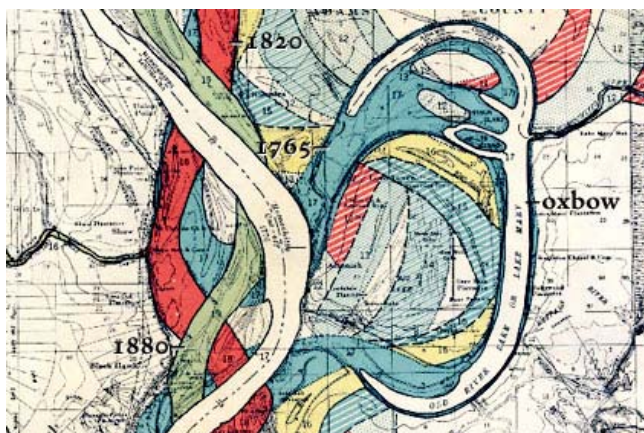
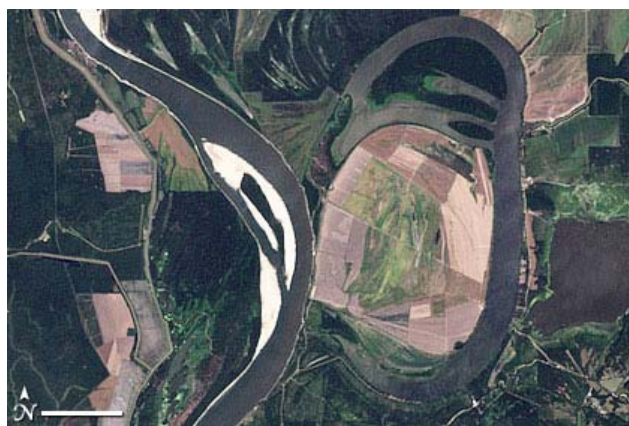
Historical Changes at Old River Lake (Simmon 2006)

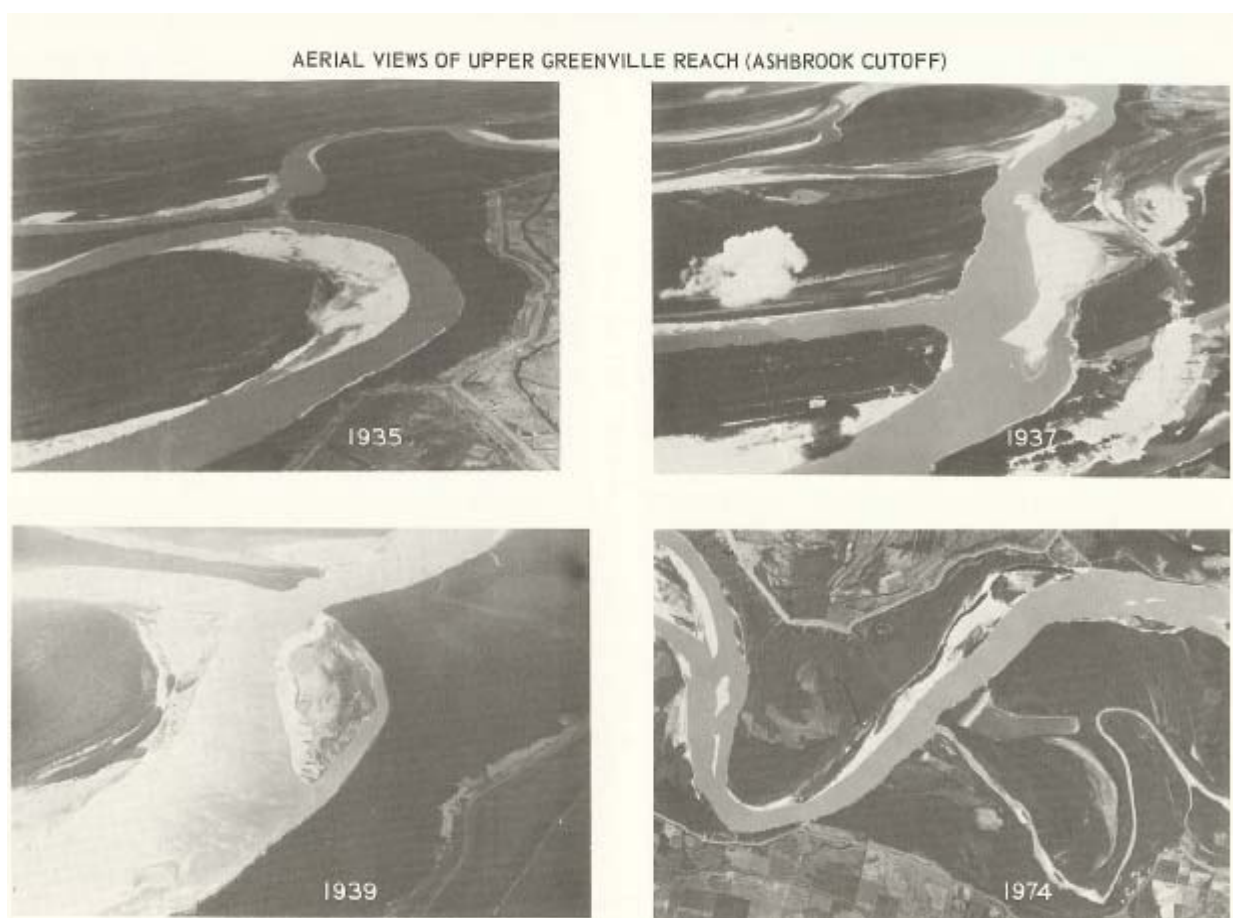
Upper Greenville Reach of the Mississippi River (Winkley 1977)

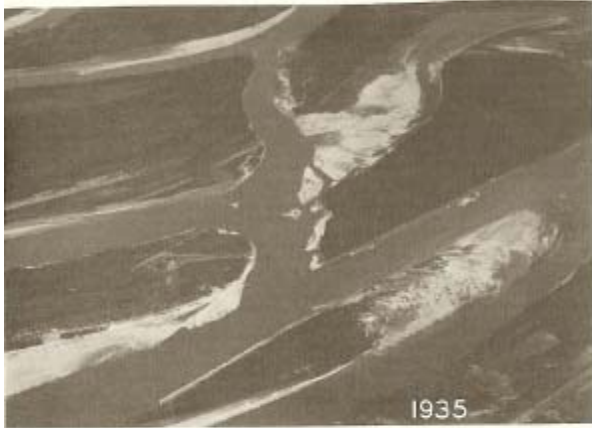
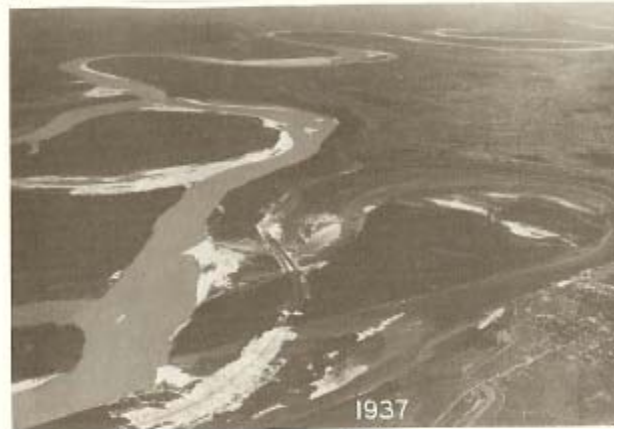
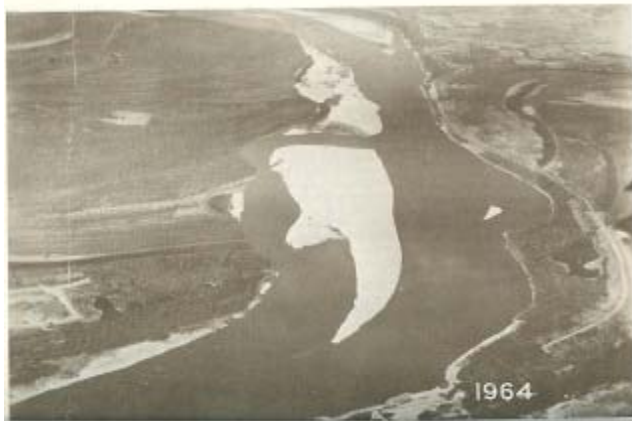
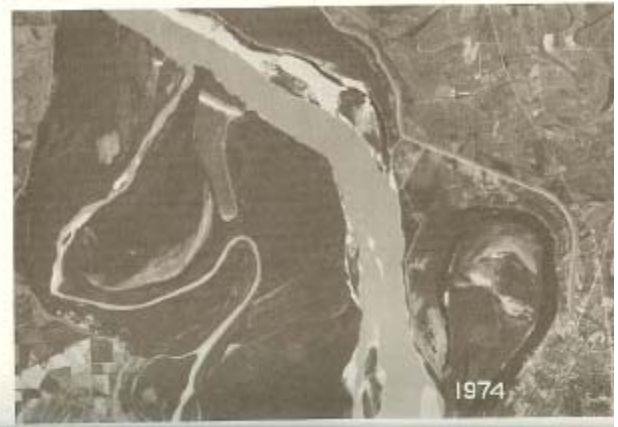
AERIAL VIEWS OF LOWER GREENVILLE REACH (LELAND NECK & TARPLEY CUTOFFS)

Lower Greenville Reach of the Mississippi River (Winkley 1977)
