Troubleshooting and Tuning Tips

Understanding OSD

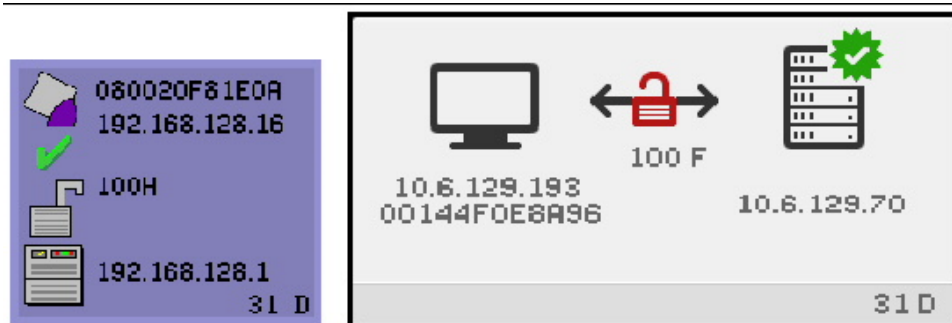
FIGURE B-1 Layout of Old (left) and New (right) OSD Icons

The original OSD supplied with earlier versions of Sun Ray Server Software and DTU firmware have now been replaced with larger icons that provide the same information in an easier to read format. It is always a good idea to make sure that you are using the latest firmware. See [Managing Firmware Versions](#). Both sets of OSD icons are composited live, based on the current state of connectivity at a given moment. Examples of the original OSD are shown at left in the figures below, with equivalent or similar examples of the newer OSD at the right.

The OSD icons display:

- Ethernet address
- Currently assigned IP address of the DTU
- Link status of the currently connected Sun Ray server

- Authentication Server IP address
- Icon code and DHCP state

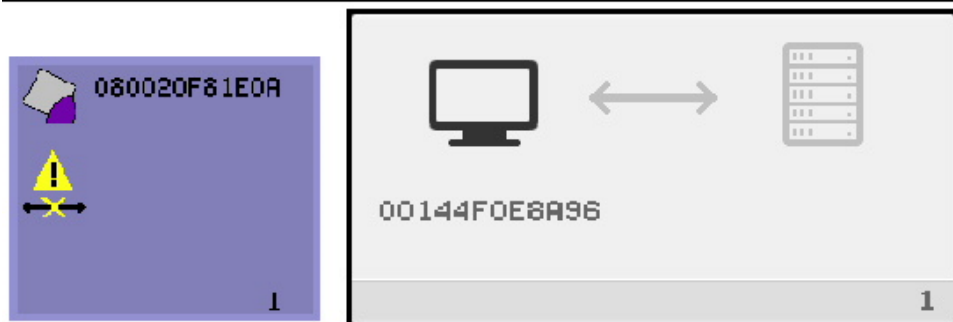
FIGURE B-2 DTU Startup OSD

This icon indicates that the DTU has passed the power-on self test but has not detected an Ethernet signal yet. This icon is displayed as part of the normal startup phase and is usually displayed for only a few seconds.

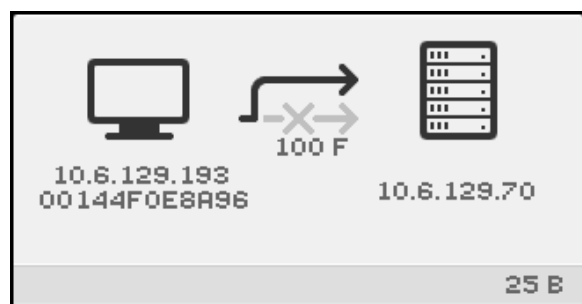
FIGURE B-5 Redirection OSD

This OSD indicates that the DTU is being redirected to a new server. This can occur for any of several reasons, including load balancing.

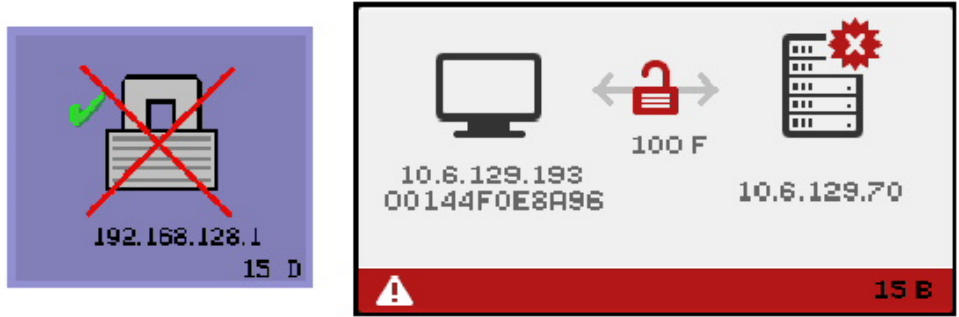
FIGURE B-11 Session Refused by DTU

Icon 15D indicates that the DTU is refusing to connect to a server because it is unable to verify the validity of the Sun Ray server. This error can occur only if an unknown Sun Ray server intercepts the messages and tries to emulate a valid Sun Ray server. This is a session security breach.

A graphically similar icon displaying the number 50 indicates that the server is refusing to grant a session to the DTU because the DTU is unable to fulfill the server's security requirements.

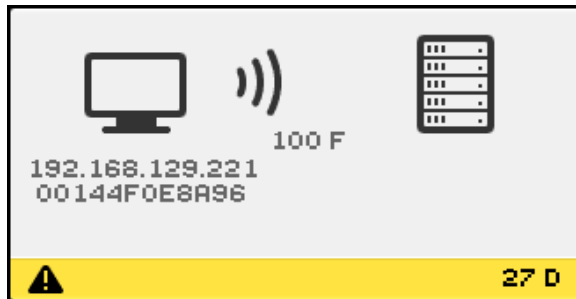
FIGURE B-12 DHCP Broadcast Failure

The following icon is displayed if the DTU is broadcasting to locate a server and either no servers respond or Sun Ray specific DHCP parameters have not been supplied correctly.

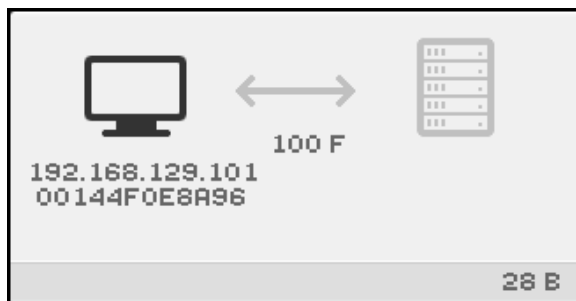
FIGURE B-13 Establishing a VPN Connection

The following icon is displayed while a DTU is trying to establish a VPN connection.

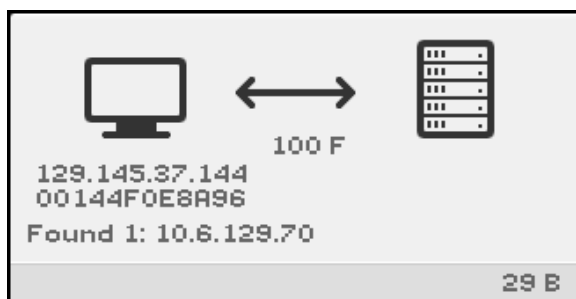
FIGURE B-14 VPN Connection Established

When the VPN connection is established, the following icon is displayed.

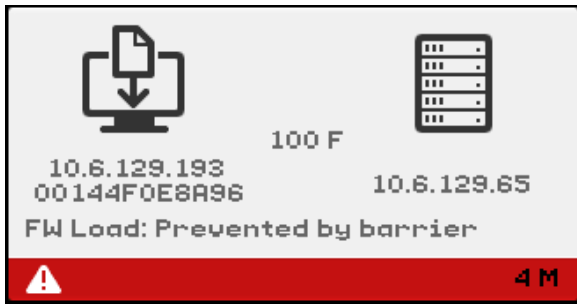
FIGURE B-15 OSD Icon 4 Displays Firmware Download Error Messages

When firmware download error occurs, OSD icon 4 (see [FIGURE B-15](#)) displays the appropriate error code and a descriptive text string. These error codes are listed in [TABLE B-4](#).

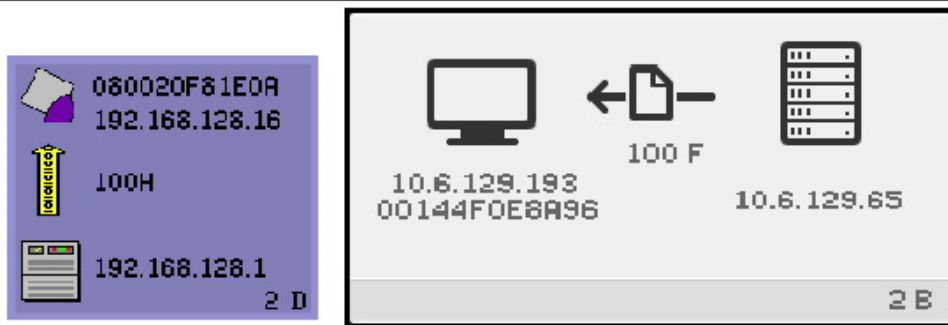
FIGURE B-16 Firmware Download in Progress

This icon indicates that the DTU is currently downloading new flash PROM software from the Sun Ray server.
