MISSISSIPPI RIVER AND TRIBUTARIES

POST - FLOOD REPORT

DEPARTMENT OF THE ARMY
CORPS OF ENGINEERS
LOWER MISSISSIPPI VALLEY DIVISION
Vicksburg, Mississippi

POST-FLOOD REPORT
1973

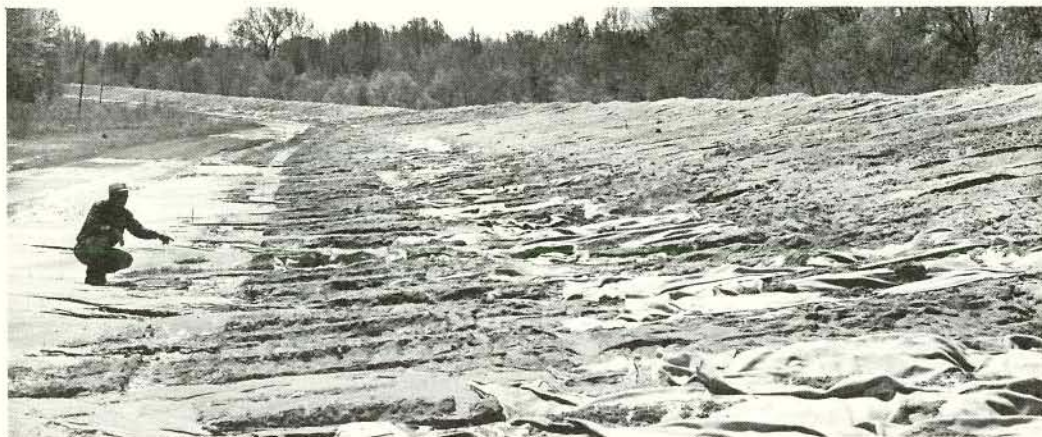
Sny Island drainage district, burlap used to stop erosion caused by seepage on land side of levee upstream from pump station No. 1, looking downstream, 28 April 1973

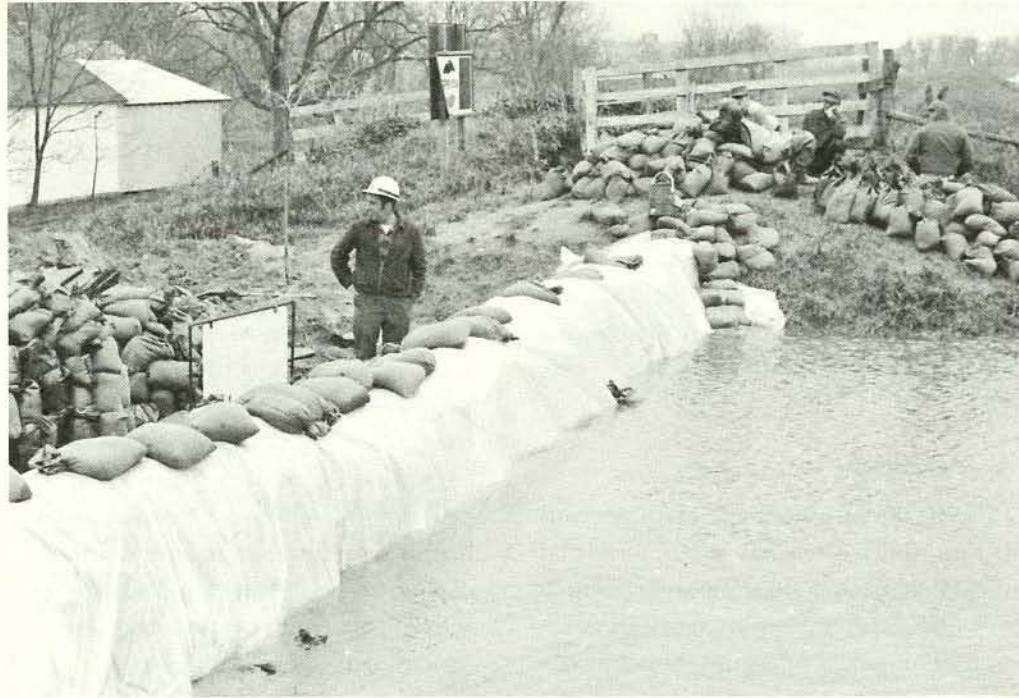
Kampsville Ferry Landing closure, Highway 108 and Eldred levee, 26 April 1973

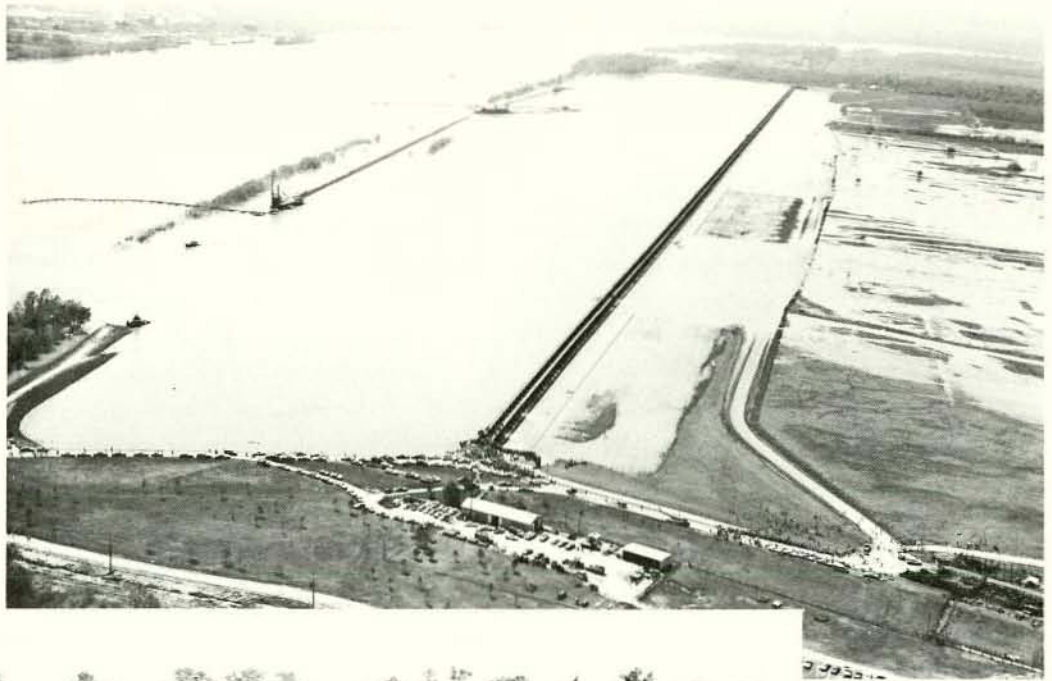
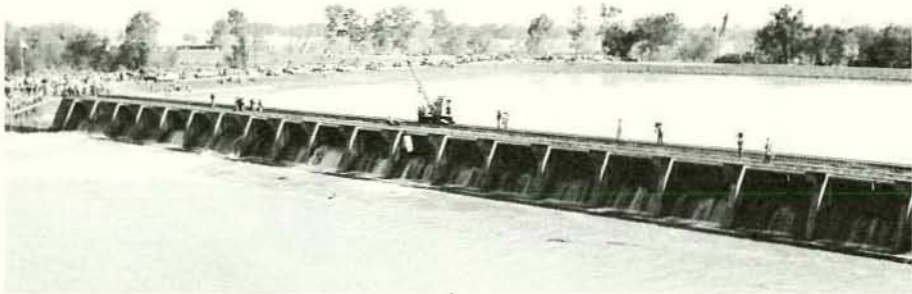
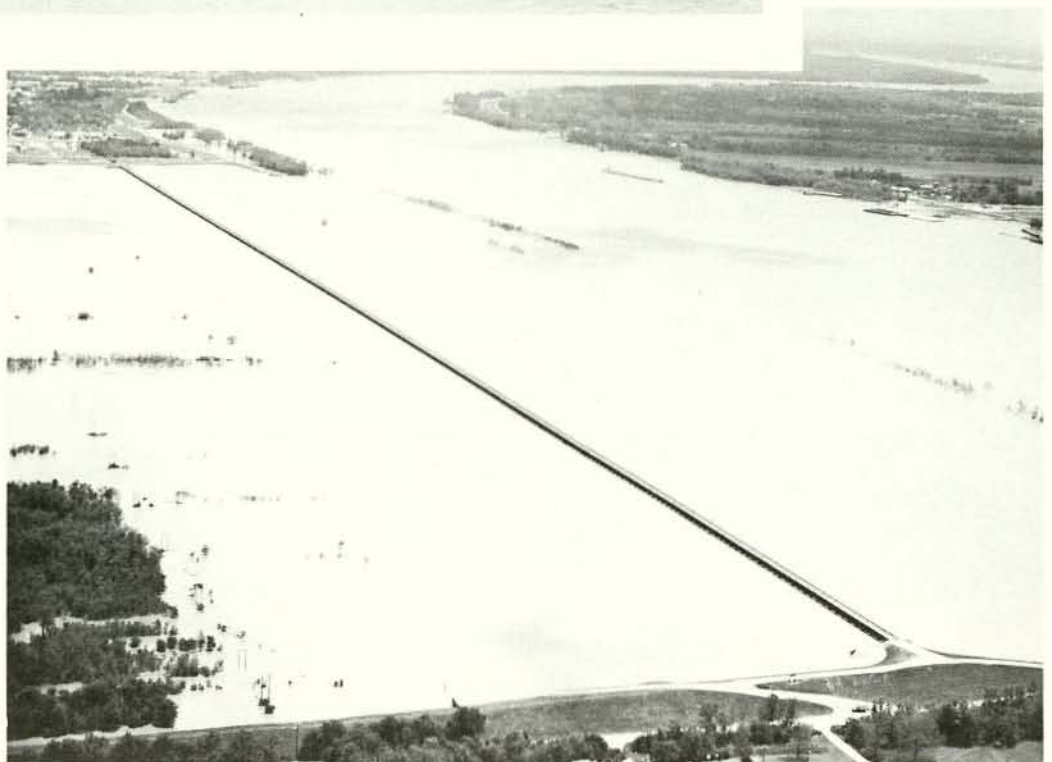
BONNET CARRÉ SPILLWAY OPENING

Bonnet Carré Spillway—Bonnet Carré Spillway is located 25 miles above New Orleans, Louisiana, and is designed to convey 250,000 cfs from the Mississippi River to the Gulf via Lake Pontchartrain. Early in February, dredging to remove routine siltation was begun in the forebay area preparing for the possible future use of the spillway. A second dredge began work on 18 March, and on 3 April the third dredge began degrading the sedimentation levee in front of the structure. The spillway opening began on 8 April and continued until all 350 bays were opened on

11 April. Operation was successful in preventing excessive flows past New Orleans. The maximum diversion of flow through the spillway was 195,000 cfs. The spillway remained fully open until 31 May 1973, when it was closed in conjunction with the closing of the Morganza Floodway Structure at a rate which would not increase the stage on the Carrollton (New Orleans) gage. This was the fourth time that the spillway had been used since it was constructed in 1931, having been previously used in 1937, 1945, and 1950.

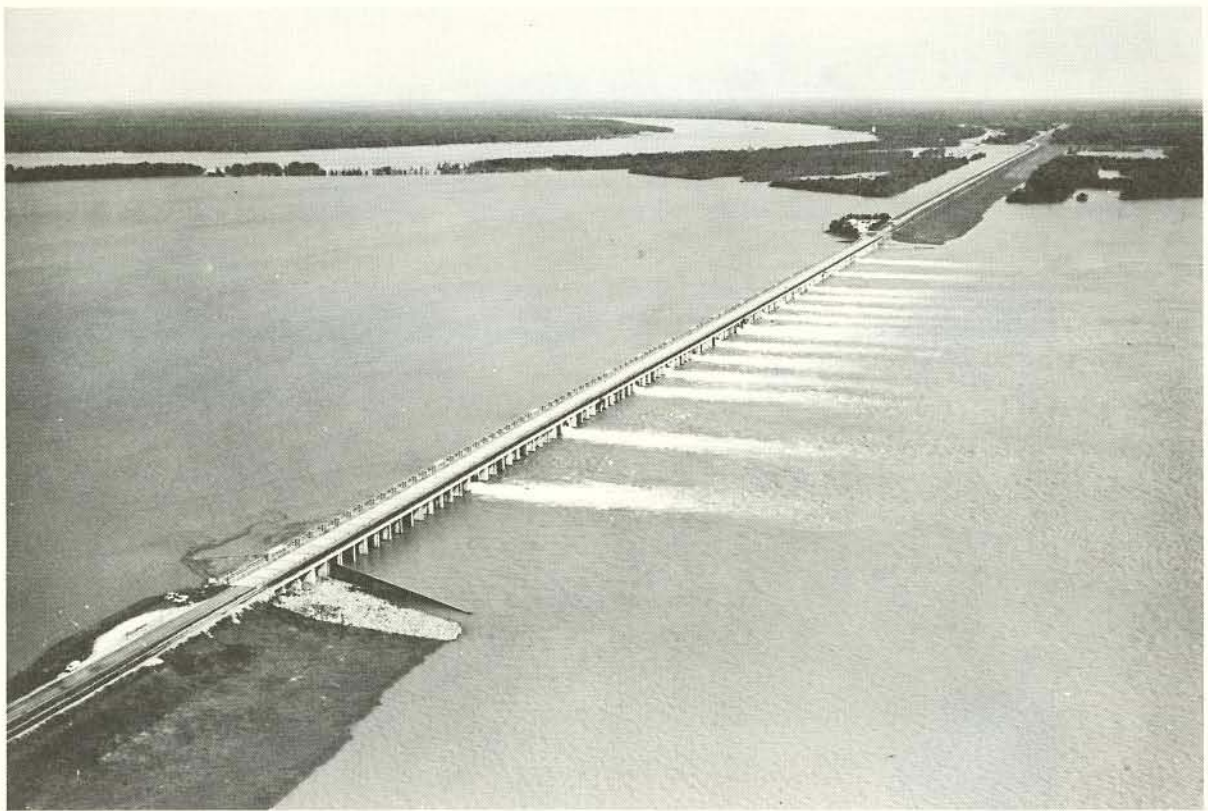
Morganza Control Structure during operation

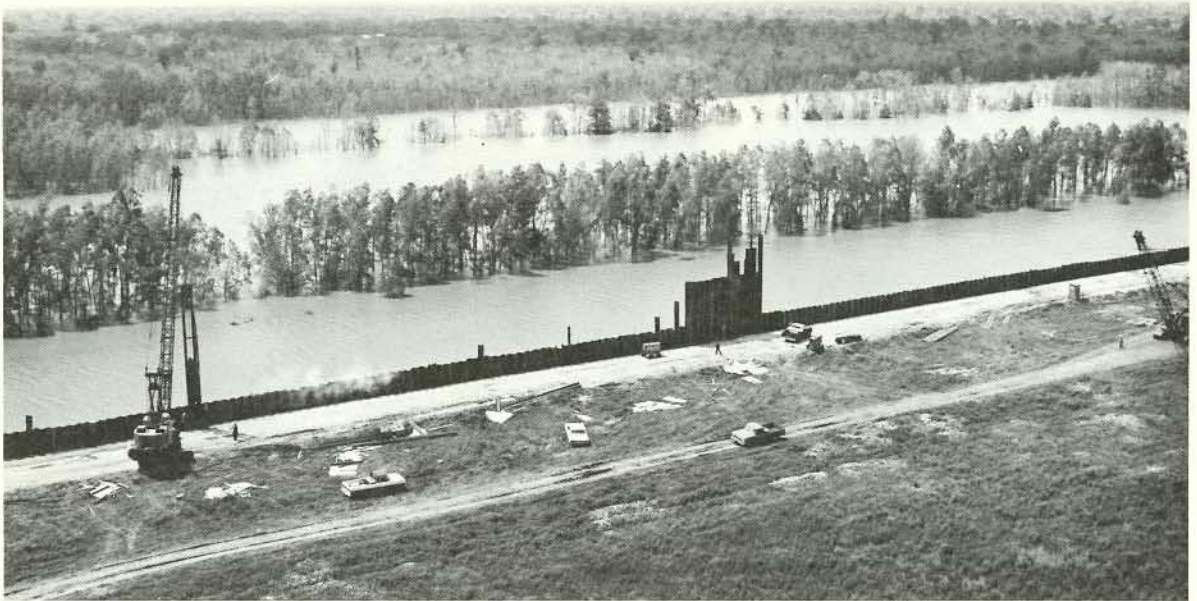
Steel sheet piling used north of Morgan City, Louisiana, East Atchafalaya Basin protection levee

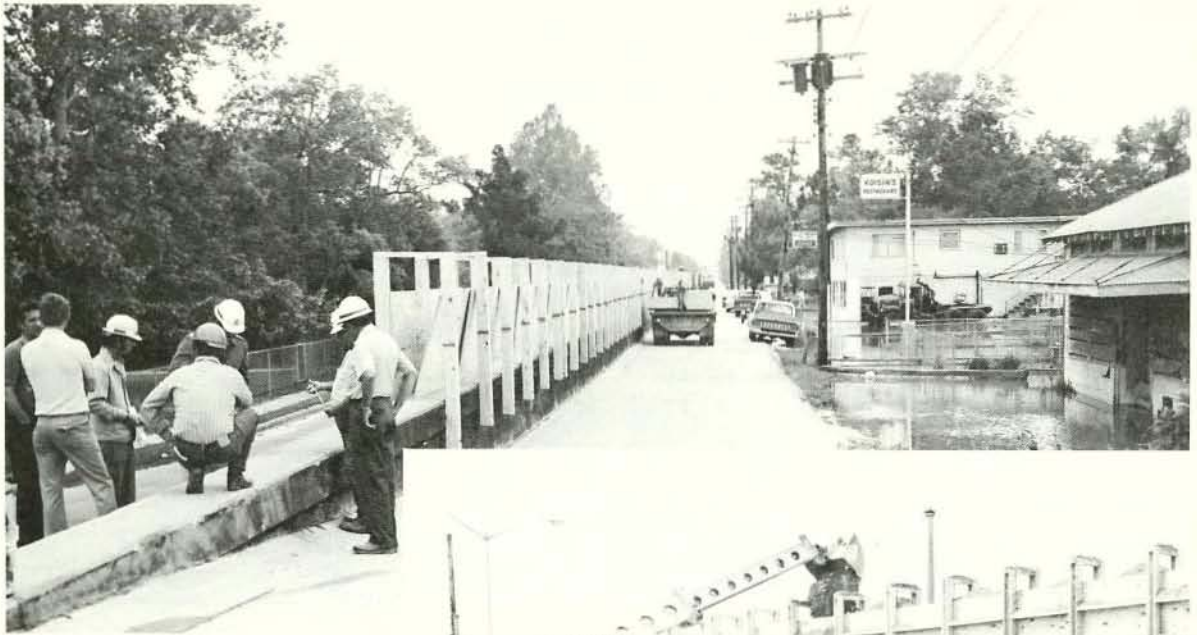
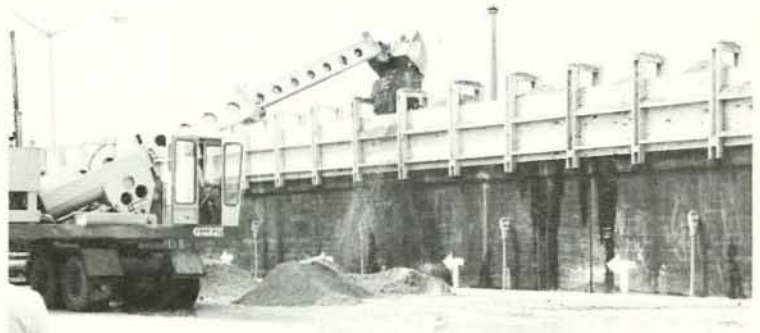
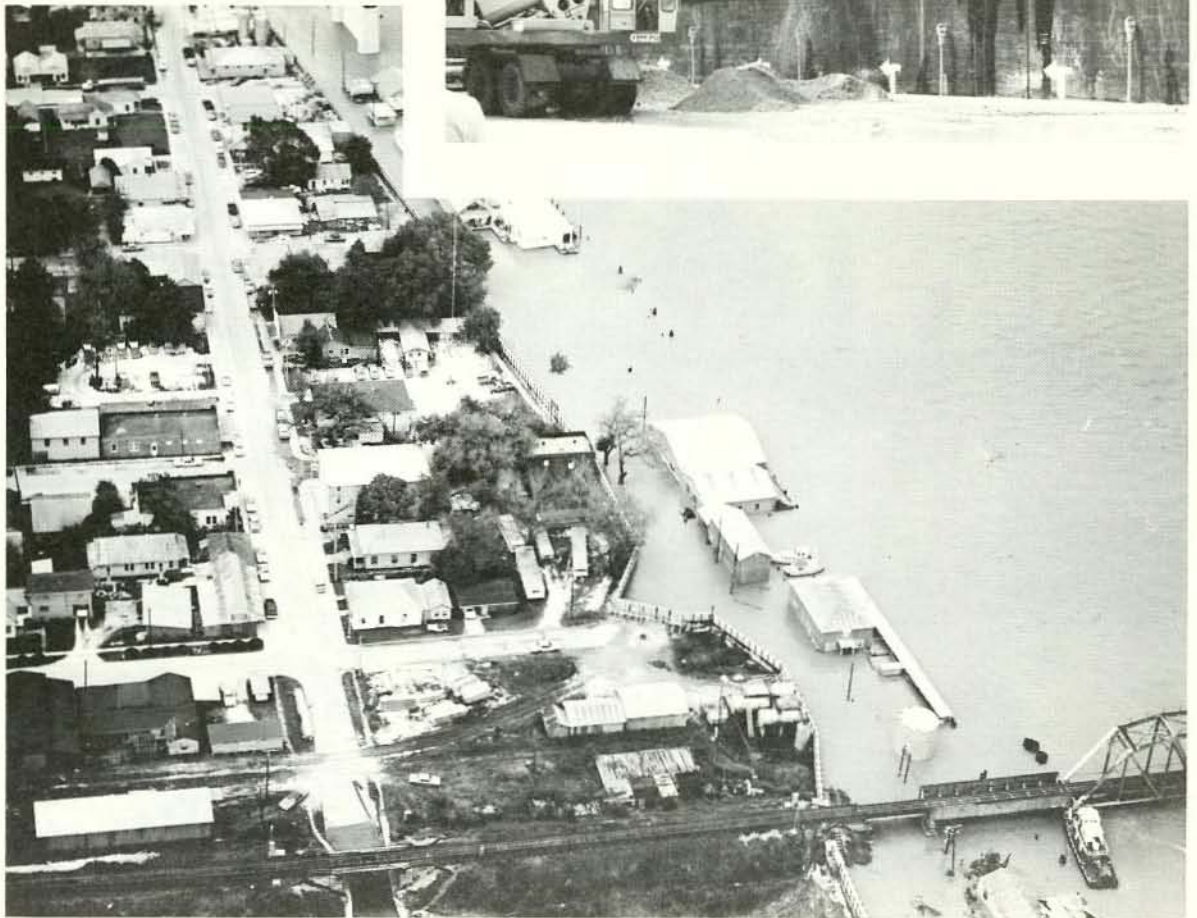
MORGAN CITY, LOUISIANA

Mudboxes atop floodwall

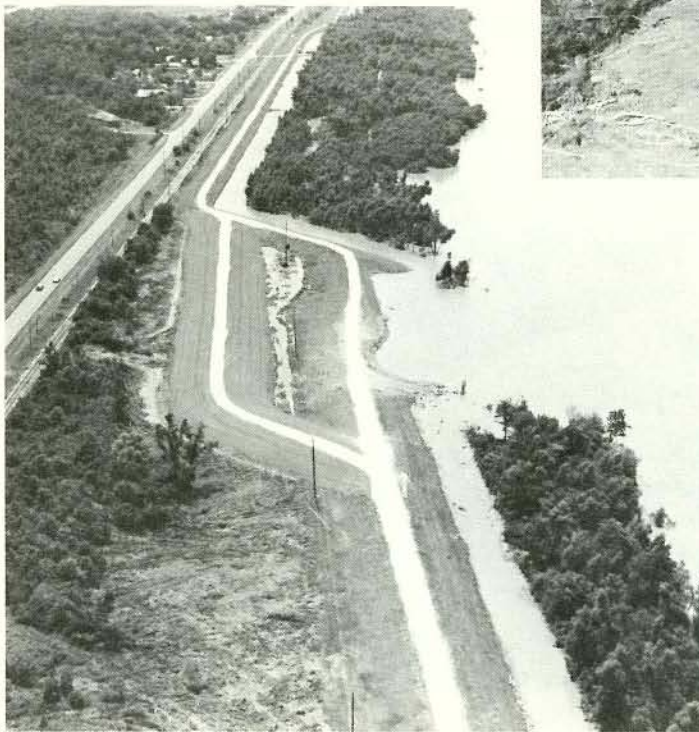
Bank failure and construction of levee setback, mile 35 AHP, Mississippi River levee, vicinity of Nairn, Louisiana

Nairn levee setback completed, right descending bank of the Mississippi River

material and construct a setback levee. There were four setback levees constructed during the flood emergency in the Lower Mississippi Valley. The northernmost one was at Pointe Pleasant, mile 205; the others were located at miles 130, 86, and 35 on the Mississippi River above Head of Passes, Louisiana. Three additional setback levees were required as a result of bank failures after the flood water receded.

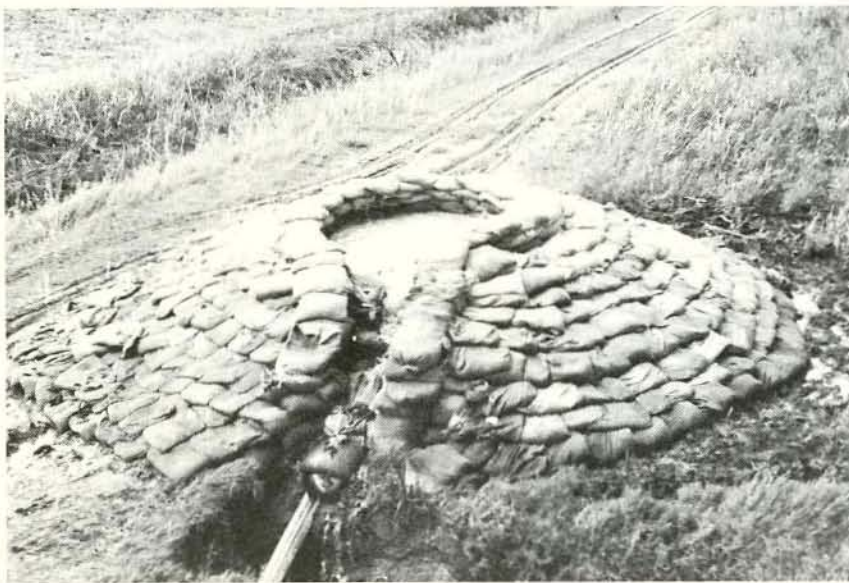
Typical example of a sand boil, ringed with sandbags to create enough head to slow the flow

1973 throughout the entire flood area. The most common method of combatting seepage erosion of levee slopes is to excavate lateral drains to collect the water and lead it away from the affected area. Sand boils are normally ringed either by sandbags or in some cases by metal drums or other means to provide a ring around the boil, and thus create a head to reduce the flow of water so that it carries no material. If the flow of water is not carrying material, a boil normally requires no protective measures. If a boil is ringed to create a head, the head should not be excessive, and no attempt is made to completely stop the flow of water because it will break out elsewhere. Wave wash on the river side of the levees is a common problem during flooding. The wave action at the waterline tends to scour and erode into the levee section. One of the most common methods of combatting wave wash is by placing sandbags at the waterline. This is not always satisfactory, because the wave action, if violent enough, will remove the sand from burlap bags. The newer style close-woven plastic bags were found to perform better as wave-wash protection than traditional burlap or open-mesh plastic bags. Another method of protecting against wave wash

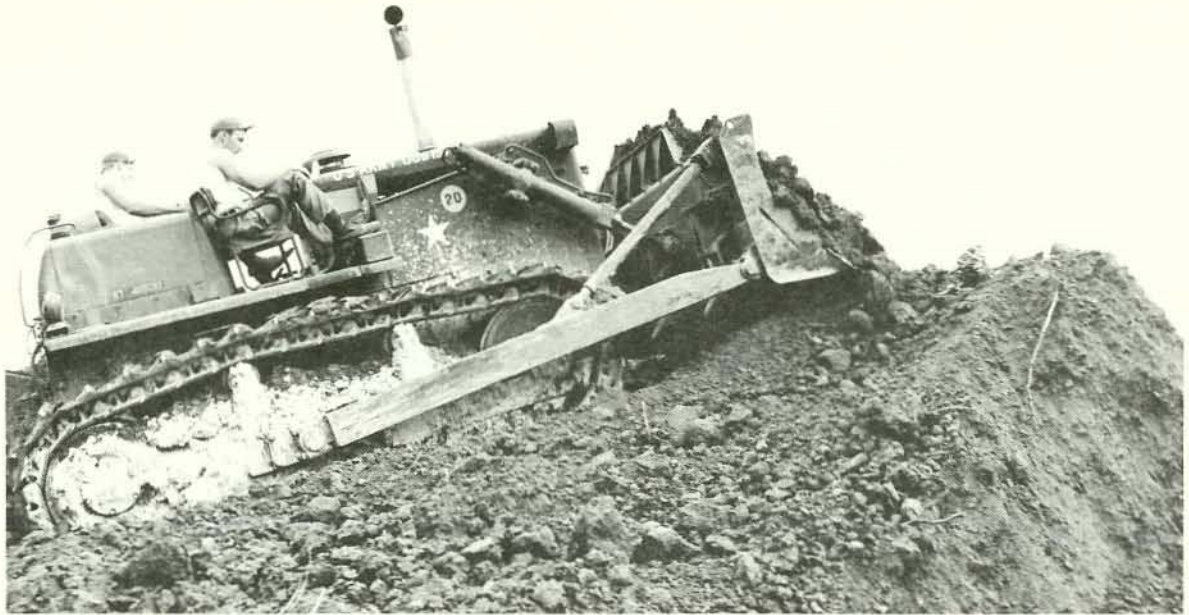
Bulldozers operated by 62d Engineer Battalion were effective in levee-raising operations, Morgan City, Louisiana
